# Harness Structural test Report - EN

Inspection certificate number: **PH\_359.2022**

Name: **Twin 2**  
 Type: **ABS**  
 Size: **L**  
 Serial number: **2752-13-5715**  
 Impact pad type: <sup>(1)</sup> **Foam**  
 Clip-in weight [kg]: **120**

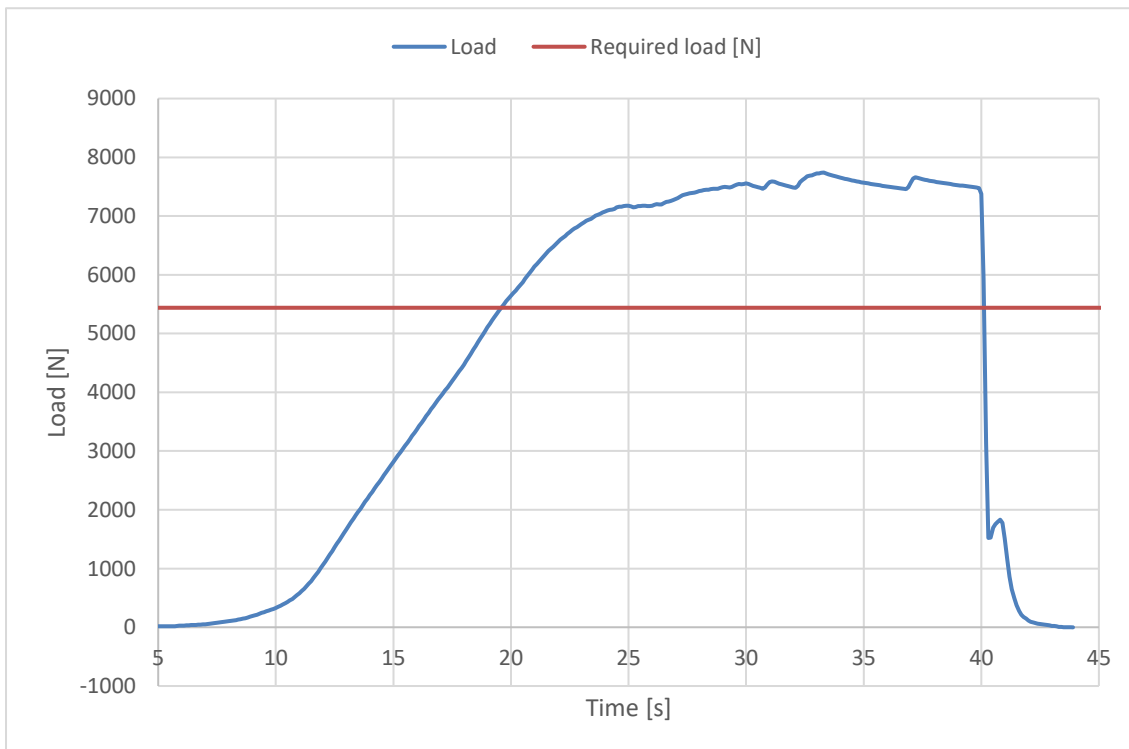
**Test ID 01**

Standard	<b>EN 1651</b>
Reference in standard	<b>5.5.1.1</b>
Test setup	<b>Positive symmetric load (Slippage)</b>
Attachment points	<b>Both main riser attachment (3,4)</b>
Anchor points	<b>Dummy (B1, B2)</b>
Required load [g]	<b>4.5</b>
Required load [N]	<b>5400</b>
Minimum test duration [s]	<b>5</b>
<b>Result</b>	
Test duration [s]	<b>20.6</b>
Any signs of structural failure	<b>No</b>
Slippery test OK	<b>Yes</b>
Test results	<b>POSITIVE</b>

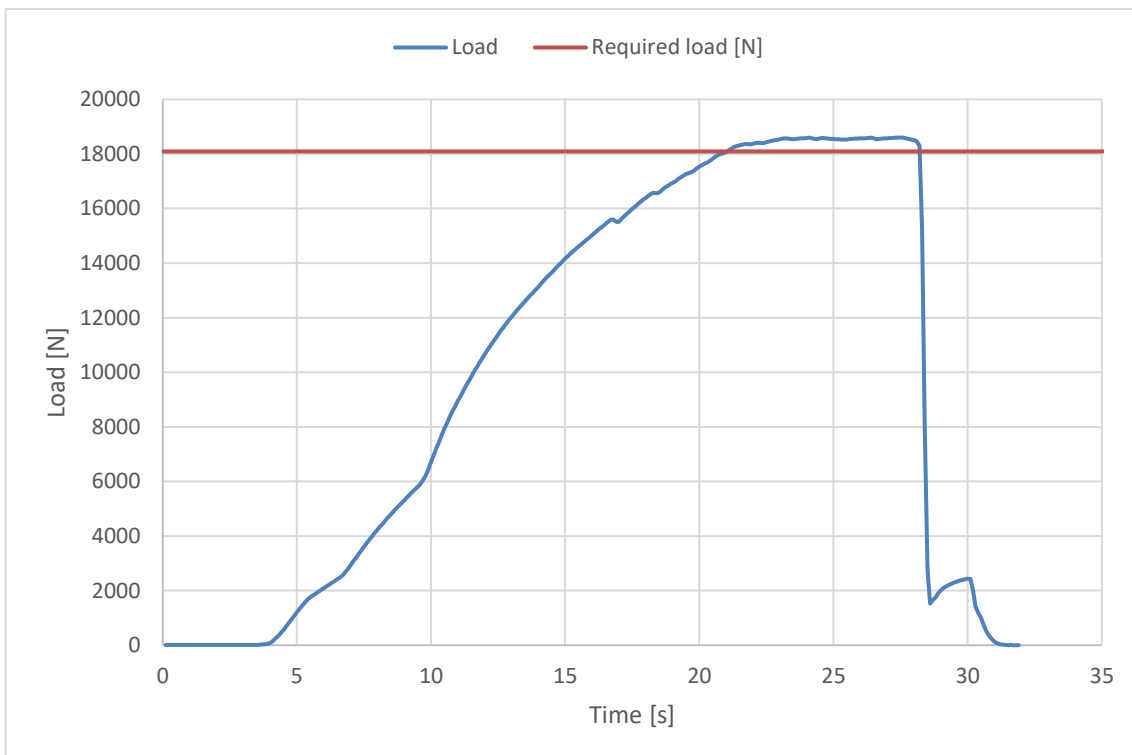
**Test ID 03**

Standard	<b>EN 1651</b>
Reference in standard	<b>5.5.1.1b</b>
Test setup	<b>Positive symmetric load</b>
Attachment points	<b>Both main riser attachment (3,4)</b>
Anchor points	<b>Dummy (B1, B2)</b>
Required load [g]	<b>15</b>
Required load [N]	<b>18000</b>
Minimum test duration [s]	<b>5</b>
<b>Result</b>	
Test duration [s]	<b>7.2</b>
Any signs of structural failure	<b>No</b>
Slippery test OK	<b>Yes</b>
Test results	<b>POSITIVE</b>

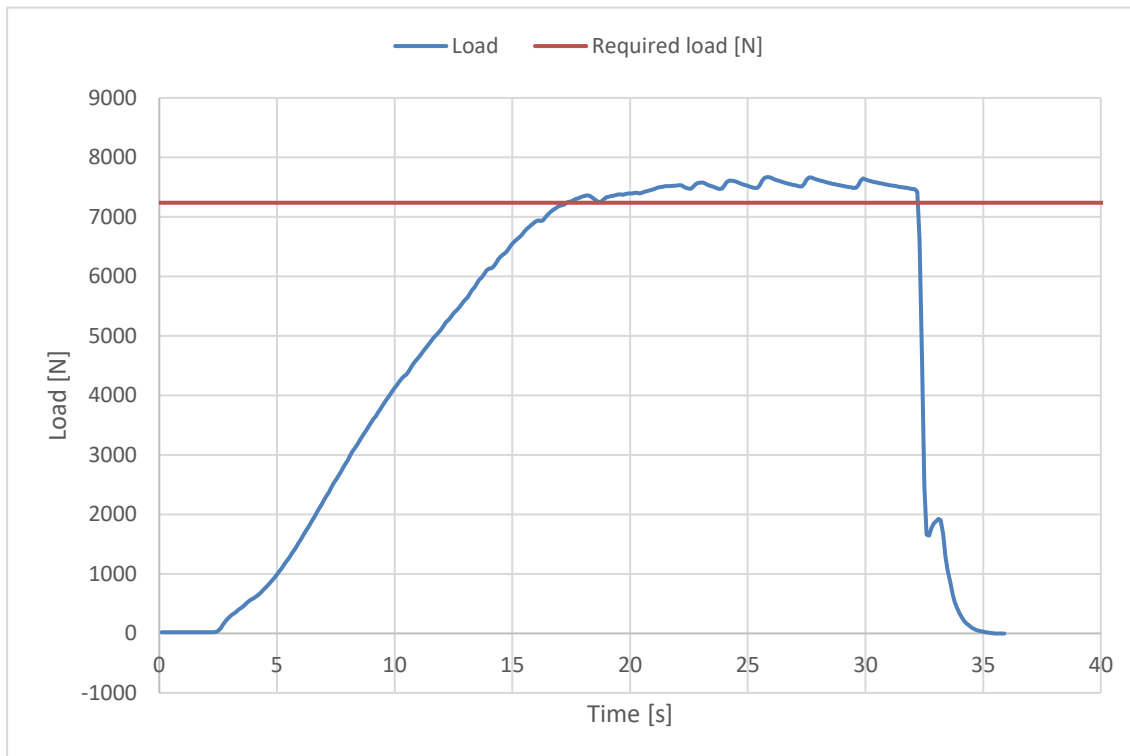
**Test ID 05**

Standard	<b>EN 1651</b>
Reference in standard	<b>5.5.1.2</b>
Test setup	<b>Positive asymmetric load</b>
Attachment points	<b>One riser attachment (3 or 4)</b>
Anchor points	<b>Dummy (C)</b>
Required load [g]	<b>6</b>
Required load [N]	<b>7200</b>
Minimum test duration [s]	<b>5</b>
<b>Result</b>	
Test duration [s]	<b>14.9</b>
Any signs of structural failure	<b>No</b>
Test results	<b>POSITIVE</b>

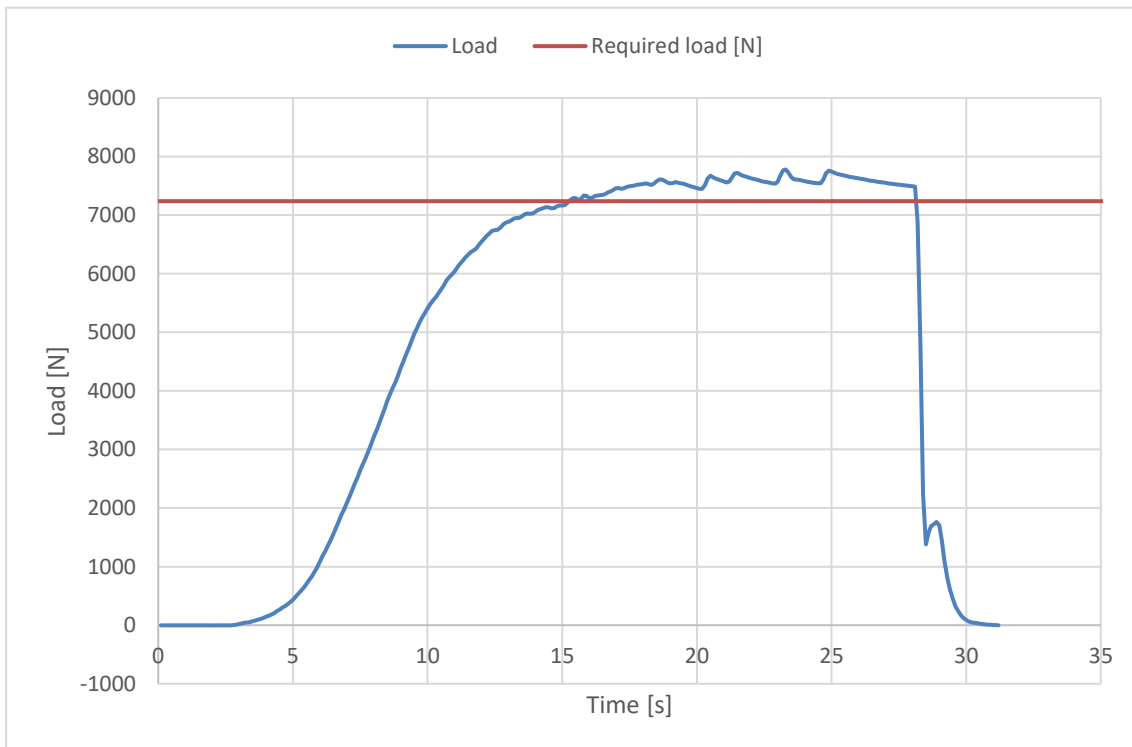
**Test ID 06**

Standard	<b>EN 1651</b>
Reference in standard	<b>5.5.1.6</b>
Test setup	<b>Negative symmetric load</b>
Attachment points	<b>Both main riser attachment (3,4)</b>
Anchor points	<b>Dummy (A)</b>
Required load [g]	<b>6</b>
Required load [N]	<b>7200</b>
Minimum test duration [s]	<b>5</b>
<b>Result</b>	
Test duration [s]	<b>12.9</b>
Any signs of structural failure	<b>No</b>
Test results	<b>POSITIVE</b>

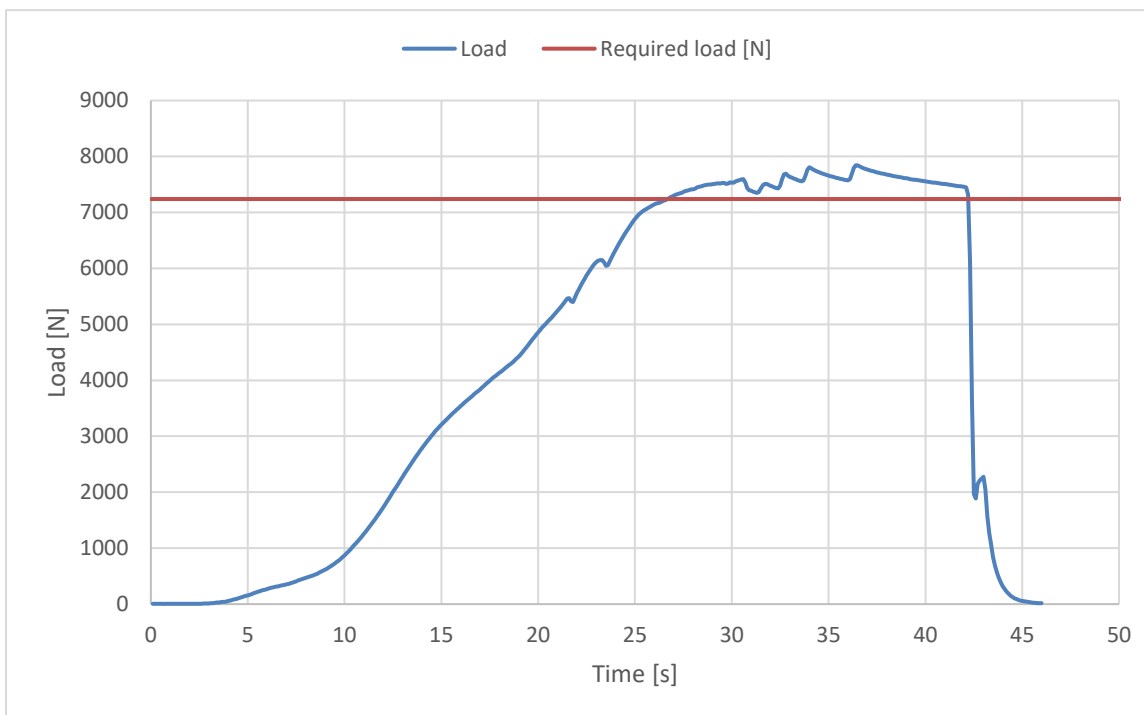
**Test ID 12**

Standard	<b>EN 1651</b>
Reference in standard	<b>5.5.1.7</b>
Test setup	<b>Upright (landing) position load</b>
Attachment points	<b>Both main riser attachment (3, 4)</b>
Anchor points	<b>Both legstrap of harness (no dummy)</b>
Required load [g]	<b>6</b>
Required load [N]	<b>7200</b>
Minimum test duration [s]	<b>5</b>
Harness type	<b>type c</b>
<b>Result</b>	
Test duration [s]	<b>15.6</b>
Any signs of structural failure	<b>No</b>
Slippery test OK	<b>Yes</b>
Test results	<b>POSITIVE</b>

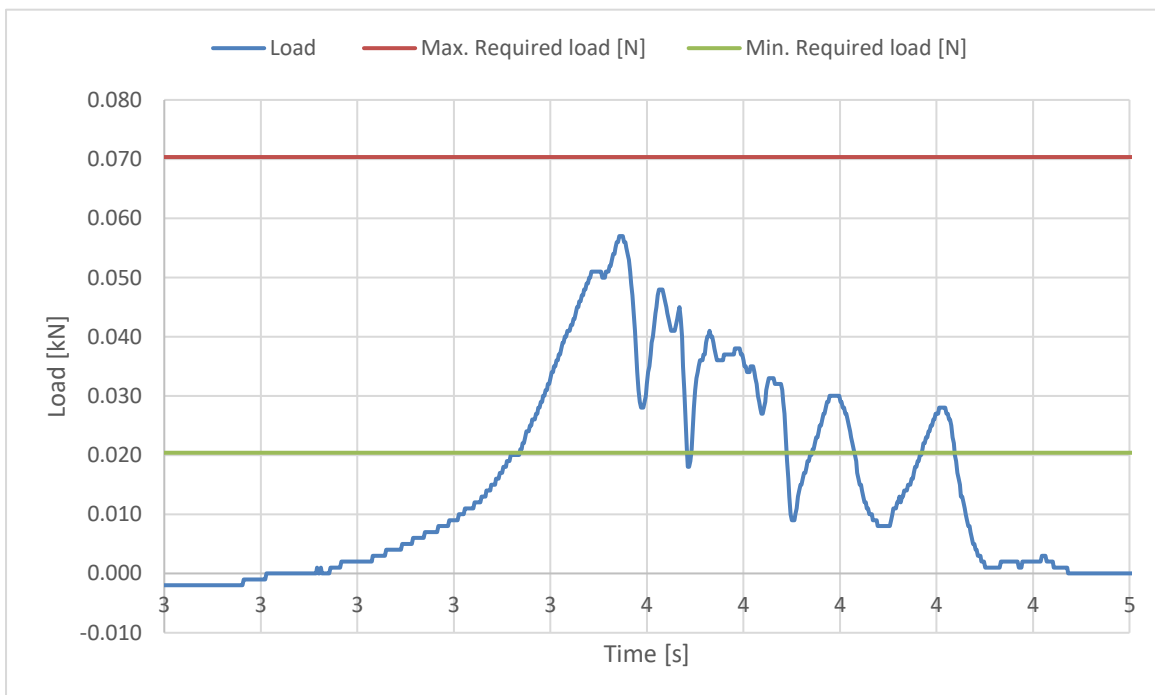
**Test ID RRDT**

Load for first action [N]	<b>57.38</b>
Test results	<b>POSITIVE</b>

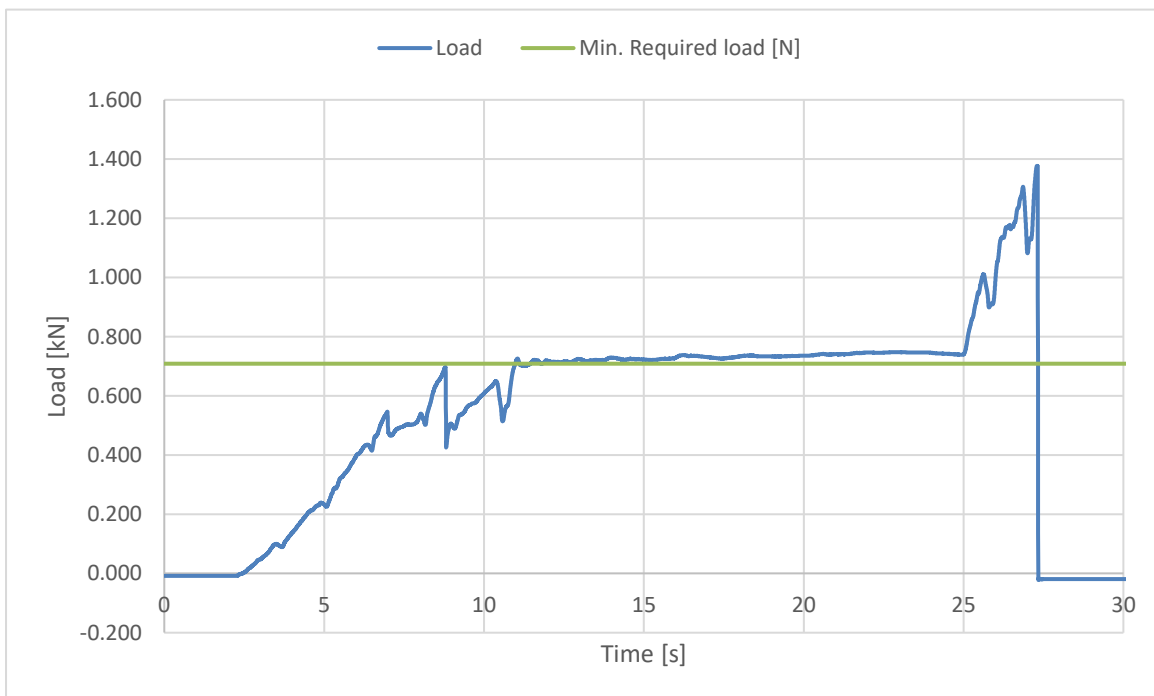
**Test ID RRST**

Standard	<b>EN 12491</b>
Reference in standard	<b>5.3.2</b>
Test setup	<b>Two end points of handle</b>
Attachment points	<b>Sensor connect to end of handle, pull on the other side</b> The handle must support min 700 N for 10 s, after measure breaking strength
Min. Required load [N]	<b>700</b>
Minimum test duration [s]	<b>10</b>
<b>Result</b>	
Test duration [s]:	<b>15.5</b>
Breaking strength [N]	<b>1367.85</b>
Test results	<b>POSITIVE</b>
