## Harness Structural test Report - NfL

Inspection certificate number: **PH\_360.2022**

Name: **A1**  
 Type: **ABS**  
 Size: **M**  
 Serial number: **A1-002**  
 Impact pad type: <sup>(1)</sup> **Foam**  
 Clip-in weight [kg]: **130**  
 Integrated container: **Yes**

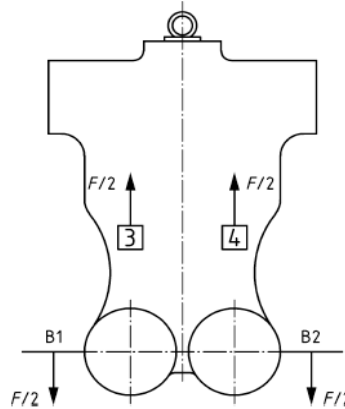
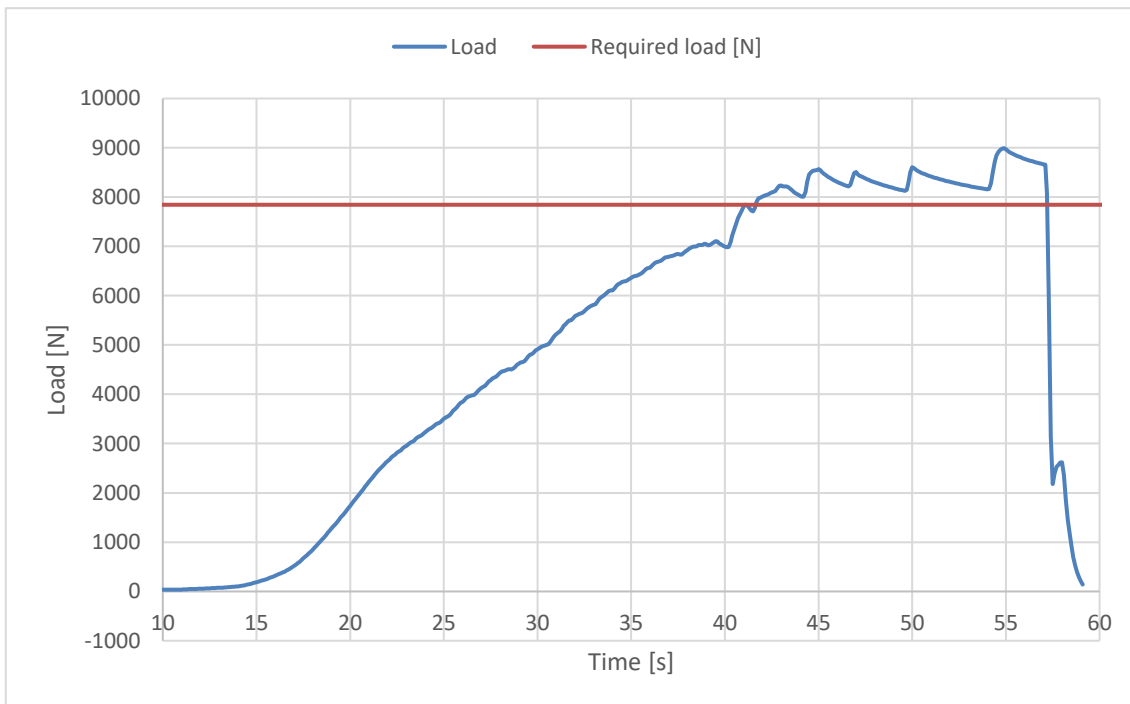
**Test ID 02**

Standard **NfL 2-565-20**  
 Reference **5.3.2.1**  
 Test setup **Default flying position**  
 Attachment points **Both main riser attachment (3,4)**  
 Anchor points **Dummy (B1, B2)**

Required load [g] **6**  
 Required load [N] **7800**  
 Minimum test duration [s] **10**

Test duration [s] **15.6**  
 Any signs of structural failure **No**  
 Test results **POSITIVE**

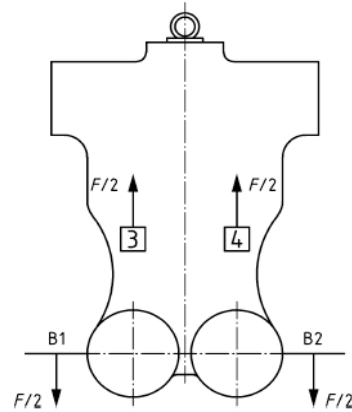
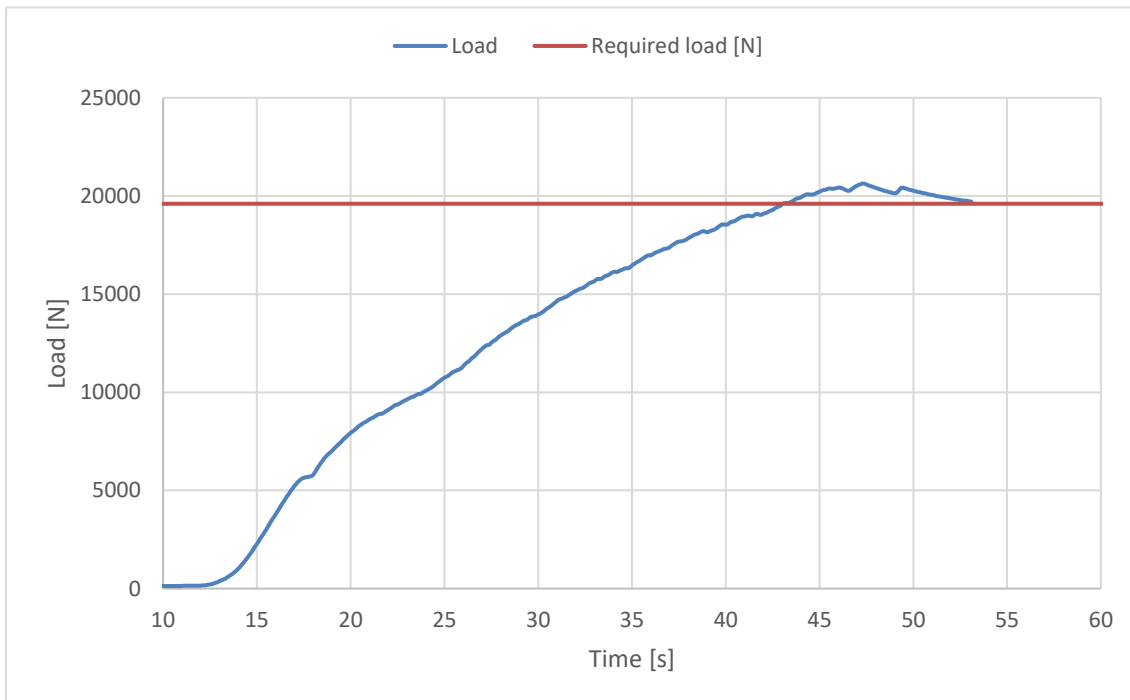
**Test ID 03**

Standard **NfL 2-565-20**  
 Reference **5.3.2.2**  
 Test setup **Default flying position**  
 Attachment points **Both main riser attachment (3,4)**  
 Anchor points **Dummy (B1, B2)**

Required load [g] **15**  
 Required load [N] **19500**  
 Minimum test duration [s] **5**

Test duration [s] **10.1**  
 Any signs of structural failure **No**  
 Test results **POSITIVE**

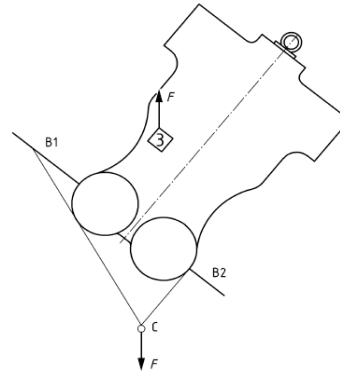
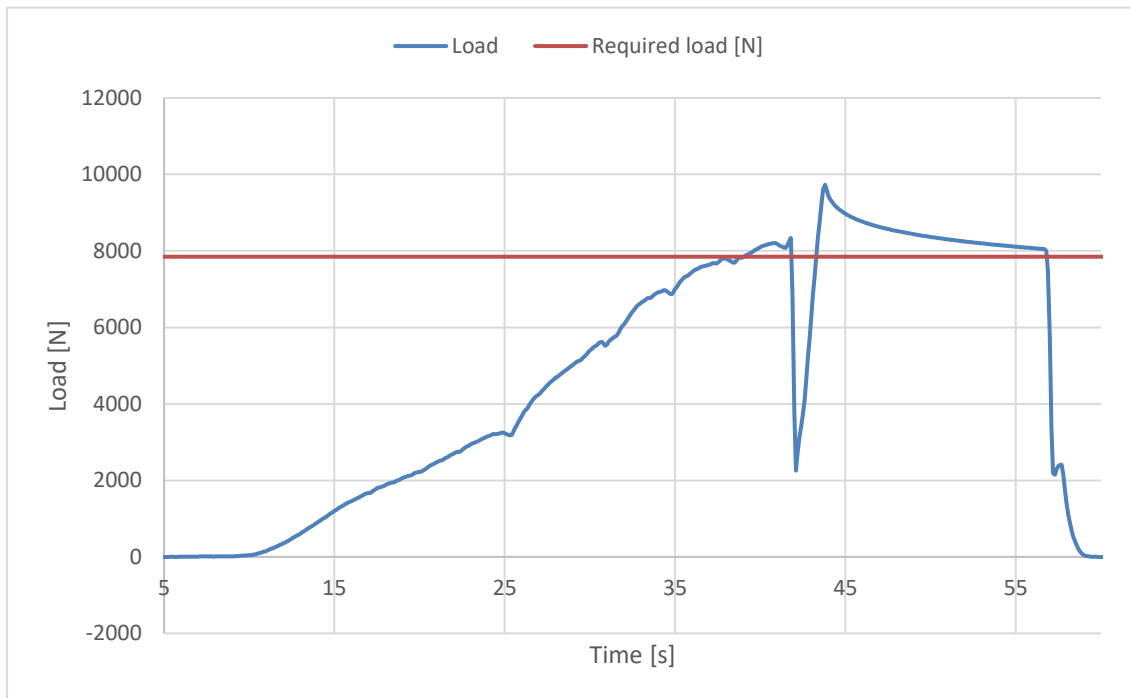
**Test ID 04**

Standard **NfL 2-565-20**  
 Reference **5.3.2.3**  
 Test setup **Asymmetric, one riser**  
 Attachment points **One main riser attachment (3)**  
 Anchor points **Dummy (B1,B2)**

Required load [g] **6**  
 Required load [N] **7800**  
 Minimum test duration [s] **10**

Test duration [s] **13.6**  
 Any signs of structural failure **No**  
 Test results **POSITIVE**

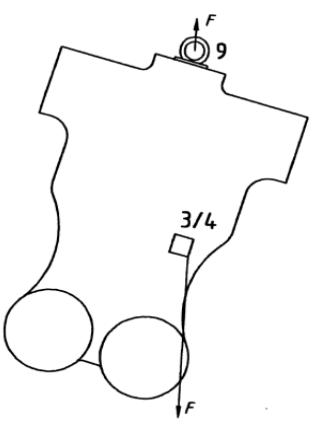
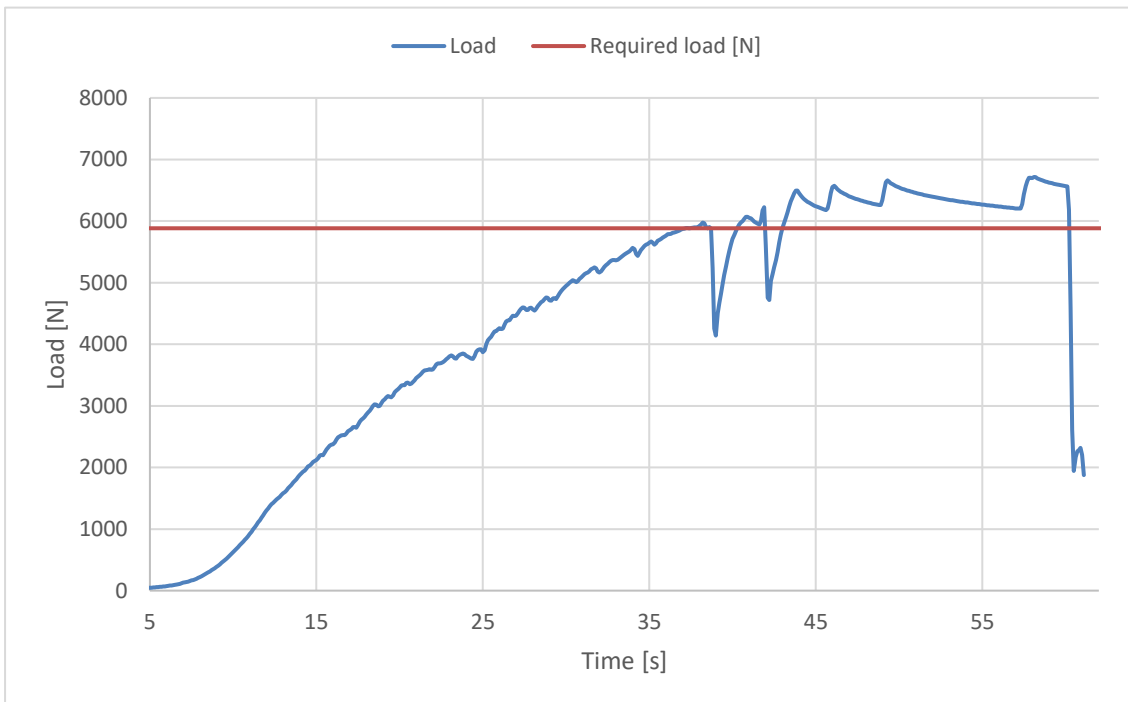
**Test ID 07**

| Test setup | <b>Asymmetric, negative</b> | |
| Attachment points | <b>One main riser attachment (3 or 4) downwards</b> | |
| Any signs of structural failure | <b>No</b> | |
| Test results | <b>POSITIVE</b> | |

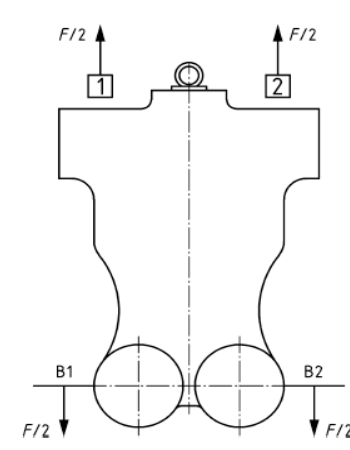
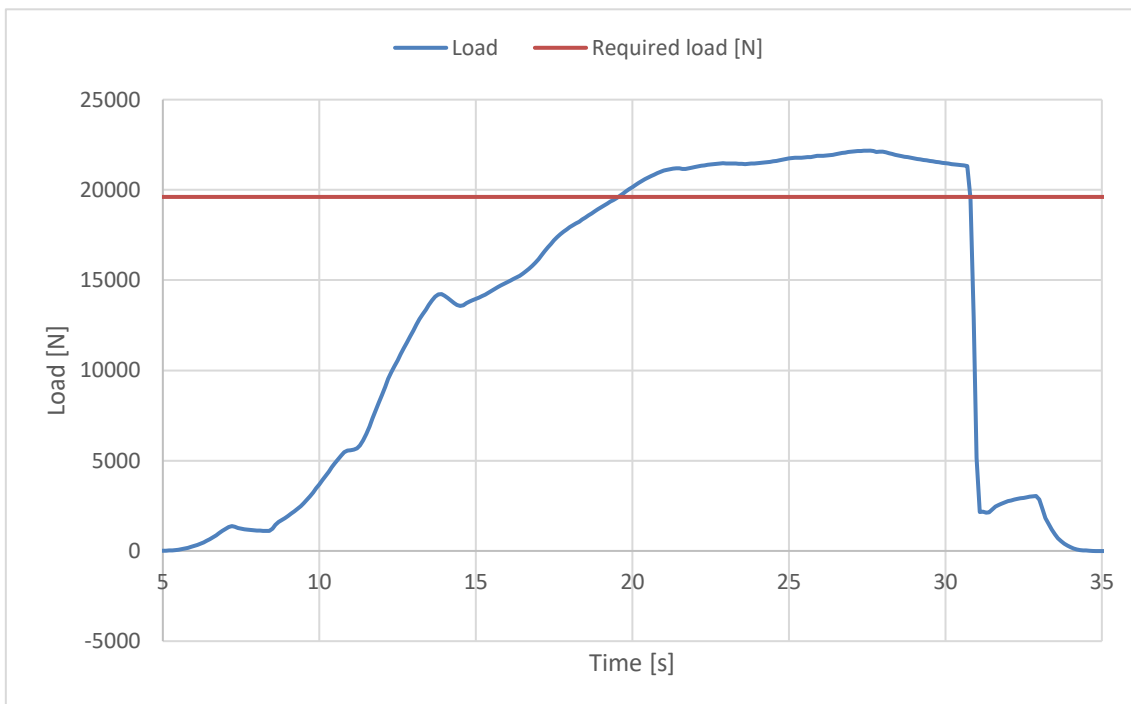
**Test ID 09**

| Test setup | <b>Rescue attachments</b> | |
| Attachment points | <b>Rescue riser attachment (1,2)</b> | |
| Any signs of structural failure | <b>No</b> | |
| Test results | <b>POSITIVE</b> | |

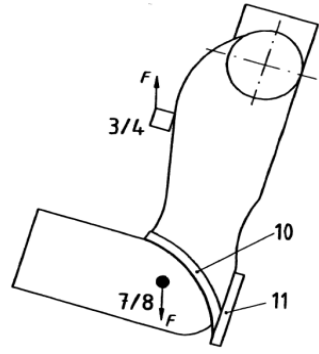
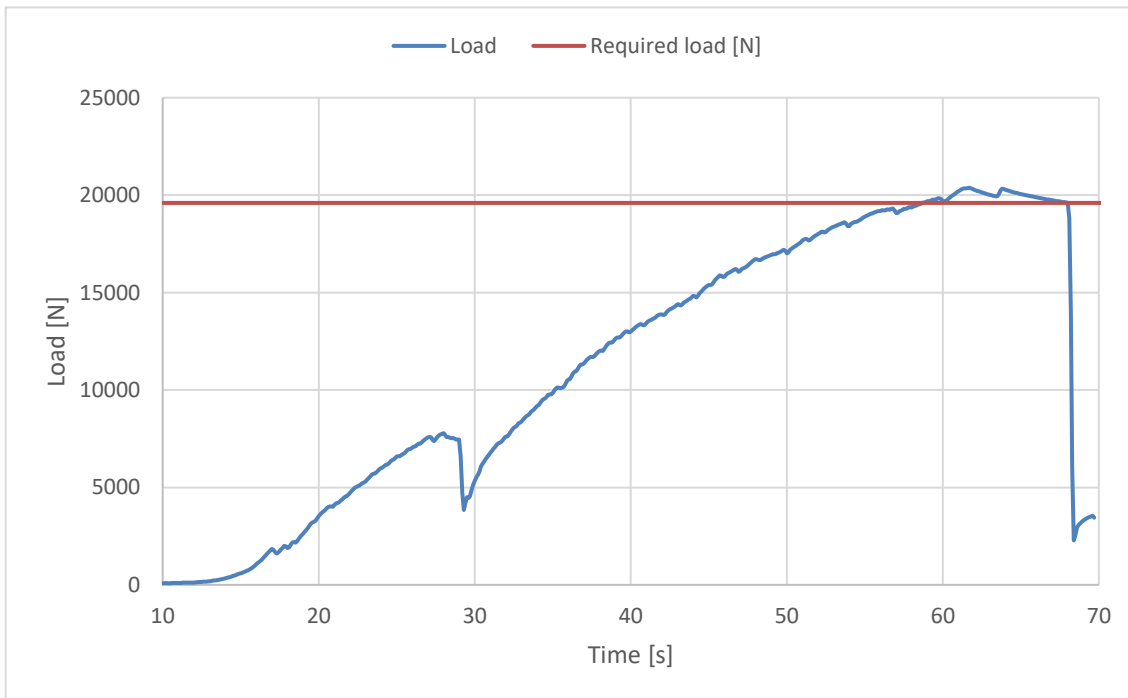
**Test ID 13**

| Test setup | <b>Flying position before landing</b> |
| Attachment points | <b>Both main riser attachment (3,4)</b> |
| Any signs of structural failure | <b>No</b> |
| Test results | <b>POSITIVE</b> |

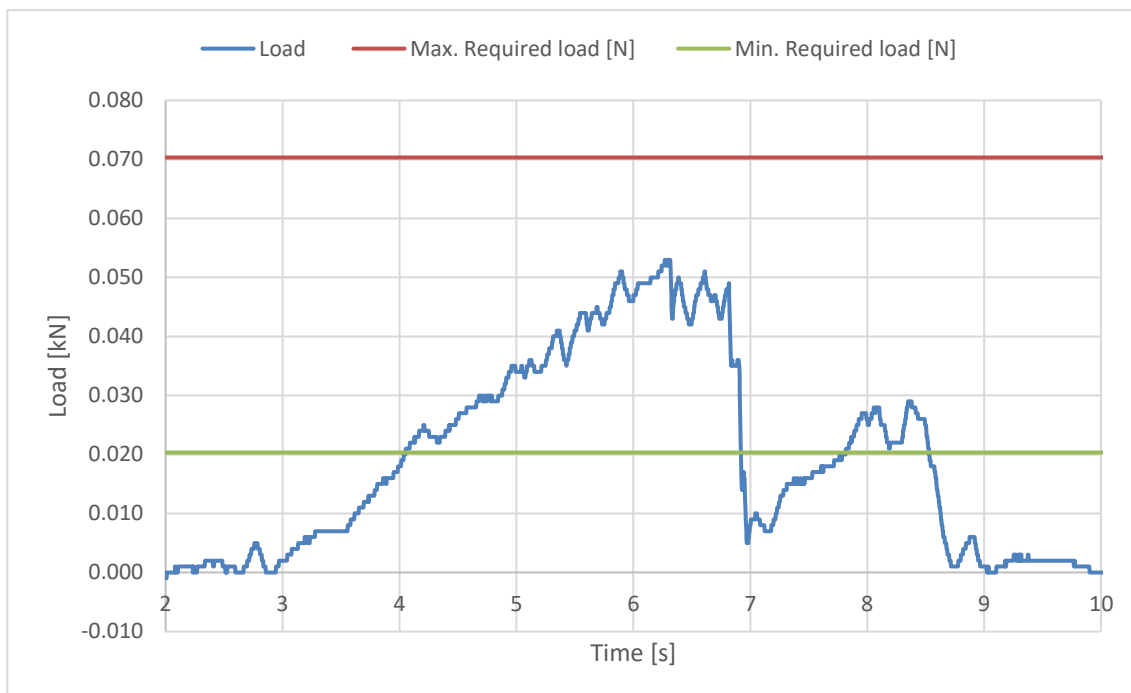
**Test ID RRDT**

| Attachment points | <b>Sensor connect to handle, and pull in opening direction</b><br>The test is to simulate the load required to open the emergency parachute(1st action). |
| Load for first action [N] | <b>52.65</b> |
| Test results | <b>POSITIVE</b> |

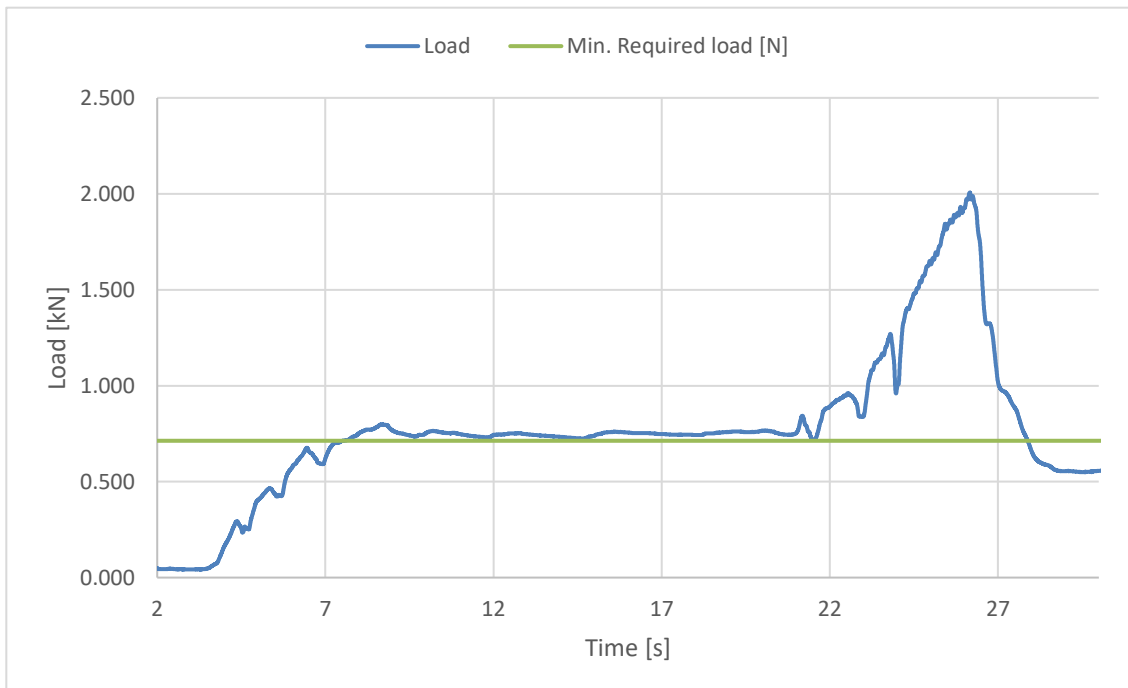
**Test ID RRST**

| Attachment points | <b>Sensor connect to end of handle, pull on the other side</b><br>The handle must support min 700 N for 10 s, after measure breaking strength |
| Breaking strength [N] | <b>1994.03</b> |
| Test results | <b>POSITIVE</b> |
