# Harness Structural test Report - EN

Inspection certificate number: **PH\_362.2022**

Name: **Arrow**  
 Type: **Zipline harness**  
 Size: **S**  
 Serial number: **0330220218**  
 Impact pad type: <sup>(1)</sup> **n/a**  
 Clip-in weight [kg]: **120**

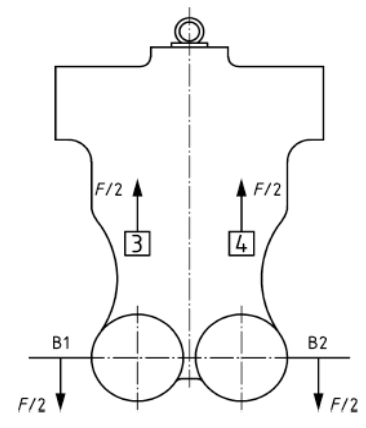
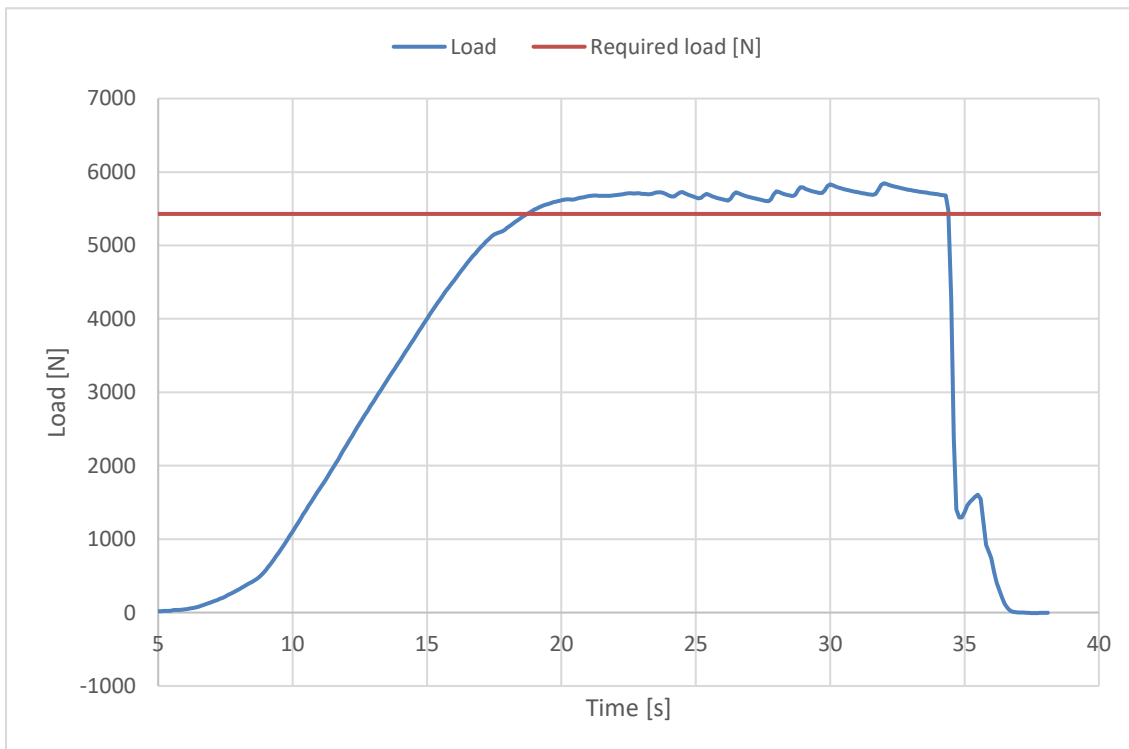
**Test ID 01**

Standard	<b>EN 1651</b>
Reference in standard	<b>5.5.1.1</b>
Test setup	<b>Positive symmetric load (Slippage)</b>
Attachment points	<b>Both main riser attachment (3,4)</b>
Anchor points	<b>Dummy (B1, B2)</b>
Required load [g]	<b>4.5</b>
Required load [N]	<b>5400</b>
Minimum test duration [s]	<b>5</b>
<b>Result</b>	
Test duration [s]	<b>15.7</b>
Any signs of structural failure	<b>No</b>
Slippery test OK	<b>Yes</b>
Test results	<b>POSITIVE</b>

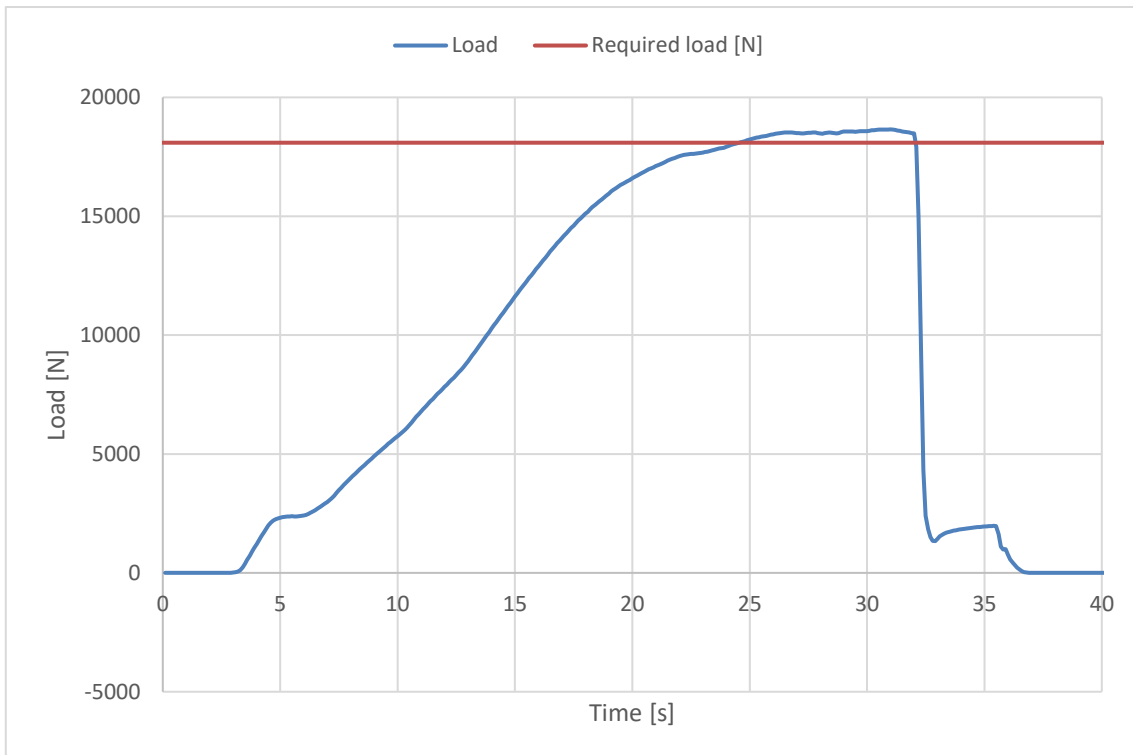
**Test ID 03**

Standard	<b>EN 1651</b>
Reference in standard	<b>5.5.1.1b</b>
Test setup	<b>Positive symmetric load</b>
Attachment points	<b>Both main riser attachment (3,4)</b>
Anchor points	<b>Dummy (B1, B2)</b>
Required load [g]	<b>15</b>
Required load [N]	<b>18000</b>
Minimum test duration [s]	<b>5</b>
<b>Result</b>	
Test duration [s]	<b>7.5</b>
Any signs of structural failure	<b>No</b>
Slippery test OK	<b>Yes</b>
Test results	<b>POSITIVE</b>

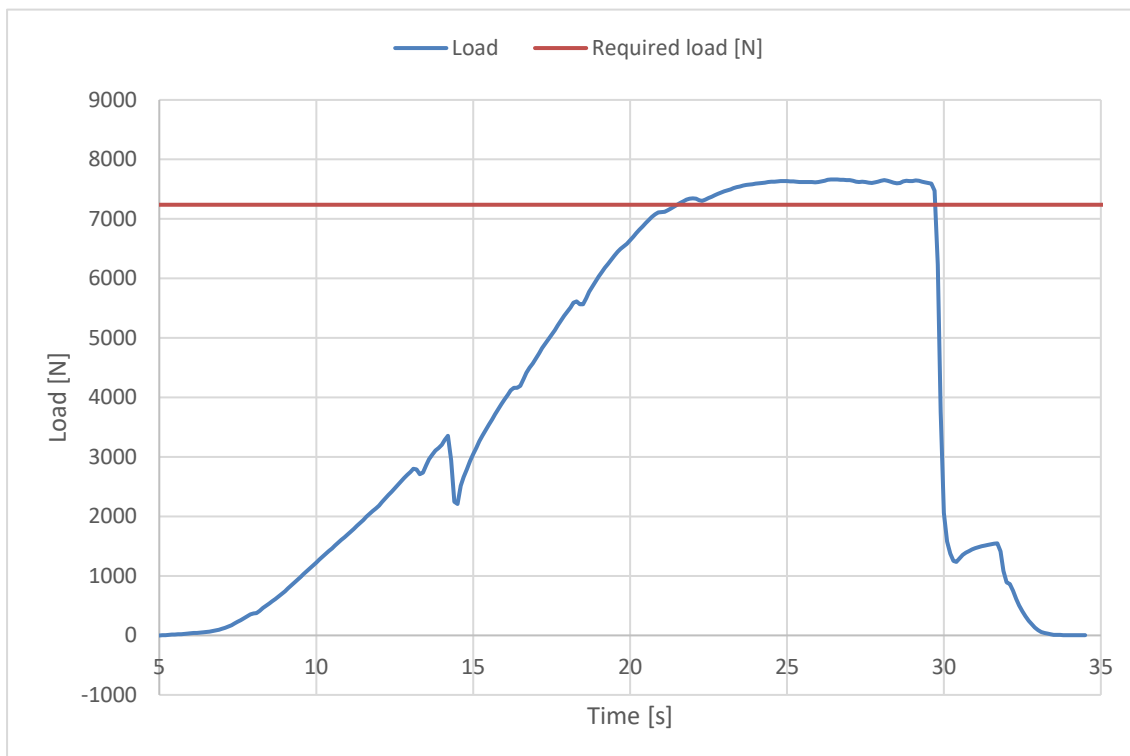
**Test ID 05**

Standard	<b>EN 1651</b>
Reference in standard	<b>5.5.1.2</b>
Test setup	<b>Positive asymmetric load</b>
Attachment points	<b>One riser attachment (3 or 4)</b>
Anchor points	<b>Dummy (C)</b>
Required load [g]	<b>6</b>
Required load [N]	<b>7200</b>
Minimum test duration [s]	<b>5</b>
<b>Result</b>	
Test duration [s]	<b>8.2</b>
Any signs of structural failure	<b>No</b>
Test results	<b>POSITIVE</b>

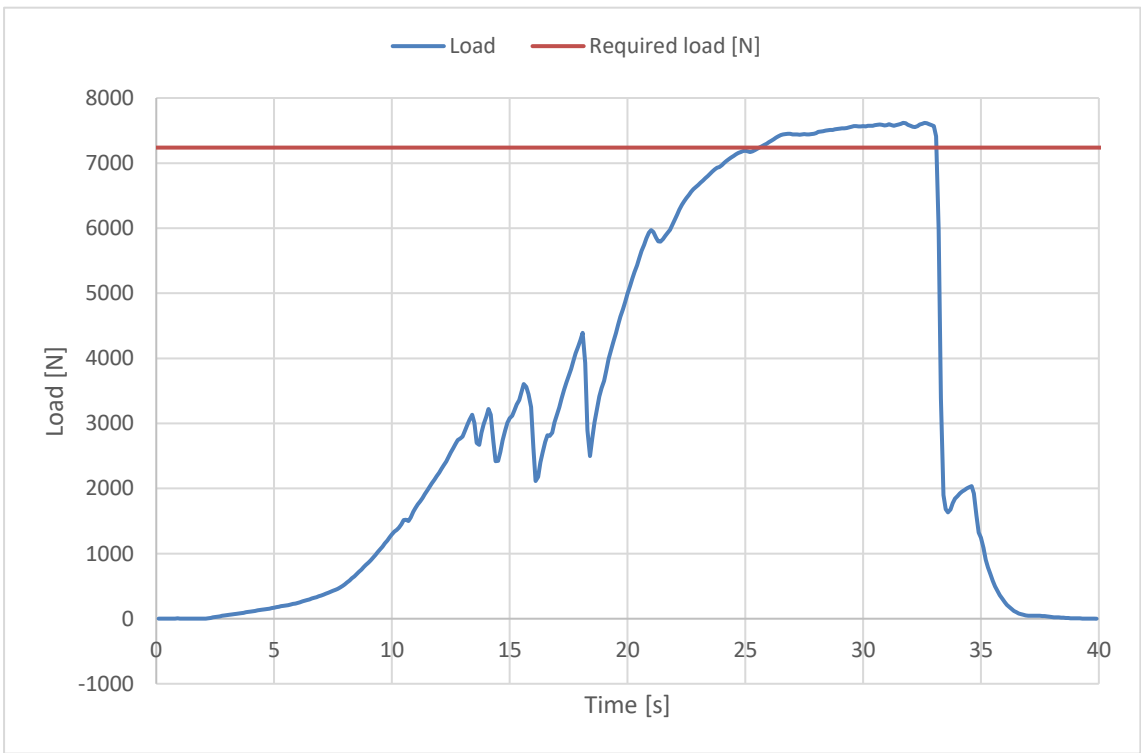
**Test ID 06**

Standard	<b>EN 1651</b>
Reference in standard	<b>5.5.1.6</b>
Test setup	<b>Negative symmetric load</b>
Attachment points	<b>Both main riser attachment (3,4)</b>
Anchor points	<b>Dummy (A)</b>
Required load [g]	<b>6</b>
Required load [N]	<b>7200</b>
Minimum test duration [s]	<b>5</b>
<b>Result</b>	
Test duration [s]	<b>7.6</b>
Any signs of structural failure	<b>No</b>
Test results	<b>POSITIVE</b>

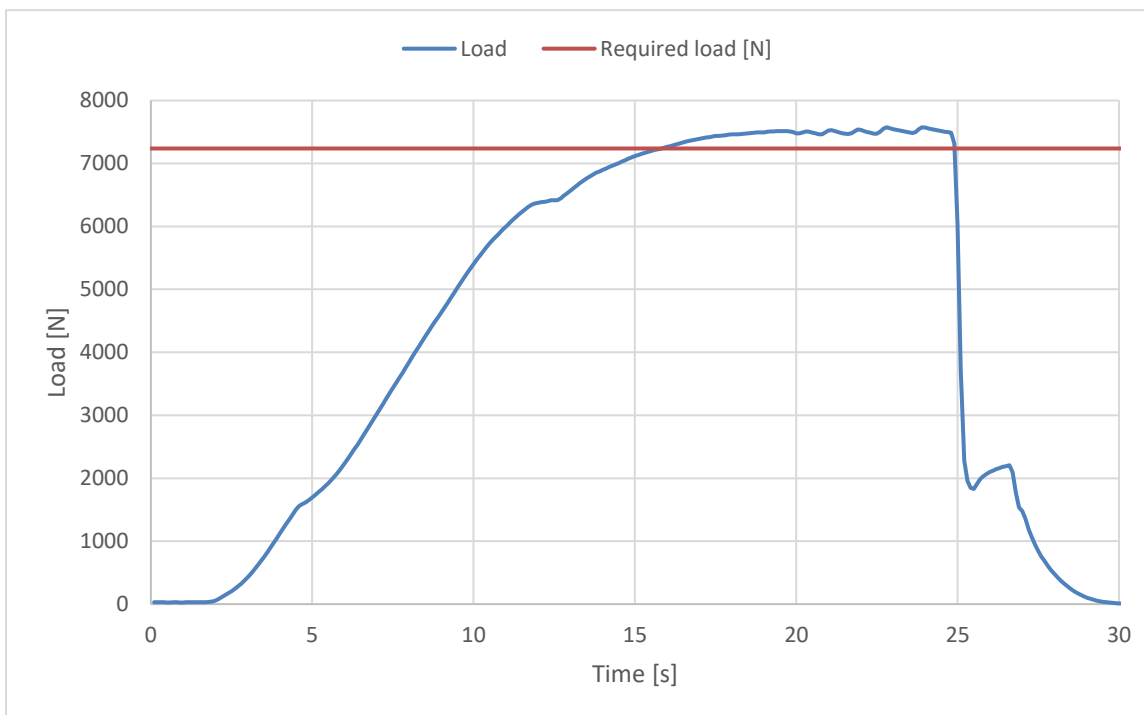
**Test ID 12**

Standard	<b>EN 1651</b>
Reference in standard	<b>5.5.1.7</b>
Test setup	<b>Upright (landing) position load</b>
Attachment points	<b>Both main riser attachment (3, 4)</b>
Anchor points	<b>Both legstrap of harness (no dummy)</b>
Required load [g]	<b>6</b>
Required load [N]	<b>7200</b>
Minimum test duration [s]	<b>5</b>
Harness type	<b>type c</b>
<b>Result</b>	
Test duration [s]	<b>9.1</b>
Any signs of structural failure	<b>No</b>
Slippery test OK	<b>Yes</b>
Test results	<b>POSITIVE</b>
