Harness Structural test Report - EN

Inspection certificate number: **PH_378.2022**

Name: **DENALI**
 Type: **ABS**
 Size: **M**
 Serial number: **1110115001P**
 Impact pad type: ⁽¹⁾ **n/a**
 Clip-in weight [kg]: **120**

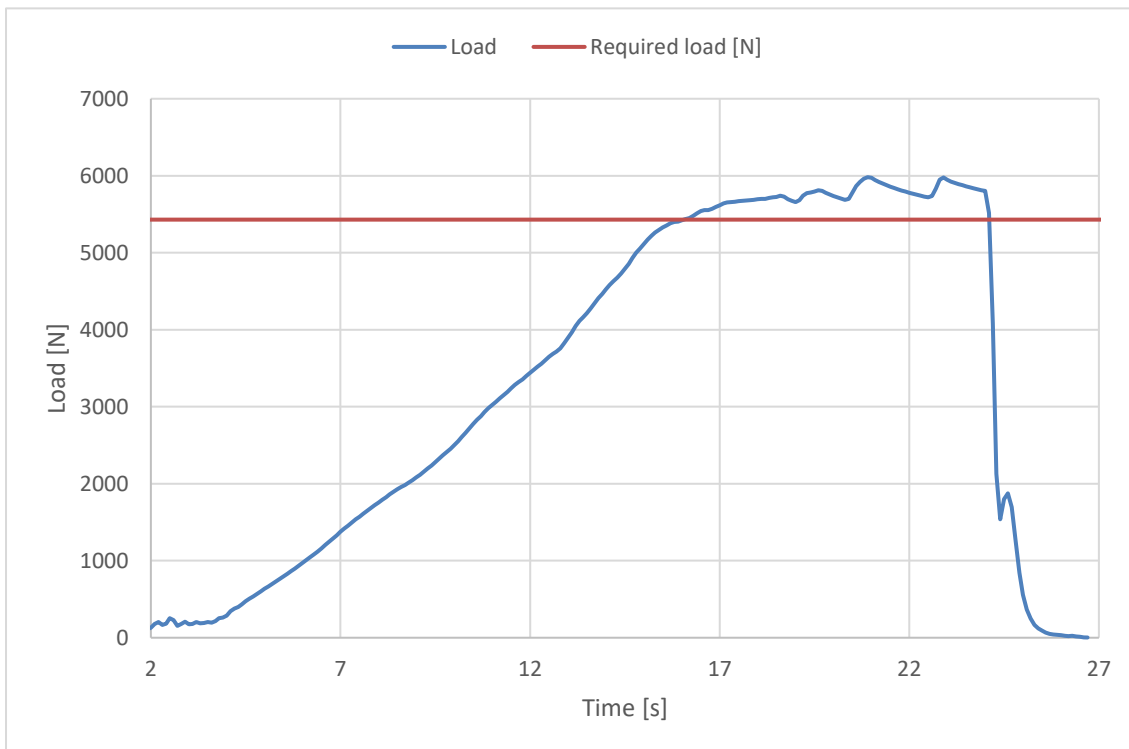
Test ID 01

Standard	EN 1651
Reference in standard	5.5.1.1
Test setup	Positive symmetric load (Slippage)
Attachment points	Both main riser attachment (3,4)
Anchor points	Dummy (B1, B2)
Required load [g]	4.5
Required load [N]	5400
Minimum test duration [s]	5
Result	
Test duration [s]	8.1
Any signs of structural failure	No
Slippery test OK	Yes
Test results	POSITIVE

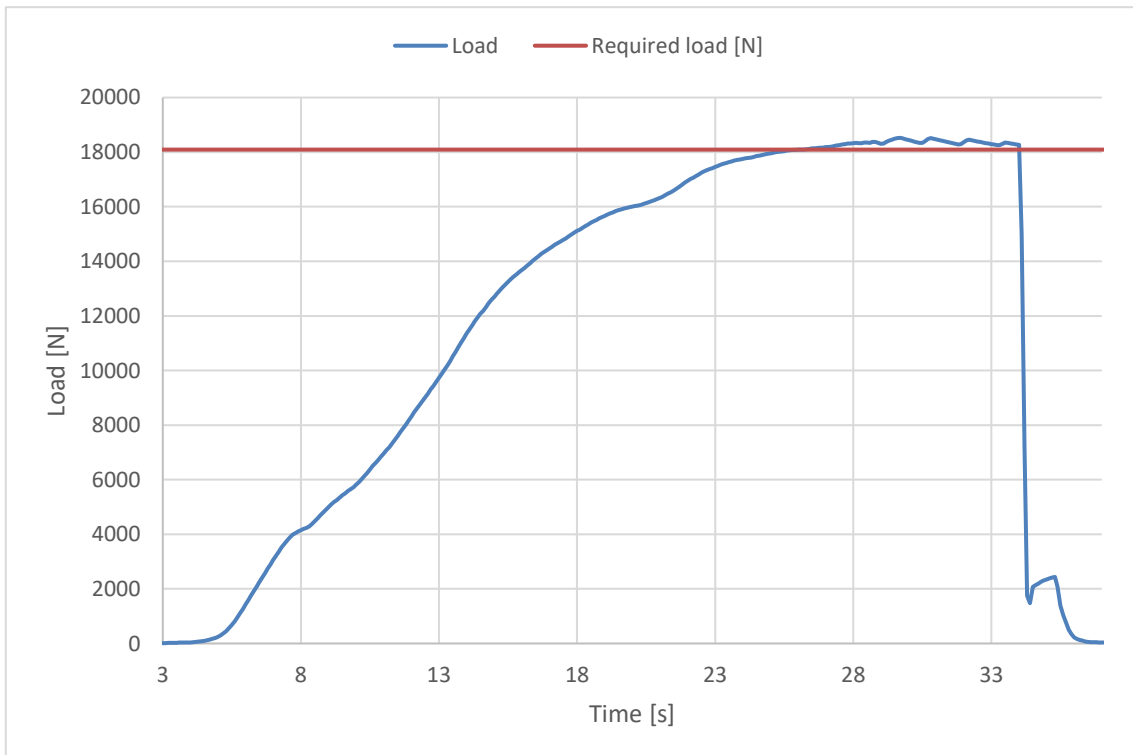
Test ID 03

Test duration [s] **7.8**
 Any signs of structural failure **No**
 Slippery test OK **Yes**
 Test results **POSITIVE**

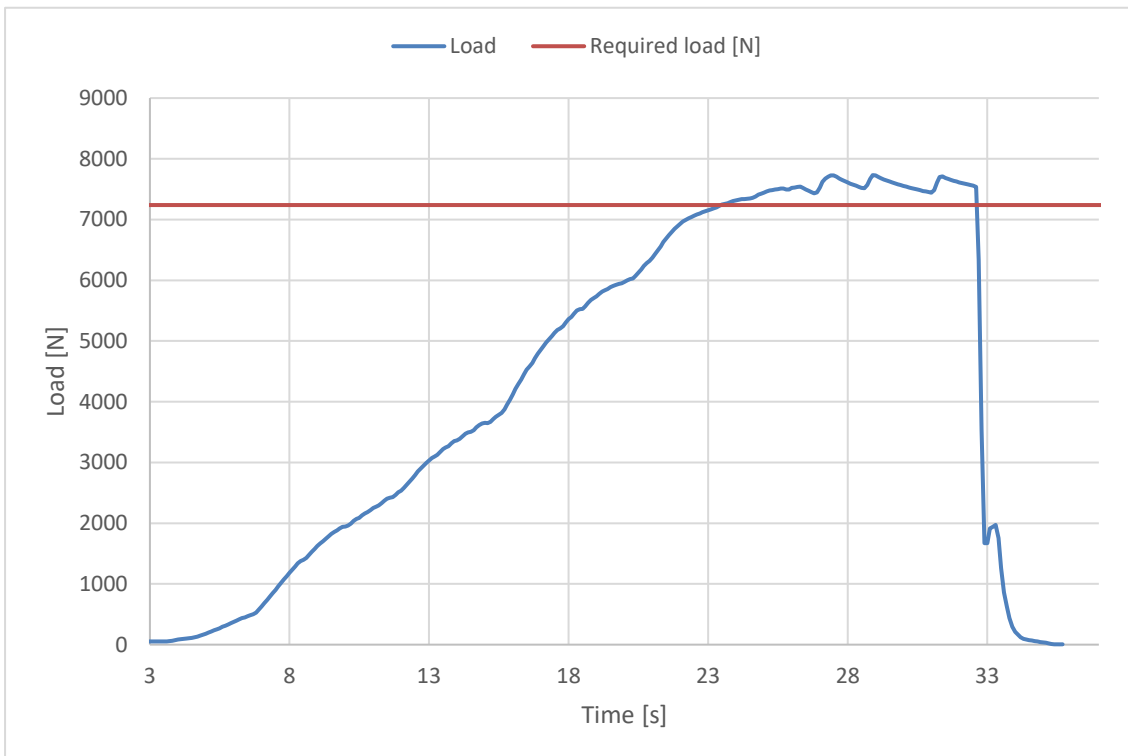
Test ID 05

Standard	EN 1651
Reference in standard	5.5.1.2
Test setup	Positive asymmetric load
Attachment points	One riser attachment (3 or 4)
Anchor points	Dummy (C)
Required load [g]	6
Required load [N]	7200
Minimum test duration [s]	5
Result	
Test duration [s]	9.2
Any signs of structural failure	No
Test results	POSITIVE

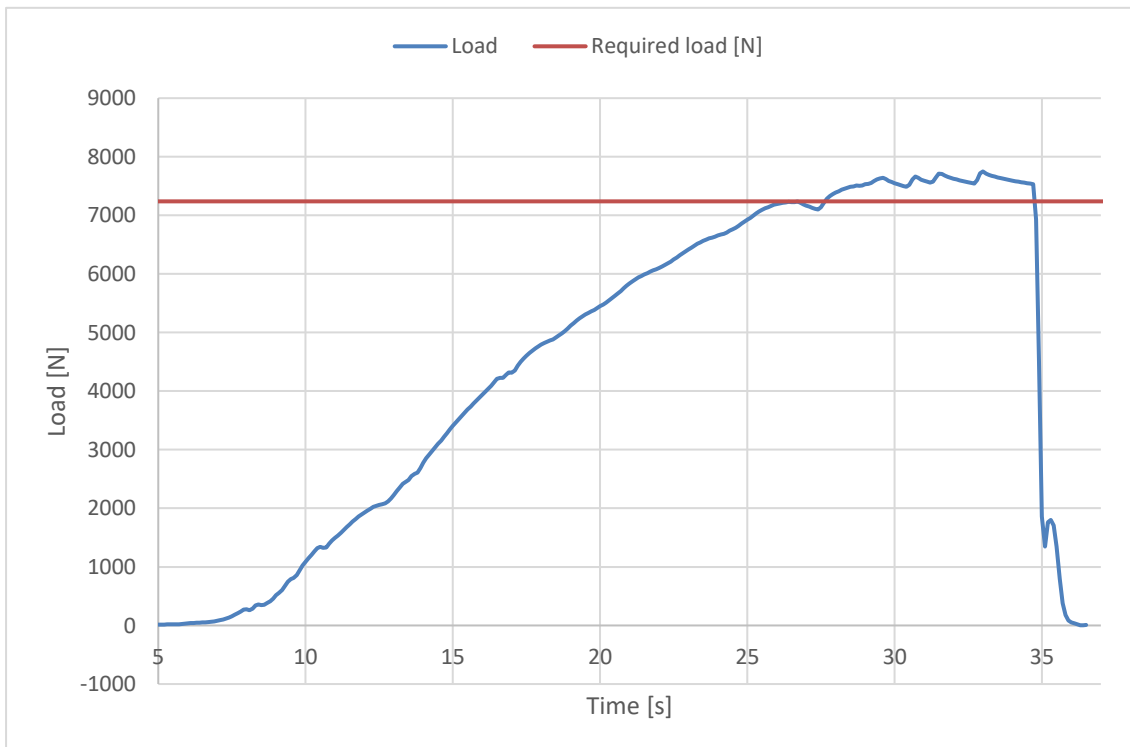
Test ID 06

Standard	EN 1651
Reference in standard	5.5.1.6
Test setup	Negative symmetric load
Attachment points	Both main riser attachment (3,4)
Anchor points	Dummy (A)
Required load [g]	6
Required load [N]	7200
Minimum test duration [s]	5
Result	
Test duration [s]	7.1
Any signs of structural failure	No
Test results	POSITIVE

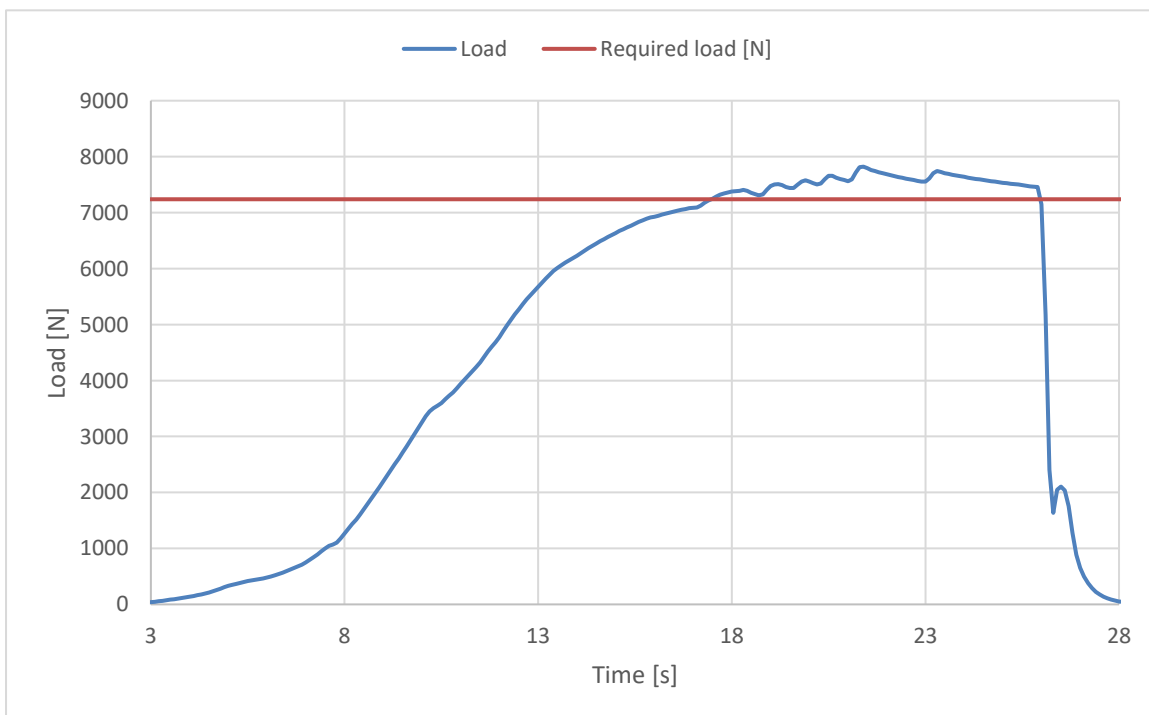
Test ID 12

Standard	EN 1651
Reference in standard	5.5.1.7
Test setup	Upright (landing) position load
Attachment points	Both main riser attachment (3, 4)
Anchor points	Both legstrap of harness (no dummy)
Required load [g]	6
Required load [N]	7200
Minimum test duration [s]	5
Harness type	type c
Result	
Test duration [s]	8.5
Any signs of structural failure	No
Slippery test OK	Yes
Test results	POSITIVE
