Harness Structural test Report - NfL

Inspection certificate number: **PH_366.2022**

Name: **Halo**
 Type: **ABS**
 Size: **M**
 Serial number: **Halo-PROTO 1**
 Impact pad type: ⁽¹⁾ **Foam**
 Clip-in weight [kg]: **140**
 Integrated container: **Yes**
 Date of test: **21.02.2023**

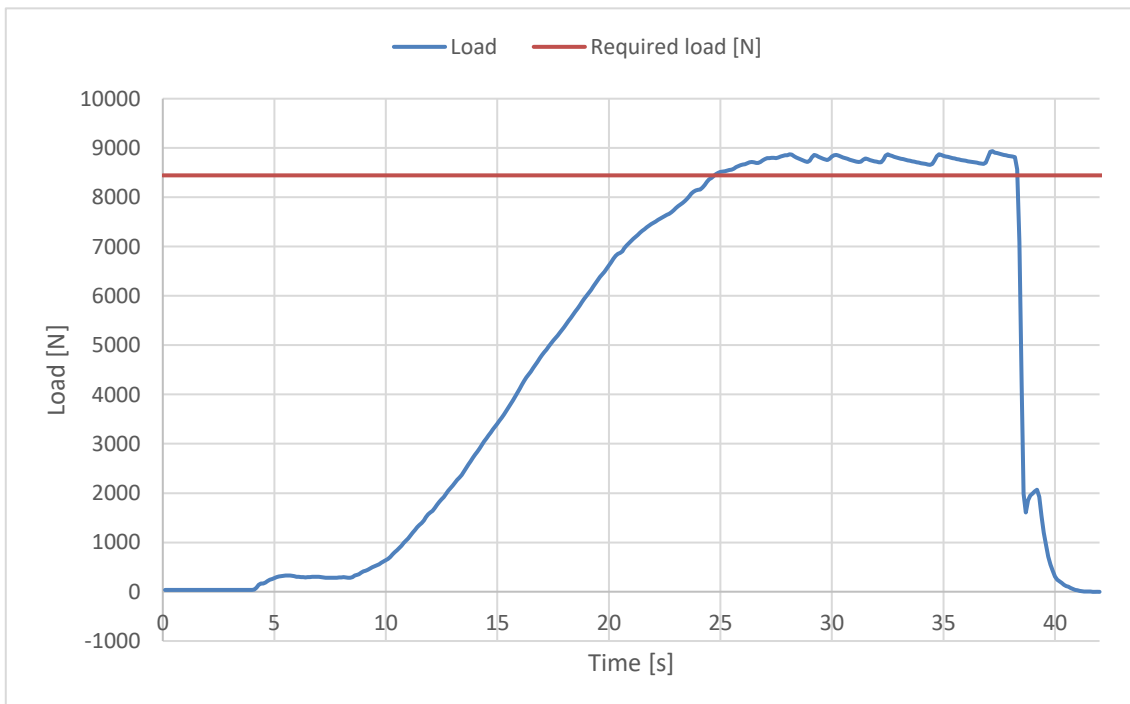
Test ID 02

Test duration [s] **13.6**
 Any signs of structural failure **No**
 Test results **POSITIVE**

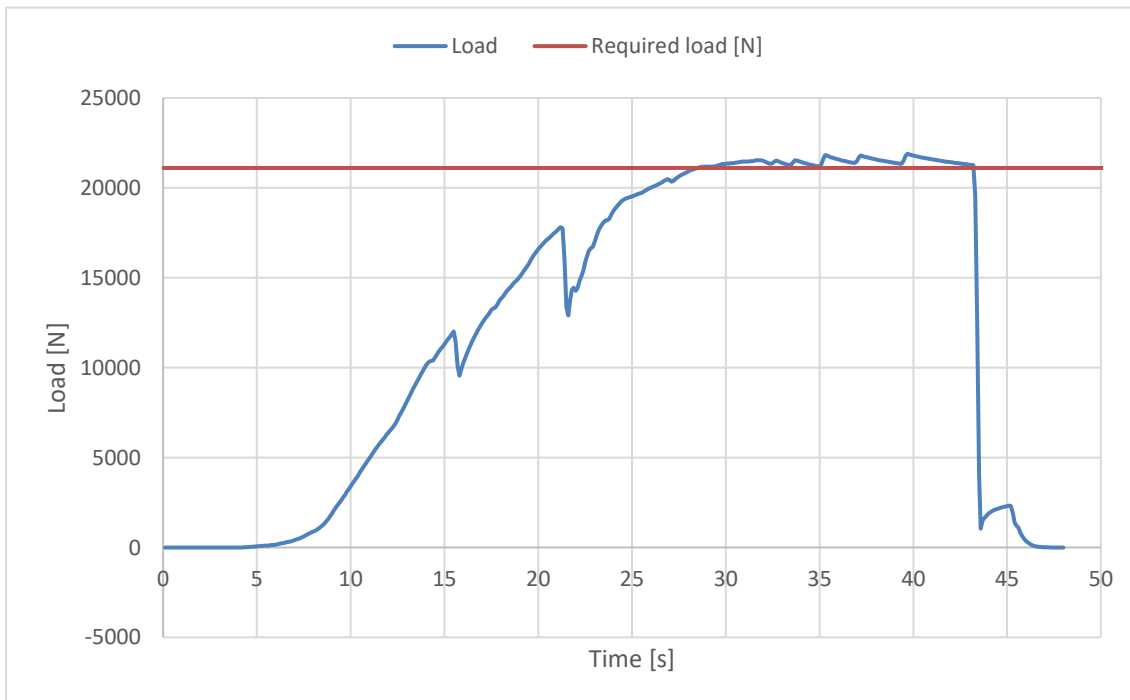
Test ID 03

Standard	EN 1651:1999
Reference	5.3.2.2
Test setup	Default flying position
Attachment points	Both main riser attachment (3,4)
Anchor points	Dummy (B1, B2)
Required load [g]	15
Required load [N]	21000
Minimum test duration [s]	5
Result	
Test duration [s]	14.8
Any signs of structural failure	No
Test results	POSITIVE

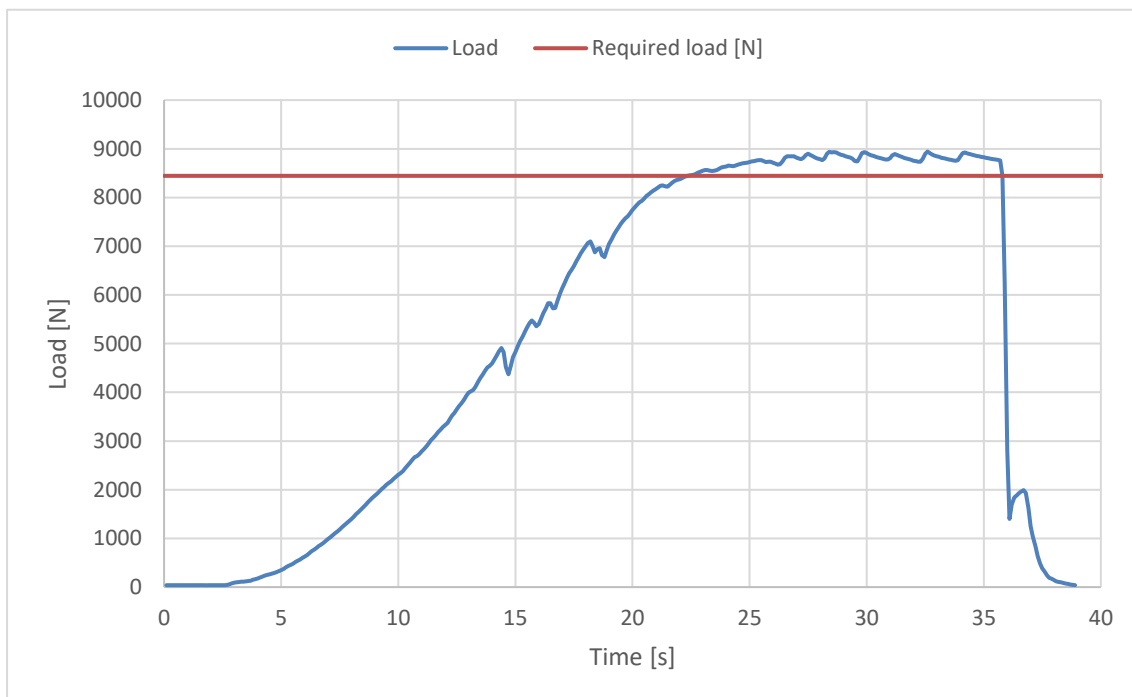
Test ID 04

Reference	5.3.2.3	
Test setup	Asymmetric, one riser	
Attachment points	One main riser attachment (3)	
Anchor points	Dummy (B1,B2)	
Required load [g]	6	
Required load [N]	8400	
Minimum test duration [s]	10	
Result		
Test duration [s]	13.4	
Any signs of structural failure	No	
Test results	POSITIVE

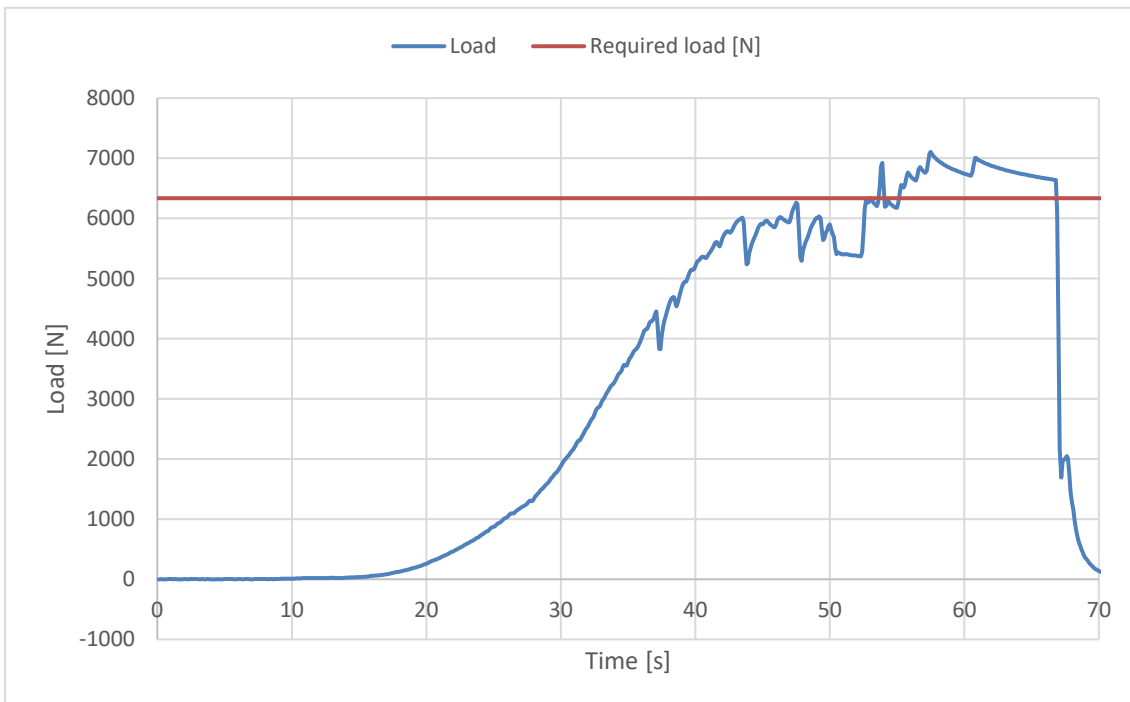
Test ID 07

Reference	5.3.2.6	
Test setup	Asymmetric, negative	
Attachment points	One main riser attachment (3 or 4) downwards	
Anchor points	Dummy (9)	
Required load [g]	4.5	
Required load [N]	6300	
Minimum test duration [s]	10	
Result		
Test duration [s]	11.7	
Any signs of structural failure	No	
Test results	POSITIVE

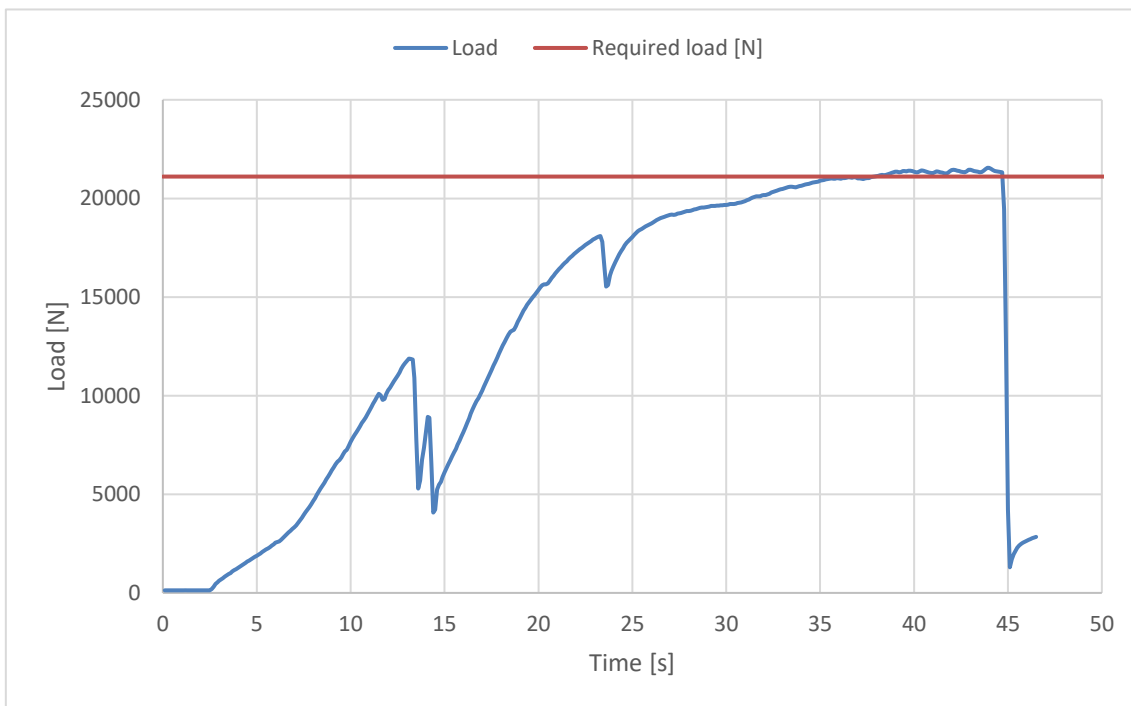
Test ID 09

Reference	5.3.2.4	
Test setup	Rescue attachments	
Attachment points	Rescue riser attachment (1,2)	
Anchor points	Dummy (B1,B2)	
Required load [g]	15	
Required load [N]	21000	
Minimum test duration [s]	5	
Result		
Test duration [s]	6.8	
Any signs of structural failure	n/a	
Test results	POSITIVE

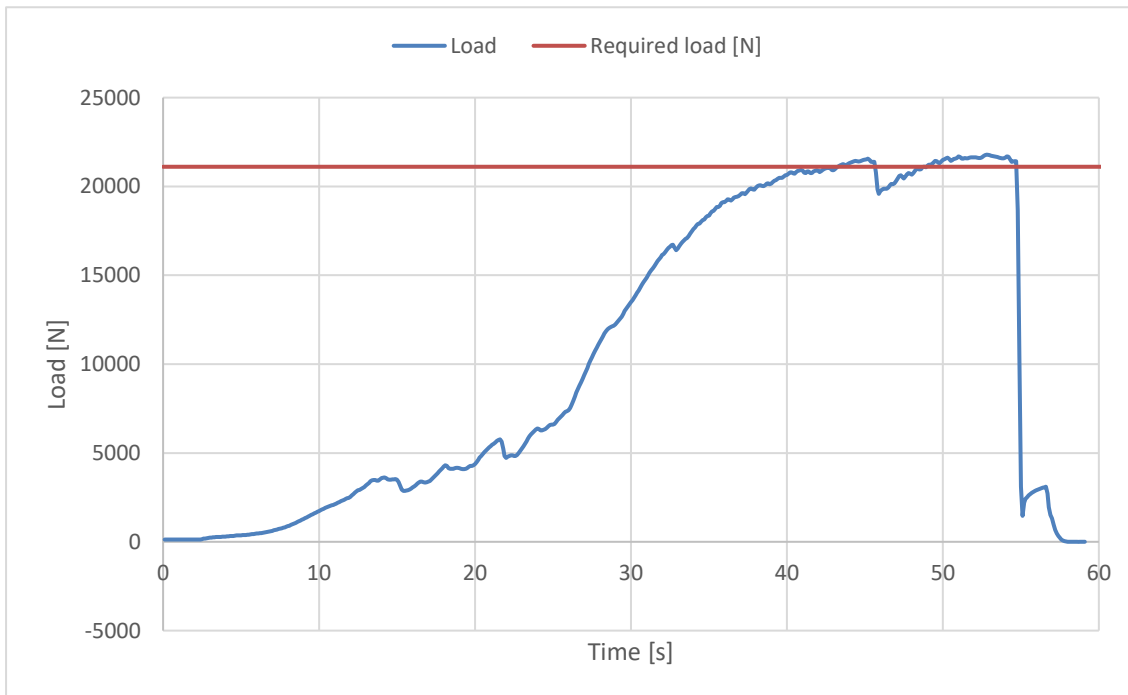
Test ID 13

Test duration [s] **5.8**
 Any signs of structural failure **No**
 Test results **POSITIVE**

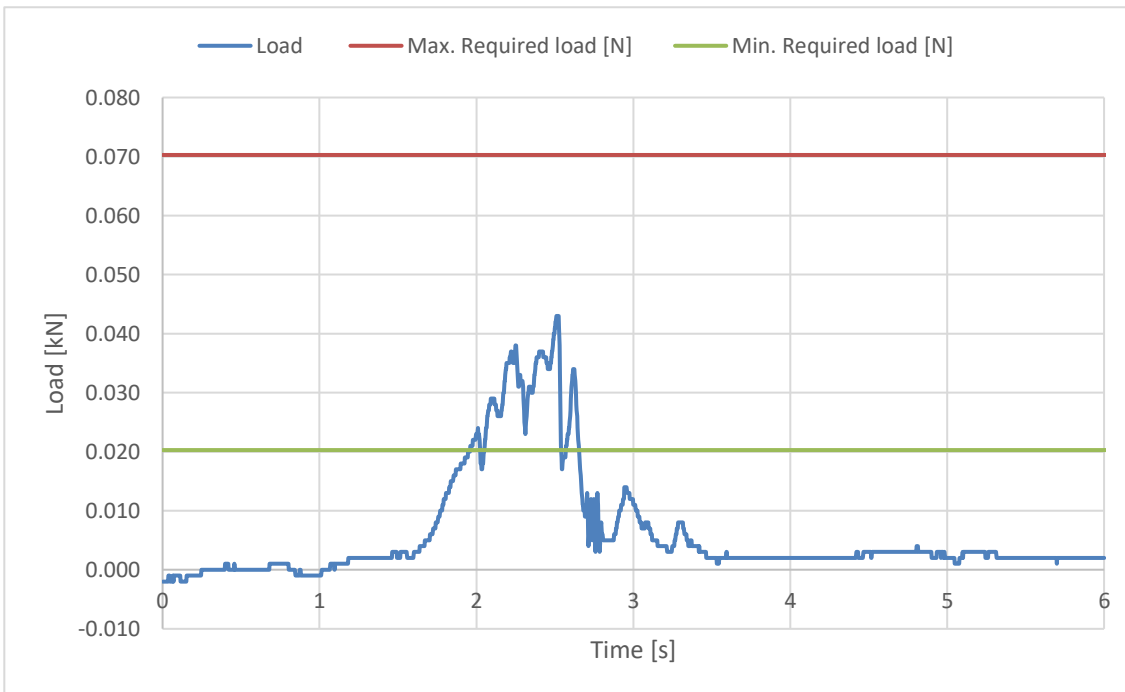
Test ID RRDT

Standard	NfL 2-565-20
Reference	6.1.5
Test setup	Default flying position
Attachment points	Sensor connect to handle, and pull in opening direction
	The test is to simulate the load required to open the emergency parachute(1st action).
Min. Required load [N]	20
Max. Required load [N]	70
Result	
Load for first action [N]	42.71
Test results	POSITIVE

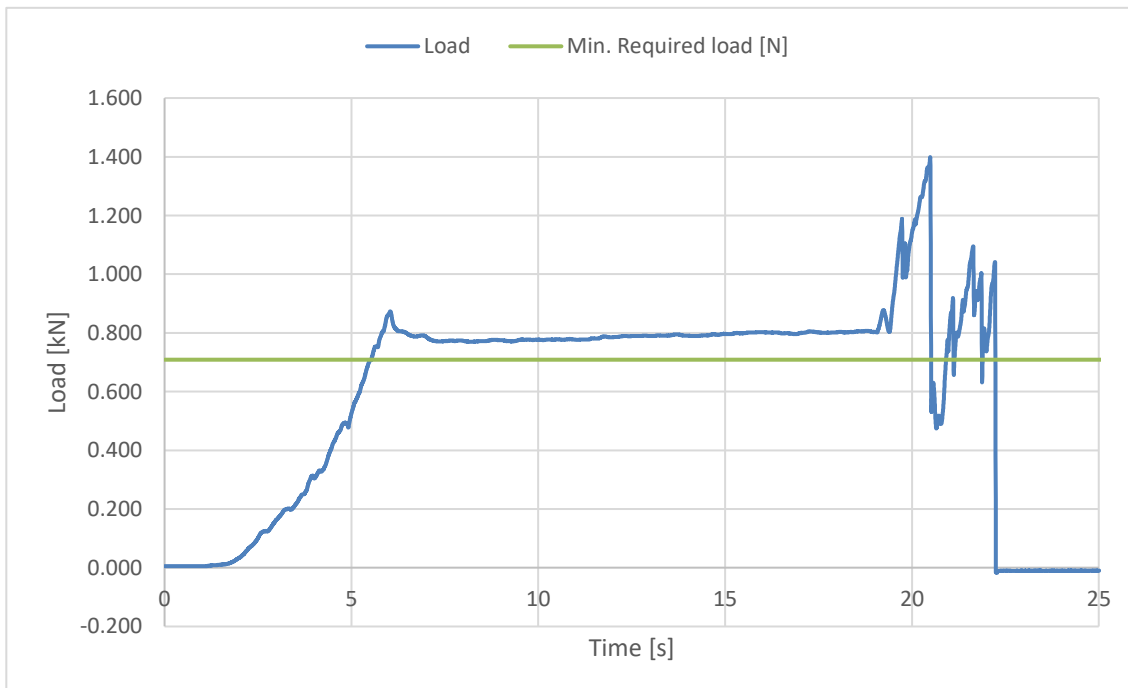
Test ID RRST

Standard	EN 12491
Reference in standard	5.3.2
Test setup	Two end points of handle
Attachment points	Sensor connect to end of handle, pull on the other side
	The handle must support min 700 N for 10 s, after measure breaking strength
Min. Required load [N]	700
Minimum test duration [s]	10
Result	
Test duration [s]:	15.0
Breaking strength [N]	1389.71
Test results	POSITIVE
