Harness Structural test Report - NfL

Inspection certificate number: **PH_384.2022**

Name: **Strapless 3**
 Type: **ABS**
 Size: **One size**
 Serial number: **1175981**
 Impact pad type: ⁽¹⁾ **Airbag**
 Clip-in weight [kg]: **110**
 Integrated container: **No**
 Date of test: **15.12.2022**

Summary of Structural test

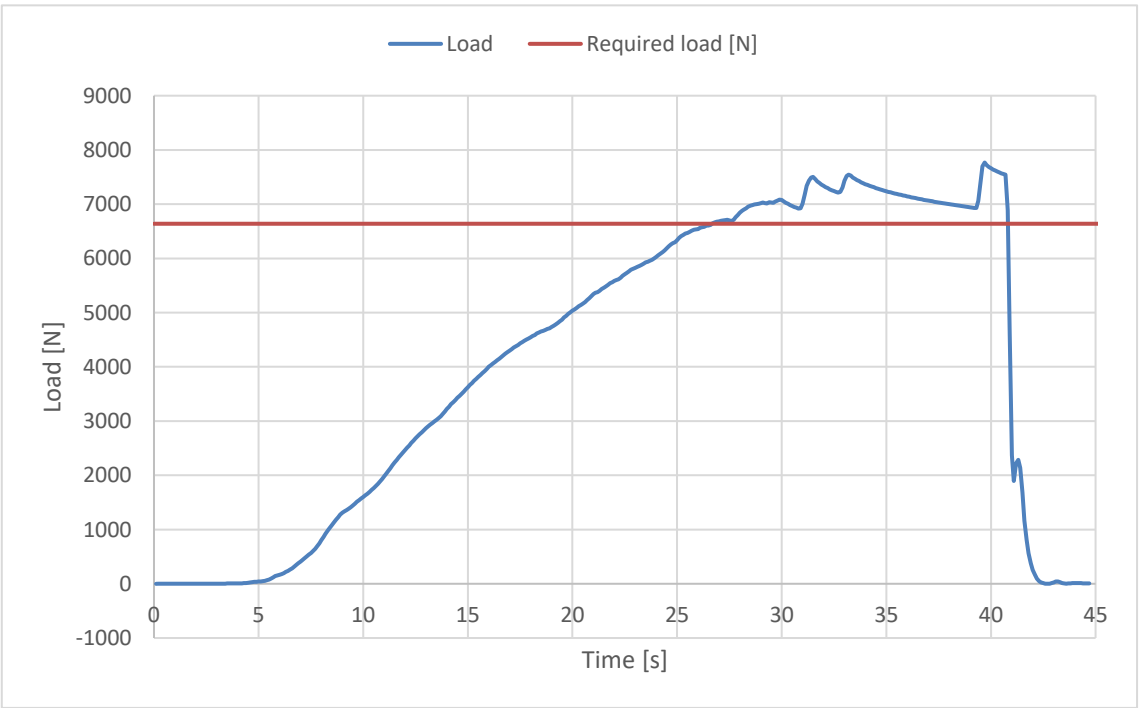
Test ID 02

Standard	EN 1651:1999
Reference	5.3.2.1
Test setup	Default flying position
Attachment points	Both main riser attachment (3,4)
Anchor points	Dummy (B1, B2)
Required load [g]	6
Required load [N]	6600
Minimum test duration [s]	10
Result	
Test duration [s]	14.2
Any signs of structural failure	No
Test results	POSITIVE

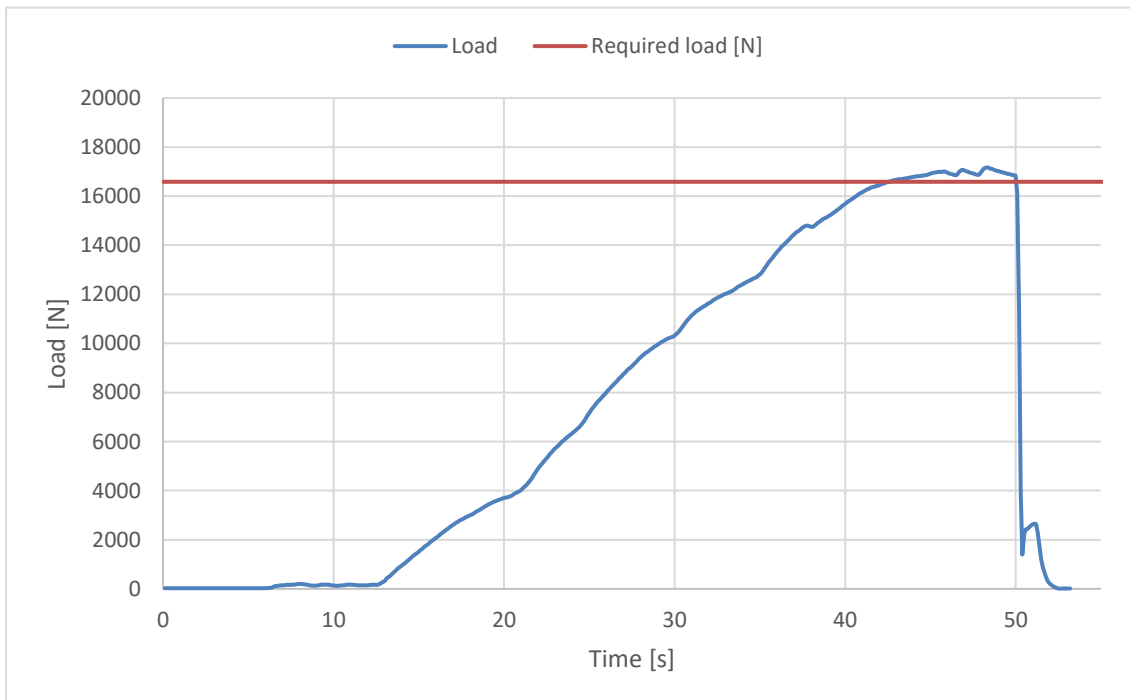
Test ID 03

Standard	EN 1651:1999
Reference	5.3.2.2
Test setup	Default flying position
Attachment points	Both main riser attachment (3,4)
Anchor points	Dummy (B1, B2)
Required load [g]	15
Required load [N]	16500
Minimum test duration [s]	5
Result	
Test duration [s]	7.5
Any signs of structural failure	No
Test results	POSITIVE

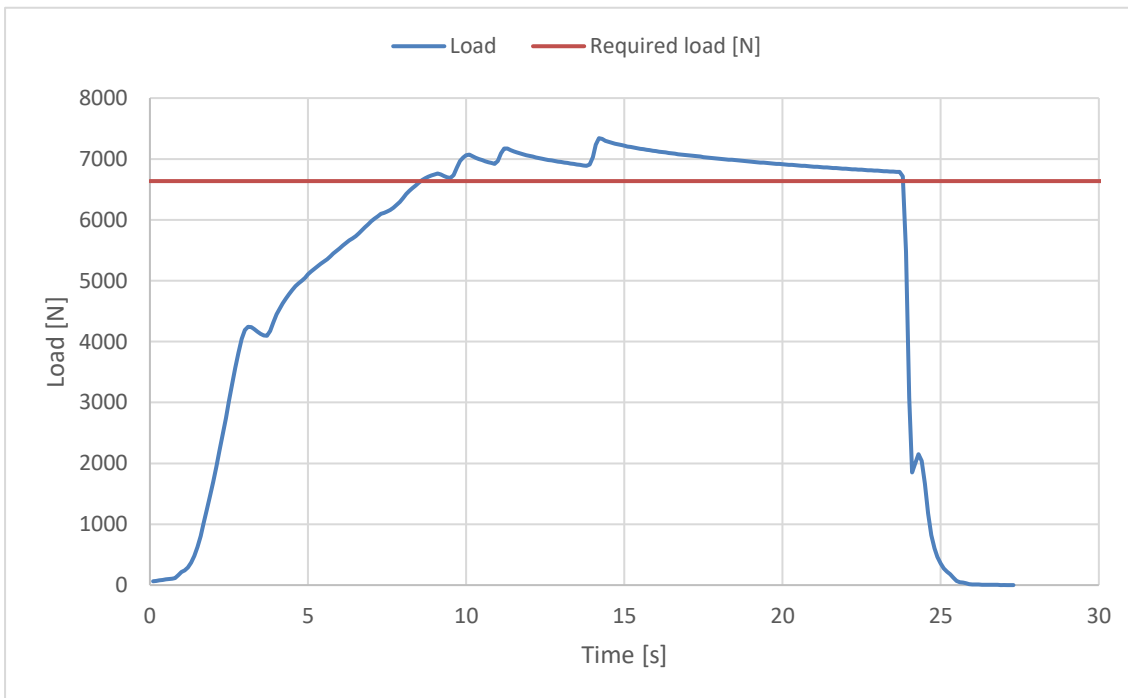
Test ID 04

Standard	EN 1651:1999
Reference	5.3.2.3
Test setup	Asymmetric, one riser
Attachment points	One main riser attachment (3)
Anchor points	Dummy (B1,B2)
Required load [g]	6
Required load [N]	6600
Minimum test duration [s]	10
Result	
Test duration [s]	15.3
Any signs of structural failure	No
Test results	POSITIVE

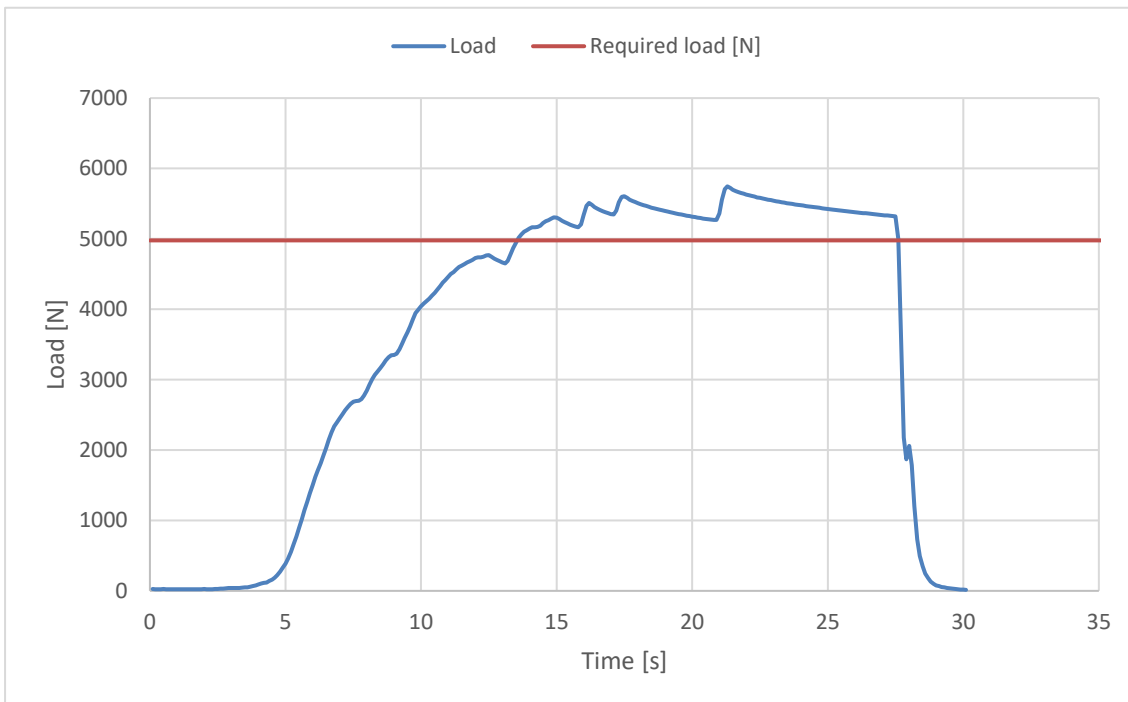
Test ID 07

Reference	5.3.2.6	
Test setup	Asymmetric, negative	
Attachment points	One main riser attachment (3 or 4) downwards	
Anchor points	Dummy (9)	
Required load [g]	4.5	
Required load [N]	4950	
Minimum test duration [s]	10	
Result		
Test duration [s]	14.1	
Any signs of structural failure	No	
Test results	POSITIVE

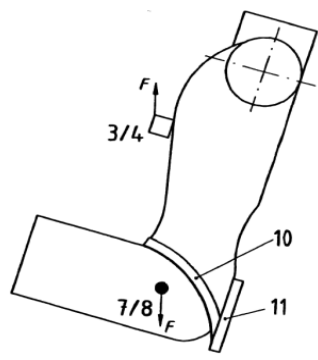
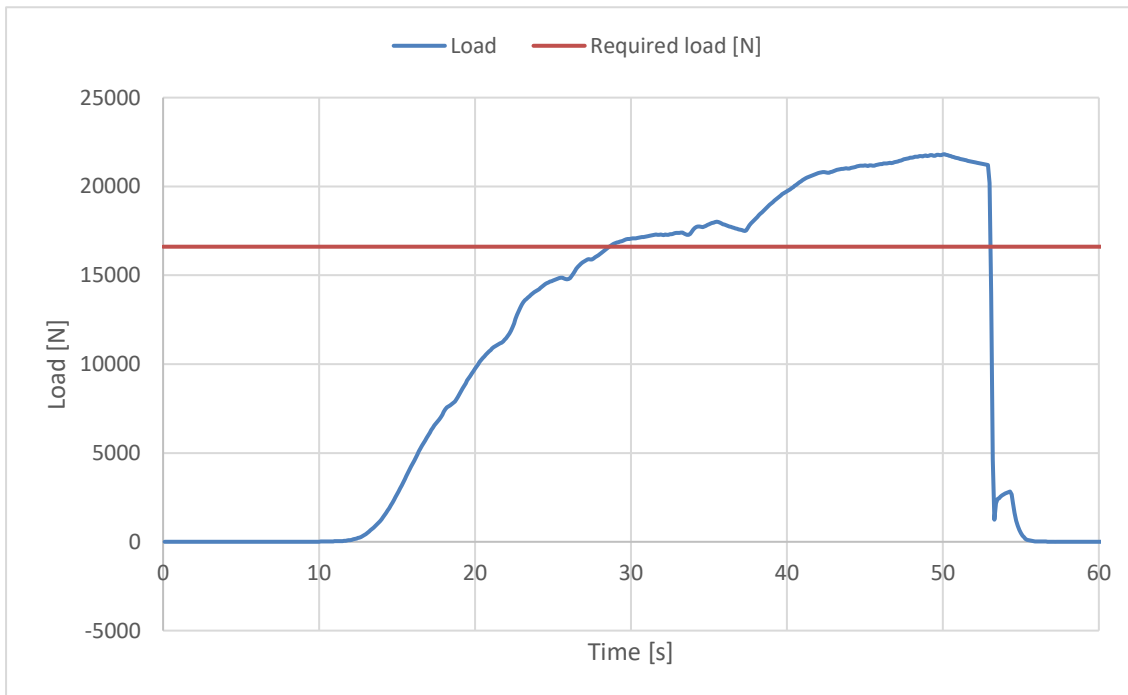
Test ID 13

Standard	EN 1651:1999
Reference	5.3.2.7
Test setup	Flying position before landing
Attachment points	Both main riser attachment (3,4)
Anchor points	Dummy (7,8)
Required load [g]	15
Required load [N]	16500
Minimum test duration [s]	5
Result	
Test duration [s]	24.4
Any signs of structural failure	No
Test results	POSITIVE
