# Harness Structural test Report - EN

Inspection certificate number: PH\_425.2024

Name: **Harmony Passenger air 2**  
 Type: **ABS**  
 Size: **One size**  
 Serial number: **HPAT-TF-59001**  
 Impact pad type: <sup>(1)</sup> **Airbag**  
 Clip-in weight [kg]: **120**

**EN1651:2018+A1:2020<sup>(6)</sup> and EN12491:2015+A1:2021<sup>(6)</sup>**

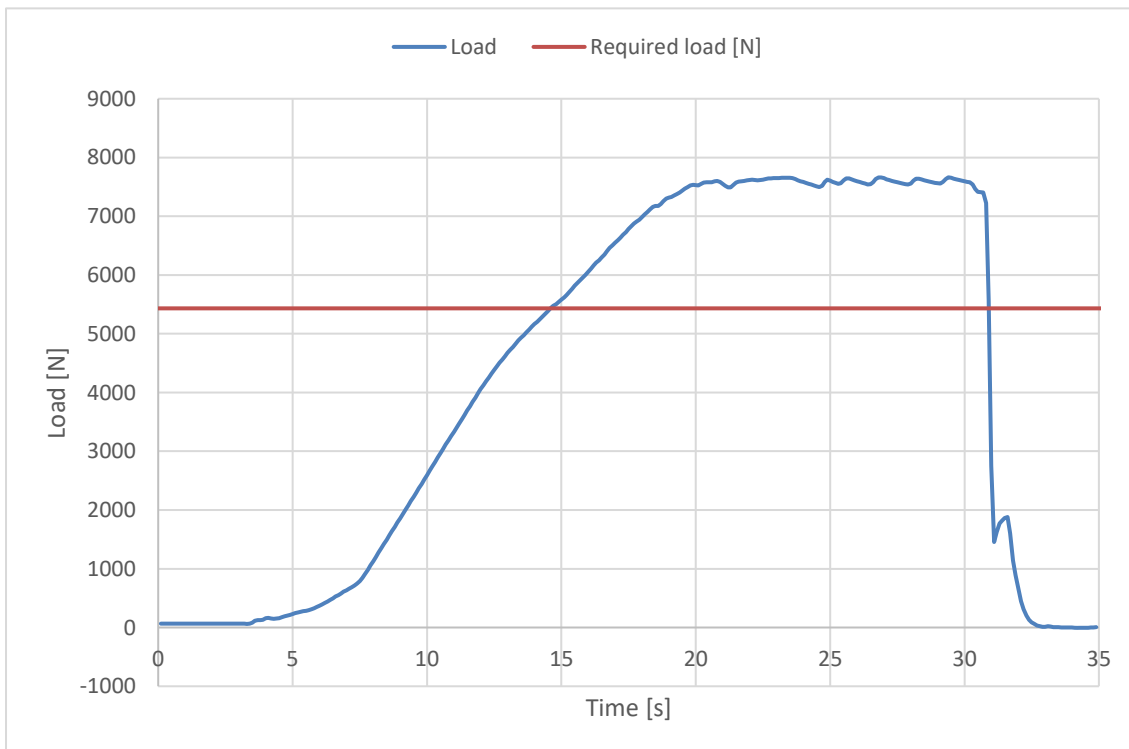
**Test ID 01**

Standard	<b>EN 1651</b>
Reference in standard	<b>5.5.1.1</b>
Test setup	<b>Positive symmetric load (Slippage)</b>
Attachment points	<b>Both main riser attachment (3,4)</b>
Anchor points	<b>Dummy (B1, B2)</b>
Required load [g]	<b>4.5</b>
Required load [N]	<b>5400</b>
Minimum test duration [s]	<b>5</b>
<b>Result</b>	
Test duration [s]	<b>16.4</b>
Any signs of structural failure	<b>No</b>
Slippery test OK	<b>Yes</b>
Test results	<b>POSITIVE</b>

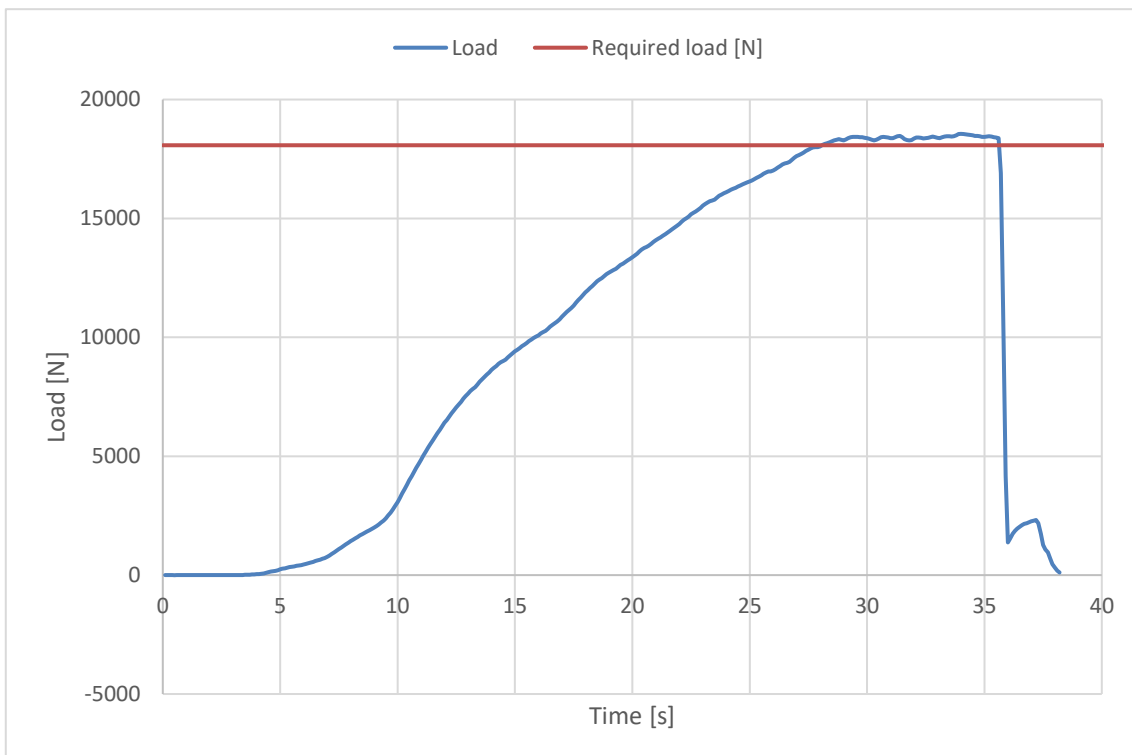
**Test ID 03**

Standard	<b>EN 1651</b>
Reference in standard	<b>5.5.1.1b</b>
Test setup	<b>Positive symmetric load</b>
Attachment points	<b>Both main riser attachment (3,4)</b>
Anchor points	<b>Dummy (B1, B2)</b>
Required load [g]	<b>15</b>
Required load [N]	<b>18000</b>
Minimum test duration [s]	<b>5</b>
<b>Result</b>	
Test duration [s]	<b>7.6</b>
Any signs of structural failure	<b>No</b>
Slippery test OK	<b>Yes</b>
Test results	<b>POSITIVE</b>

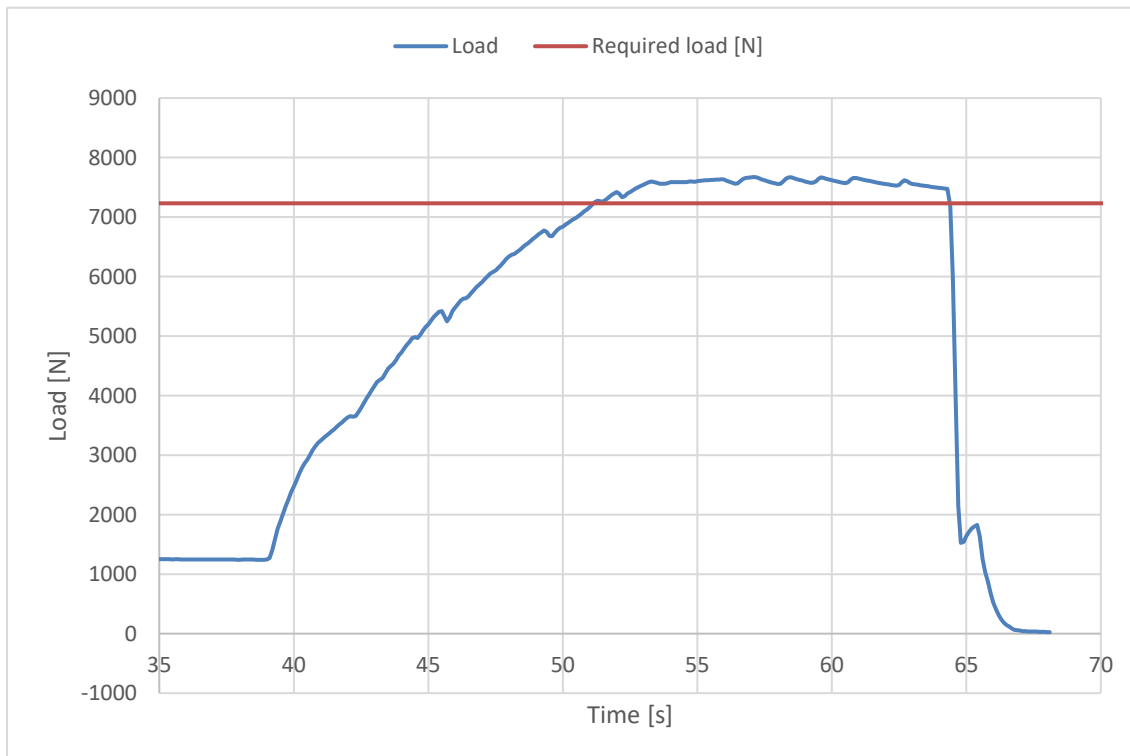
**Test ID 05**

Standard	<b>EN 1651</b>
Reference in standard	<b>5.5.1.2</b>
Test setup	<b>Positive asymmetric load</b>
Attachment points	<b>One riser attachment (3 or 4)</b>
Anchor points	<b>Dummy (C)</b>
Required load [g]	<b>6</b>
Required load [N]	<b>7200</b>
Minimum test duration [s]	<b>5</b>
<b>Result</b>	
Test duration [s]	<b>13.2</b>
Any signs of structural failure	<b>No</b>
Test results	<b>POSITIVE</b>

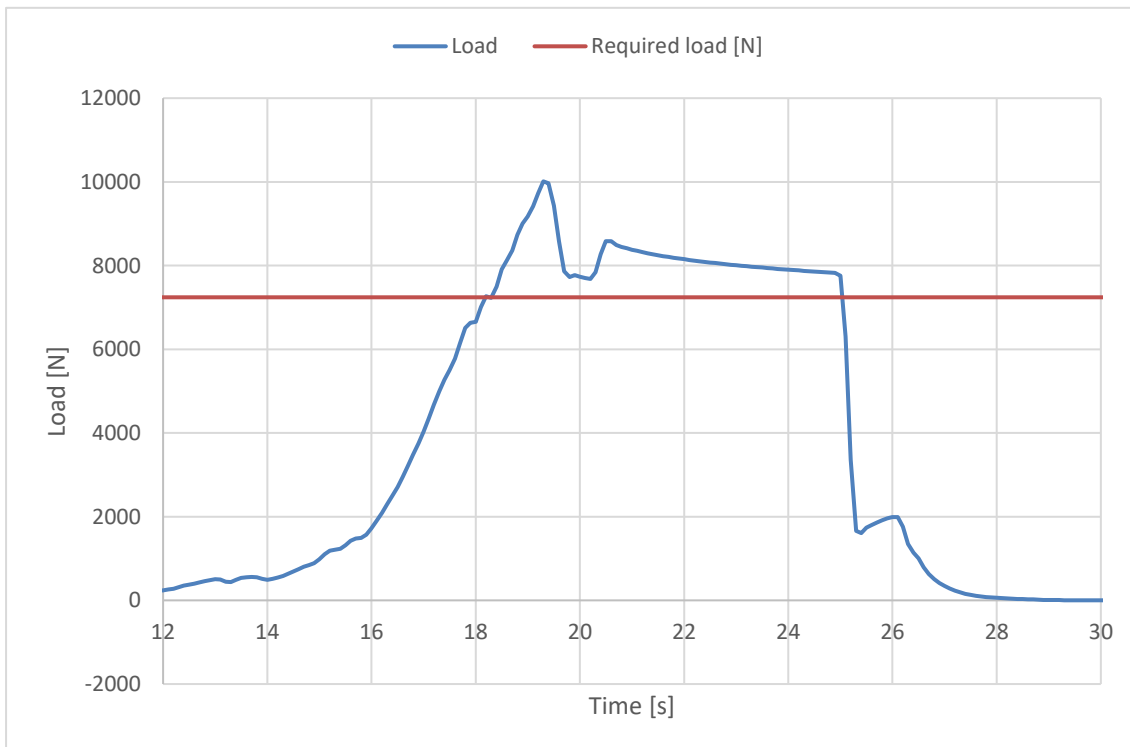
**Test ID 06**

Standard	<b>EN 1651</b>
Reference in standard	<b>5.5.1.6</b>
Test setup	<b>Negative symmetric load</b>
Attachment points	<b>Both main riser attachment (3,4)</b>
Anchor points	<b>Dummy (A)</b>
Required load [g]	<b>6</b>
Required load [N]	<b>7200</b>
Minimum test duration [s]	<b>5</b>
<b>Result</b>	
Test duration [s]	<b>6.7</b>
Any signs of structural failure	<b>No</b>
Test results	<b>POSITIVE</b>

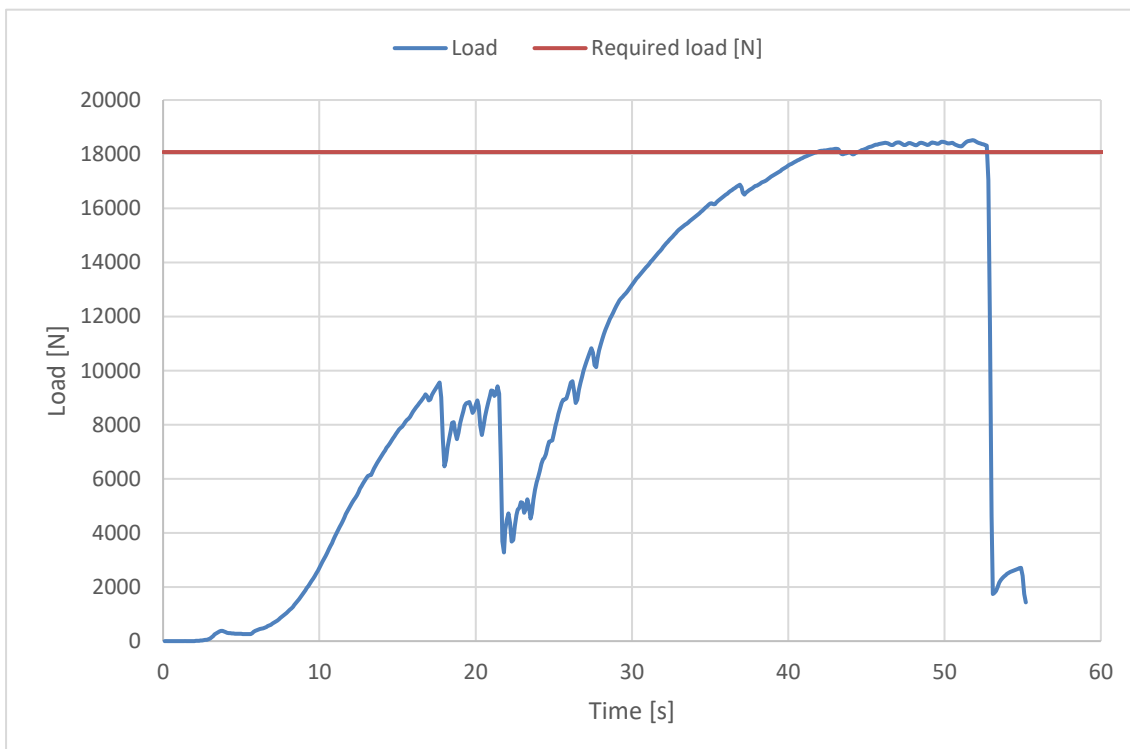
**Test ID 09**

Standard	<b>EN 1651</b>
Reference in standard	<b>5.5.1.3</b>
Test setup	<b>Positive symmetric load rescue points</b>
Attachment points	<b>Both main riser attachment (1,2)</b>
Anchor points	<b>Dummy (B1,B2)</b>
Required load [g]	<b>15</b>
Required load [N]	<b>18000</b>
Minimum test duration [s]	<b>5</b>
<b>Result</b>	
Test duration [s]	<b>8.3</b>
Any signs of structural failure	<b>No</b>
Slippery test OK	<b>Yes</b>
Test results	<b>POSITIVE</b>

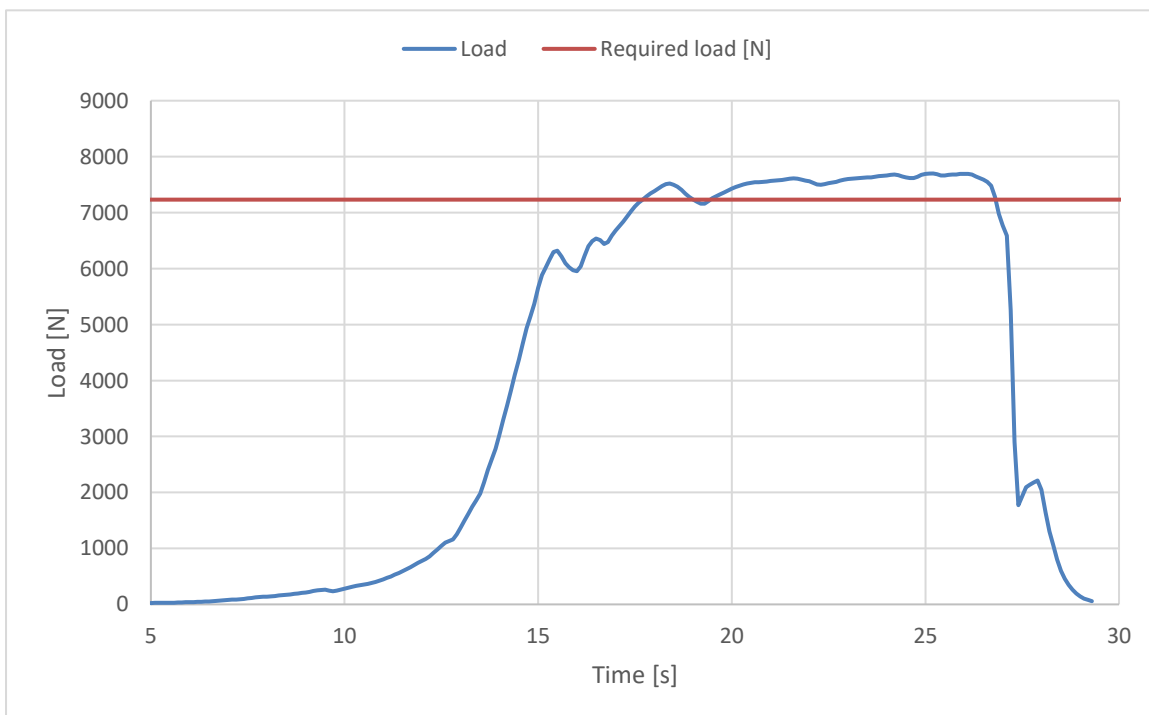
**Test ID 12**

Standard	<b>EN 1651</b>
Reference in standard	<b>5.5.1.7</b>
Test setup	<b>Upright (landing) position load</b>
Attachment points	<b>Both main riser attachment (3, 4)</b>
Anchor points	<b>Both legstrap of harness (no dummy)</b>
Required load [g]	<b>6</b>
Required load [N]	<b>7200</b>
Minimum test duration [s]	<b>5</b>
Harness type	<b>type b</b>
<b>Result</b>	
Test duration [s]	<b>7.4</b>
Any signs of structural failure	<b>No</b>
Slippery test OK	<b>Yes</b>
Test results	<b>POSITIVE</b>
