## Harness Structural test Report - NfL

Inspection certificate number: **PH\_425.2024**

Name: **Harmony Passenger air 2**  
 Type: **ABS**  
 Size: **One size**  
 Serial number: **HPAT-TF-59001**  
 Impact pad type: <sup>(1)</sup> **Airbag**  
 Clip-in weight [kg]: **120**  
 Integrated container: **No**

**NfL 2-565-20, EN12491:2015 and EN1651:1999**

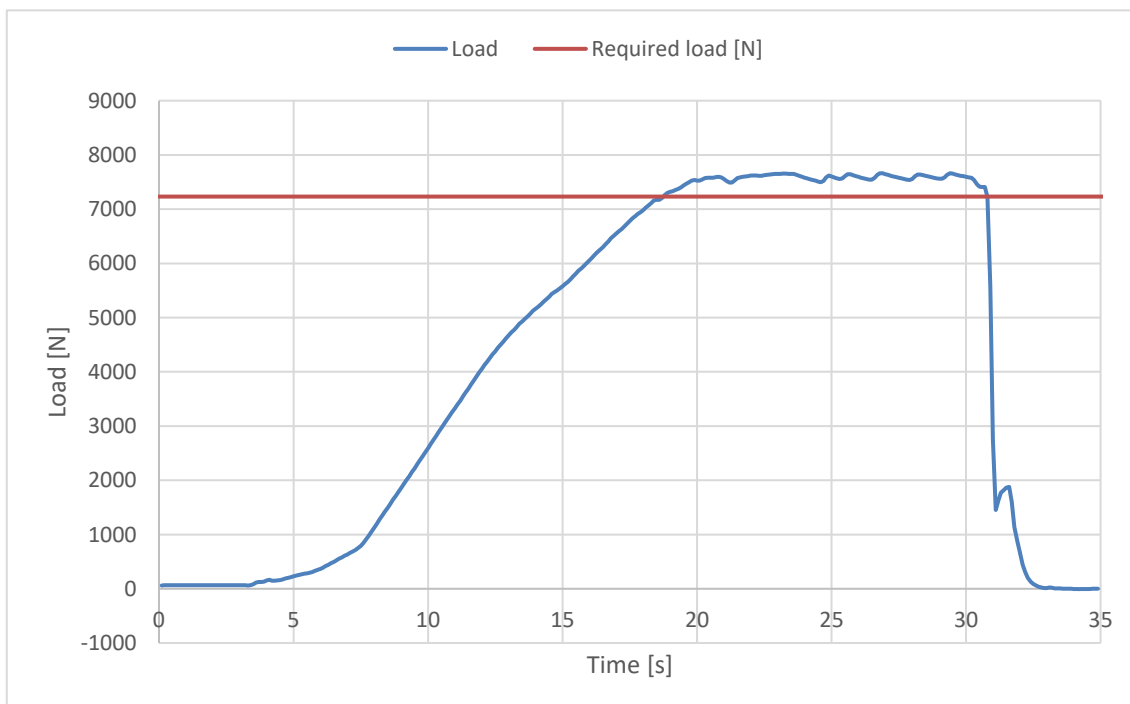
Test ID 02

Test duration [s] **12**  
Any signs of structural failure **No**  
Test results **POSITIVE**

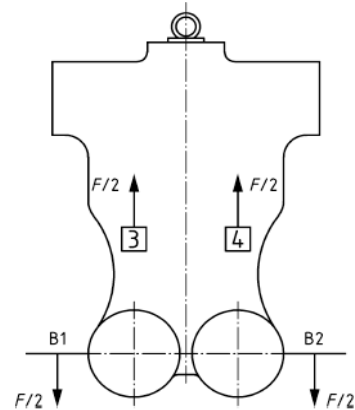
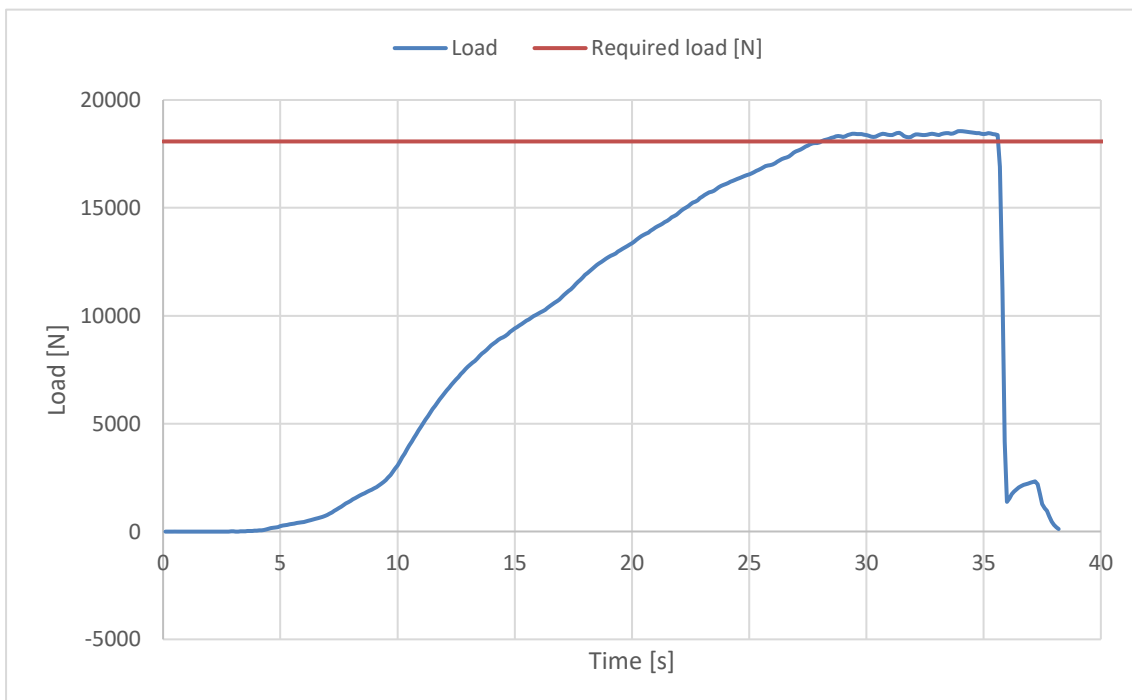
Test ID 03

Test duration [s] **7.6**  
Any signs of structural failure **No**  
Test results **POSITIVE**

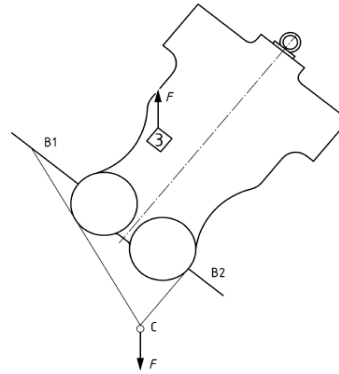
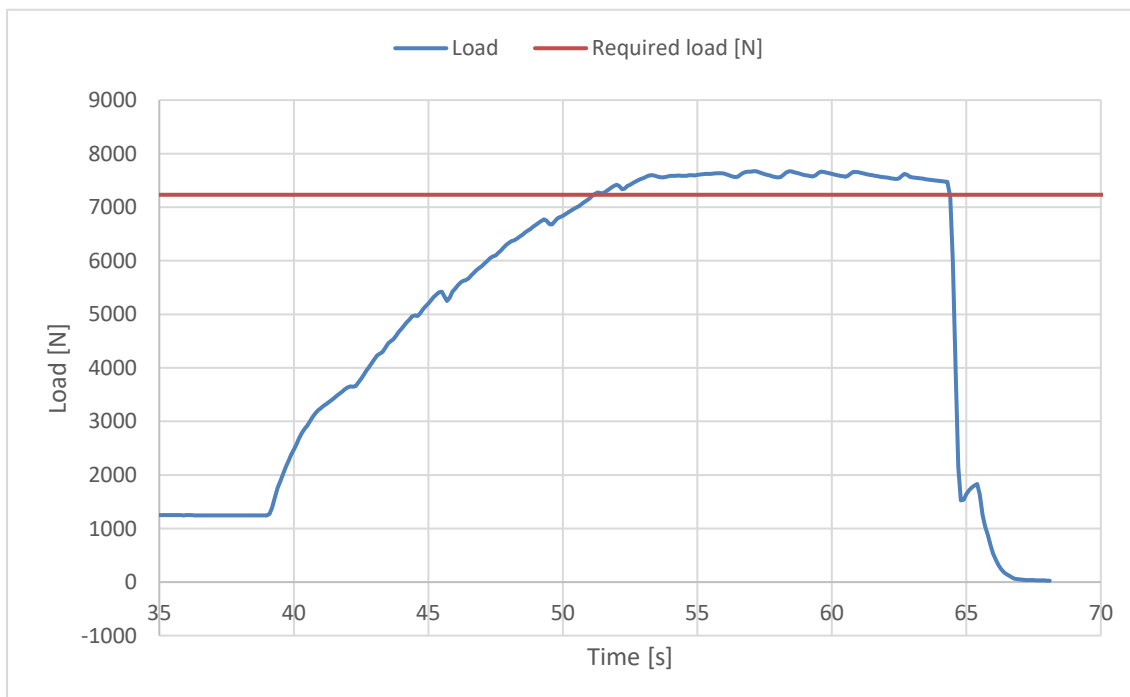
Test ID 04

Test duration [s] **13.2**  
Any signs of structural failure **No**  
Test results **POSITIVE**

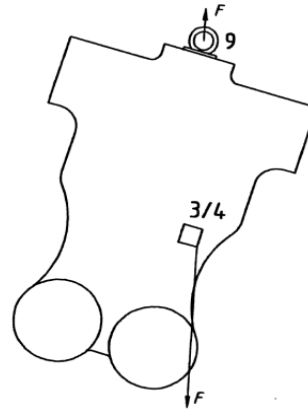
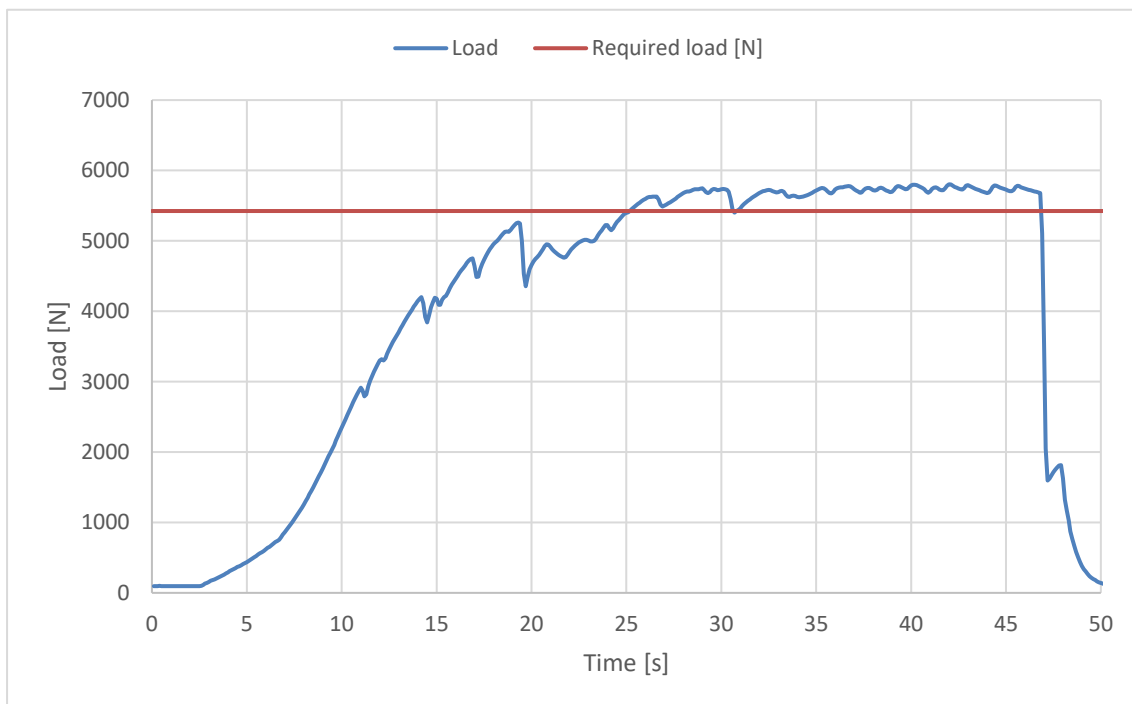
Test ID 07

Test duration [s] **16**  
Any signs of structural failure **No**  
Test results **POSITIVE**

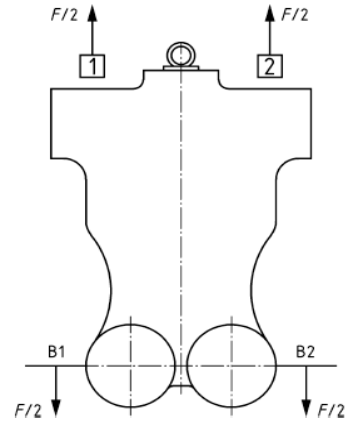
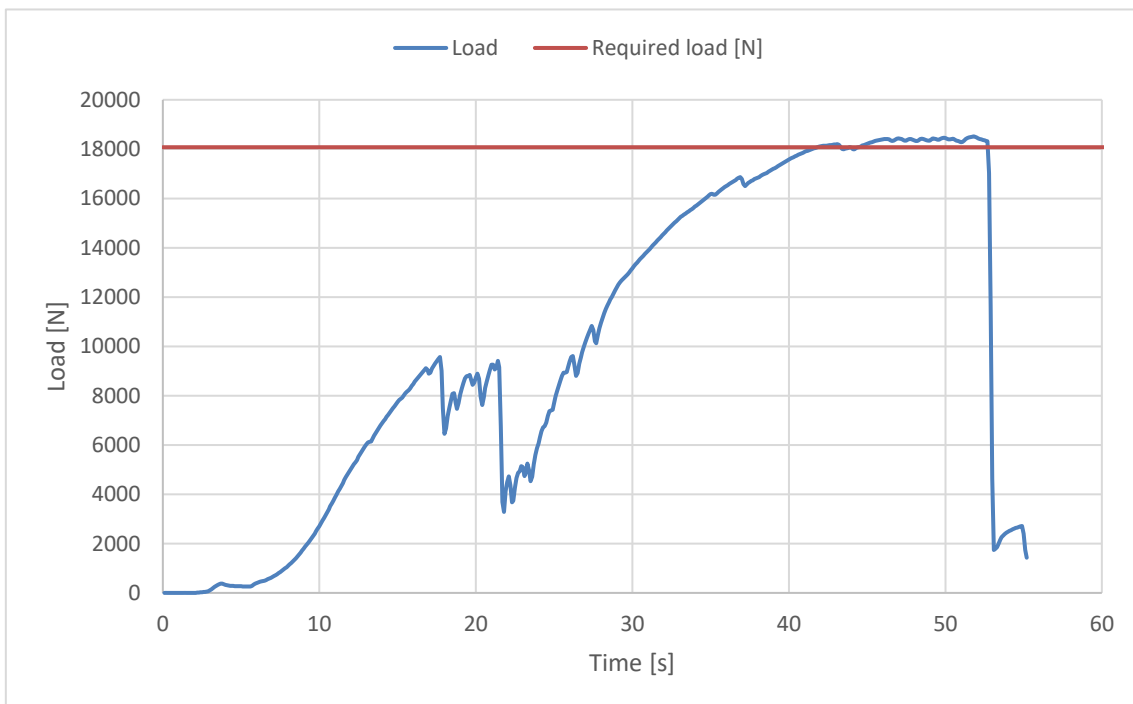
Test ID 09

Test duration [s] **8.3**  
Any signs of structural failure **No**  
Test results **POSITIVE**

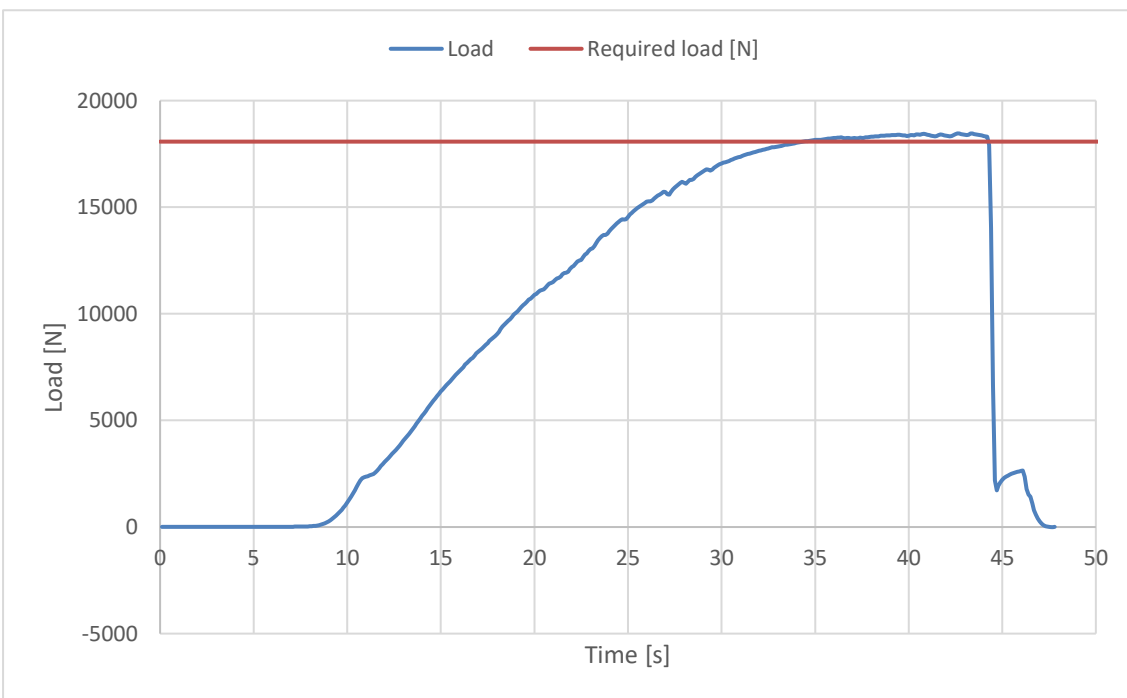
Test ID 13

Test duration [s] **9.9**  
Any signs of structural failure **No**  
Test results **POSITIVE**
