Harness Structural test Report - NfL

Inspection certificate number: **PH_431.2024**

Name: **Pigi eleve**
 Type: **ABS**
 Size: **One size**
 Serial number: **300124/01**
 Impact pad type: ⁽¹⁾ **Foam**
 Clip-in weight [kg]: **120**
 Integrated container: **No**
 Date of test: **31.01.2024**

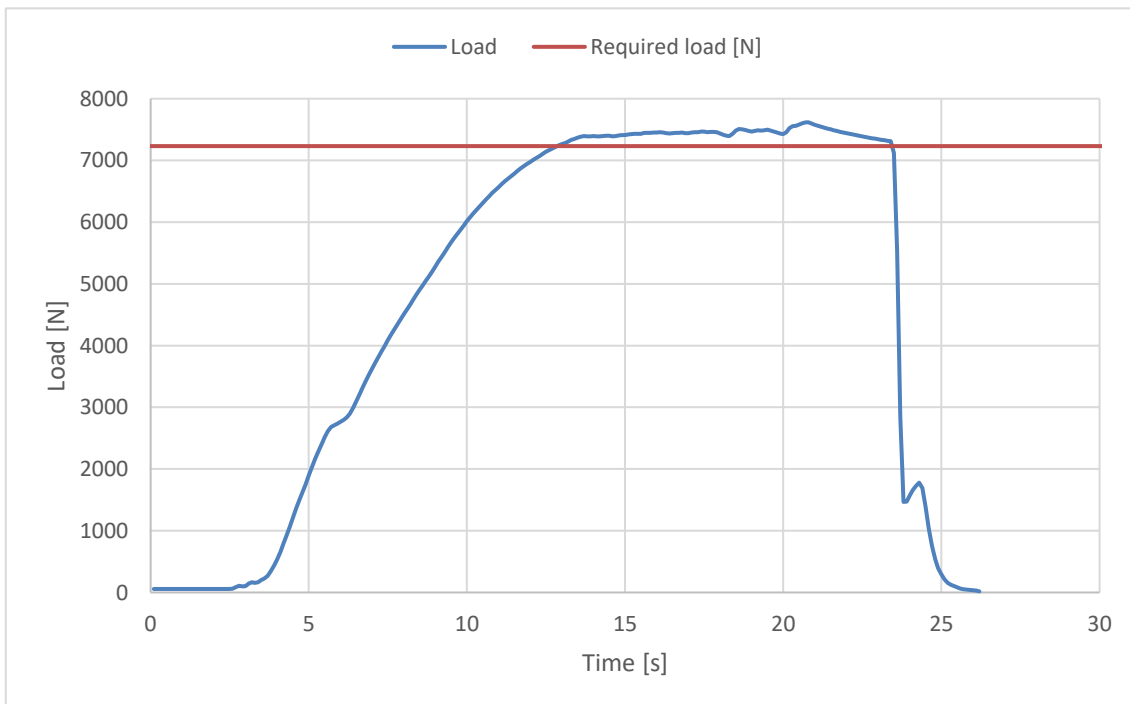
Test ID 02

Standard	EN 1651:1999
Reference	5.3.2.1
Test setup	Default flying position
Attachment points	Both main riser attachment (3,4)
Anchor points	Dummy (B1, B2)
Required load [g]	6
Required load [N]	7200
Minimum test duration [s]	10
Result	
Test duration [s]	10.6
Any signs of structural failure	No
Test results	POSITIVE

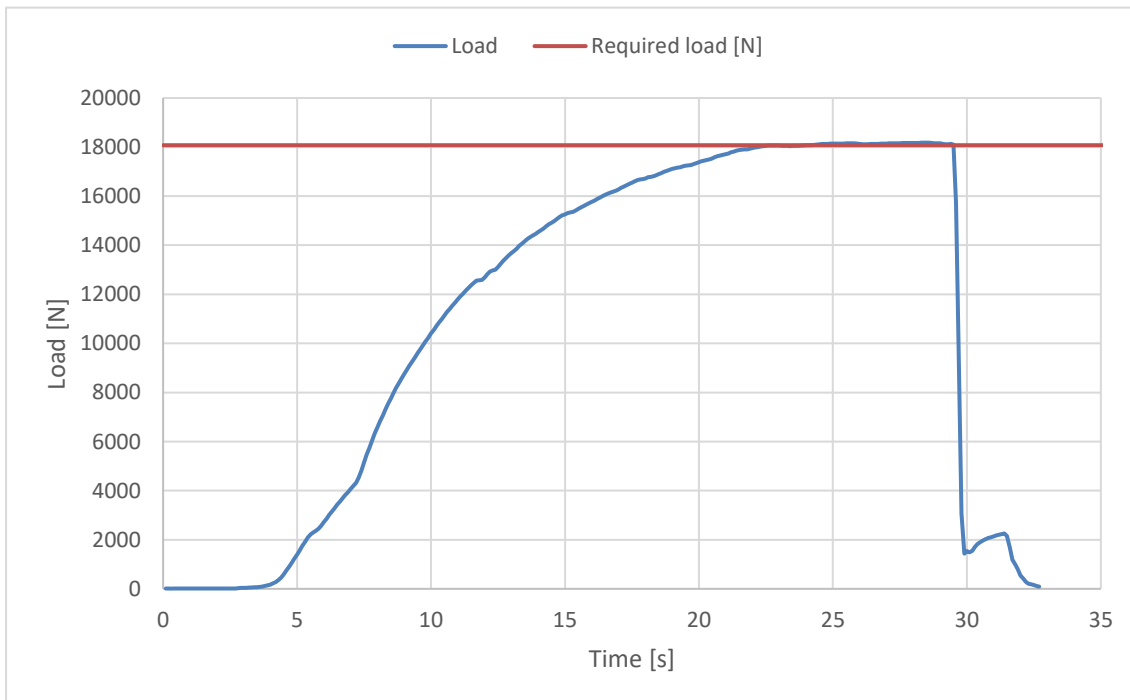
Test ID 03

Test duration [s] **5.5**
 Any signs of structural failure **No**
 Test results **POSITIVE**

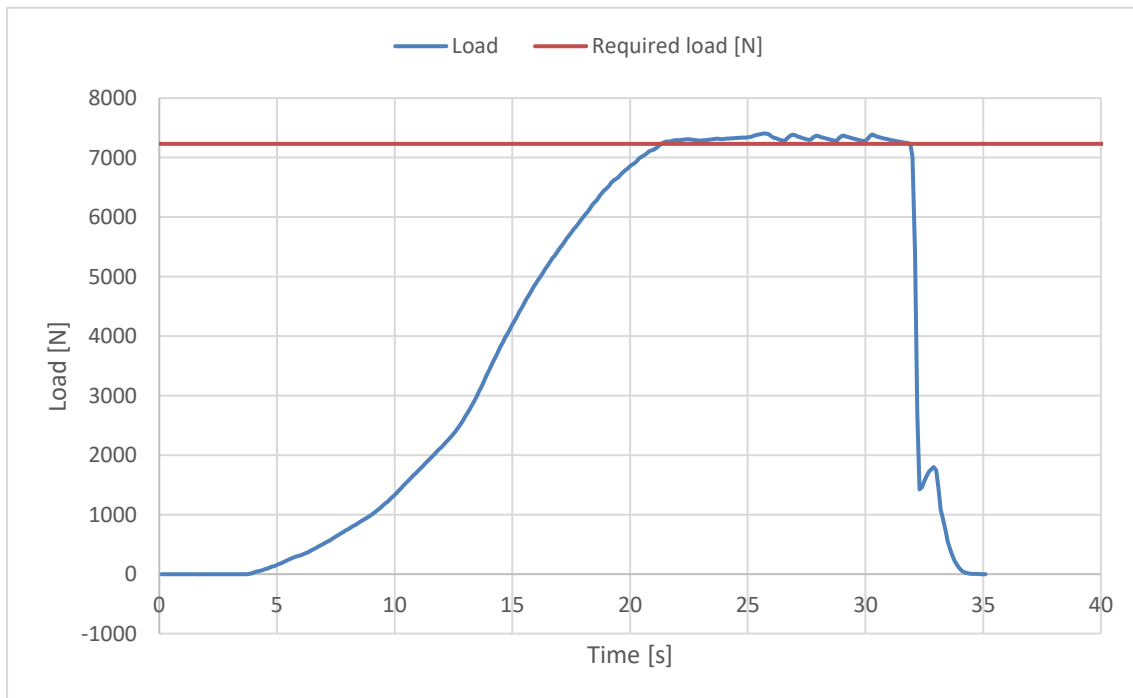
Test ID 04

Standard	EN 1651:1999
Reference	5.3.2.3
Test setup	Asymmetric, one riser
Attachment points	One main riser attachment (3)
Anchor points	Dummy (B1,B2)
Required load [g]	6
Required load [N]	7200
Minimum test duration [s]	10
Result	
Test duration [s]	10.6
Any signs of structural failure	No
Test results	POSITIVE

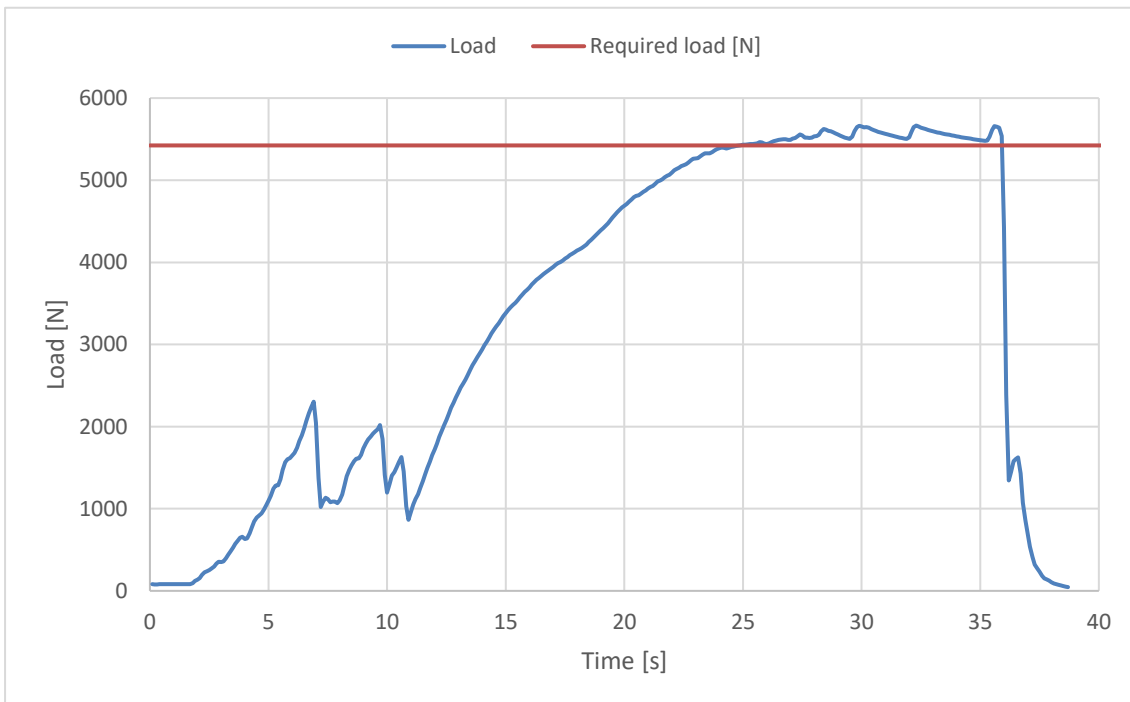
Test ID 07

Reference	5.3.2.6	
Test setup	Asymmetric, negative	
Attachment points	One main riser attachment (3 or 4) downwards	
Anchor points	Dummy (9)	
Required load [g]	4.5	
Required load [N]	5400	
Minimum test duration [s]	10	
Result		
Test duration [s]	11.1	
Any signs of structural failure	No	
Test results	POSITIVE

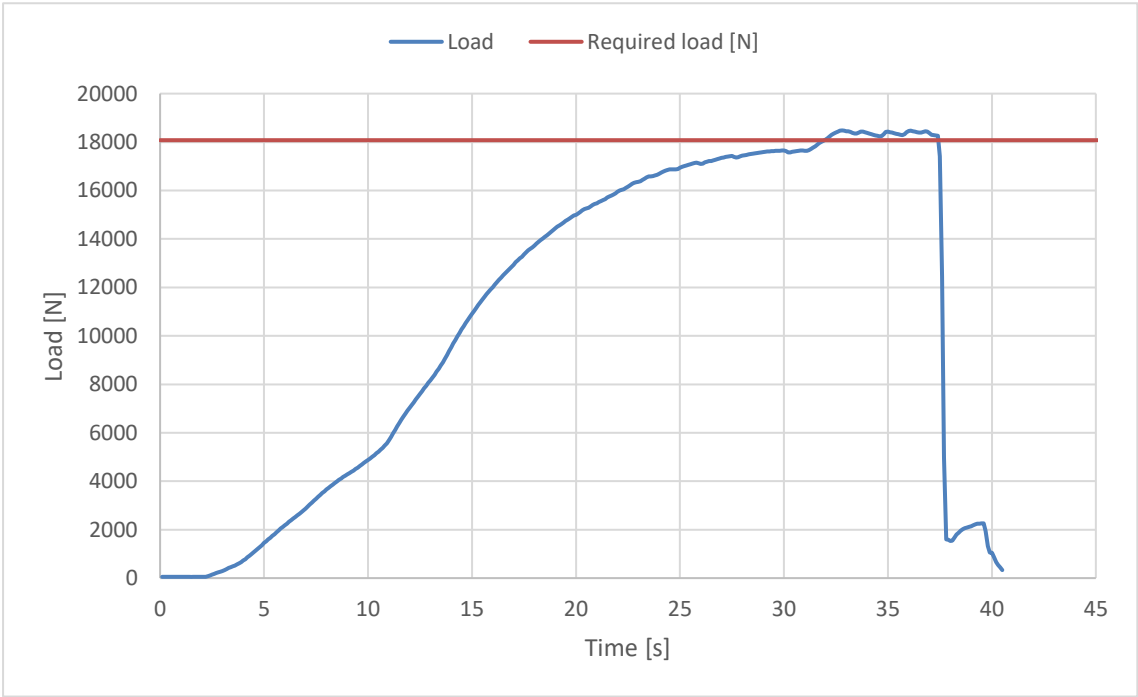
Test ID 13

Standard	EN 1651:1999
Reference	5.3.2.7
Test setup	Flying position before landing
Attachment points	Both main riser attachment (3,4)
Anchor points	Dummy (7,8)
Required load [g]	15
Required load [N]	18000
Minimum test duration [s]	5
Result	
Test duration [s]	5.5
Any signs of structural failure	No
Test results	POSITIVE
