# Harness Structural test Report - EN

Inspection certificate number: **PH\_376.2022**

Name: **Forza 2**  
 Type: **ABS**  
 Size: **M**  
 Serial number: **OPGP-022**  
 Impact pad type: <sup>(1)</sup> **Foam**  
 Clip-in weight [kg]: **120**

model: **Forza 2**

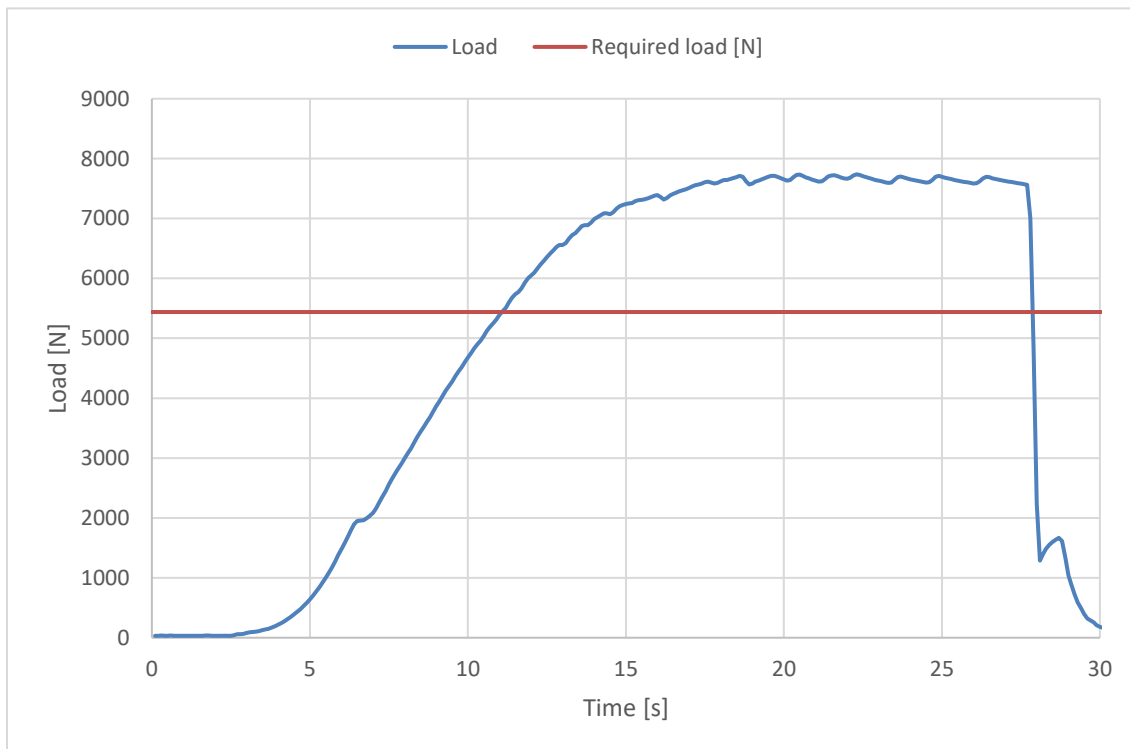
Test ID 01

Test duration [s] **16.8**  
Any signs of structural failure **No**  
Slippery test OK **Yes**  
Test results **POSITIVE**

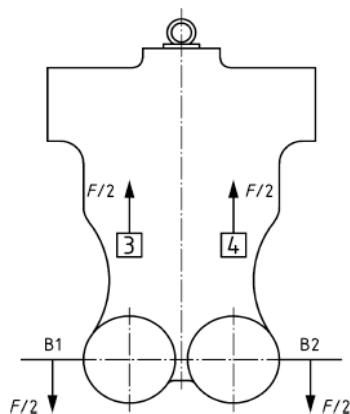
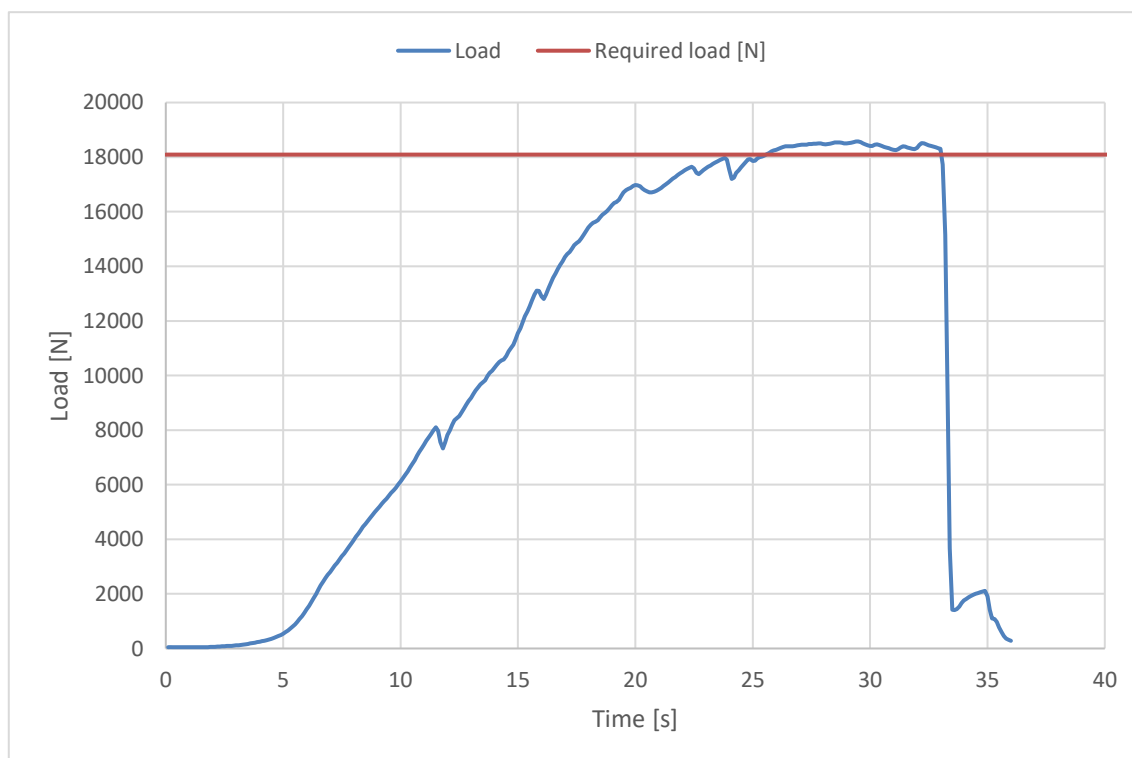
Test ID 03

Test duration [s] **7.5**  
Any signs of structural failure **No**  
Slippery test OK **Yes**  
Test results **POSITIVE**

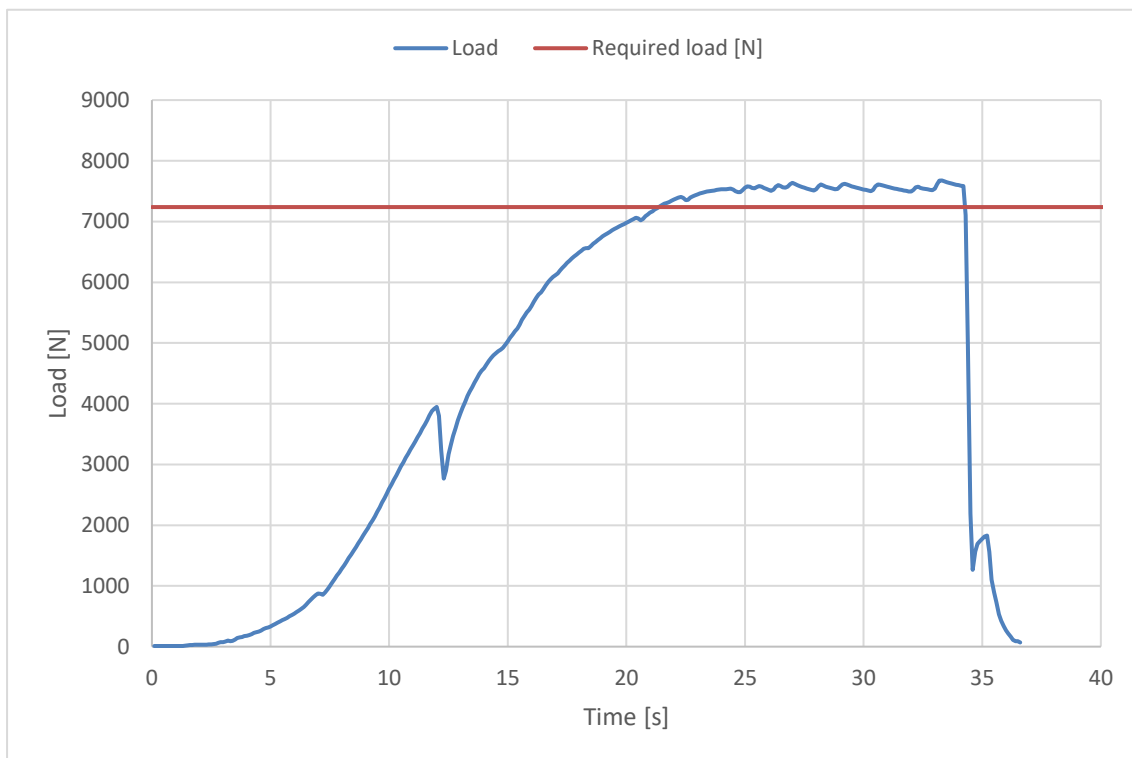
Test ID 05

Test duration [s] **12.9**  
Any signs of structural failure **No**  
Test results **POSITIVE**

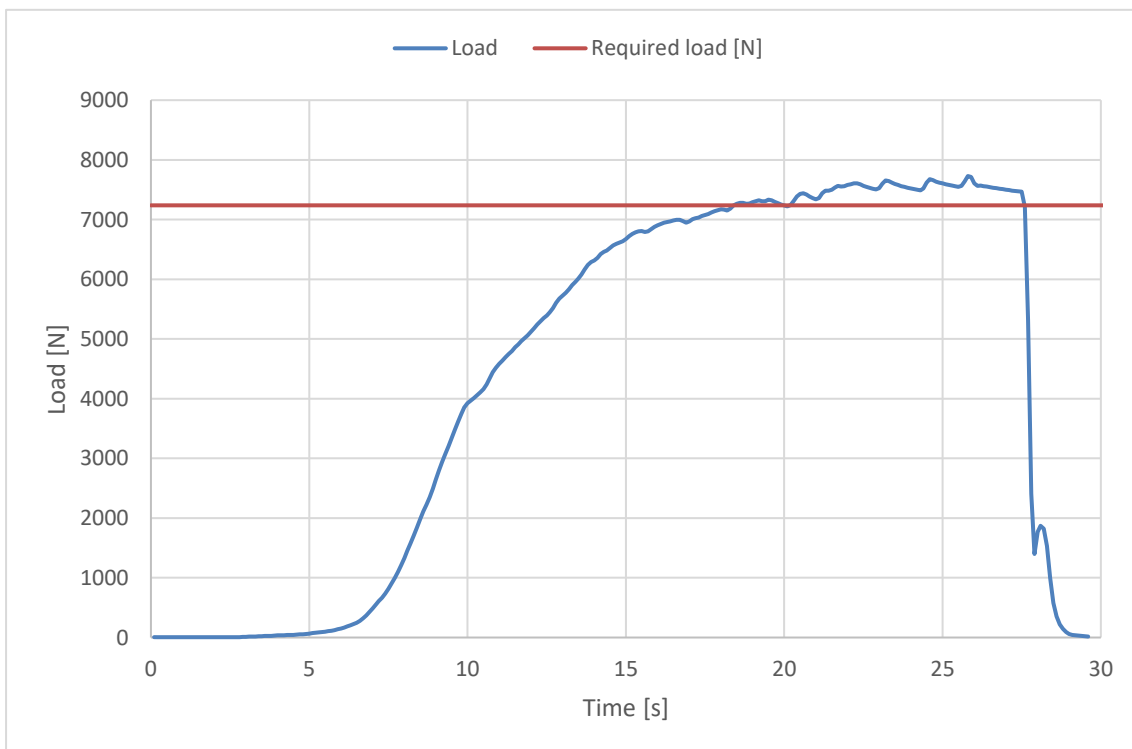
Test ID 06

Test duration [s] **7.4**  
Any signs of structural failure **No**  
Test results **POSITIVE**

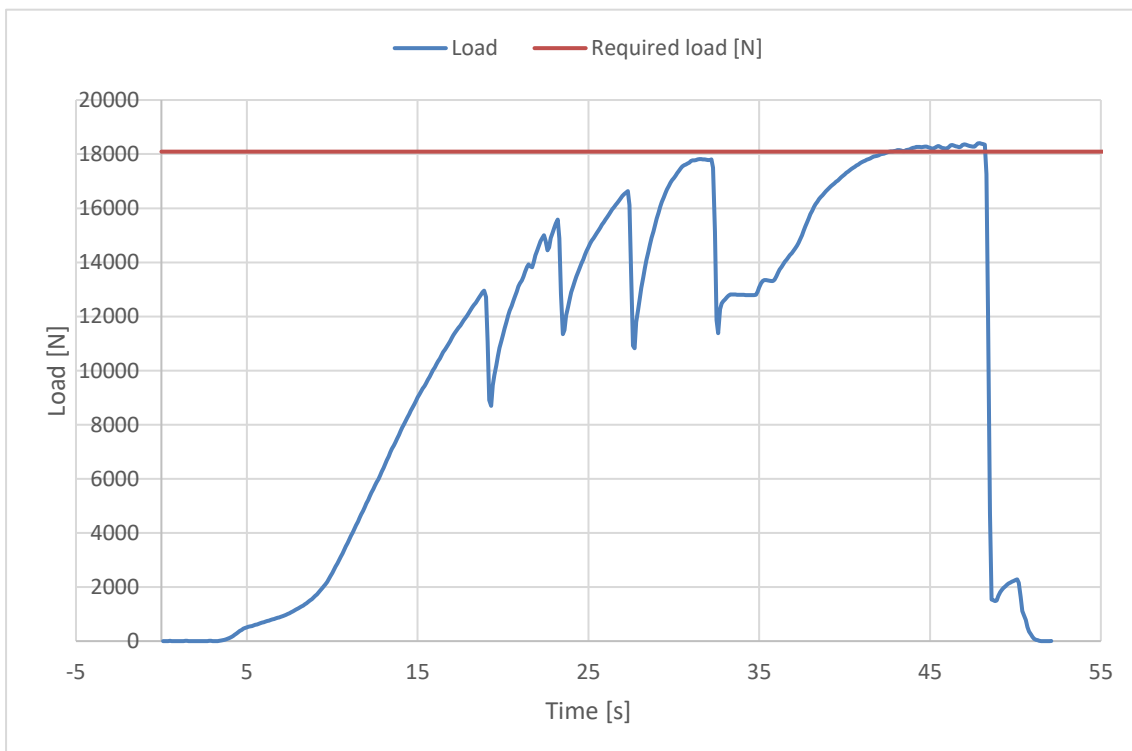
Test ID 09

Test duration [s] **5.6**  
Any signs of structural failure **No**  
Slippery test OK **Yes**  
Test results **POSITIVE**

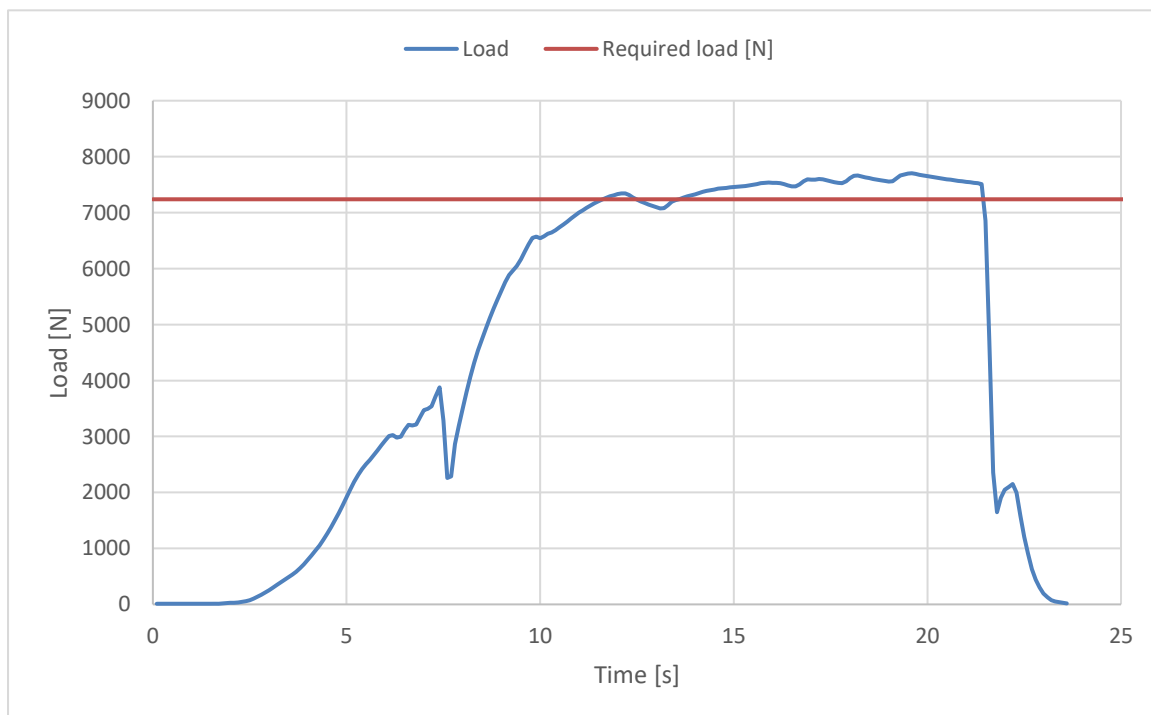
Test ID 12

Test duration [s] **7.9**  
Any signs of structural failure **No**  
Slippery test OK **Yes**  
Test results **POSITIVE**

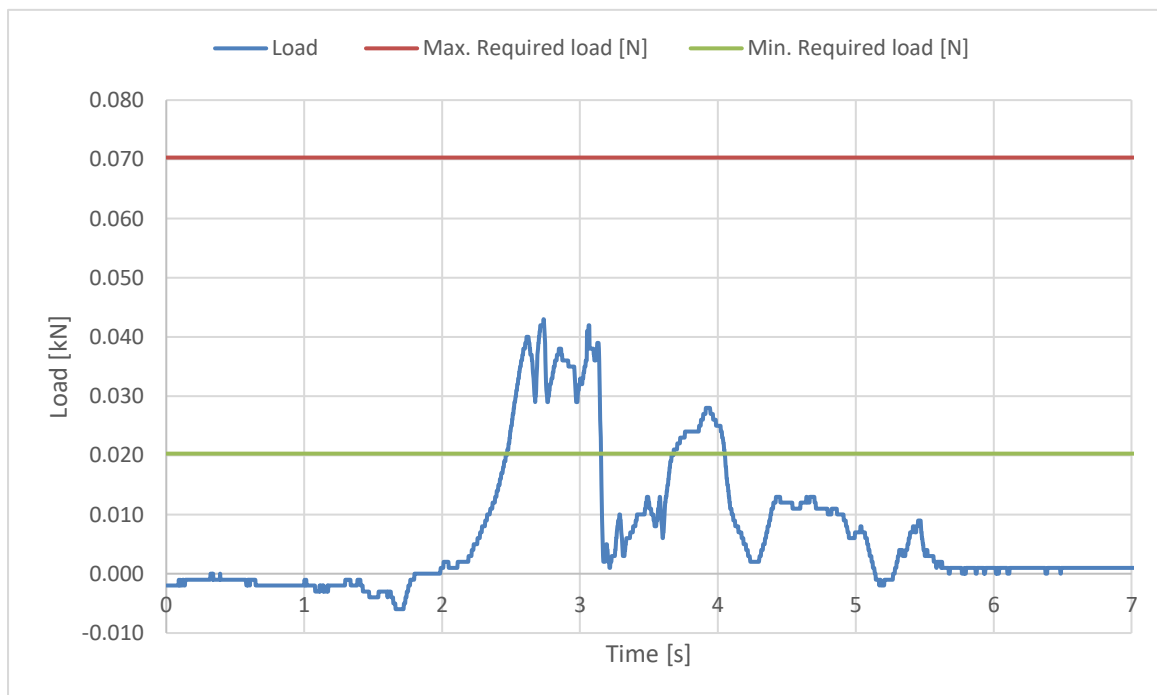
Test ID RRDT

| Load for first action [N] | <b>43.29</b> |
| Test results | <b>POSITIVE</b> |

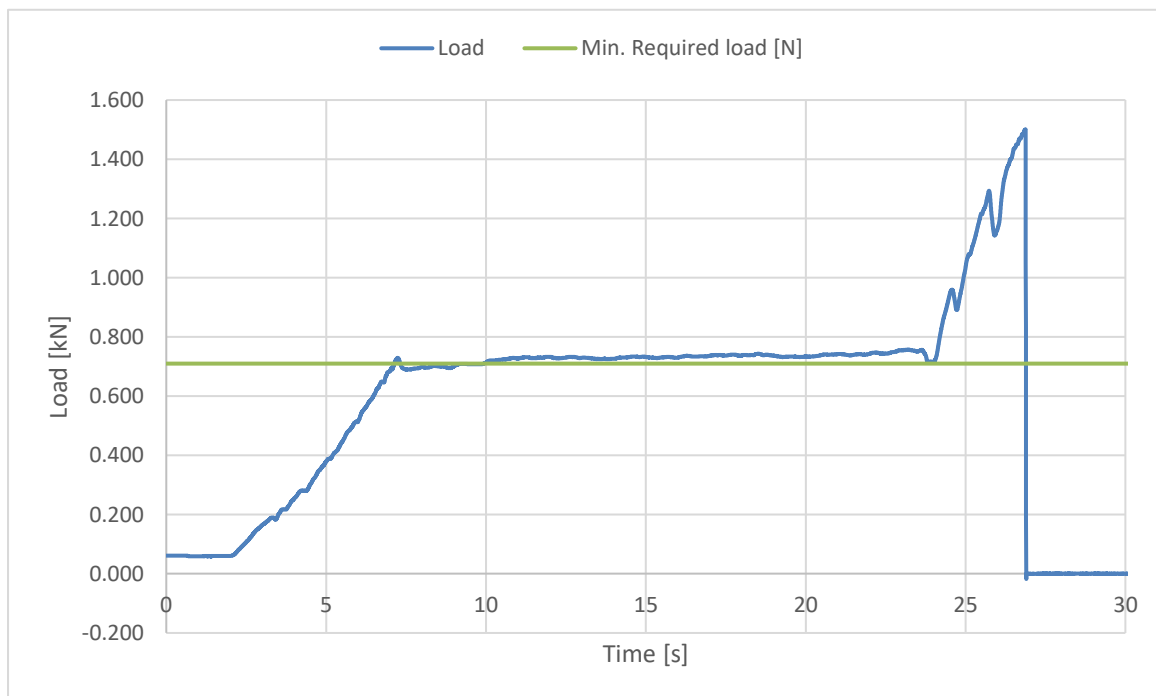
Test ID RRST

Test duration [s]: **17.0**  
Breaking strength [N] **1491.03**  
Test results **POSITIVE**
