## Harness Structural test Report - NfL

Inspection certificate number: **PH\_376.2022**

Name: **Forza 2**  
 Type: **ABS**  
 Size: **M**  
 Serial number: **OPGP-022**  
 Impact pad type: <sup>(1)</sup> **Foam**  
 Clip-in weight [kg]: **120**  
 Integrated container: **Yes**

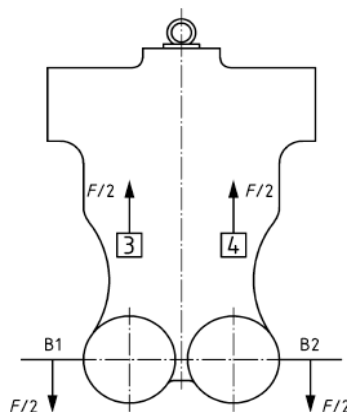
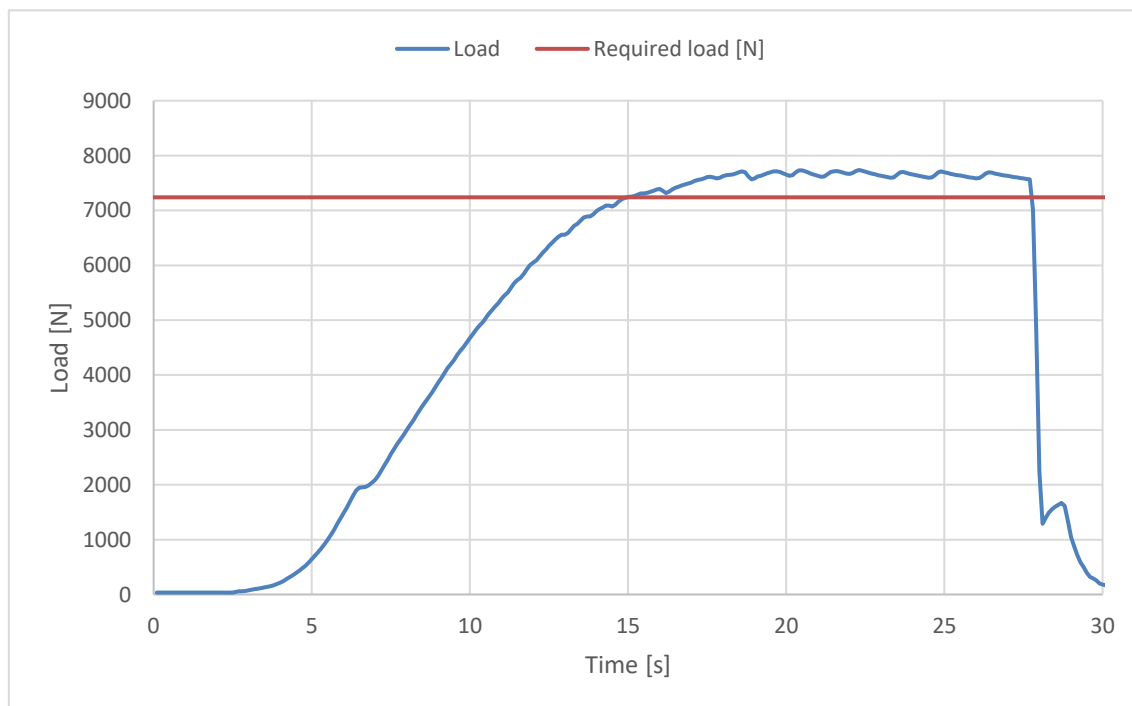
Test ID 02

Test duration [s] **12.8**  
Any signs of structural failure **No**  
Test results **POSITIVE**

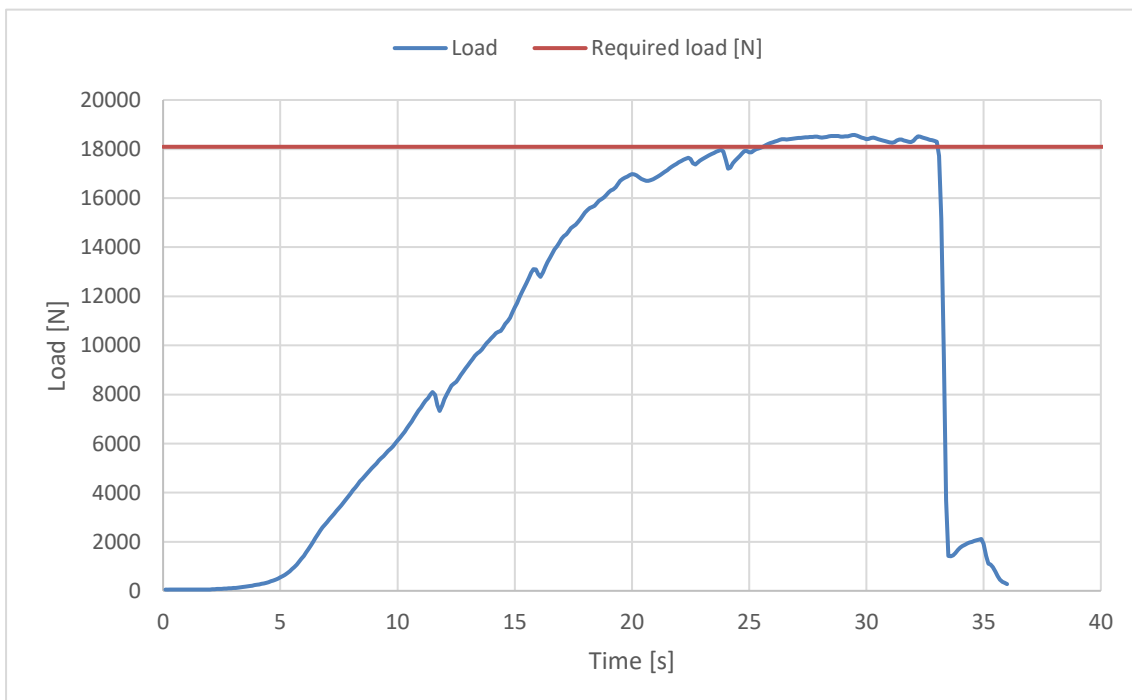
Test ID 03

Test duration [s] **7.5**  
Any signs of structural failure **No**  
Test results **POSITIVE**

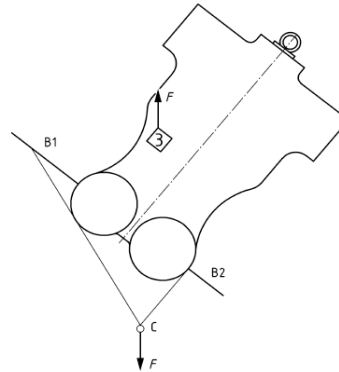
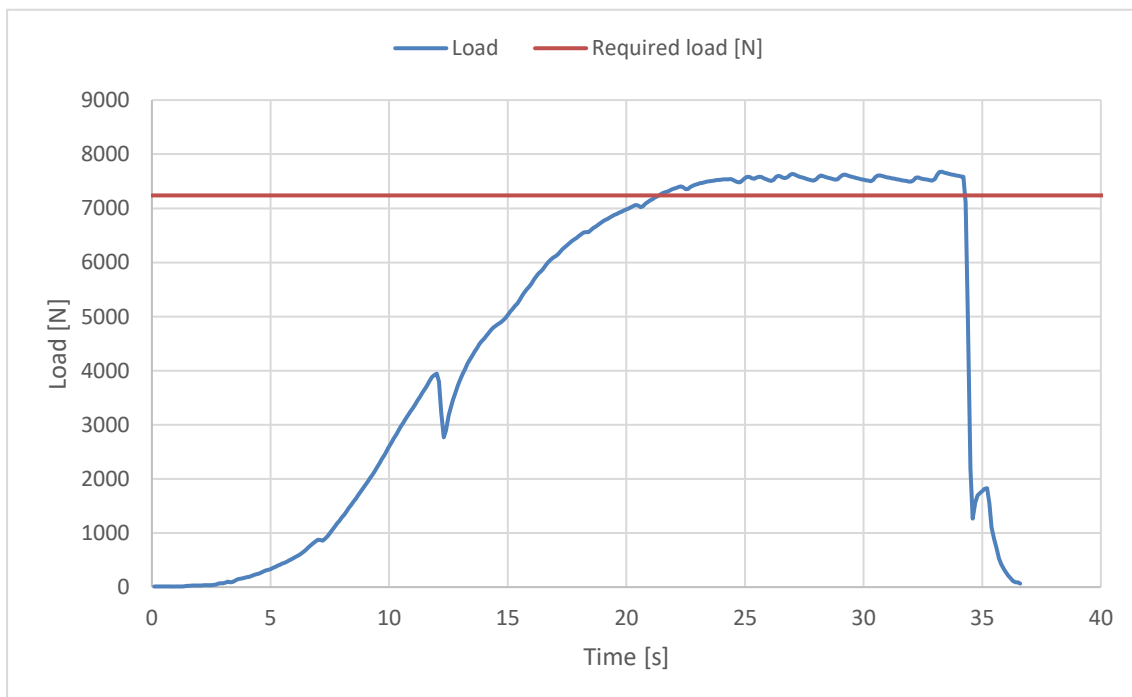
Test ID 04

Test duration [s] **12.9**  
Any signs of structural failure **No**  
Test results **POSITIVE**

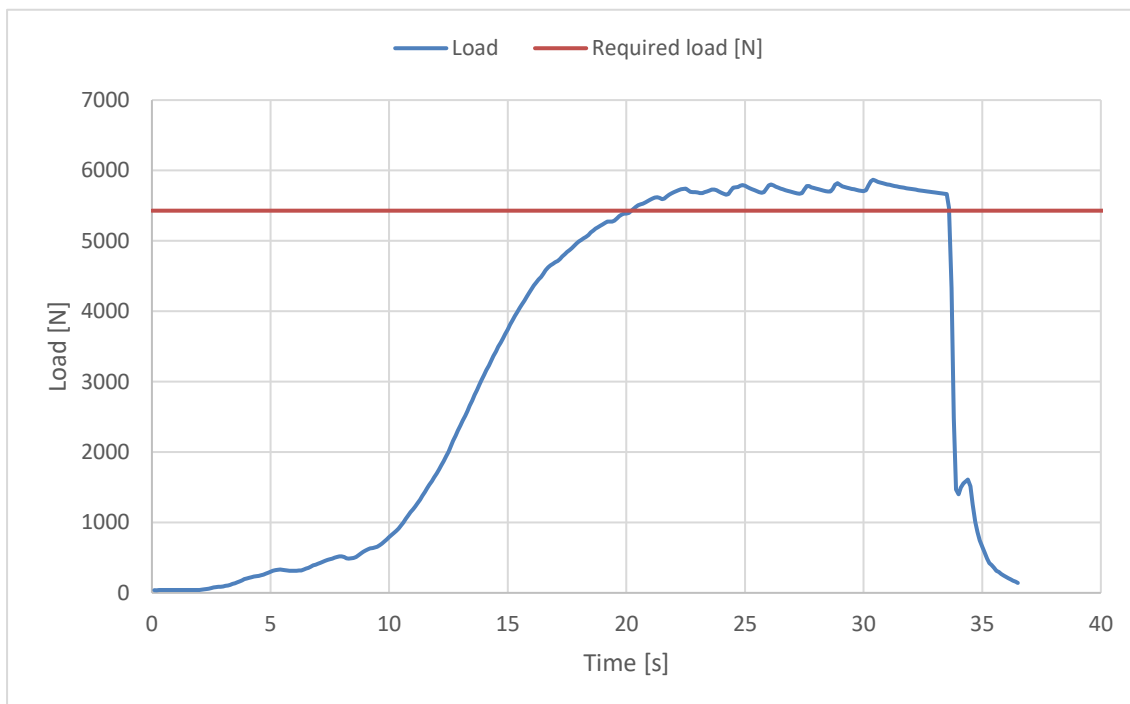
Test ID 07

Test duration [s] **13.4**  
Any signs of structural failure **No**  
Test results **POSITIVE**

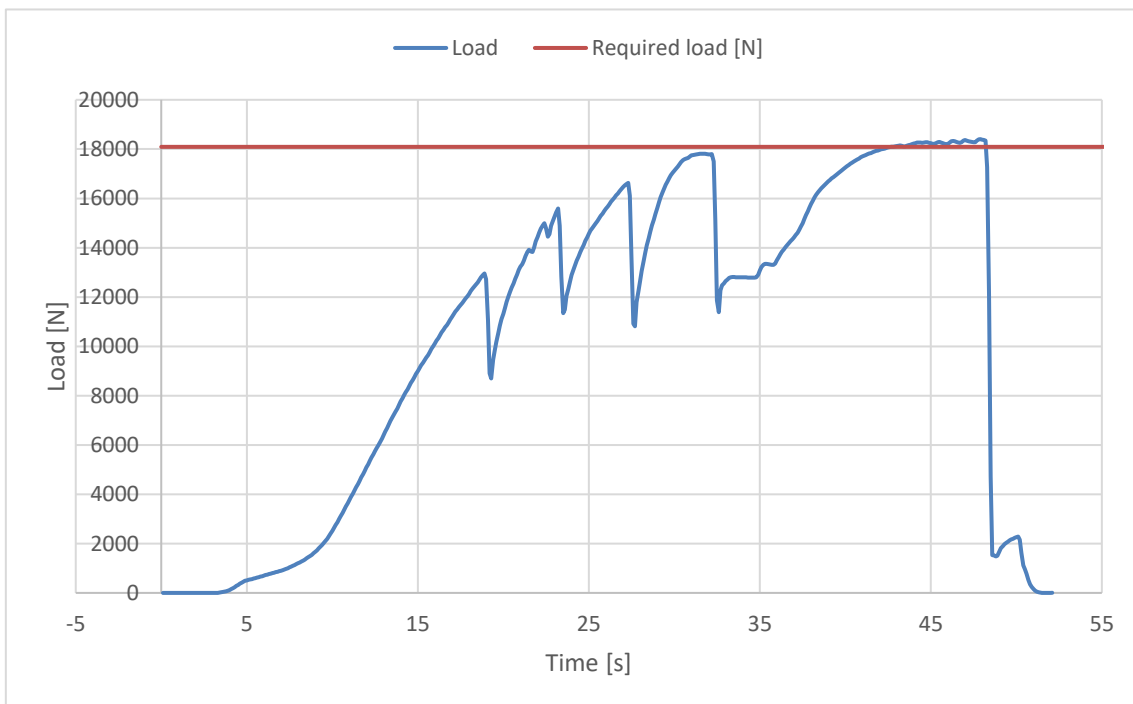
Test ID 09

Test duration [s] **5.6**  
Any signs of structural failure **No**  
Test results **POSITIVE**

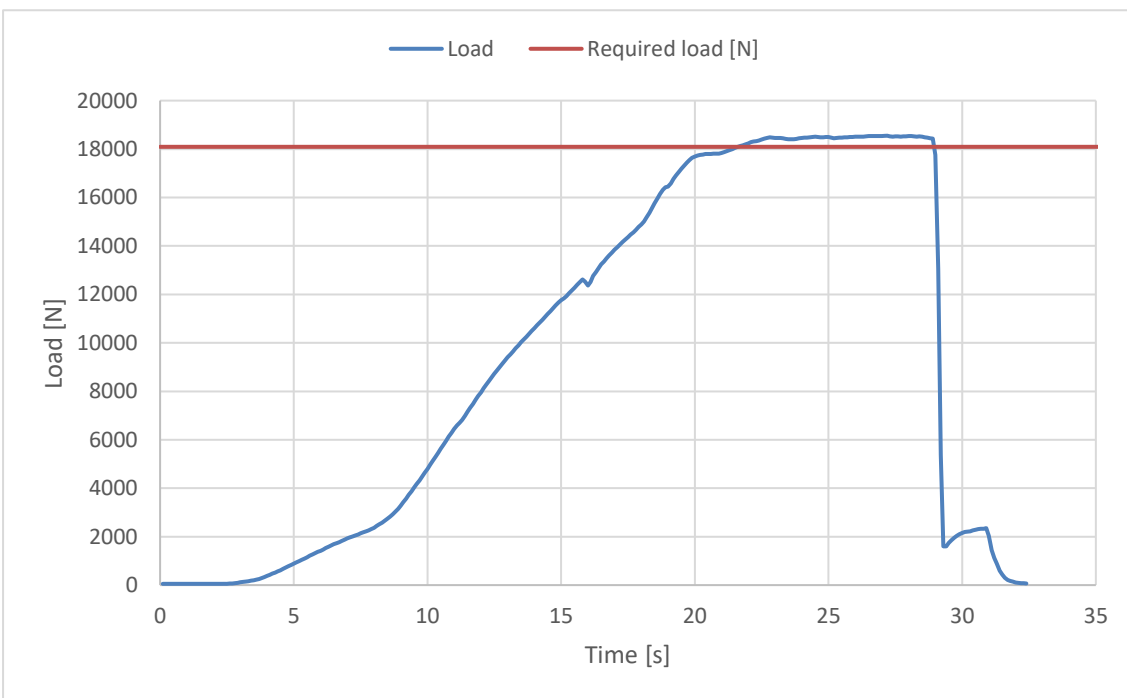
Test ID 13

Test duration [s] **7.4**  
Any signs of structural failure **No**  
Test results **POSITIVE**

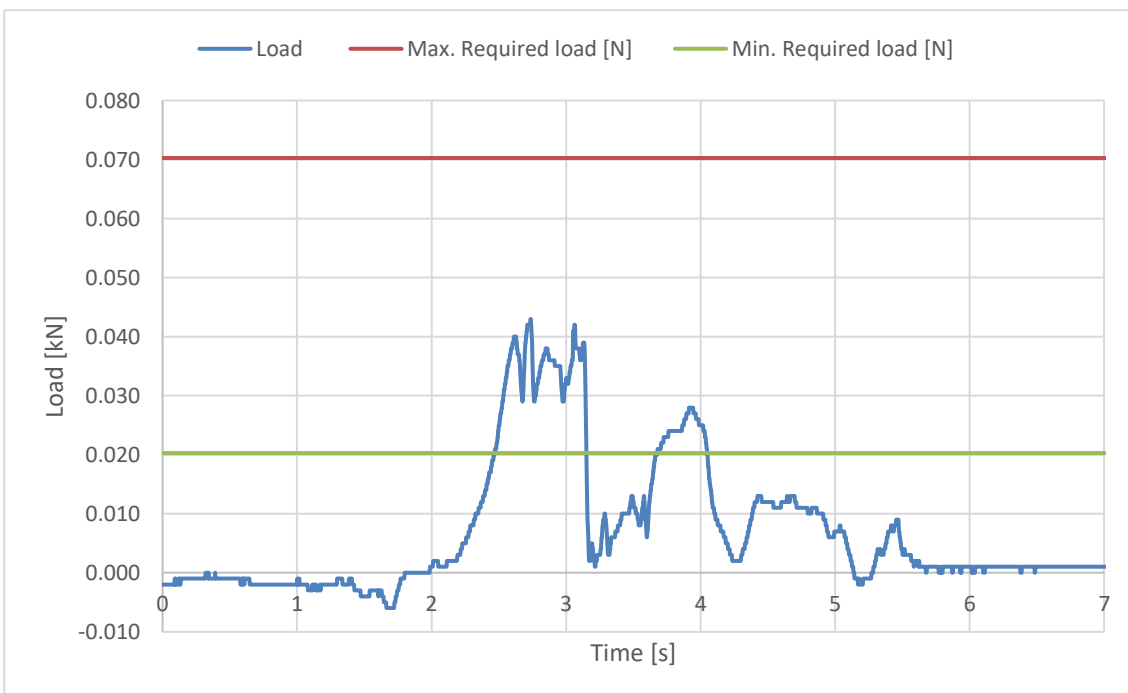
Test ID RRDT

| Load for first action [N] | <b>42.71</b> |
| Test results | <b>POSITIVE</b> |

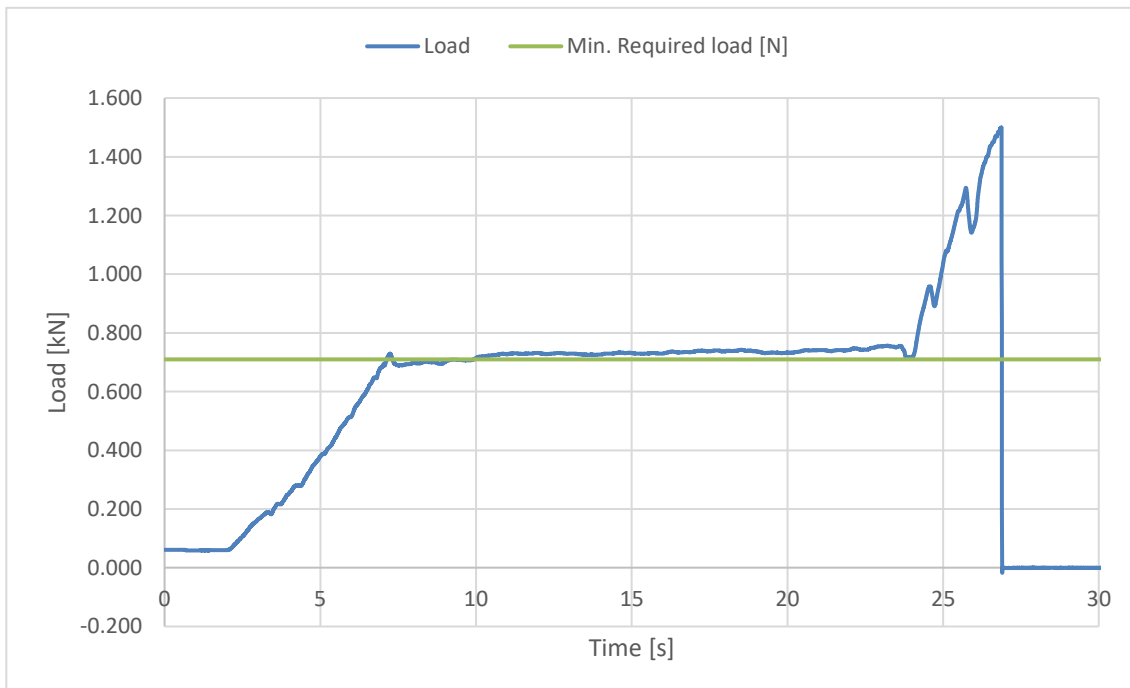
Test ID RRST

Test duration [s]: **17.0**  
Breaking strength [N] **1491.03**  
Test results **POSITIVE**
