Harness Structural test Report - NfL

Inspection certificate number: PH_357.2022

Name: **Breeze 2**
 Type: **ABS**
 Size: **M**
 Serial number: **SHBR2M005**
 Impact pad type: ⁽¹⁾ **Inflatable**
 Clip-in weight [kg]: **120**
 Integrated container: **Yes**

Summary of Structural test

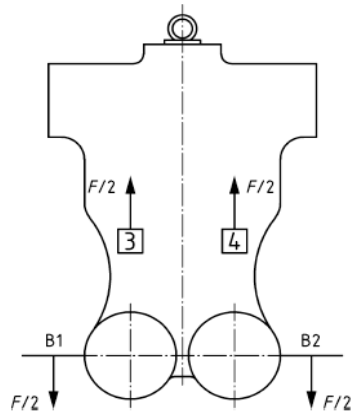
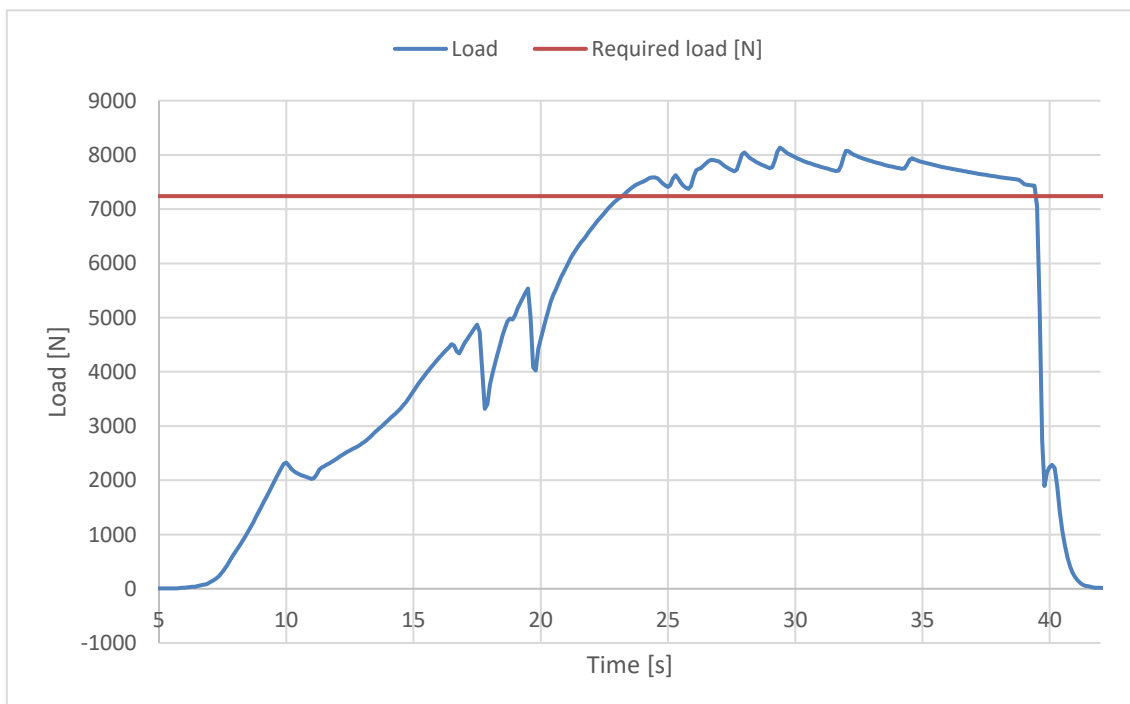
Test ID 02

Test duration [s] **16.2**
Any signs of structural failure **No**
Test results **POSITIVE**

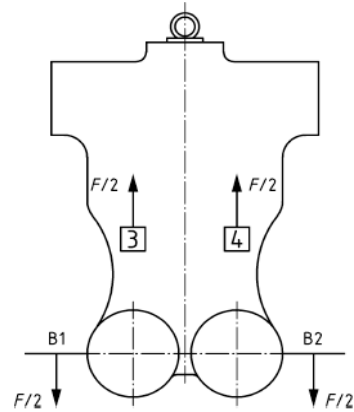
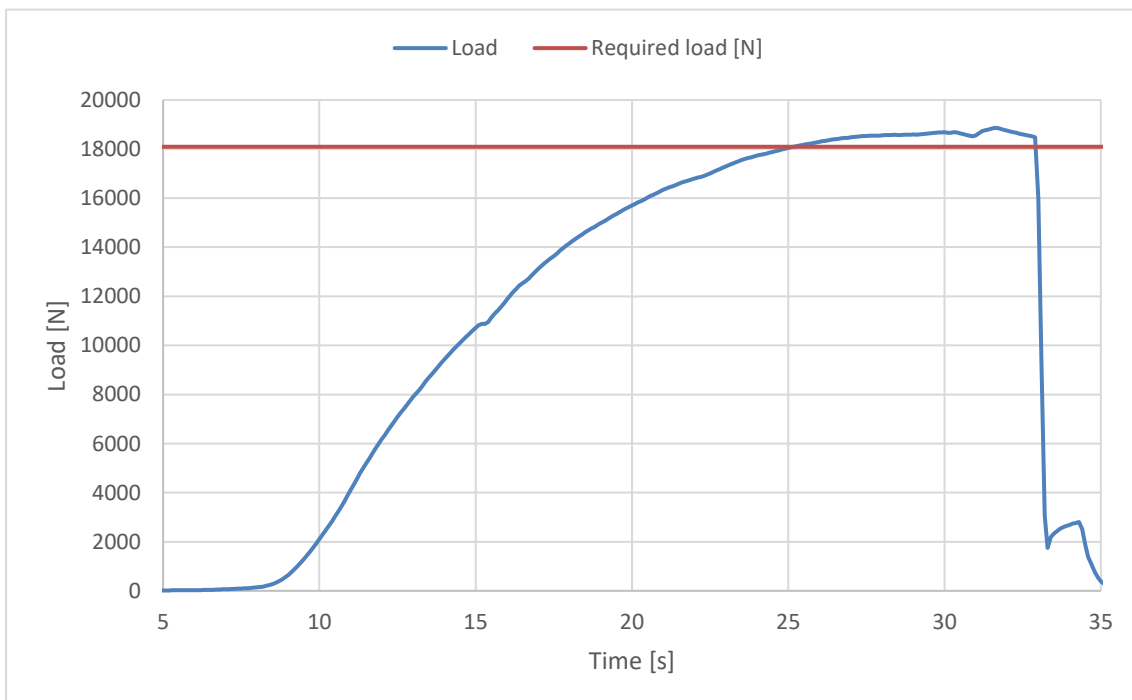
Test ID 03

Test duration [s] **7.8**
Any signs of structural failure **No**
Test results **POSITIVE**

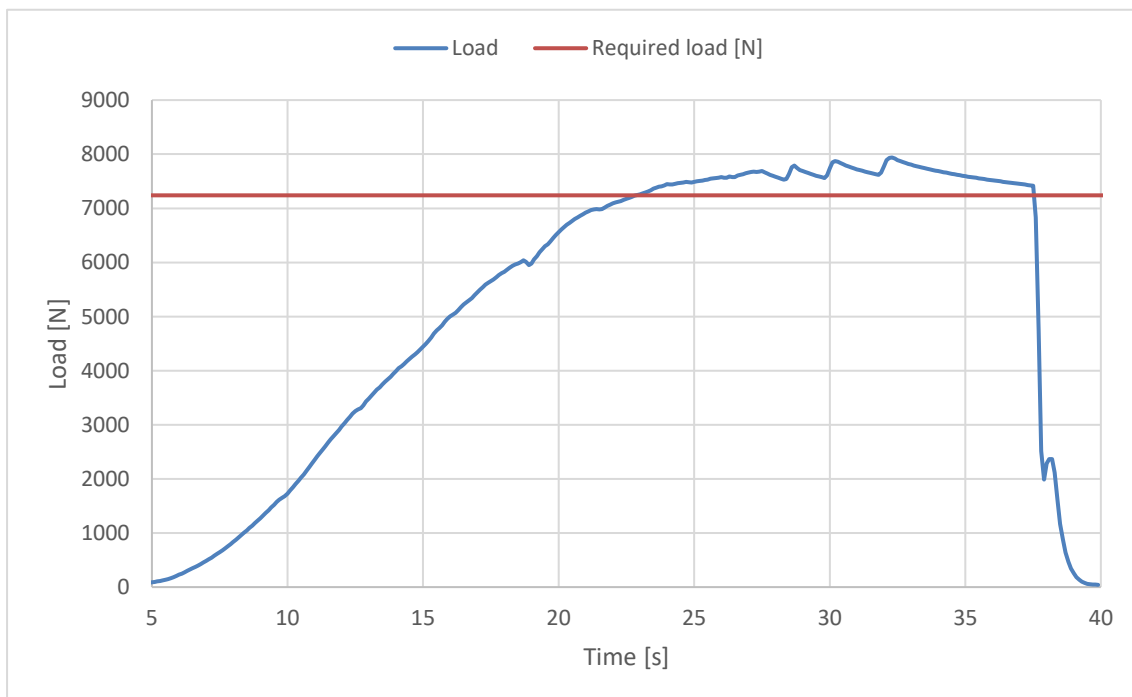
Test ID 04

Test duration [s] **14.7**
Any signs of structural failure **No**
Test results **POSITIVE**

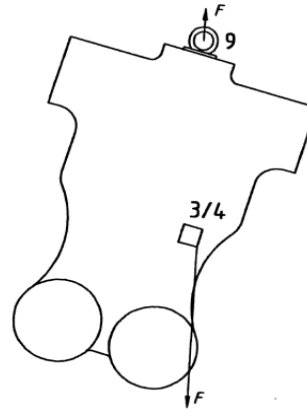
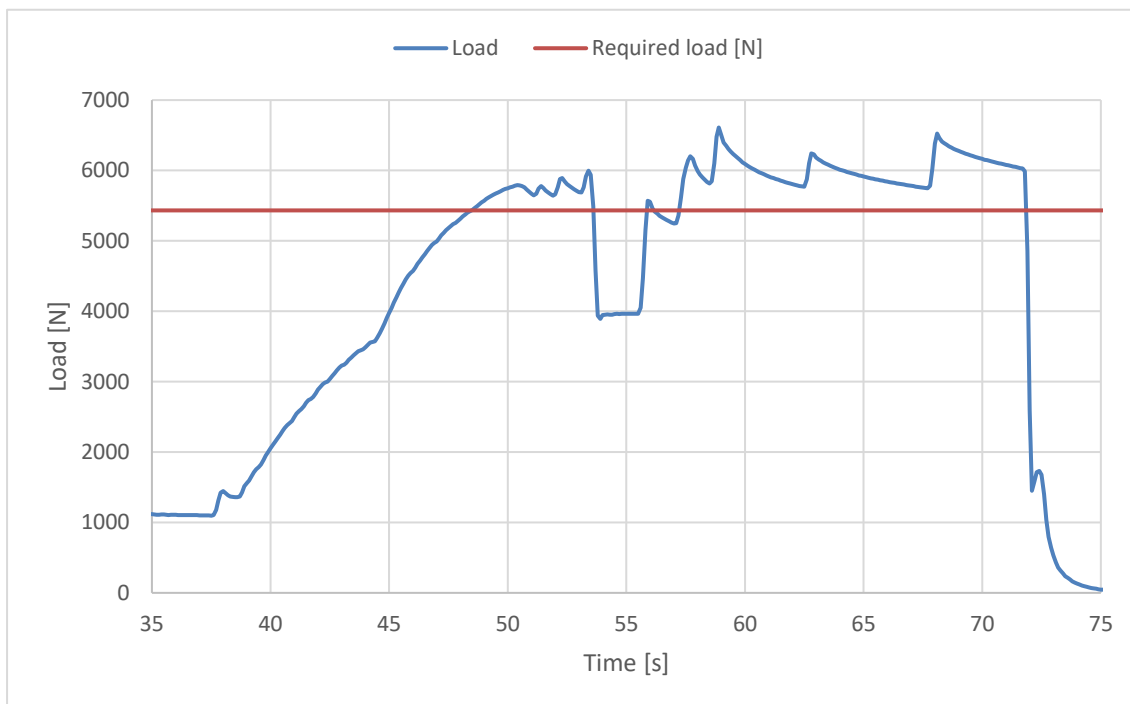
Test ID 07

Test duration [s] **14.6**
Any signs of structural failure **No**
Test results **POSITIVE**

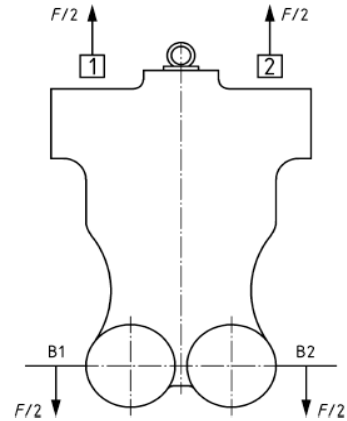
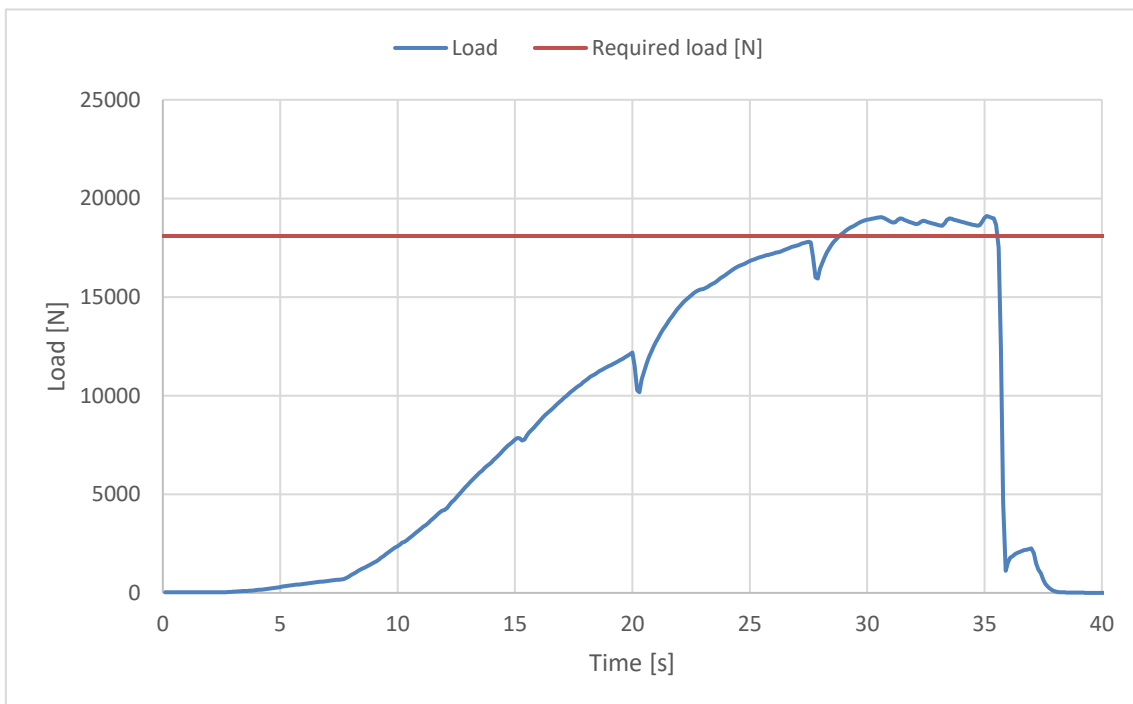
Test ID 09

Test duration [s] **6.7**
Any signs of structural failure **No**
Test results **POSITIVE**

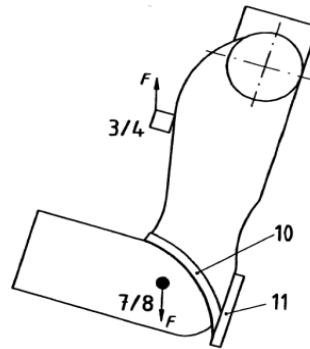
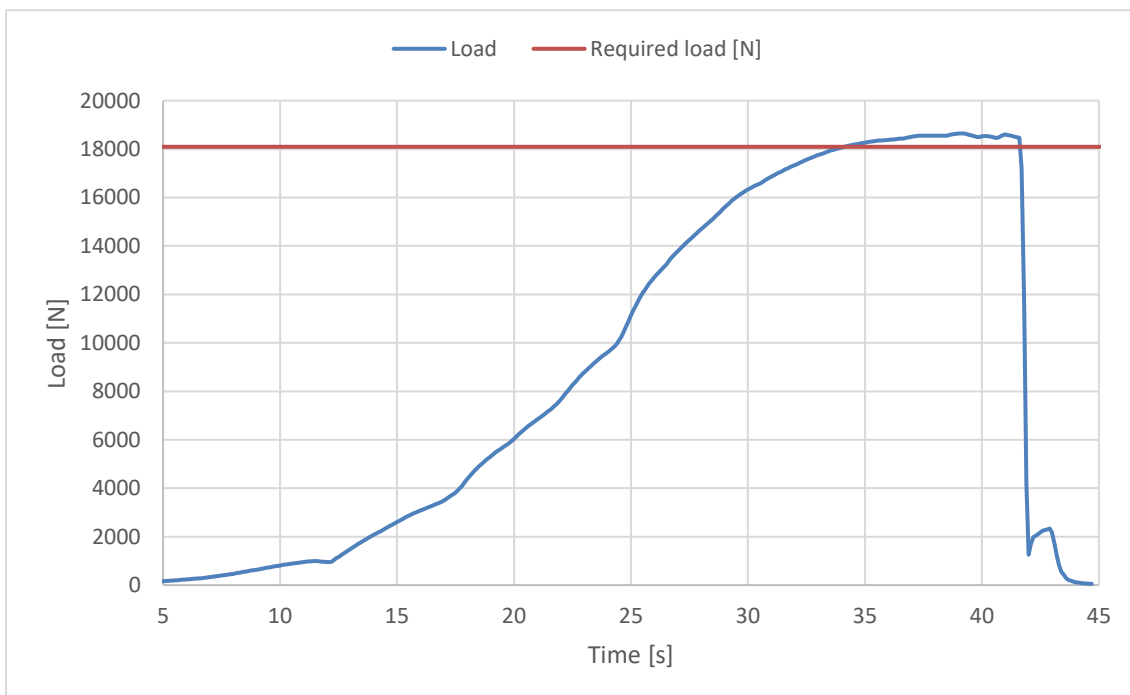
Test ID 13

Test duration [s] **7.5**
Any signs of structural failure **No**
Test results **POSITIVE**

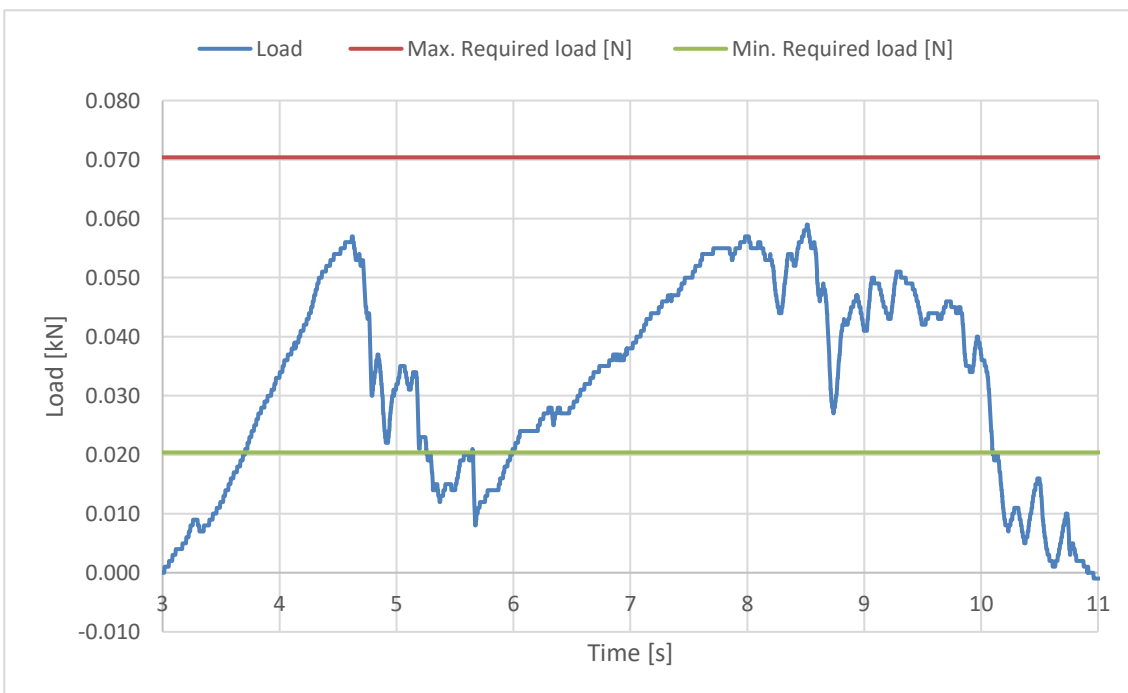
Test ID RRDT

Load for first action [N] **58.61**
Test results **POSITIVE**

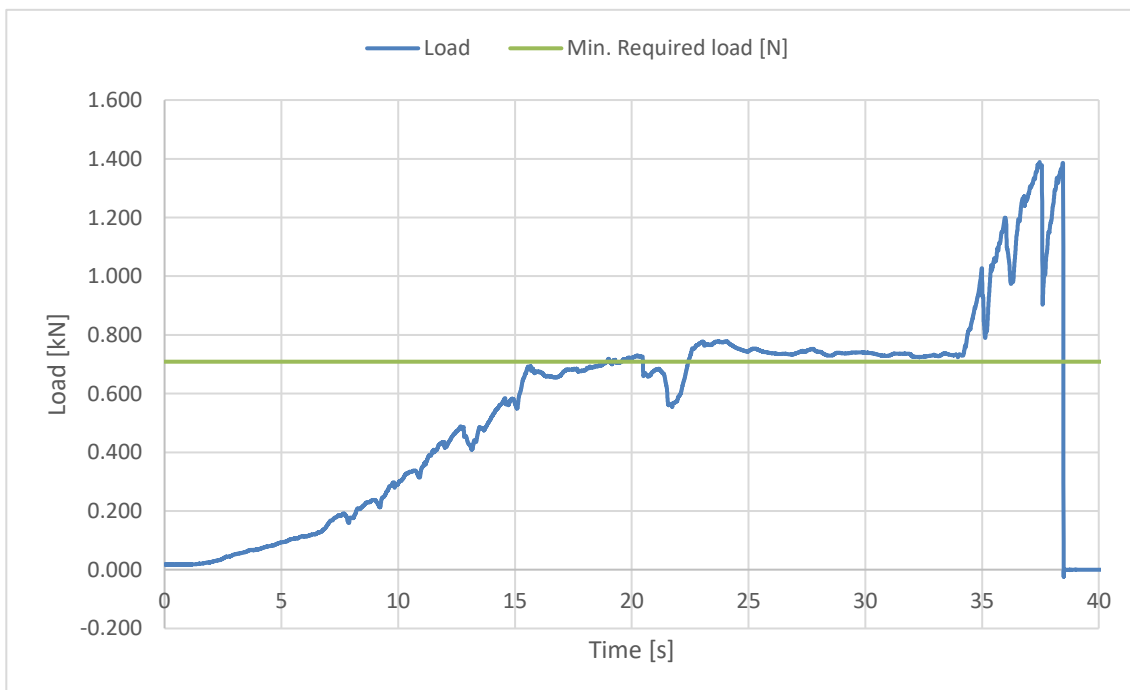
Test ID RRST

Test duration [s]: **16.0**
Breaking strength [N] **1379.77**
Test results **POSITIVE**
