Harness Structural test Report - EN

Inspection certificate number: PH_438.2024

Name: **VisstaXC**
 Type: **ABS**
 Size: **L**
 Serial number: **BFLOWLV351**
 Impact pad type: ⁽¹⁾ **Foam**
 Clip-in weight [kg]: **120**

Date of test: **04.01.2024**

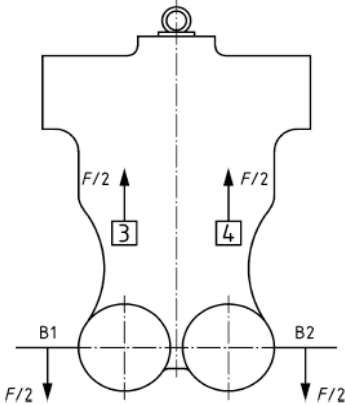
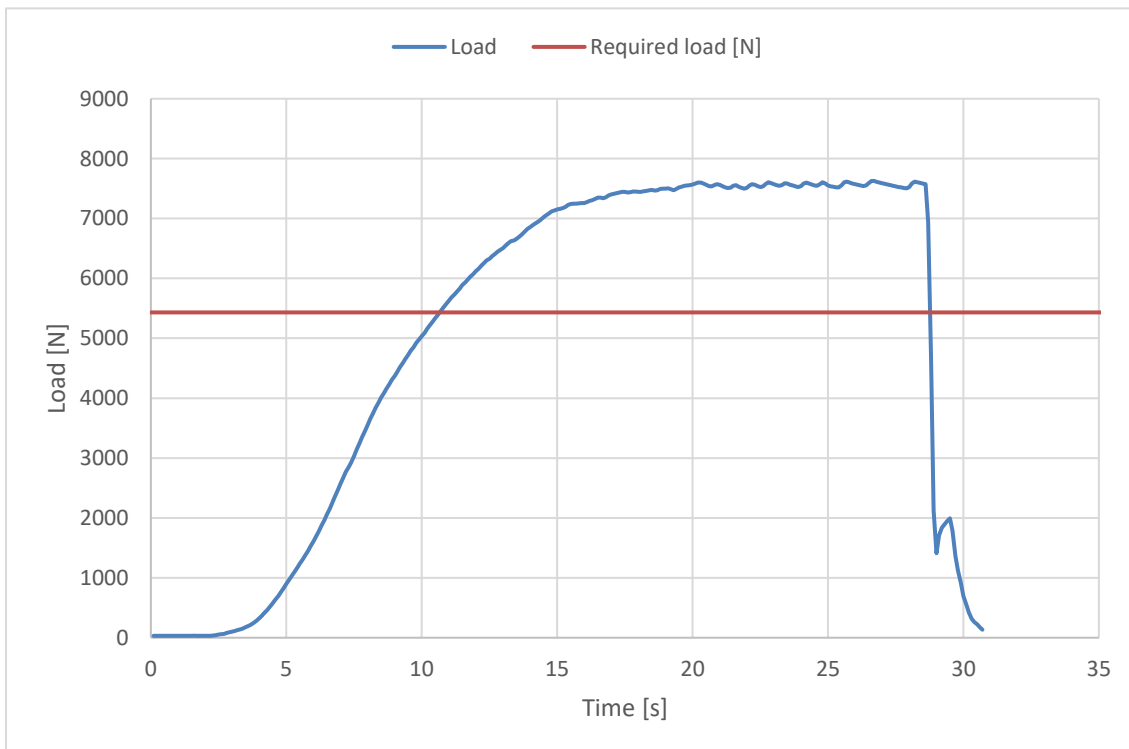
Test ID 01

| Any signs of structural failure | No |
| Slippery test OK | Yes |
| Test results | POSITIVE |

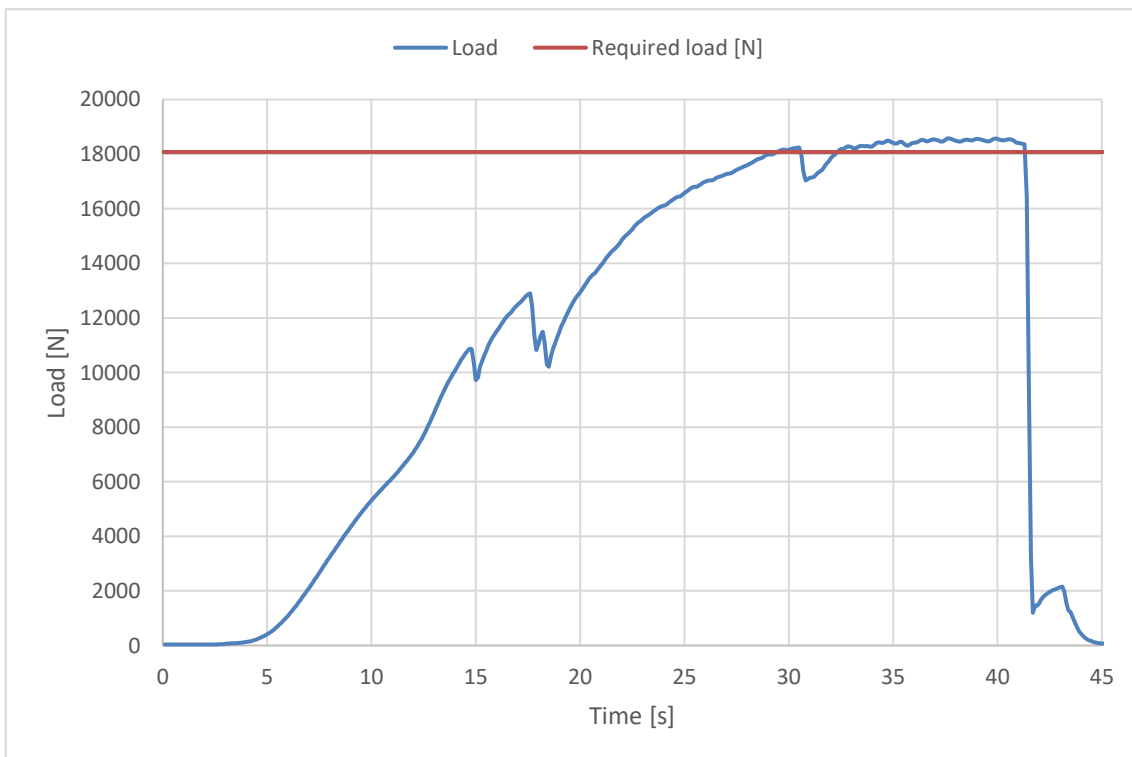
Test ID 03

Test duration [s] **9**
 Any signs of structural failure **No**
 Slippery test OK **Yes**
 Test results **POSITIVE**

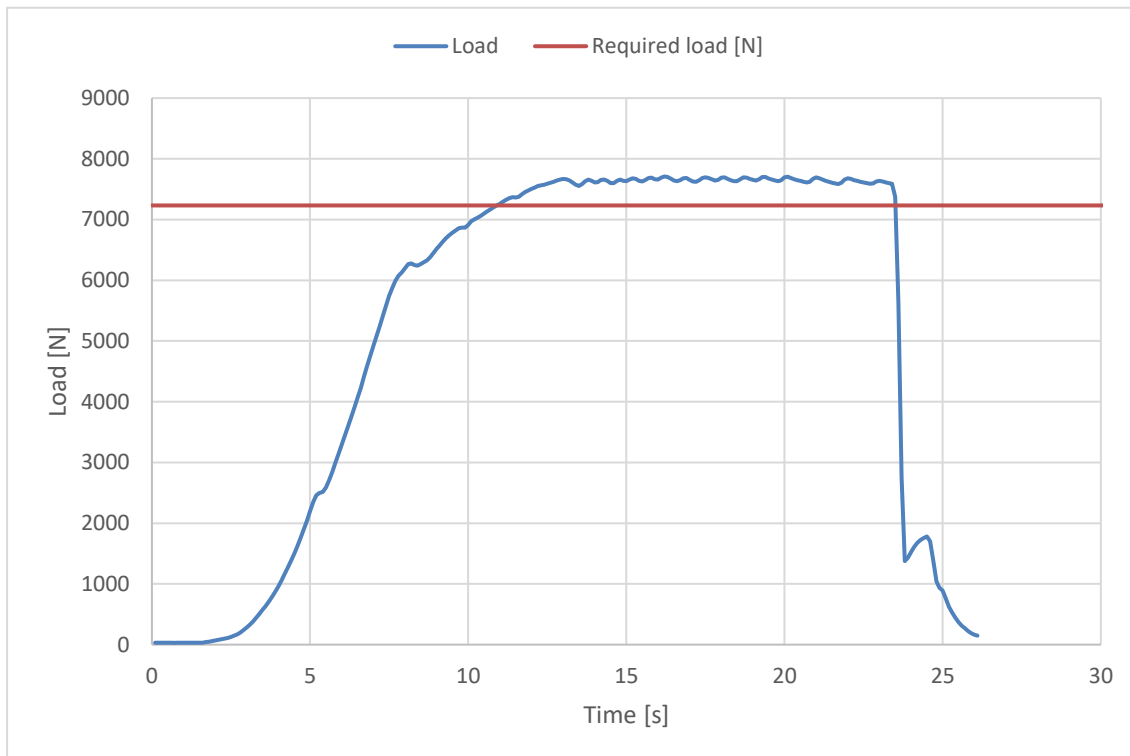
Test ID 05

| Any signs of structural failure | No |
| Test results | POSITIVE |

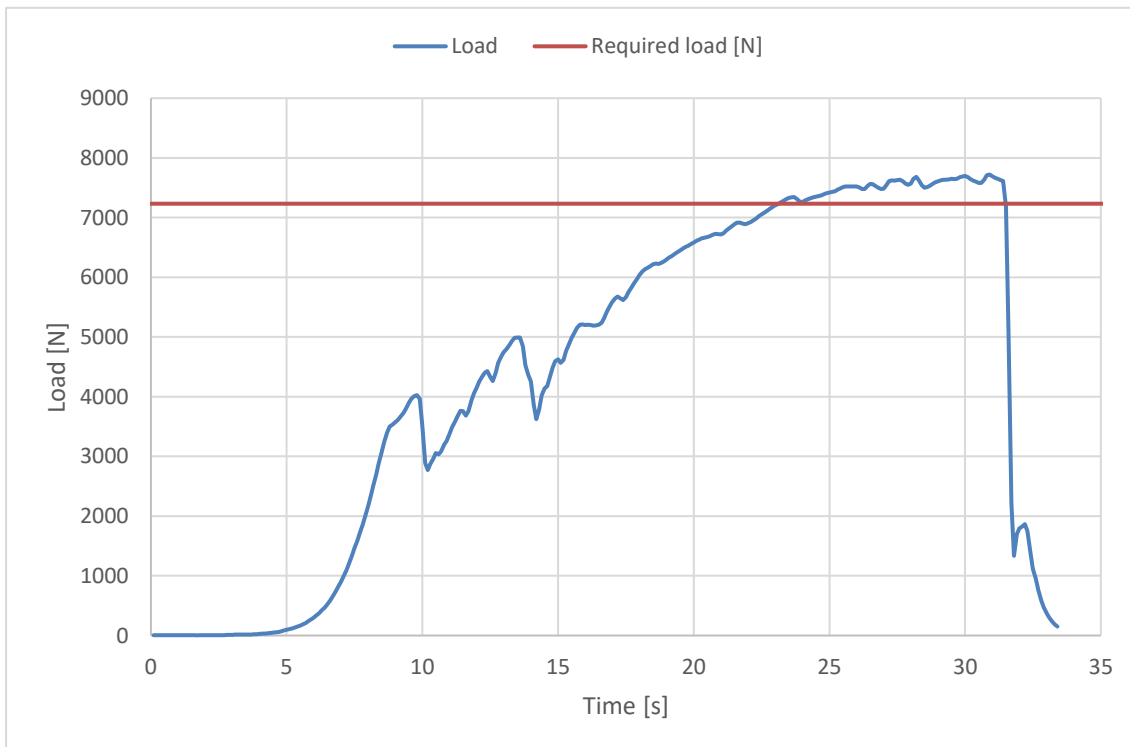
Test ID 06

| Any signs of structural failure | No |
| Test results | POSITIVE |

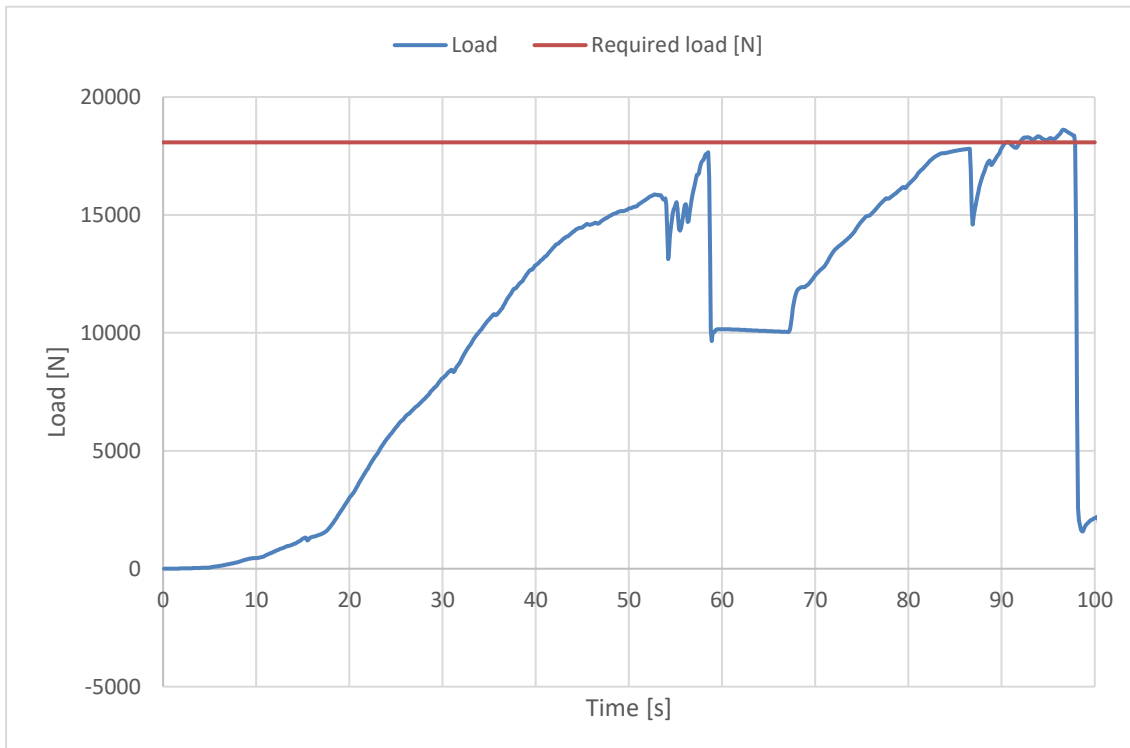
Test ID 09

| Any signs of structural failure | No |
| Slippery test OK | Yes |
| Test results | POSITIVE |

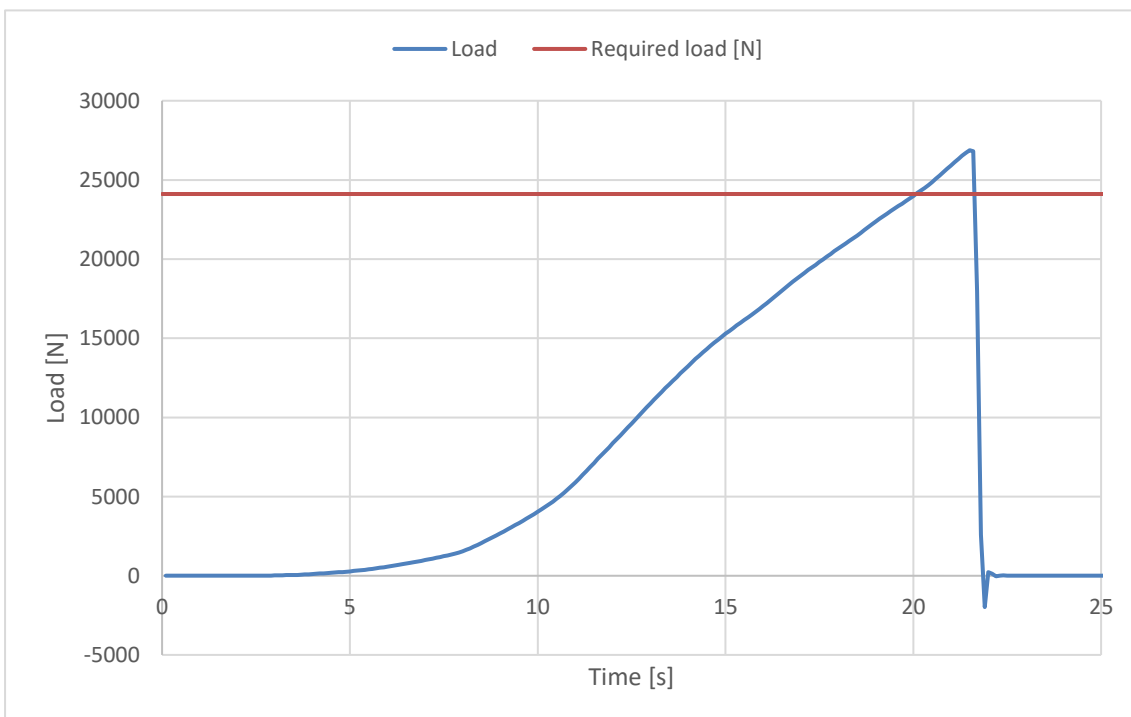
Test ID 11

| Any signs of structural failure | No |
| Test results | POSITIVE |

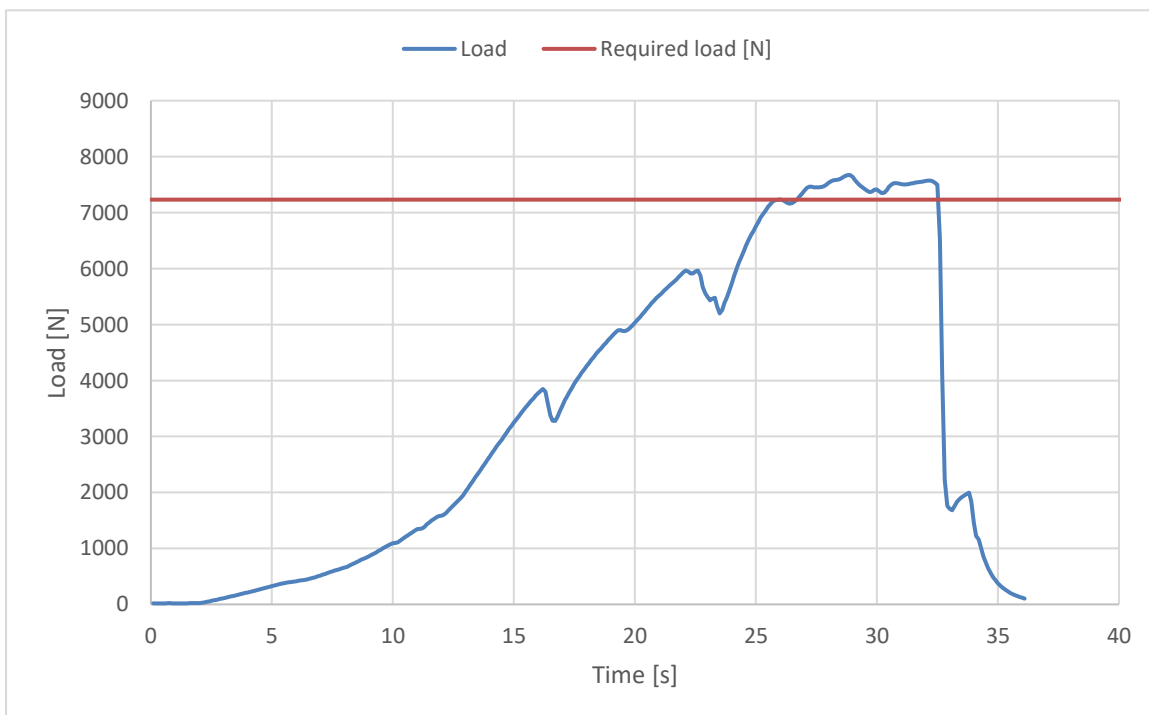
Test ID 12

| Any signs of structural failure | No |
| Slippery test OK | Yes |
| Test results | POSITIVE |

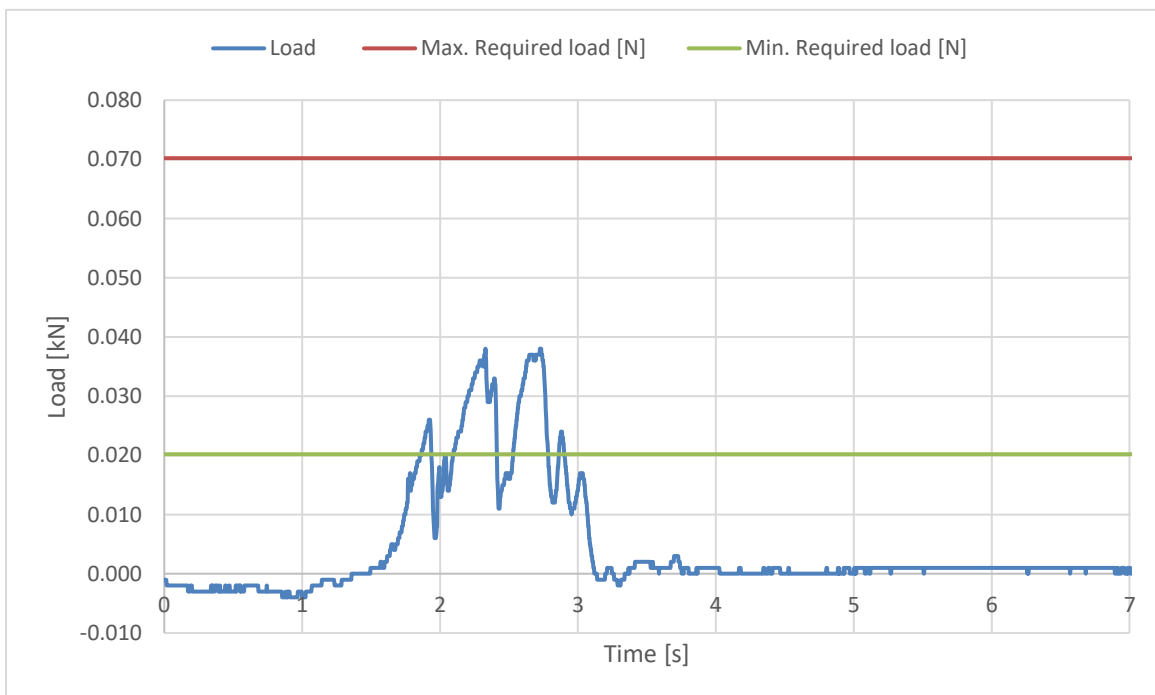
Test ID RRDT

| Load for first action [N] | 38.20 |
| Test results | POSITIVE |

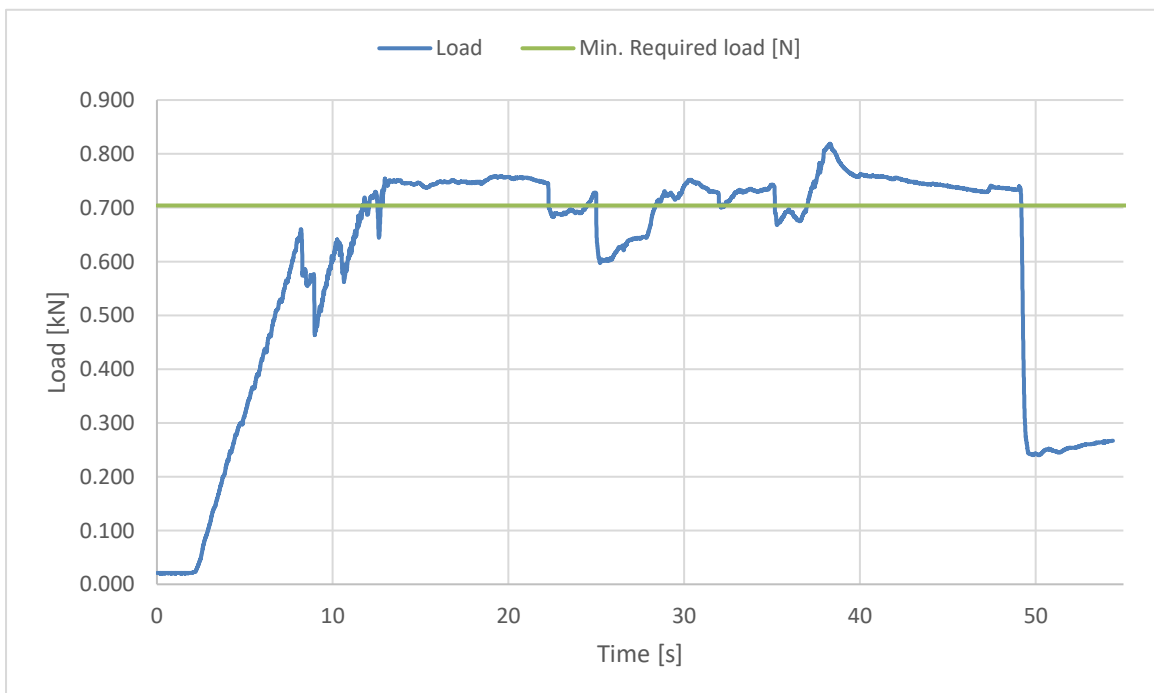
Test ID RRST

| Breaking strength [N] | 814.79 |
| Test results | POSITIVE |
