# Harness Structural test Report - EN

Inspection certificate number: PH\_441.2024

Name: **Passenger B1**  
 Type: **ABS**  
 Size: **One size**  
 Serial number: **B1-001**  
 Impact pad type: <sup>(1)</sup> **Foam**  
 Clip-in weight [kg]: **130**

**Harness Structural test**

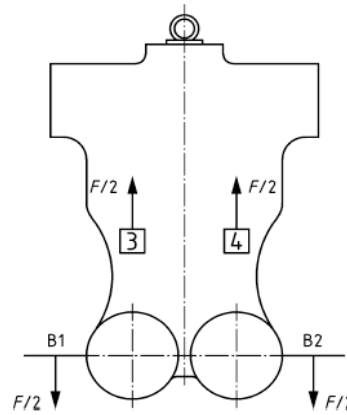
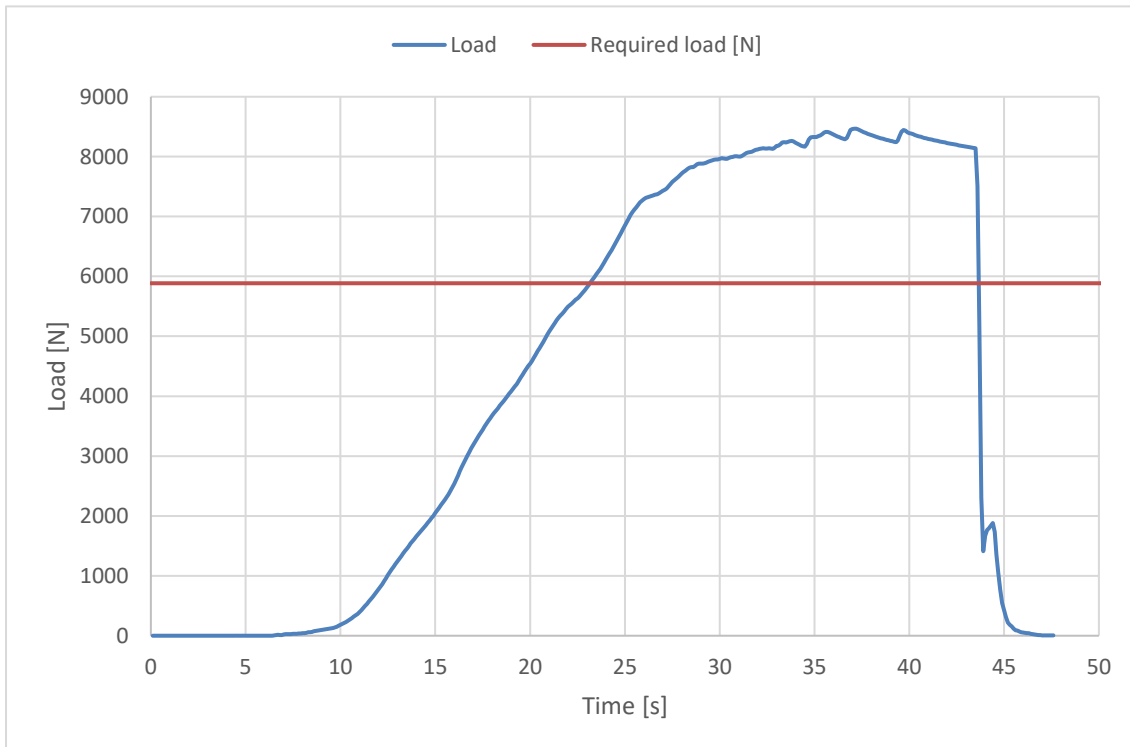
**Test ID 01**

Test duration [s] **20.5**  
 Any signs of structural failure **No**  
 Slippery test OK **Yes**  
 Test results **POSITIVE**

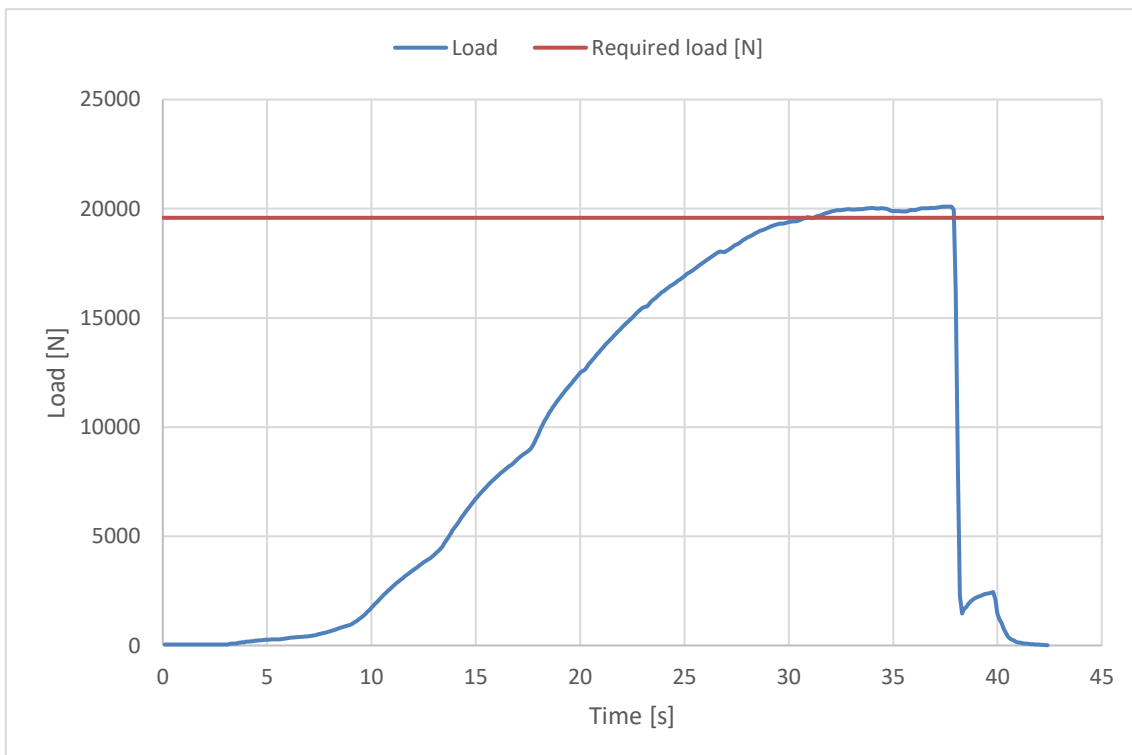
**Test ID 03**

| Test duration [s] | <b>6.8</b> | |
| Any signs of structural failure | <b>No</b> | |
| Slippery test OK | <b>Yes</b> | |
| Test results | <b>POSITIVE</b> | |

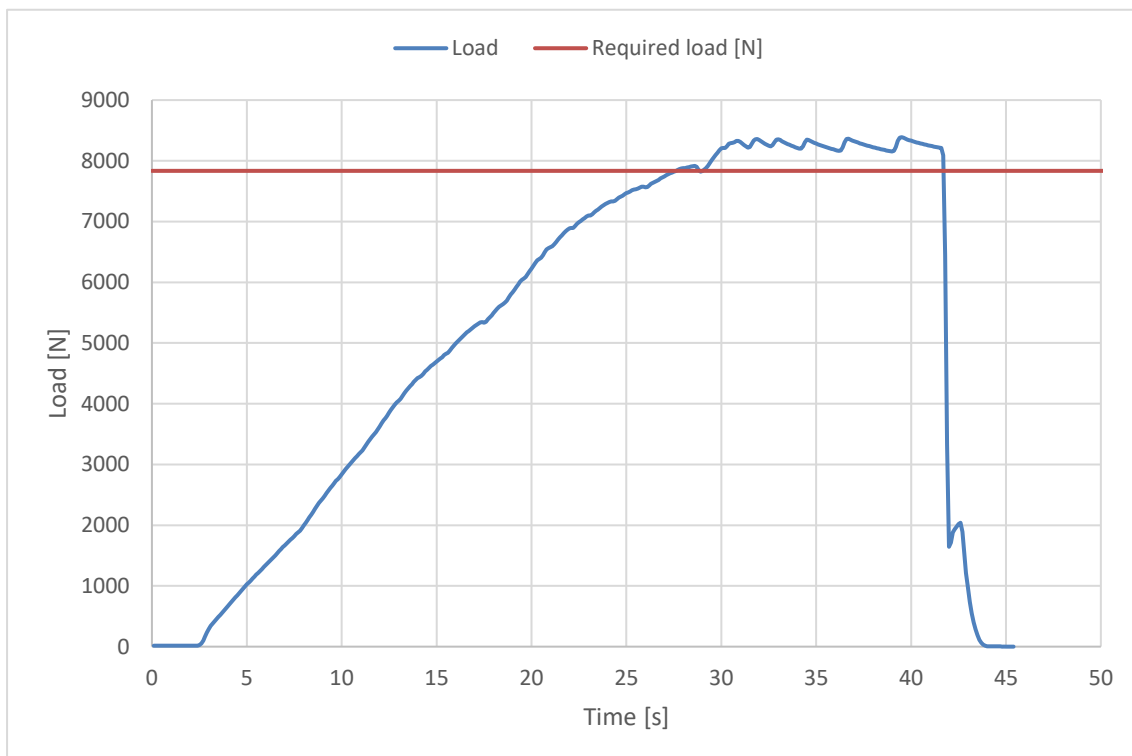
**Test ID 05**

| Test duration [s] | <b>12.7</b> |
| Any signs of structural failure | <b>No</b> |
| Test results | <b>POSITIVE</b> |

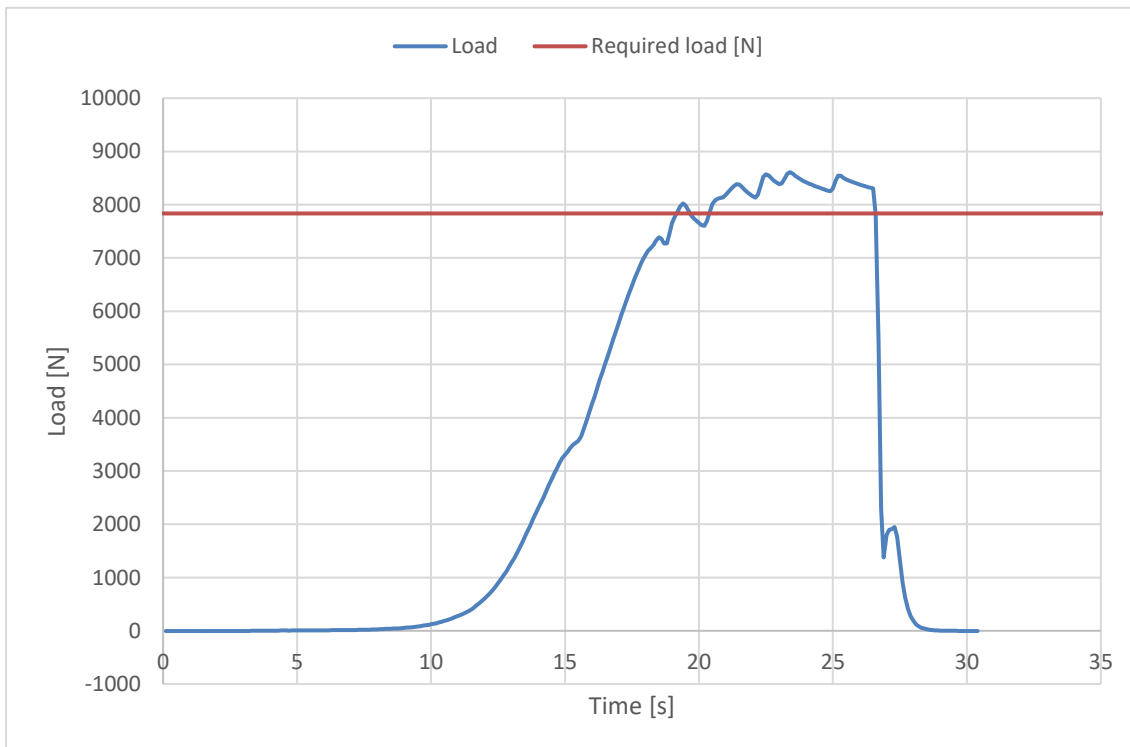
**Test ID 06**

| Test duration [s] | <b>6.2</b> |
| Any signs of structural failure | <b>No</b> |
| Test results | <b>POSITIVE</b> |

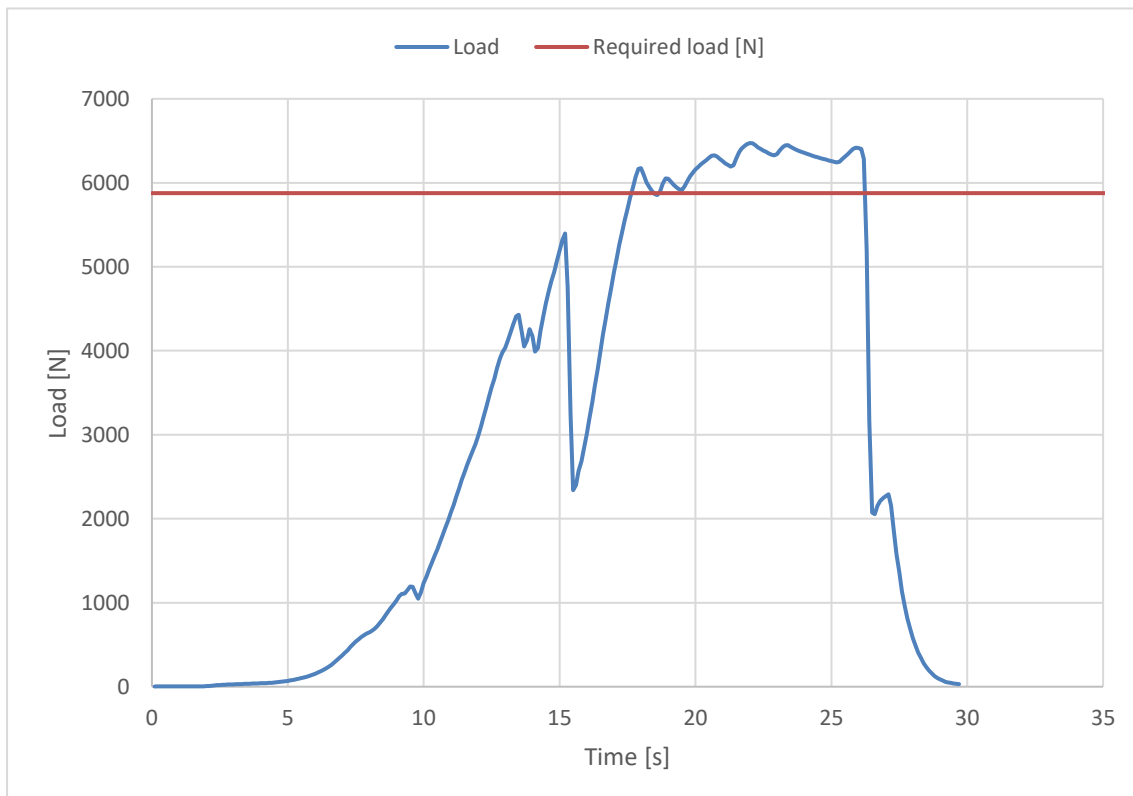
**Test ID 08**

| Test duration [s] | <b>7.6</b> |
| Any signs of structural failure | <b>No</b> |
| Test results | <b>POSITIVE</b> |

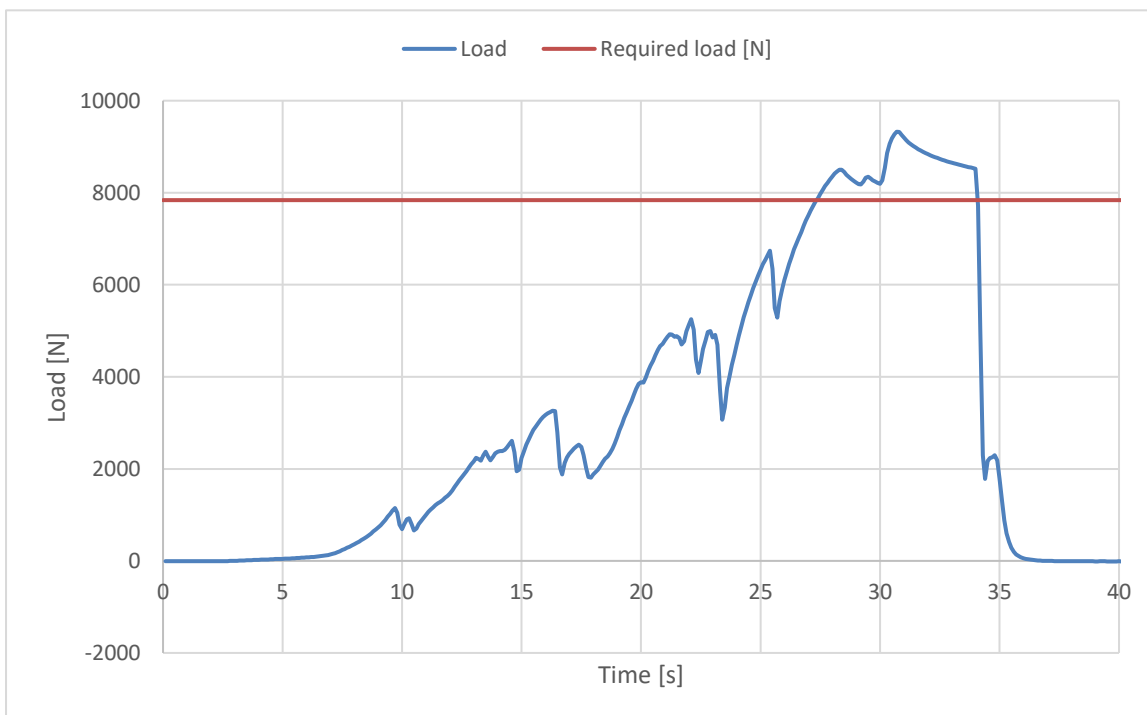
**Test ID 12**

| Test duration [s] | <b>6.7</b> |
| Any signs of structural failure | <b>No</b> |
| Slippery test OK | <b>Yes</b> |
| Test results | <b>POSITIVE</b> |
