# Harness Structural test Report - NfL

Inspection certificate number: PH\_441.2024

Name: **Passenger B1**  
 Type: **ABS**  
 Size: **One size**  
 Serial number: **B1-001**  
 Impact pad type: <sup>(1)</sup> **Foam**  
 Clip-in weight [kg]: **130**  
 Integrated container: **No**

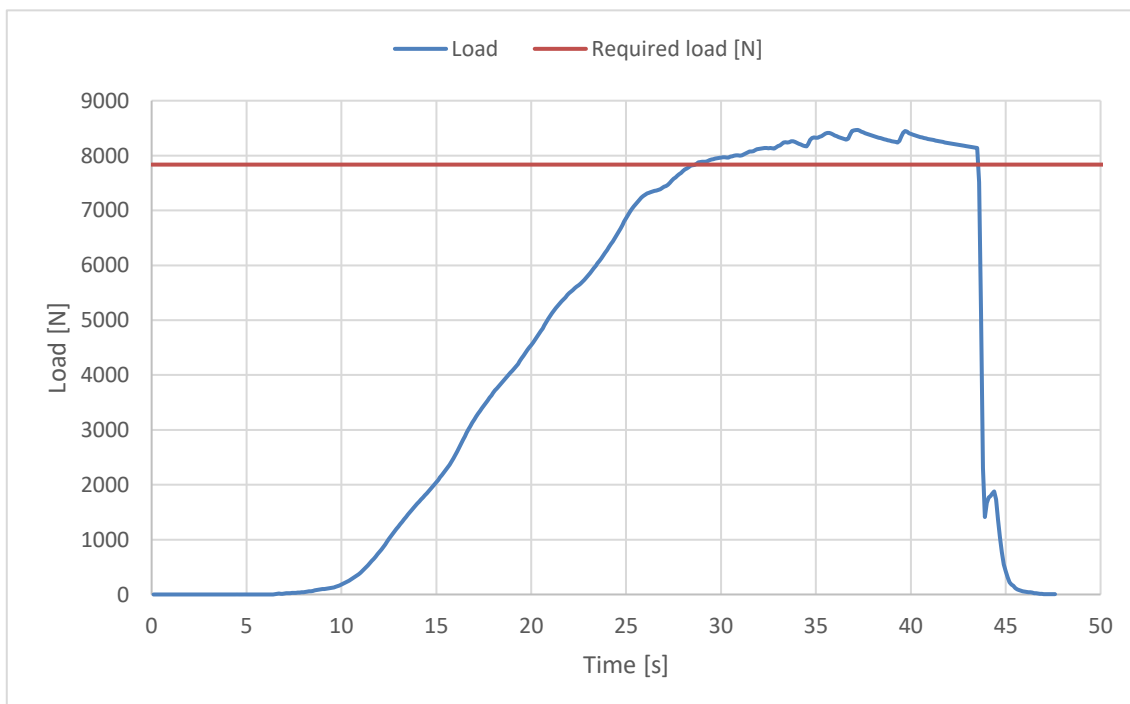
Test ID 02

Test duration [s] **14.9**  
Any signs of structural failure **No**  
Test results **POSITIVE**

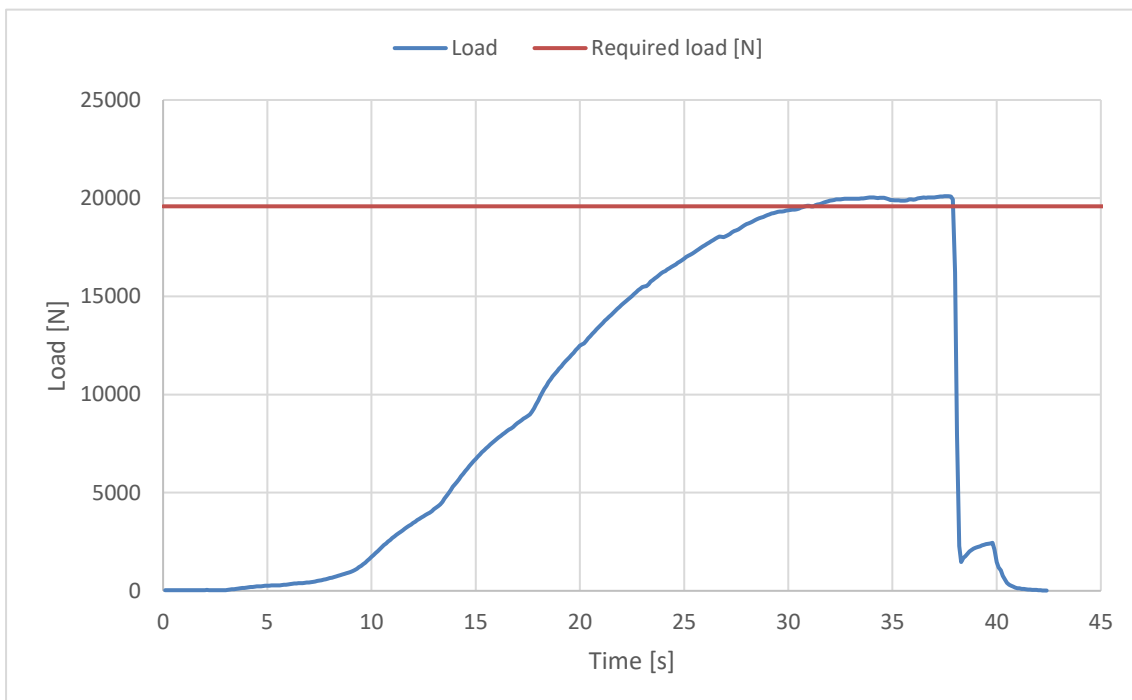
Test ID 03

Test duration [s] **6.8**  
Any signs of structural failure **No**  
Test results **POSITIVE**

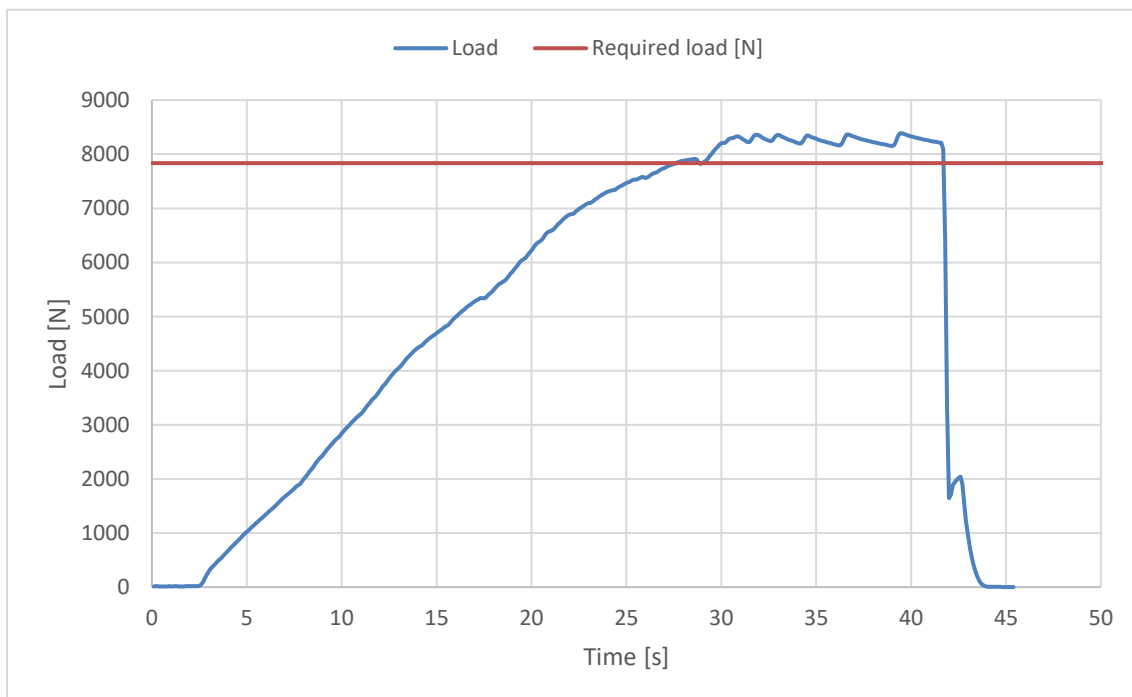
Test ID 04

Test duration [s] **12.7**  
Any signs of structural failure **No**  
Test results **POSITIVE**

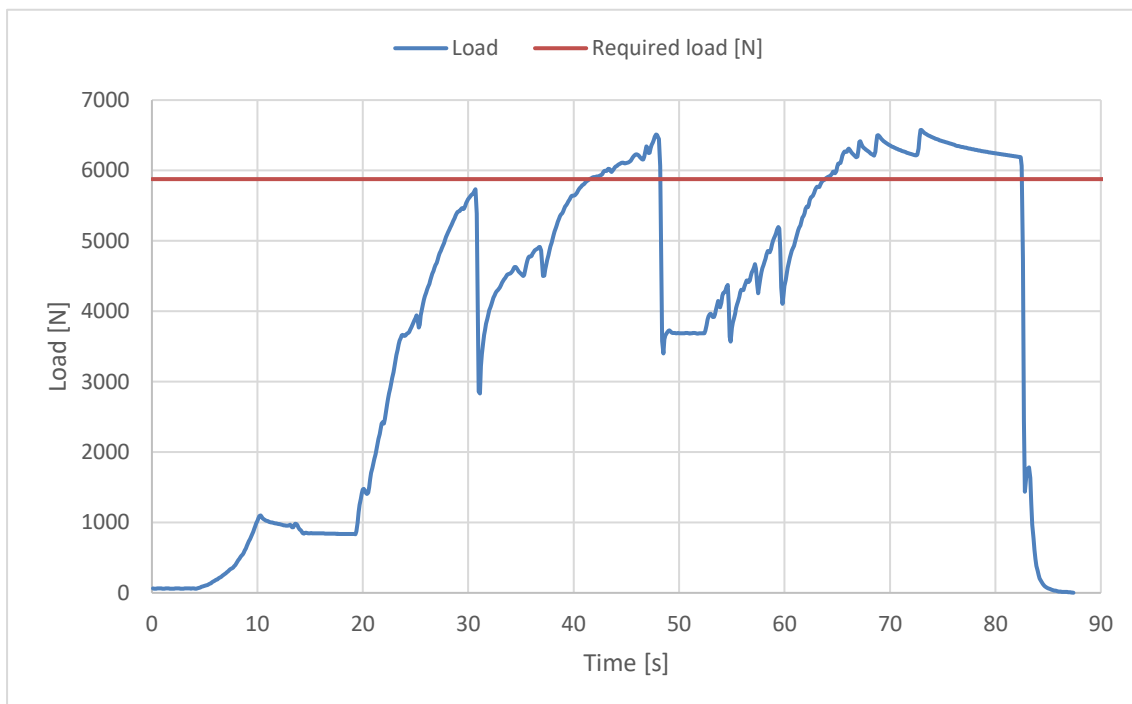
Test ID 07

Test duration [s] **18.7**  
Any signs of structural failure **No**  
Test results **POSITIVE**

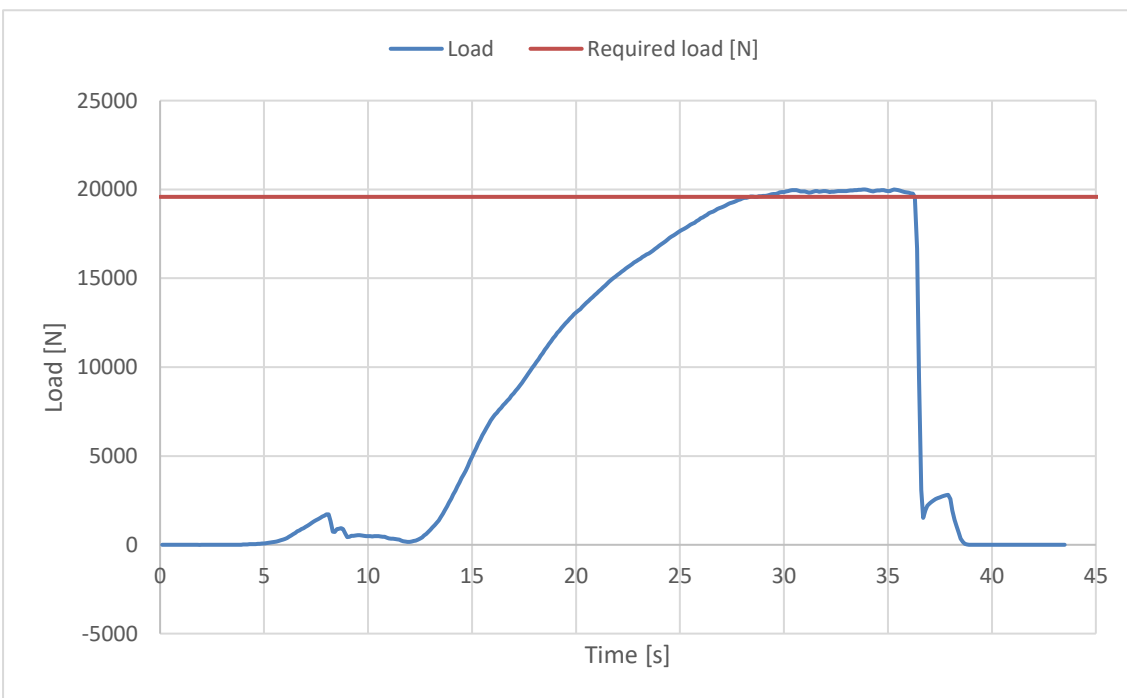
Test ID 13

Test duration [s] **7.6**  
Any signs of structural failure **No**  
Test results **POSITIVE**
