Harness Structural test Report - NfL

Inspection certificate number: **PH_435.2024**

Name: **LIGHTNESS 4**
 Type: **ABS**
 Size: **M**
 Serial number: **1183070**
 Impact pad type: ⁽¹⁾ **Foam**
 Clip-in weight [kg]: **120**
 Integrated container: **Yes**
 Date of test: **06.03.2024**

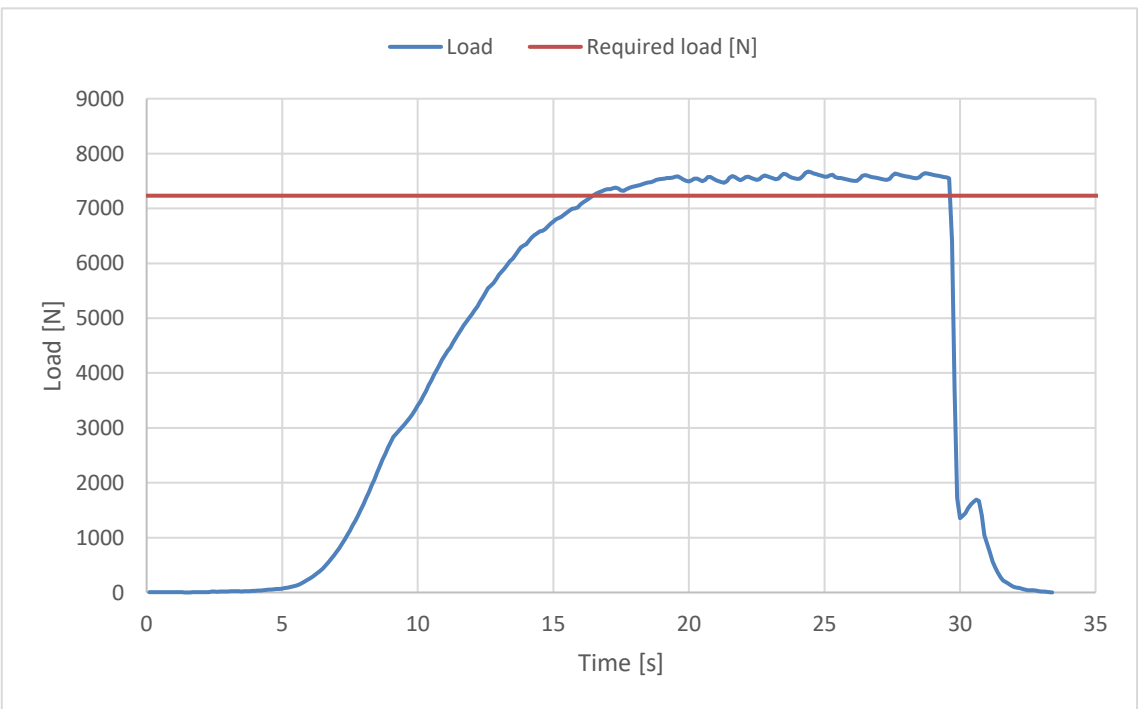
Test ID 02

Reference	5.3.2.1	
Test setup	Default flying position	
Attachment points	Both main riser attachment (3,4)	
Anchor points	Dummy (B1, B2)	
Required load [g]	6	
Required load [N]	7200	
Minimum test duration [s]	10	
Result		
Test duration [s]	13.2	
Any signs of structural failure	No	
Test results	POSITIVE

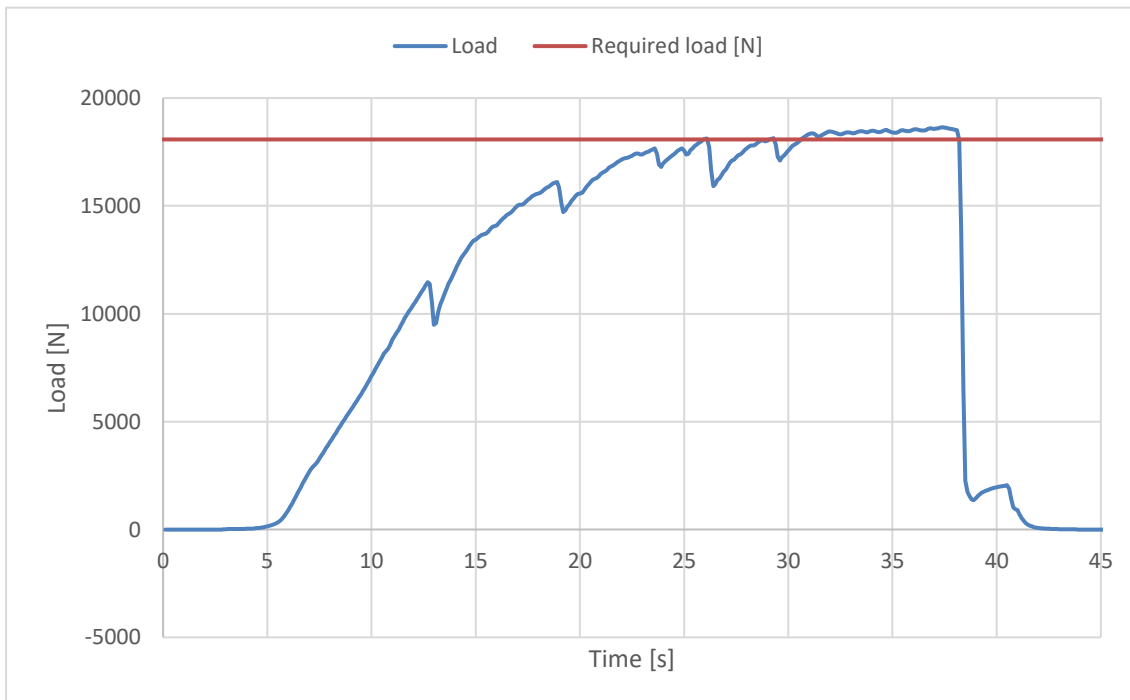
Test ID 03

Standard	EN 1651:1999
Reference	5.3.2.2
Test setup	Default flying position
Attachment points	Both main riser attachment (3,4)
Anchor points	Dummy (B1, B2)
Required load [g]	15
Required load [N]	18000
Minimum test duration [s]	5
Result	
Test duration [s]	7.5
Any signs of structural failure	No
Test results	POSITIVE

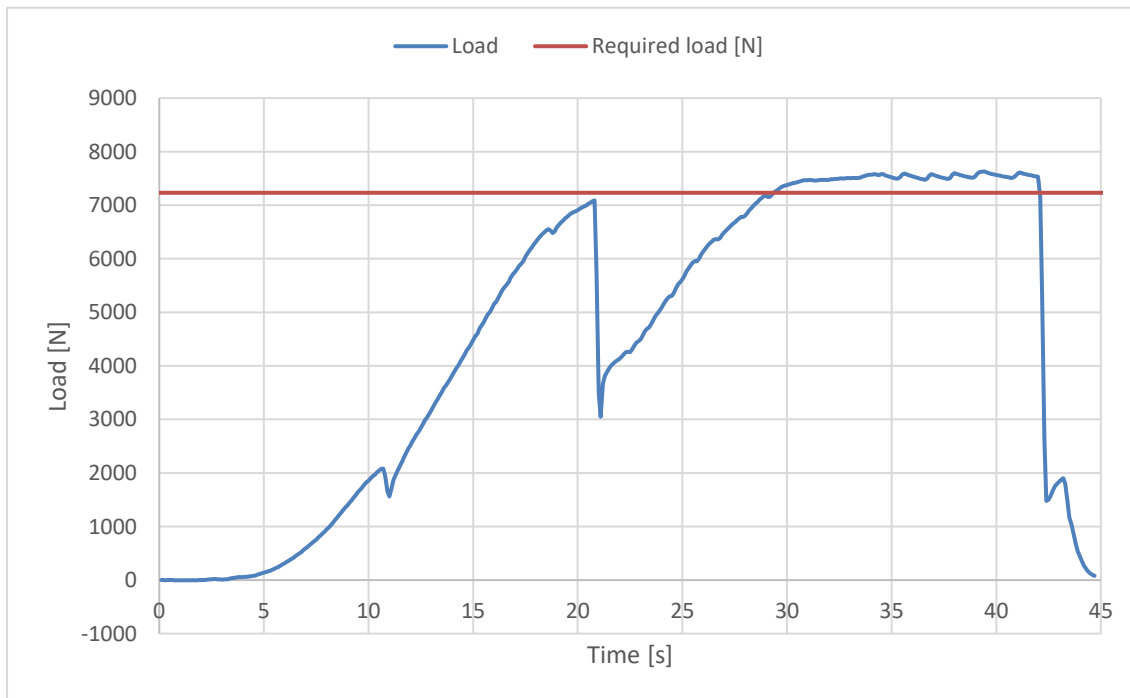
Test ID 04

Standard **EN 1651:1999**
 Reference **5.3.2.3**
 Test setup **Asymmetric, one riser**
 Attachment points **One main riser attachment (3)**
 Anchor points **Dummy (B1,B2)**

Test duration [s] **12.7**
 Any signs of structural failure **No**
 Test results **POSITIVE**

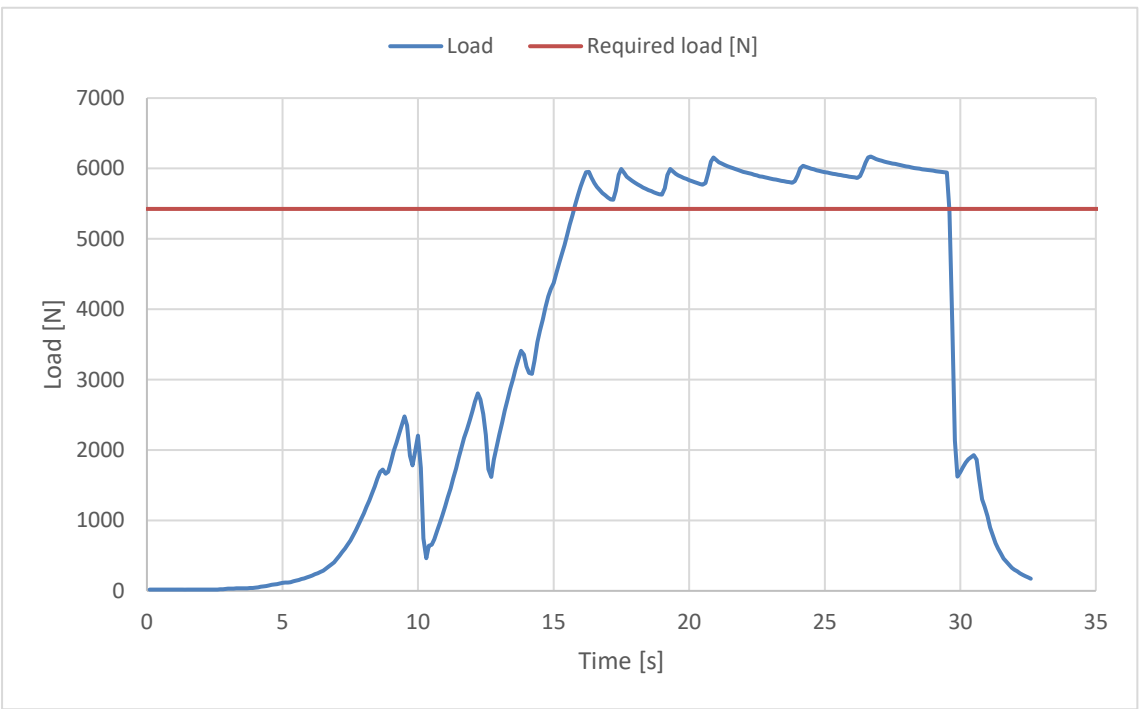
Test ID 07

Reference	5.3.2.6	
Test setup	Asymmetric, negative	
Attachment points	One main riser attachment (3 or 4) downwards	
Anchor points	Dummy (9)	
Required load [g]	4.5	
Required load [N]	5400	
Minimum test duration [s]	10	
Result		
Test duration [s]	13.8	
Any signs of structural failure	No	
Test results	POSITIVE

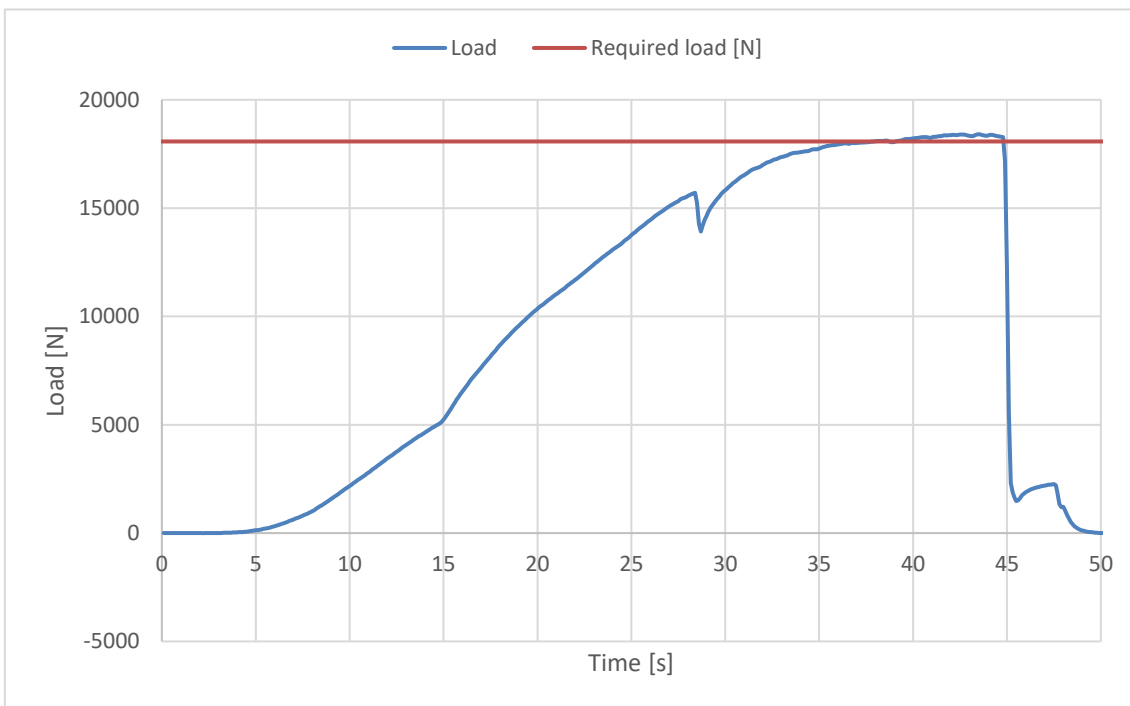
Test ID 09

Standard **EN 1651:1999**
 Reference **5.3.2.4**
 Test setup **Rescue attachments**
 Attachment points **Rescue riser attachment (1,2)**
 Anchor points **Dummy (B1,B2)**

Test duration [s] **5.8**
 Any signs of structural failure **No**
 Test results **POSITIVE**

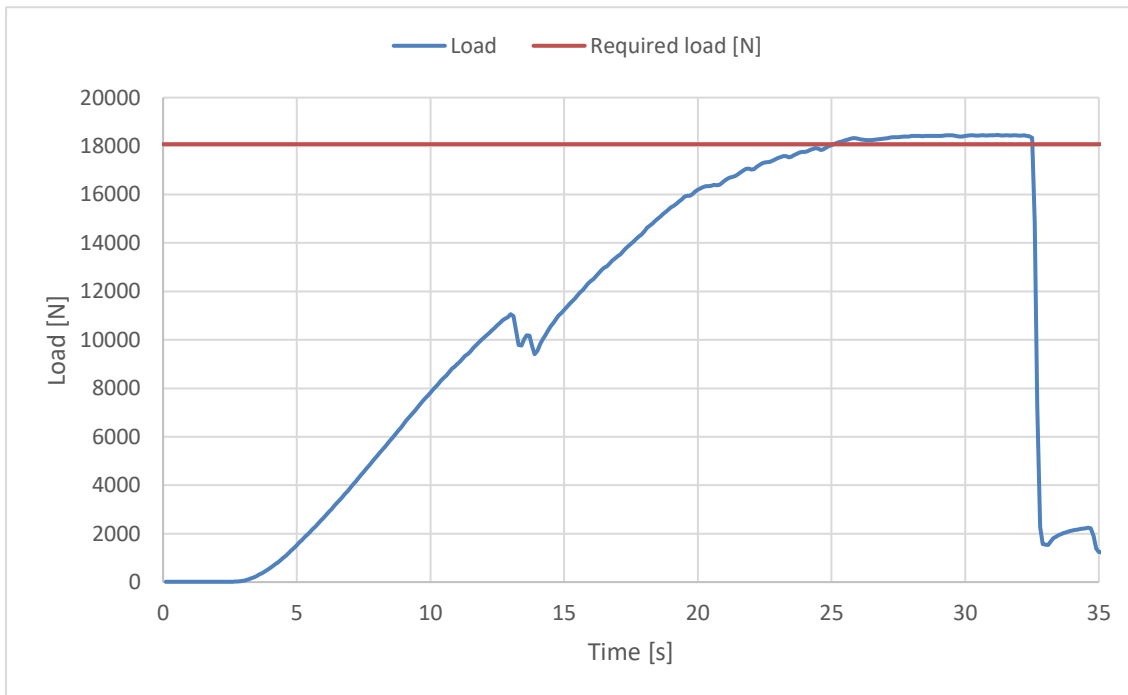
Test ID 13

Standard	EN 1651:1999
Reference	5.3.2.7
Test setup	Flying position before landing
Attachment points	Both main riser attachment (3,4)
Anchor points	Dummy (7,8)
Required load [g]	15
Required load [N]	18000
Minimum test duration [s]	5
Result	
Test duration [s]	7.5
Any signs of structural failure	No
Test results	POSITIVE

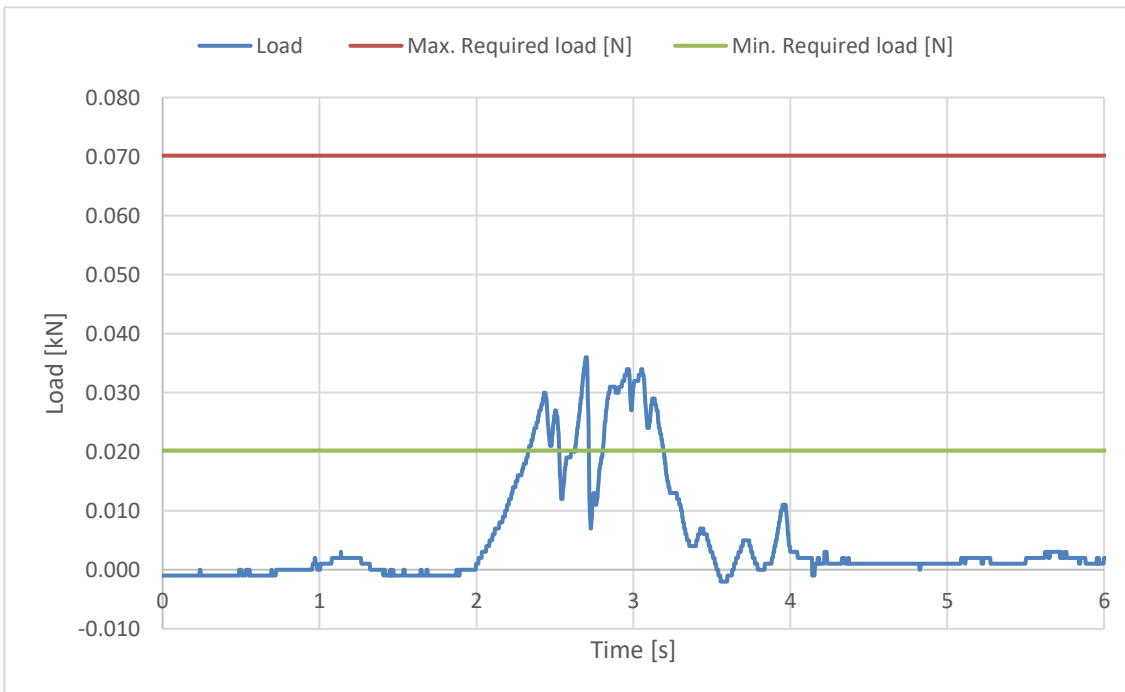
Test ID RRDT

Standard	NfL 2-565-20
Reference	6.1.5
Test setup	Default flying position
Attachment points	Sensor connect to handle, and pull in opening direction
	The test is to simulate the load required to open the emergency parachute(1st action).
Min. Required load [N]	20
Max. Required load [N]	70
Result	
Load for first action [N]	35.82
Test results	POSITIVE

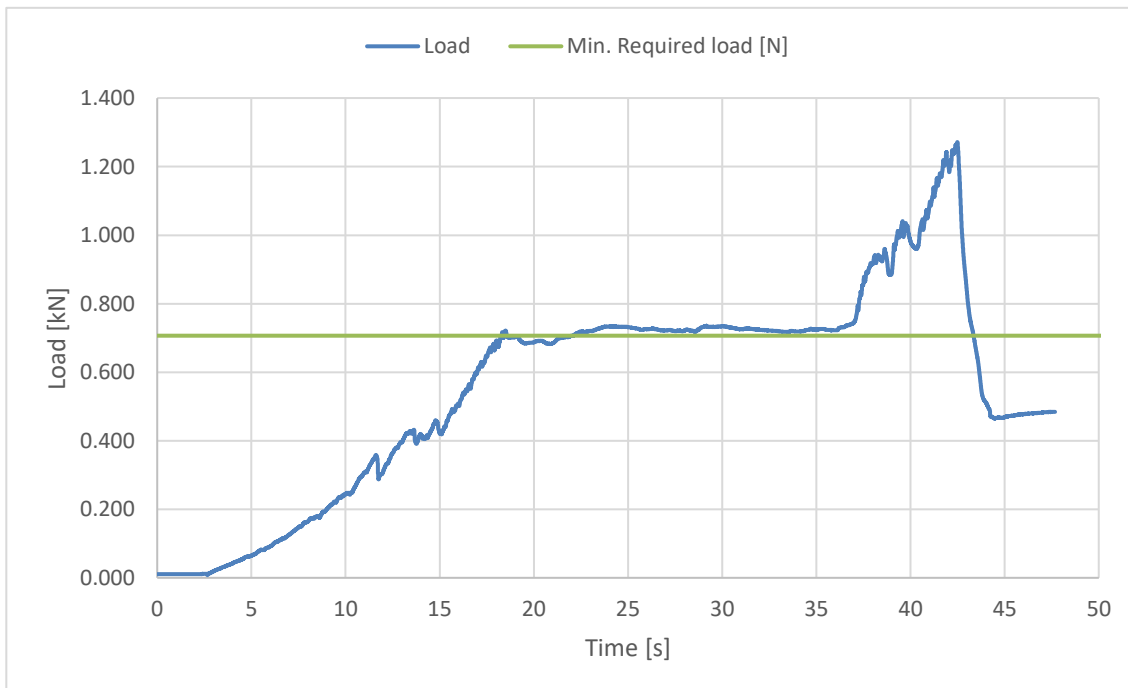
Test ID RRST

Standard	EN 12491
Reference in standard	5.3.2
Test setup	Two end points of handle
Attachment points	Sensor connect to end of handle, pull on the other side
	The handle must support min 700 N for 10 s, after measure breaking strength
Min. Required load [N]	700
Minimum test duration [s]	10
Result	
Test duration [s]:	21.2
Breaking strength [N]	1265.47
Test results	POSITIVE
