Harness Structural test Report - EN

Inspection certificate number: PH_445.2024

Name: **Safari passenger 3**
 Type: **ABS**
 Size: **M**
 Serial number: **SPA31311_S**
 Impact pad type: ⁽¹⁾ **Airbag**
 Clip-in weight [kg]: **120**

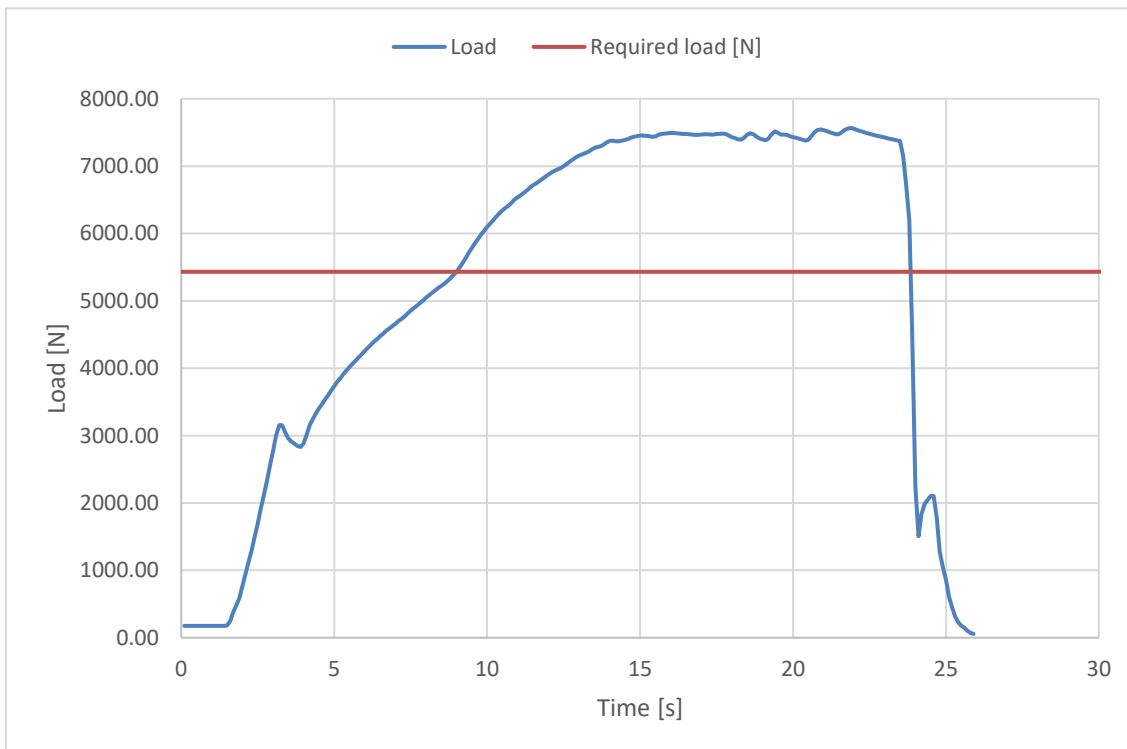
Test ID 01

Standard **EN 1651**
 Reference in standard **5.5.1.1**
 Test setup **Positive symmetric load (Slippage)**
 Attachment points **Both main riser attachment (3,4)**
 Anchor points **Dummy (B1, B2)**

Test duration [s] **14.9**
 Any signs of structural failure **No**
 Slippery test OK **Yes**
 Test results **POSITIVE**

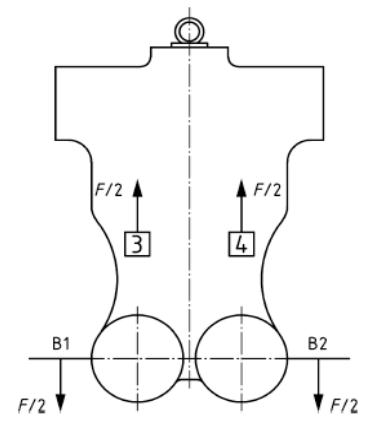
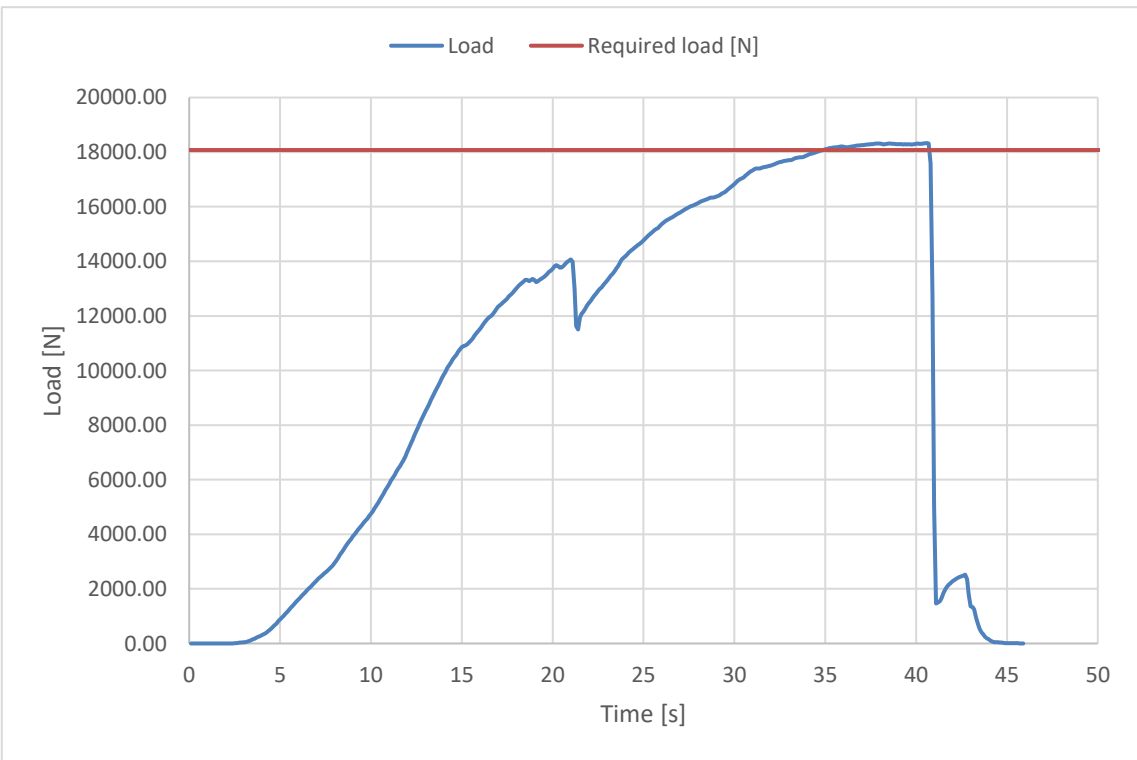
Test ID 03

Reference in standard	5.5.1.1b	
Test setup	Positive symmetric load	
Attachment points	Both main riser attachment (3,4)	
Anchor points	Dummy (B1, B2)	
Required load [g]	15	
Required load [N]	18000	
Minimum test duration [s]	5	
Result		
Test duration [s]	5.9	
Any signs of structural failure	No	
Slippery test OK	Yes	
Test results	POSITIVE

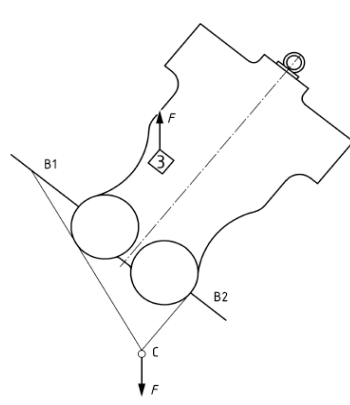
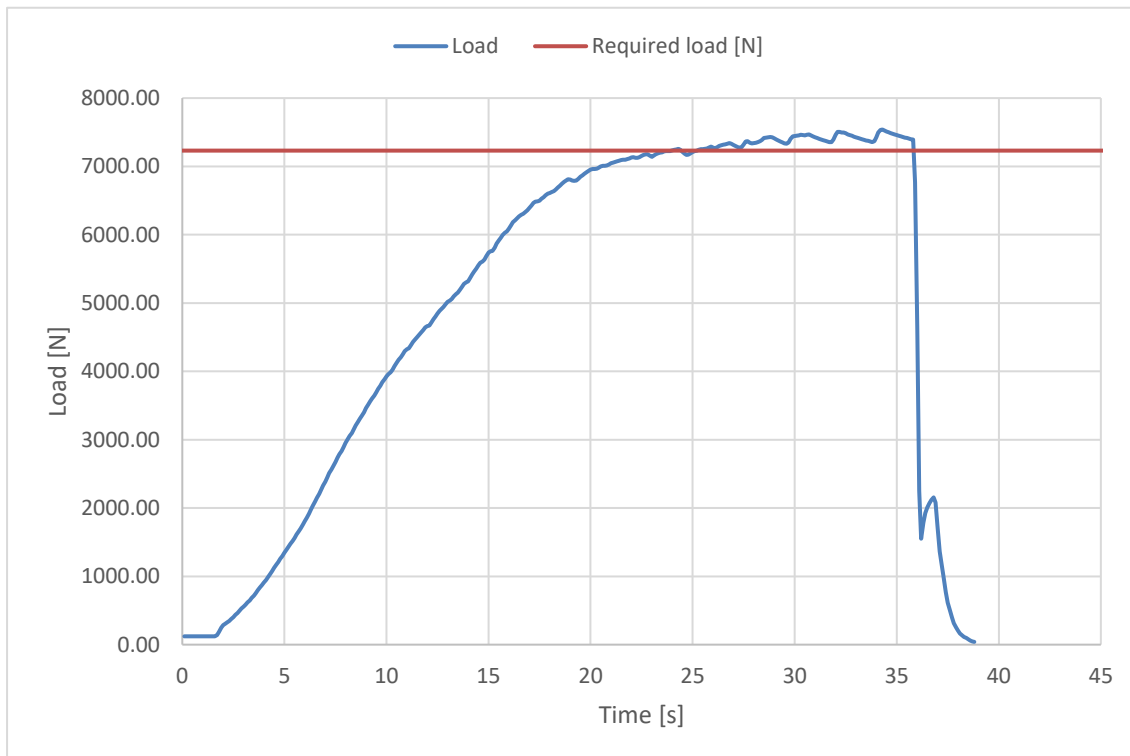
Test ID 05

Standard	EN 1651
Reference in standard	5.5.1.2
Test setup	Positive asymmetric load
Attachment points	One riser attachment (3 or 4)
Anchor points	Dummy (C)
Required load [g]	6
Required load [N]	7200
Minimum test duration [s]	5
Result	
Test duration [s]	10.6
Any signs of structural failure	No
Test results	POSITIVE

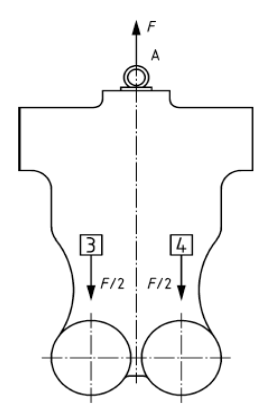
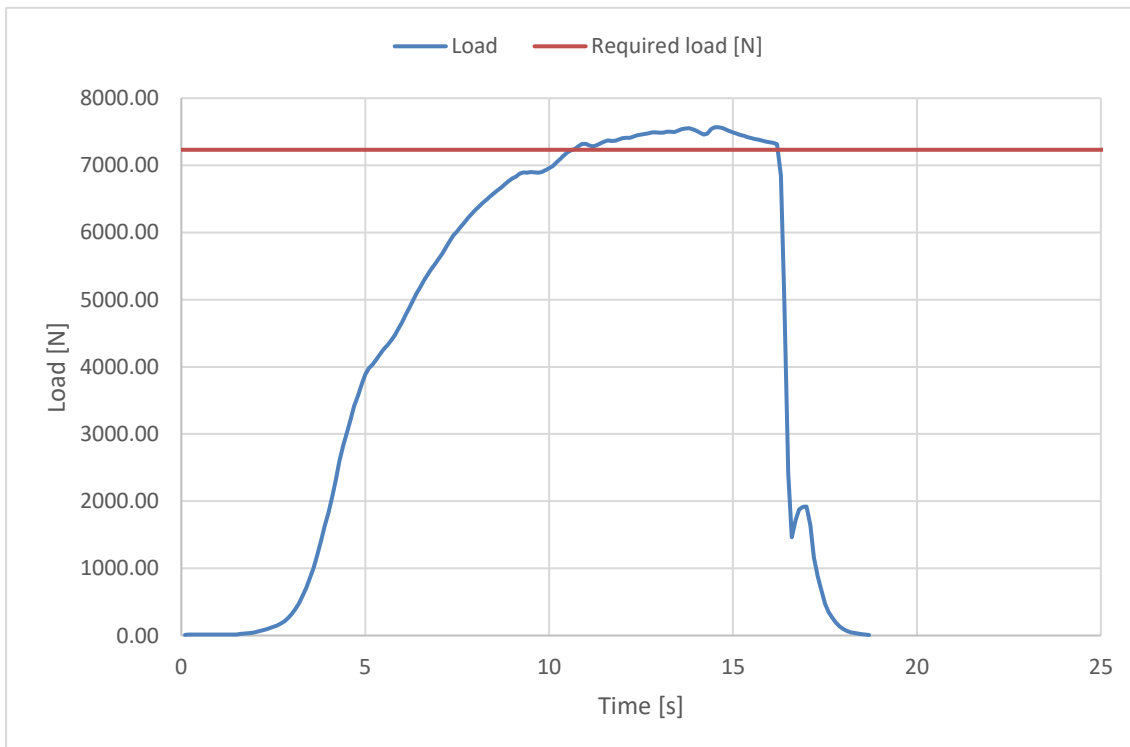
Test ID 06

Standard	EN 1651
Reference in standard	5.5.1.6
Test setup	Negative symmetric load
Attachment points	Both main riser attachment (3,4)
Anchor points	Dummy (A)
Required load [g]	6
Required load [N]	7200
Minimum test duration [s]	5
Result	
Test duration [s]	5.6
Any signs of structural failure	No
Test results	POSITIVE

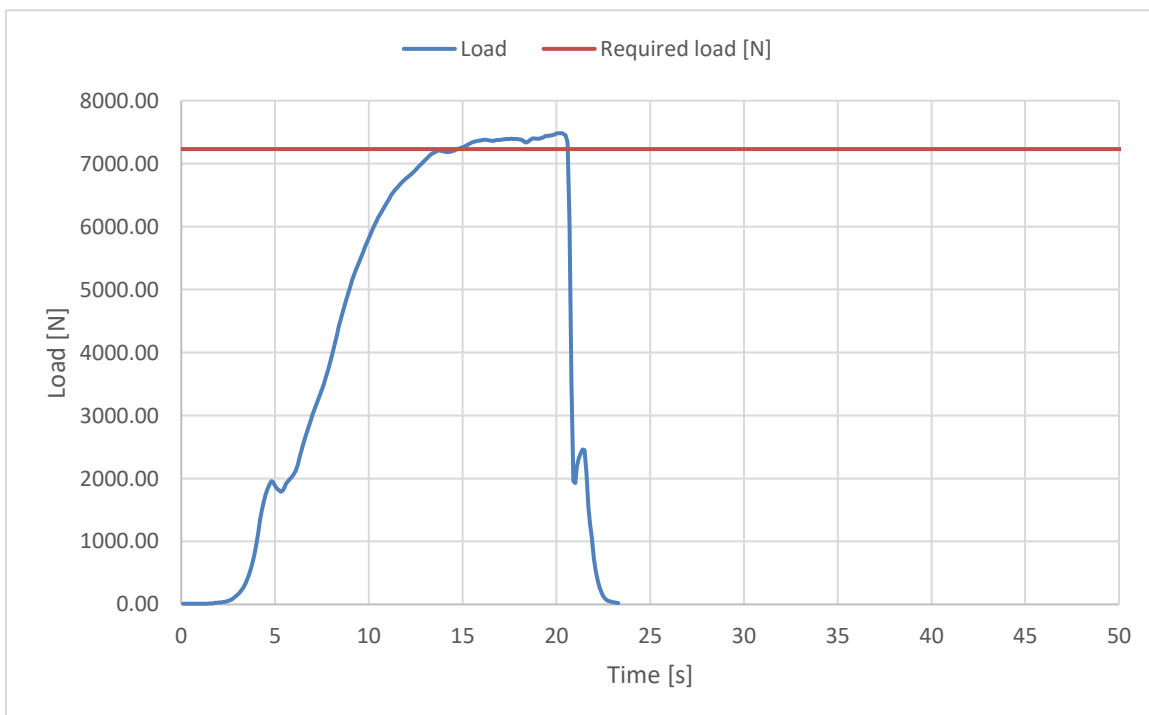
Test ID 12

Standard	EN 1651
Reference in standard	5.5.1.7
Test setup	Upright (landing) position load
Attachment points	Both main riser attachment (3, 4)
Anchor points	Both legstrap of harness (no dummy)
Required load [g]	6
Required load [N]	7200
Minimum test duration [s]	5
Harness type	type c
Result	
Test duration [s]	5.9
Any signs of structural failure	No
Slippery test OK	Yes
Test results	POSITIVE
