# Harness Structural test Report - EN

Inspection certificate number: **PH\_491.2025**

Name: **ULTRALIGHT**  
 Type: **ABS**  
 Size: **M**  
 Serial number: **C1**  
 Impact pad type: <sup>(1)</sup> **n/a**  
 Clip-in weight [kg]: **120**

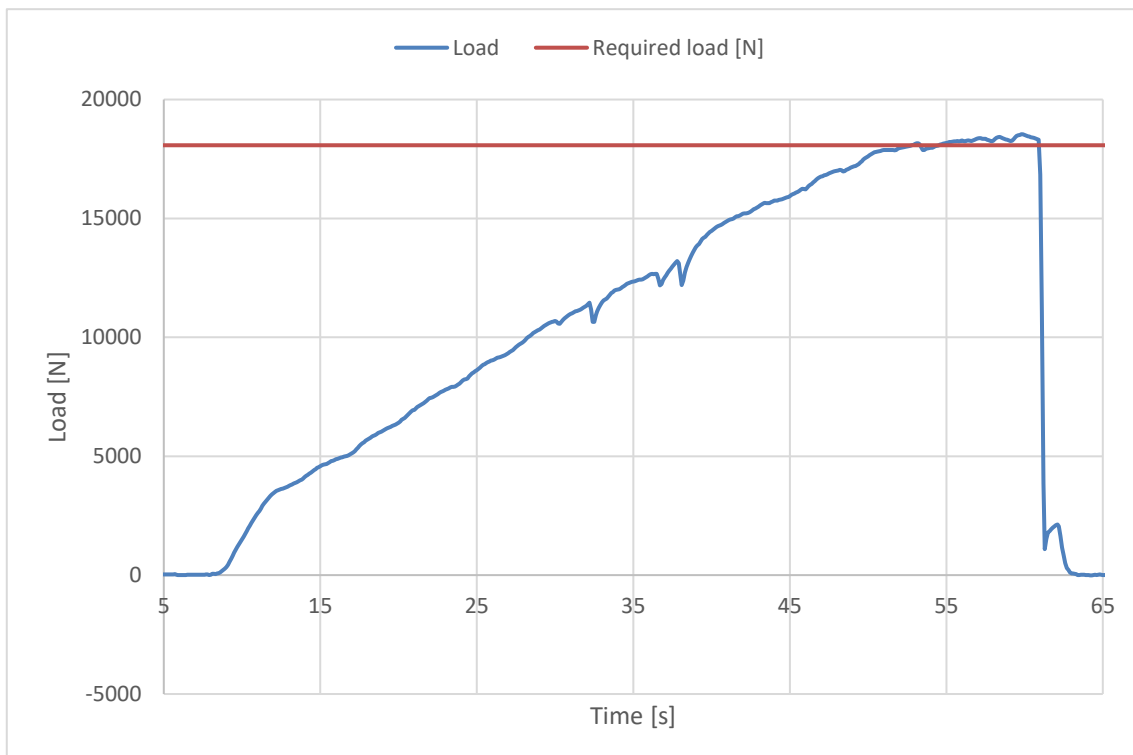
Test ID 03

Standard **EN 1651**  
Reference in standard **5.5.1.1b**  
Test setup **Positive symmetric load**  
Attachment points **Both main riser attachment (3,4)**  
Anchor points **Dummy (B1, B2)**

Test duration [s] **6.4**  
Any signs of structural failure **No**  
Slippery test OK **Yes**  
Test results **POSITIVE**

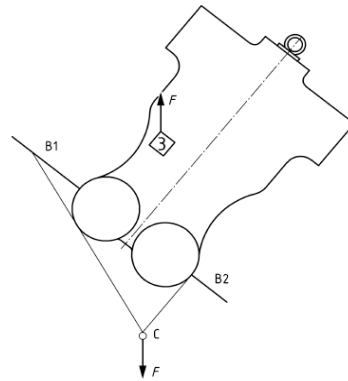
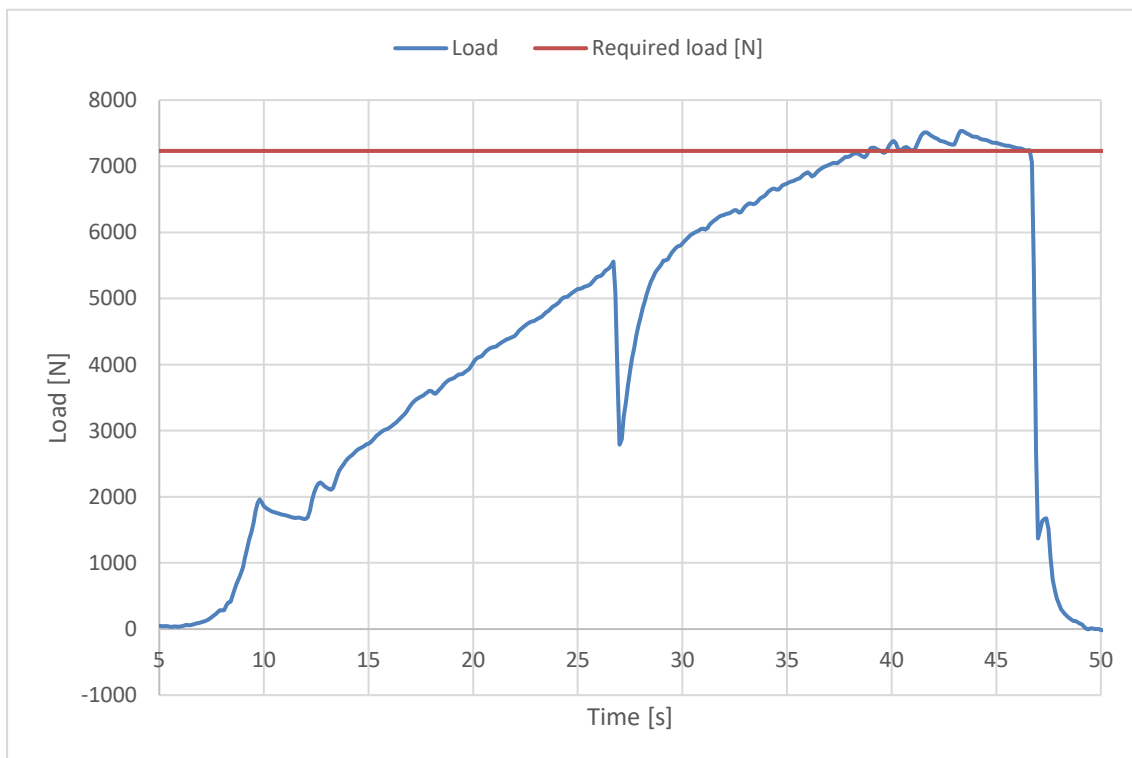
Test ID 05

Standard **EN 1651**  
Reference in standard **5.5.1.2**  
Test setup **Positive asymmetric load**  
Attachment points **One riser attachment (3 or 4)**  
Anchor points **Dummy (C)**

Test duration [s] **6.2**  
Any signs of structural failure **No**  
Test results **POSITIVE**

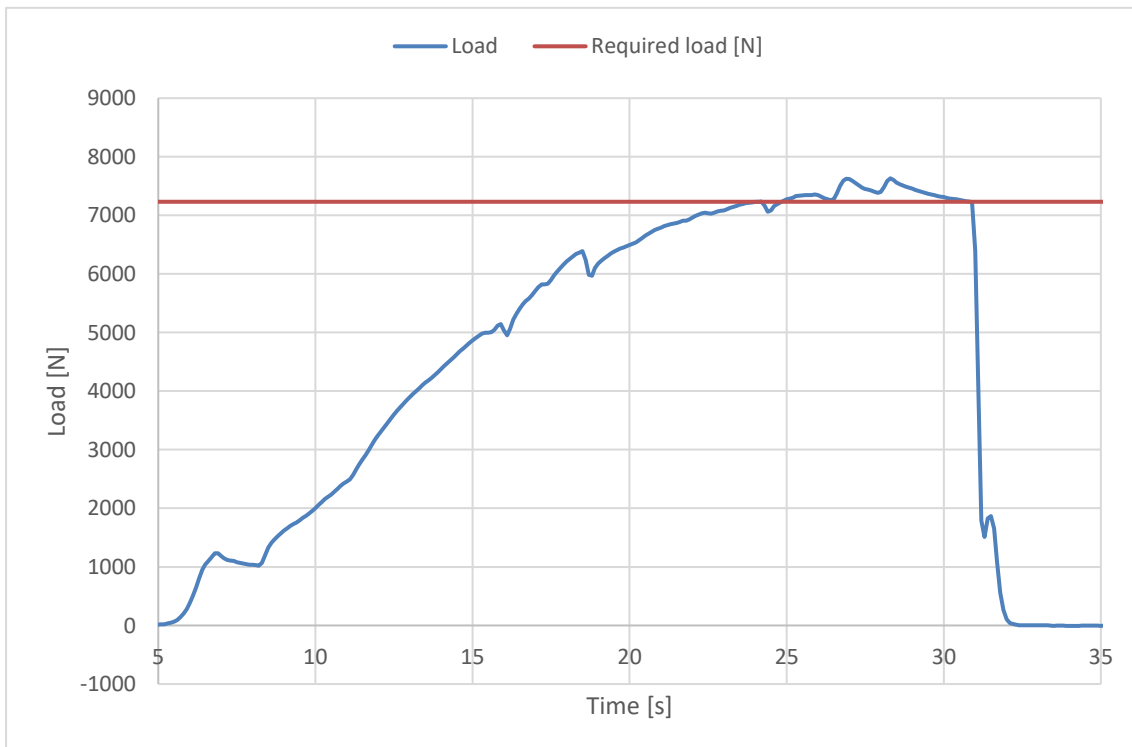
Test ID 06

Standard **EN 1651**  
Reference in standard **5.5.1.6**  
Test setup **Negative symmetric load**  
Attachment points **Both main riser attachment (3,4)**  
Anchor points **Dummy (A)**

Test duration [s] **6**  
Any signs of structural failure **No**  
Test results **POSITIVE**

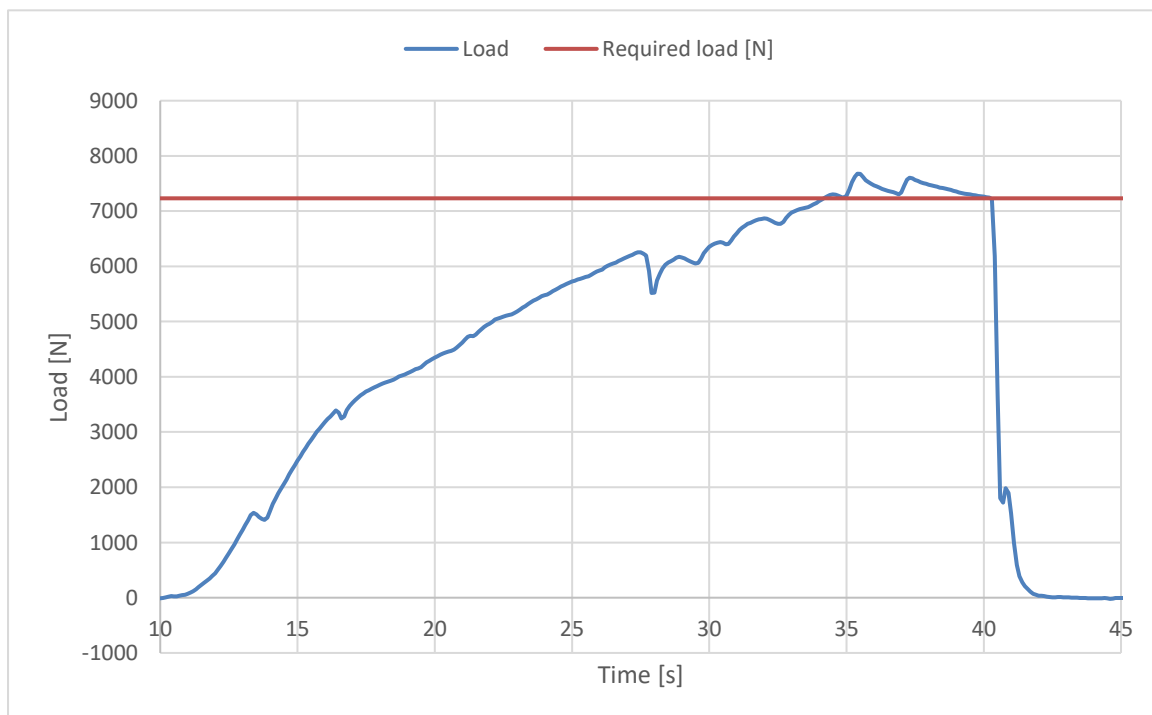
Test ID 12

Standard **EN 1651**  
Reference in standard **5.5.1.7**  
Test setup **Upright (landing) position load**  
Attachment points **Both main riser attachment (3, 4)**  
Anchor points **Both legstrap of harness (no dummy)**

Test duration [s] **6.1**  
Any signs of structural failure **No**  
Slippery test OK **Yes**  
Test results **POSITIVE**
