# Harness Structural test Report

Inspection certificate number: **PH\_222.2018**
**Manufacturer data:**

Name: **Axess 4**  
 Type: **ABS**  
 Size: **M**  
 Serial number: **114 50 66**  
 Impact pad type: <sup>(1)</sup> **Hybrid**  
 Clip-in weight [kg]: **120**

**Summary of Structural test**

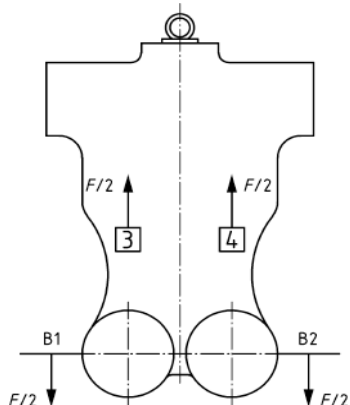
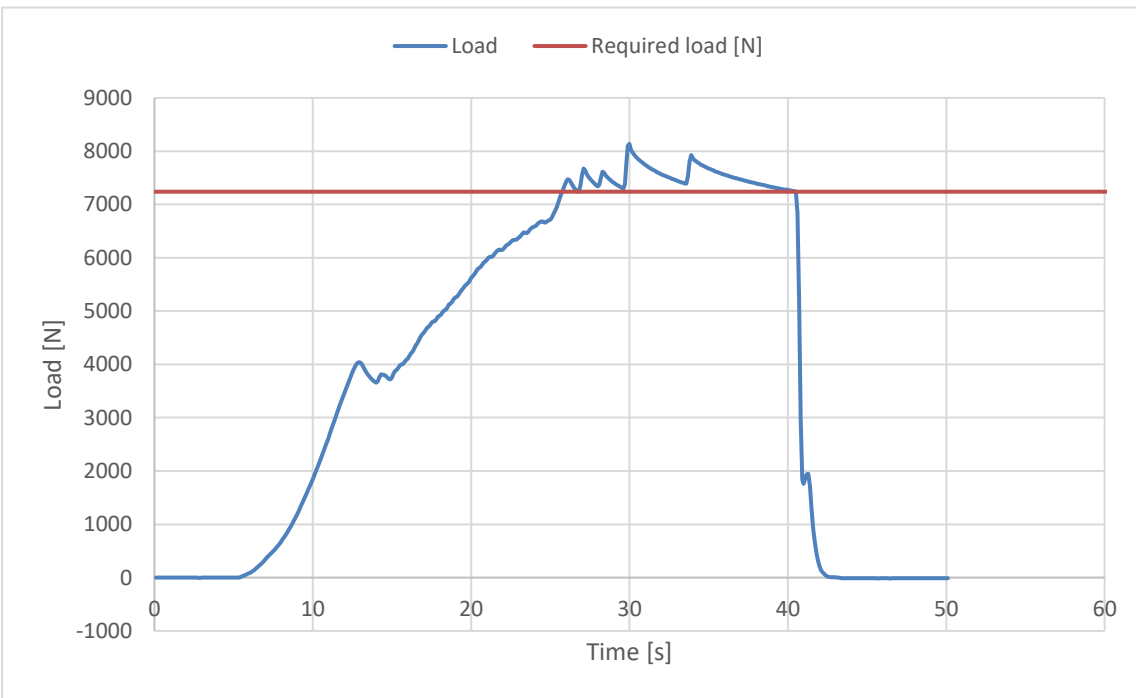
**Test ID R0**

Reference in standard	<b>5.3.2.1</b>	
Test setup	<b>Default flying position</b>	
Attachment points	<b>Both main riser attachment (3,4)</b>	
Anchor points	<b>Dummy (B1, B2)</b>	
Required load [g]	<b>6</b>	
Required load [N]	<b>7200</b>	
Minimum test duration [s]	<b>10</b>	
<b>Result</b>		
Test duration [s]	<b>14.8</b>	
Any signs of structural failure	<b>No</b>	
Test results	<b>POSITIVE</b>

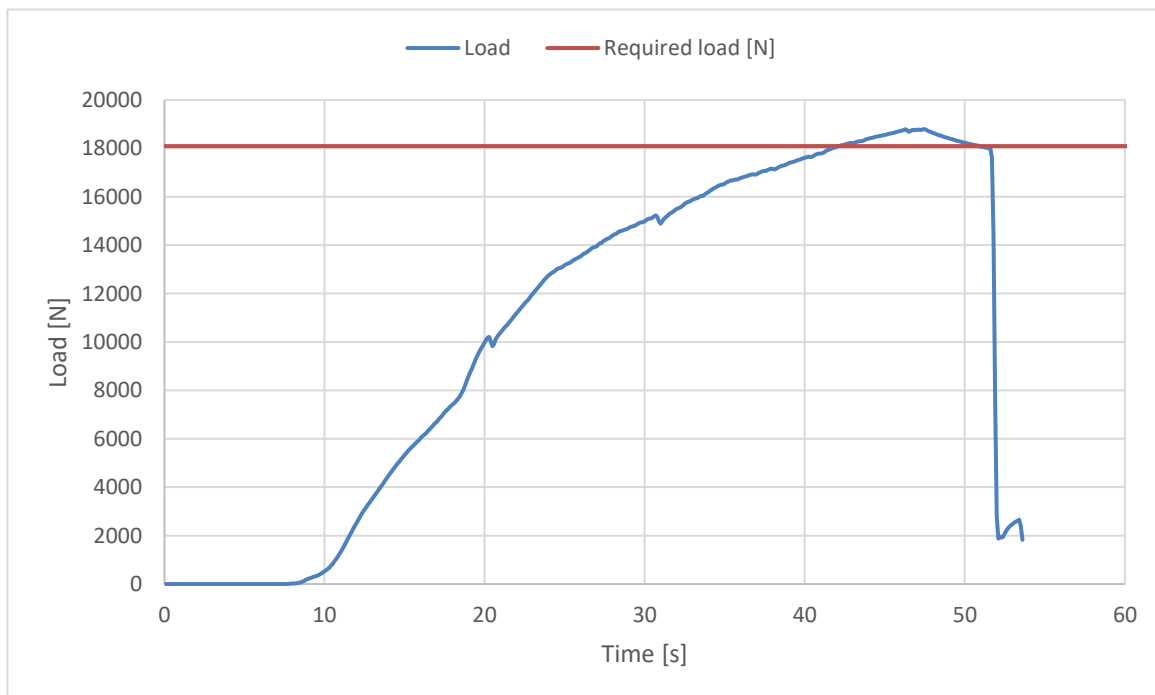
**Test ID R2**

Standard	<b>EN 1651:1999</b>
Reference in standard	<b>5.3.2.2</b>
Test setup	<b>Default flying position</b>
Attachment points	<b>Both main riser attachment (3,4)</b>
Anchor points	<b>Dummy (B1, B2)</b>
Required load [g]	<b>15</b>
Required load [N]	<b>18000</b>
Minimum test duration [s]	<b>5</b>
<b>Result</b>	
Test duration [s]	<b>8.8</b>
Any signs of structural failure	<b>No</b>
Test results	<b>POSITIVE</b>

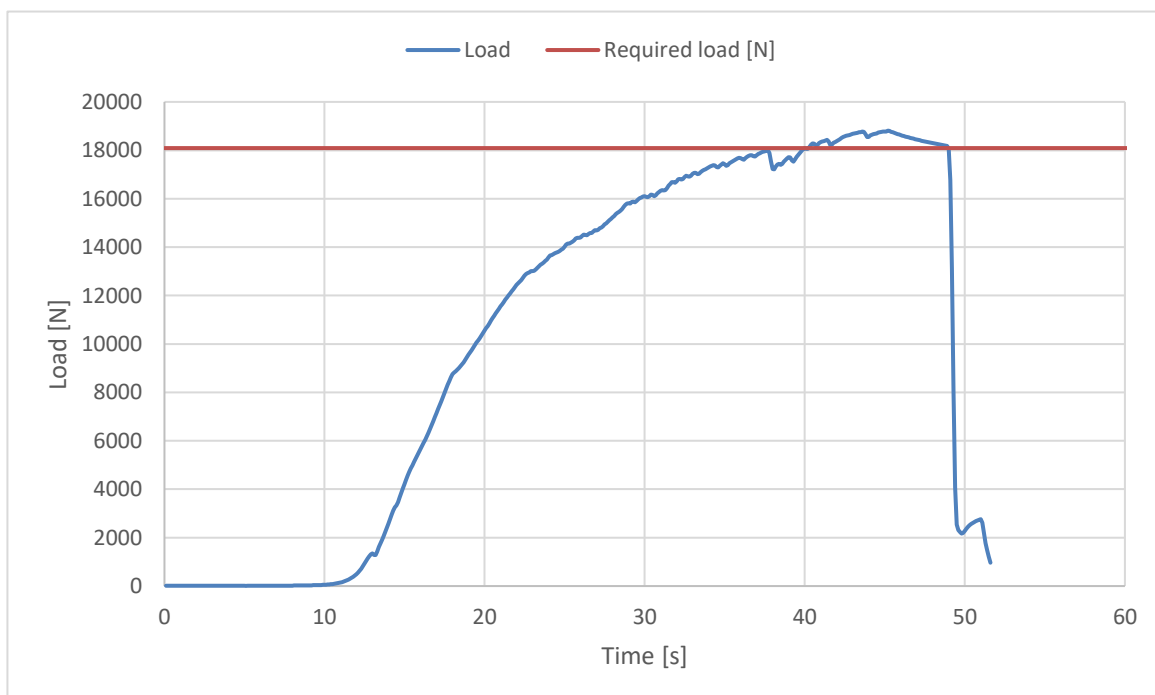
**Test ID R4**

Standard	<b>EN 1651:1999</b>
Reference in standard	<b>5.3.2.7</b>
Test setup	<b>Flying position before landing</b>
Attachment points	<b>Both main riser attachment (3,4)</b>
Anchor points	<b>Dummy (7,8)</b>
Required load [g]	<b>15</b>
Required load [N]	<b>18000</b>
Minimum test duration [s]	<b>5</b>
<b>Result</b>	
Test duration [s]	<b>8.7</b>
Any signs of structural failure	<b>No</b>
Test results	<b>POSITIVE</b>

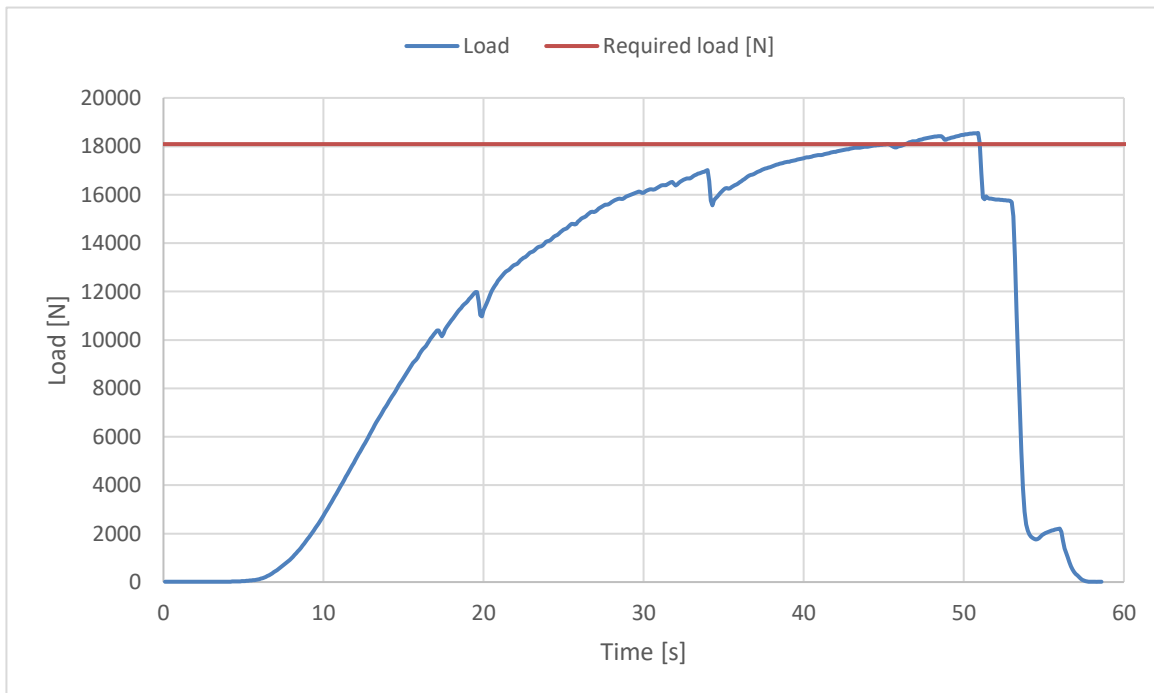
**Test ID R6**

Standard	<b>EN 1651:1999</b>
Reference in standard	<b>5.3.2.4</b>
Test setup	<b>Rescue attachments</b>
Attachment points	<b>Rescue riser attachment (1,2)</b>
Anchor points	<b>Dummy (B1,B2)</b>
Required load [g]	<b>15</b>
Required load [N]	<b>18000</b>
Minimum test duration [s]	<b>5</b>
<b>Result</b>	
Test duration [s]	<b>4.7</b>
Any signs of structural failure	<b>No</b>
Test results	<b>POSITIVE</b>

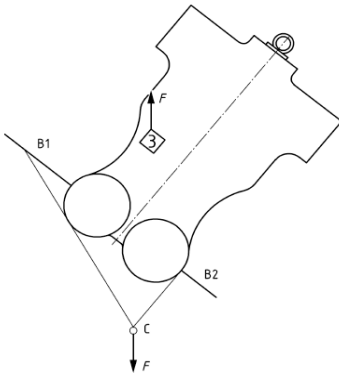
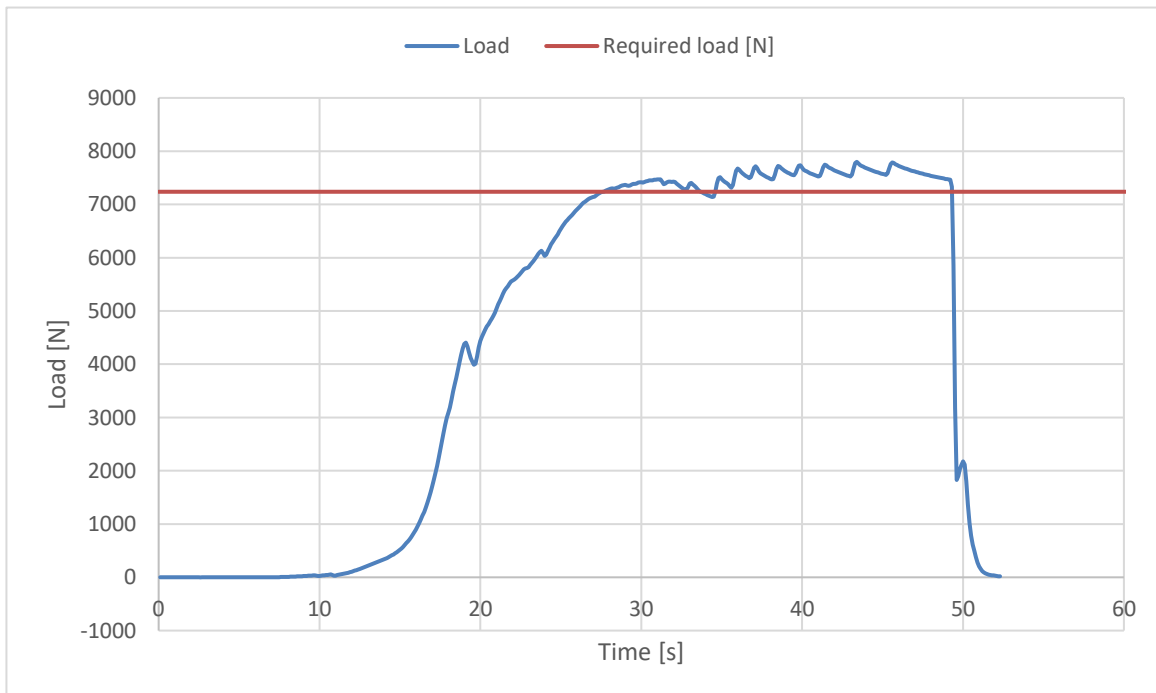
**Test ID R8**

Reference in standard	<b>5.3.2.3</b>	
Test setup	<b>Asymmetric, one riser</b>	
Attachment points	<b>One main riser attachment (3)</b>	
Anchor points	<b>Dummy (B1,B2)</b>	
Required load [g]	<b>6</b>	
Required load [N]	<b>7200</b>	
Minimum test duration [s]	<b>10</b>	
<b>Result</b>		
Test duration [s]	<b>14.7</b>	
Any signs of structural failure	<b>No</b>	
Test results	<b>POSITIVE</b>

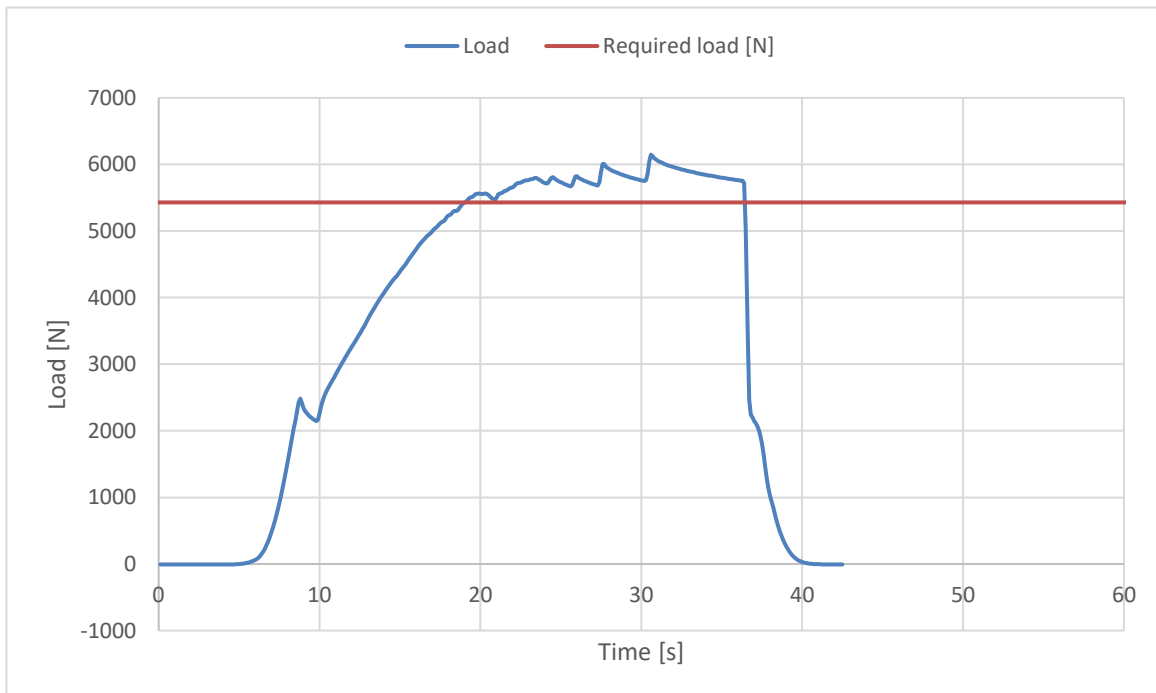
**Test ID R10**

Reference in standard	<b>5.3.2.6</b>	
Test setup	<b>Asymmetric, negative</b>	
Attachment points	<b>One main riser attachment (3 or 4) downwards</b>	
Anchor points	<b>Dummy (9)</b>	
Required load [g]	<b>4.5</b>	
Required load [N]	<b>5400</b>	
Minimum test duration [s]	<b>10</b>	
<b>Result</b>		
Test duration [s]	<b>17.4</b>	
Any signs of structural failure	<b>No</b>	
Test results	<b>POSITIVE</b>

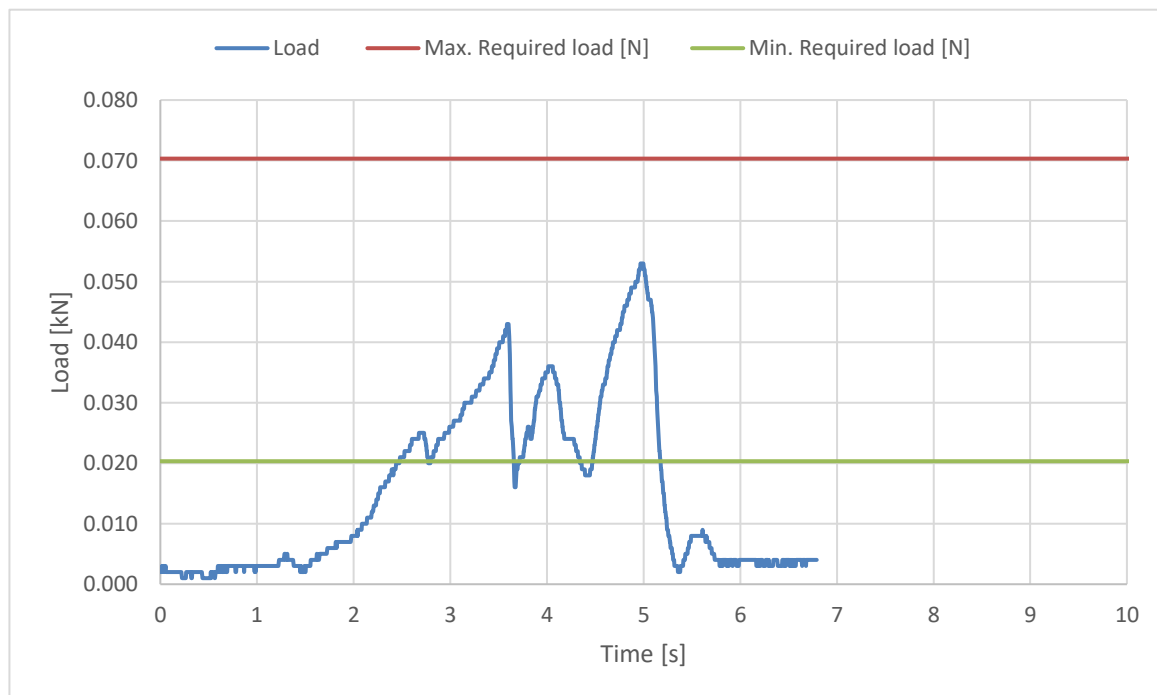
**Test ID RRDT**

Standard	<b>LTF NfL II 91/09</b>
Reference in standard	<b>6.1.5</b>
Test setup	<b>Default flying position</b>
Attachment points	<b>Sensor connect to handle, and pull in opening direction</b>
	The test is to simulate the load required to open the emergency parachute(1st action).
Min. Required load [N]	<b>20</b>
Max. Required load [N]	<b>70</b>
<b>Result</b>	
Load for first action [N]	<b>52.68</b>
Test results	<b>POSITIVE</b>

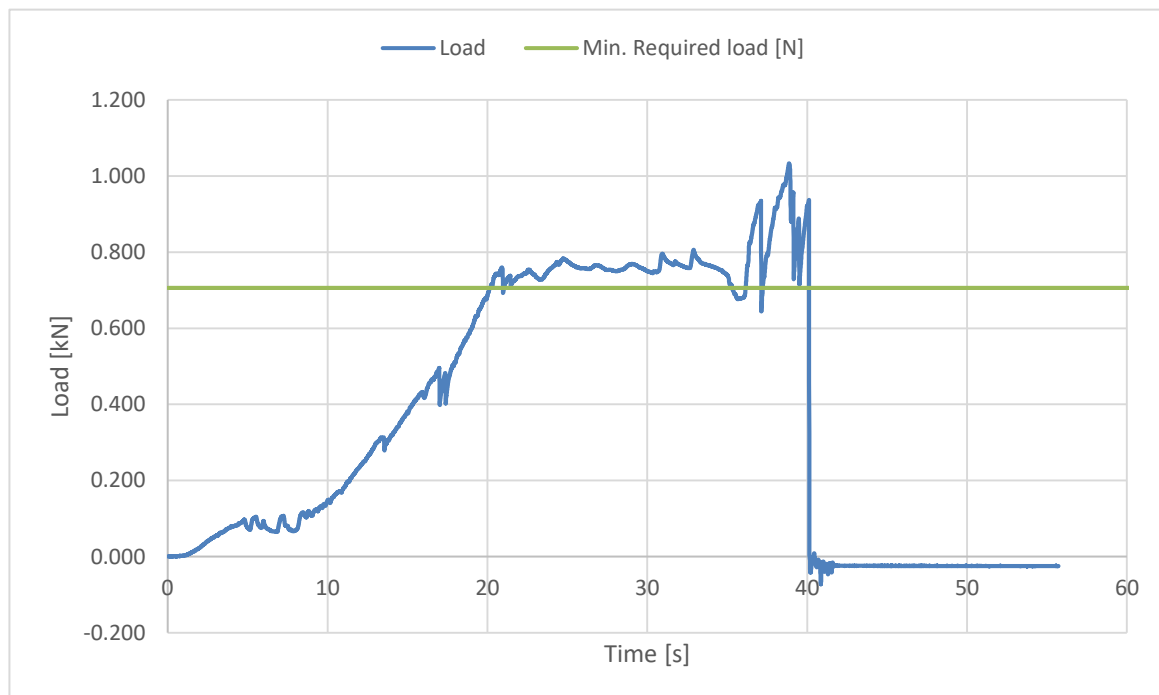
**Test ID RRST**

Standard	<b>EN12491:2015</b>
Reference in standard	<b>5.3.2</b>
Test setup	<b>Two end points of handle</b>
Attachment points	<b>Sensor connect to end of handle, pull on the other side</b>
	The handle must support min 700 N for 10 s, after measure breaking strength
Min. Required load [N]	<b>700</b>
Minimum test duration [s]	<b>10</b>
<b>Result</b>	
Test duration [s]:	<b>14.1</b>
Breaking strength [N]	<b>1026.79</b>
Test results	<b>POSITIVE</b>
