Harness Structural test Report - EN

Inspection certificate number: **PH_375.2022**

Name: **Axess 5**
 Type: **ABS**
 Size: **L**
 Serial number: **1174919**
 Impact pad type: ⁽¹⁾ **Hybrid**
 Clip-in weight [kg]: **120**

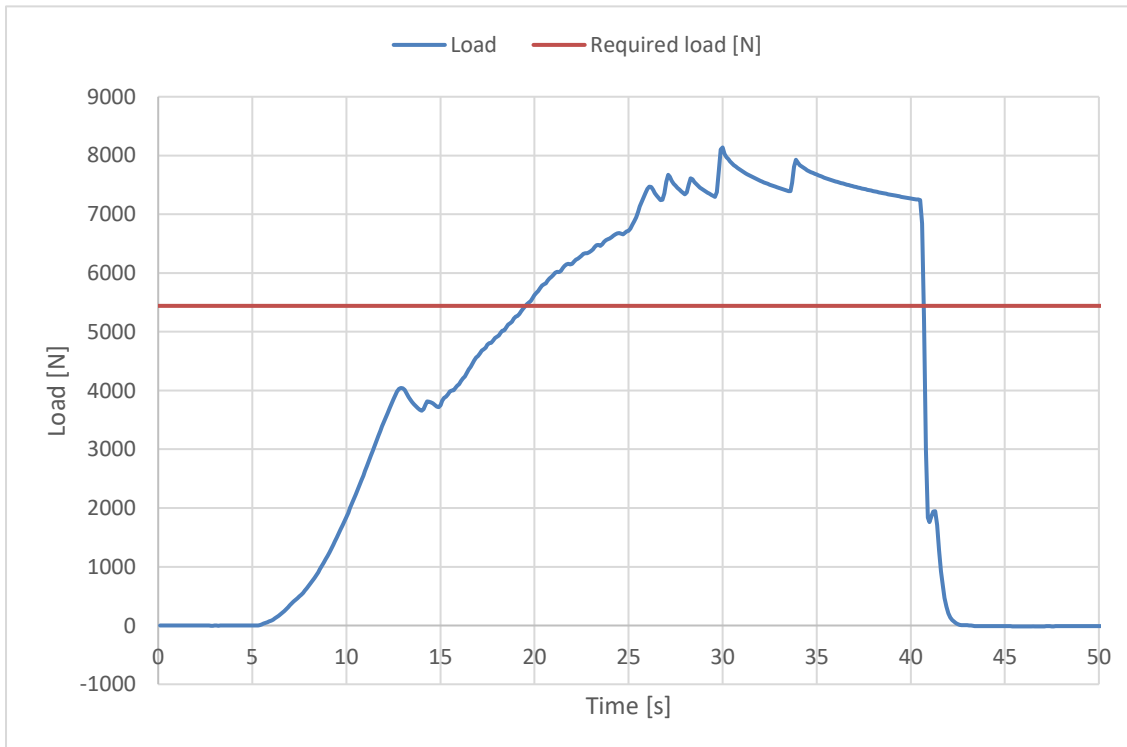
Test ID 01

Test duration [s] **21.1**
 Any signs of structural failure **No**
 Slippery test OK **Yes**
 Test results **POSITIVE**

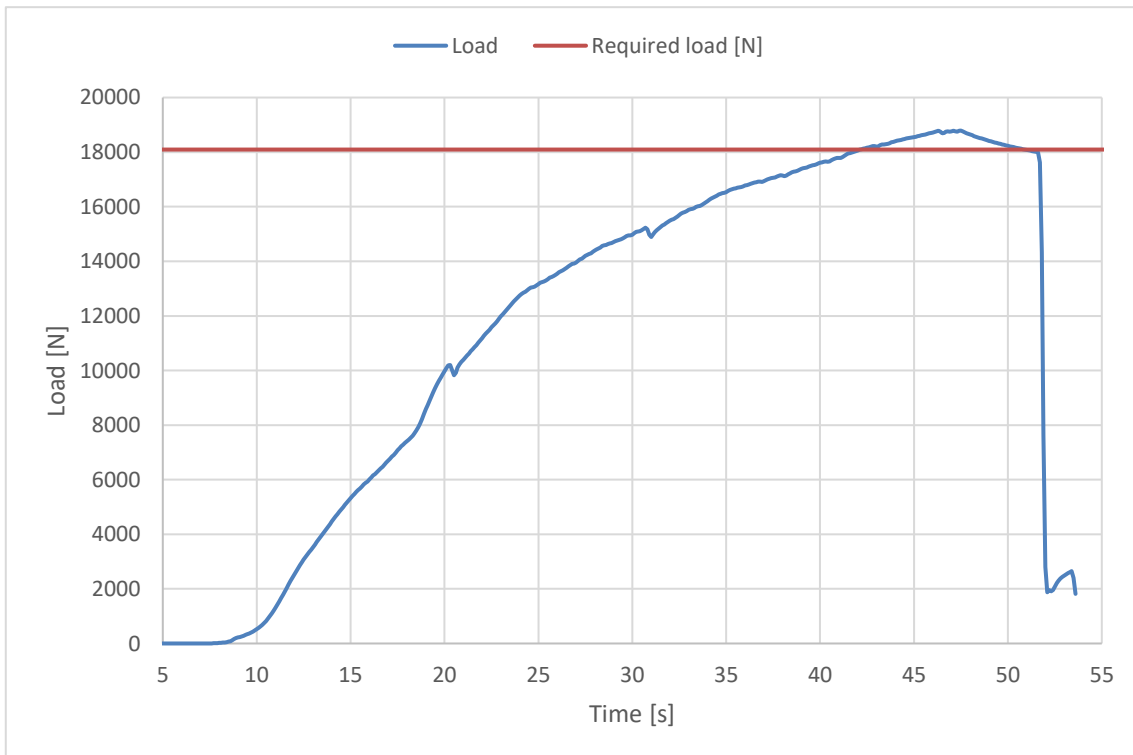
Test ID 03

Standard	EN 1651
Reference in standard	5.5.1.1b
Test setup	Positive symmetric load
Attachment points	Both main riser attachment (3,4)
Anchor points	Dummy (B1, B2)
Required load [g]	15
Required load [N]	18000
Minimum test duration [s]	5
Result	
Test duration [s]	8.7
Any signs of structural failure	No
Slippery test OK	Yes
Test results	POSITIVE

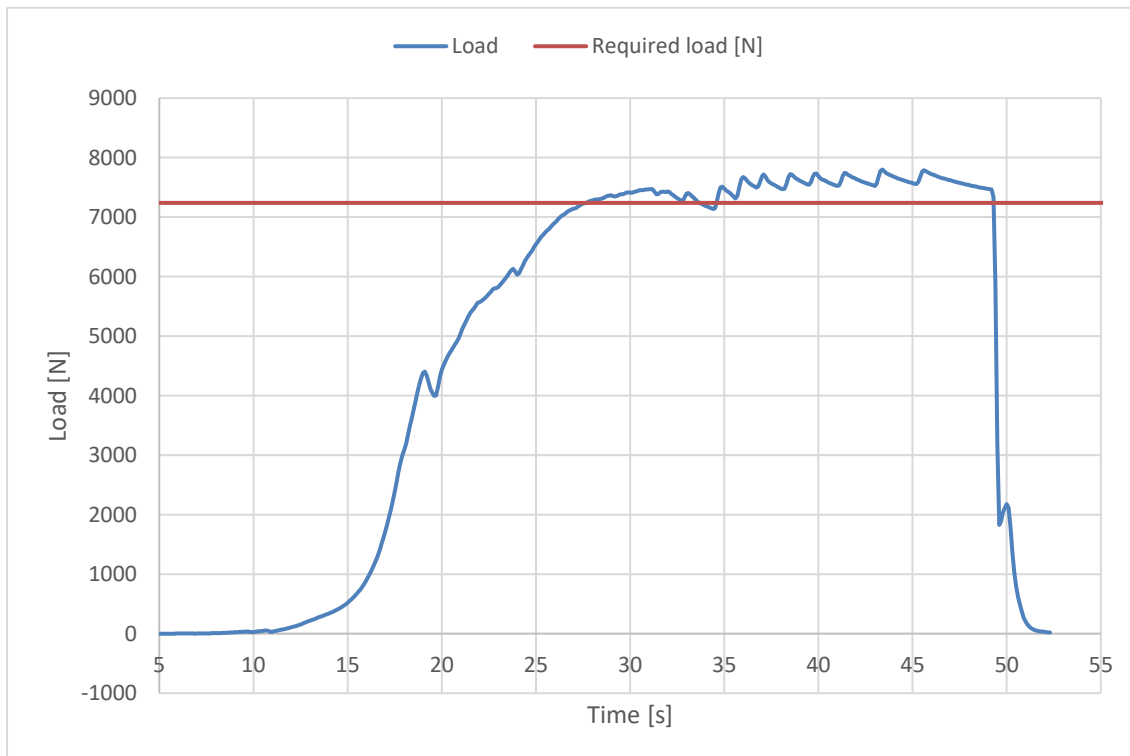
Test ID 05

Standard	EN 1651
Reference in standard	5.5.1.2
Test setup	Positive asymmetric load
Attachment points	One riser attachment (3 or 4)
Anchor points	Dummy (C)
Required load [g]	6
Required load [N]	7200
Minimum test duration [s]	5
Result	
Test duration [s]	14.7
Any signs of structural failure	No
Test results	POSITIVE

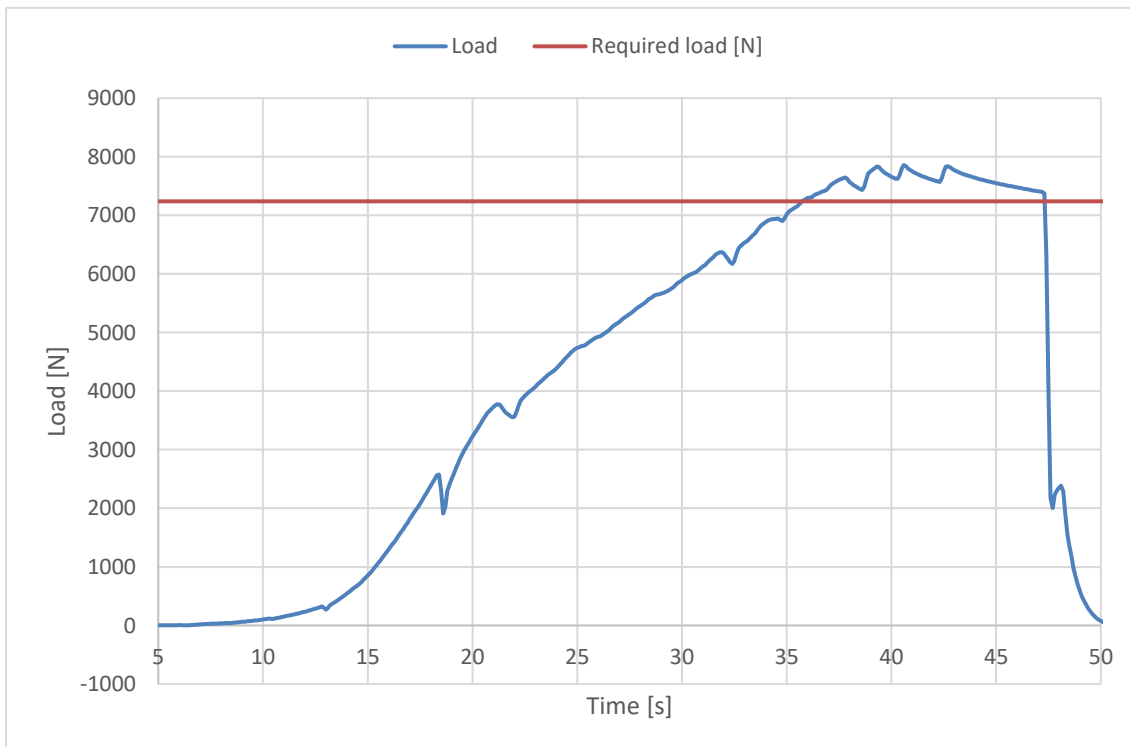
Test ID 06

Standard	EN 1651
Reference in standard	5.5.1.6
Test setup	Negative symmetric load
Attachment points	Both main riser attachment (3,4)
Anchor points	Dummy (A)
Required load [g]	6
Required load [N]	7200
Minimum test duration [s]	5
Result	
Test duration [s]	11.6
Any signs of structural failure	No
Test results	POSITIVE

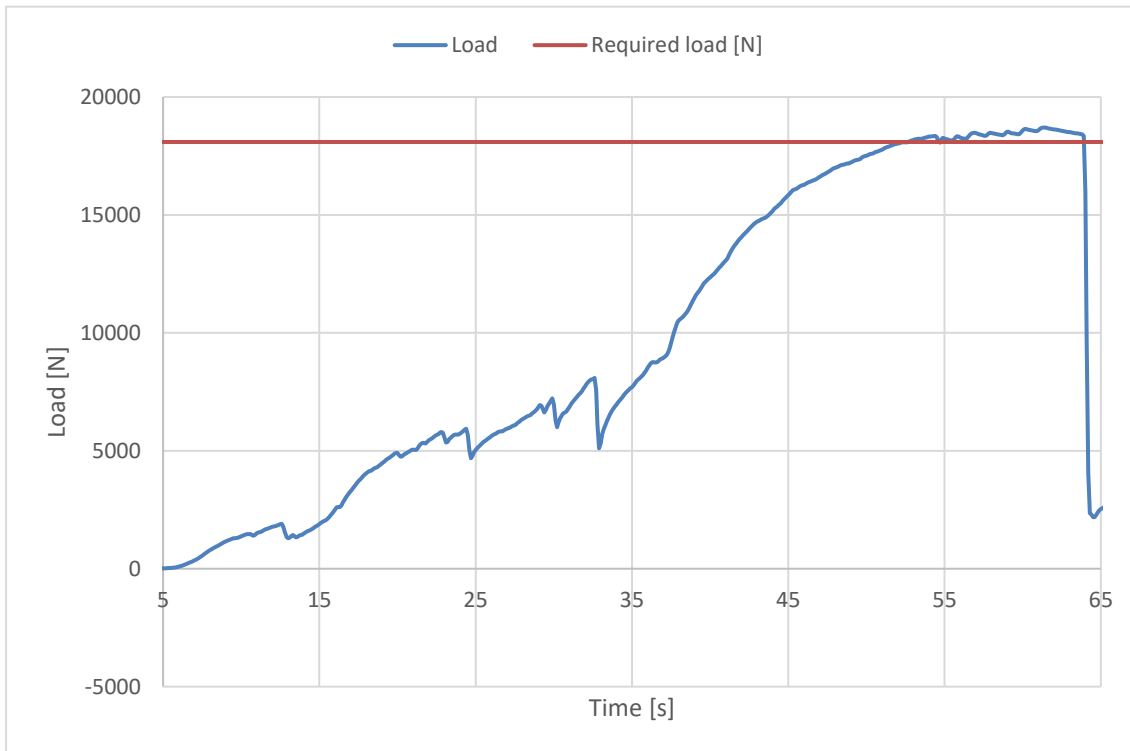
Test ID 09

Standard	EN 1651
Reference in standard	5.5.1.3
Test setup	Positive symmetric load rescue points
Attachment points	Both main riser attachment (1,2)
Anchor points	Dummy (B1,B2)
Required load [g]	15
Required load [N]	18000
Minimum test duration [s]	5
Result	
Test duration [s]	9.2
Any signs of structural failure	No
Slippery test OK	Yes
Test results	POSITIVE

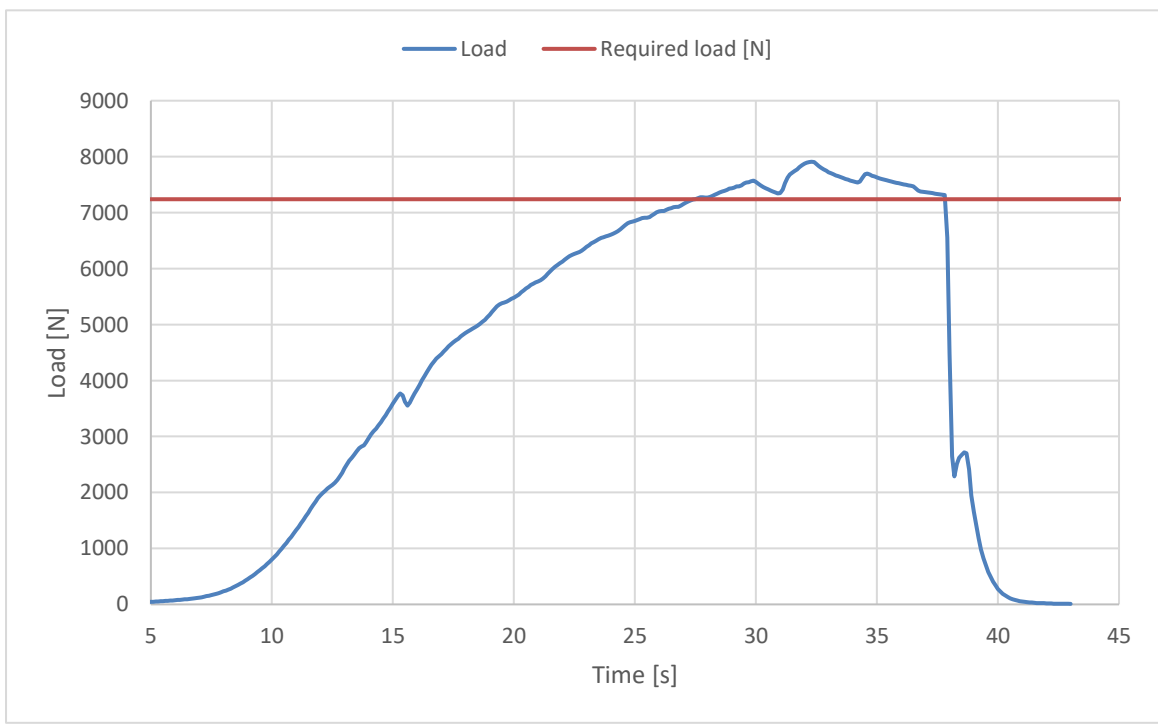
Test ID 12

Standard	EN 1651
Reference in standard	5.5.1.7
Test setup	Upright (landing) position load
Attachment points	Both main riser attachment (3, 4)
Anchor points	Both legstrap of harness (no dummy)
Required load [g]	6
Required load [N]	7200
Minimum test duration [s]	5
Harness type	type b
Result	
Test duration [s]	10.4
Any signs of structural failure	No
Slippery test OK	Yes
Test results	POSITIVE

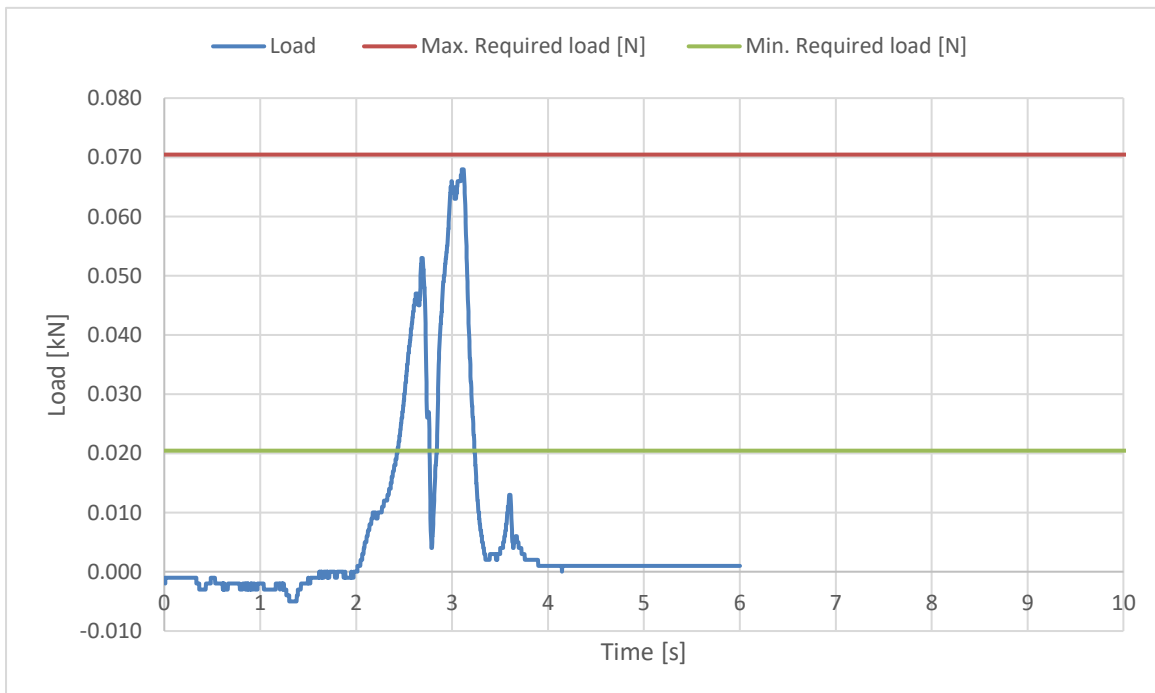
Test ID RRDT

Standard	EN 1651
Reference in standard	5.5.1.11
Test setup	Default flying position
Attachment points	Sensor connect to handle, and pull in opening direction
	The test is to simulate the load required to open the emergency parachute(1st action).
Min. Required load [N]	20
Max. Required load [N]	70
Result	
Load for first action [N]	68.45
Test results	POSITIVE

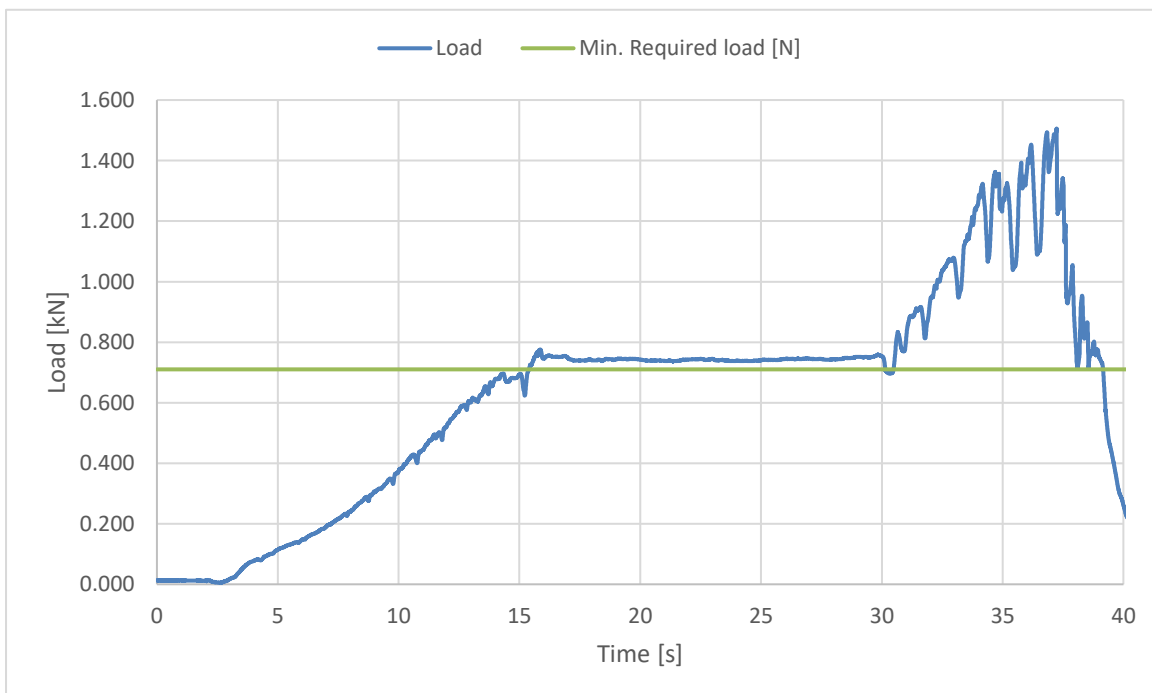
Test ID RRST

Standard	EN 12491
Reference in standard	5.3.2
Test setup	Two end points of handle
Attachment points	Sensor connect to end of handle, pull on the other side
	The handle must support min 700 N for 10 s, after measure breaking strength
Min. Required load [N]	700
Minimum test duration [s]	10
Result	
Test duration [s]:	14.7
Breaking strength [N]	1496.00
Test results	POSITIVE
