Harness Structural test Report - EN

Inspection certificate number: **PH_279.2019**

Name: **Bi Pax**
 Type: **ABS**
 Size: **M**
 Serial number: **1150061**
 Impact pad type: ⁽¹⁾ **Hybrid**
 Clip-in weight [kg]: **120**
 Date of test: **21.08.2019**

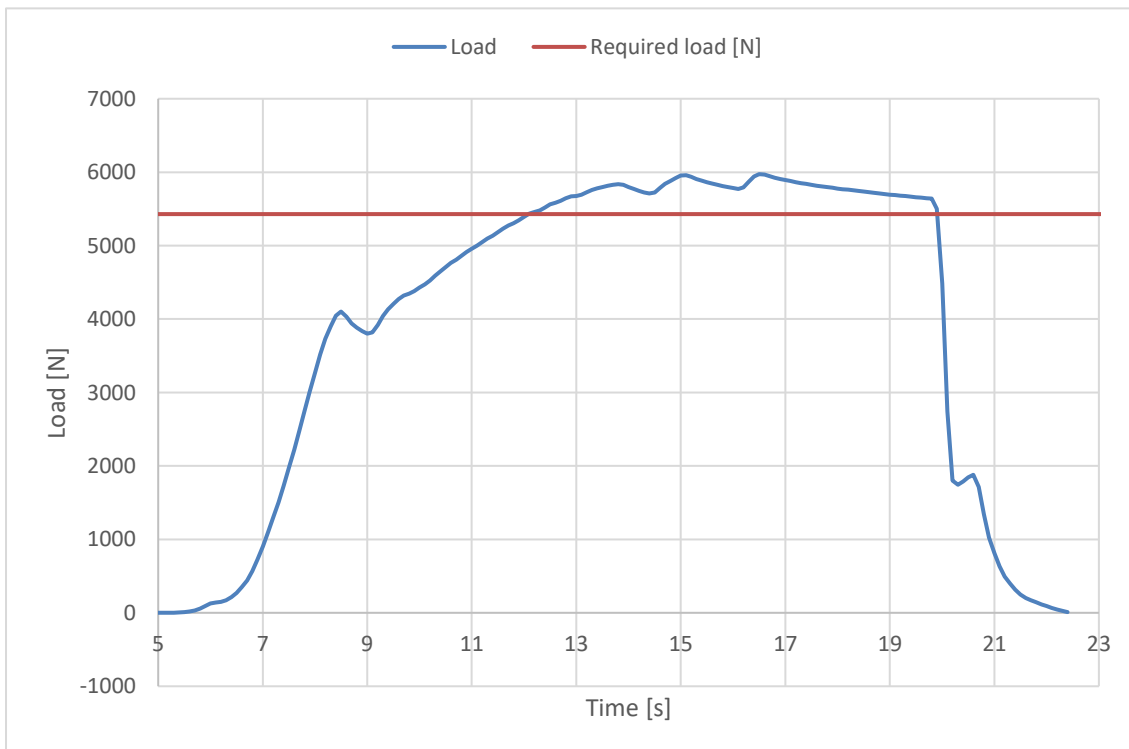
Test ID 01

Standard	EN 1651
Reference in standard	5.5.1.1
Test setup	Positive symmetric load (Slippage)
Attachment points	Both main riser attachment (3,4)
Anchor points	Dummy (B1, B2)
Required load [g]	4.5
Required load [N]	5400
Minimum test duration [s]	5
Result	
Test duration [s]	7.9
Any signs of structural failure	No
Slippery test OK	No
Test results	POSITIVE

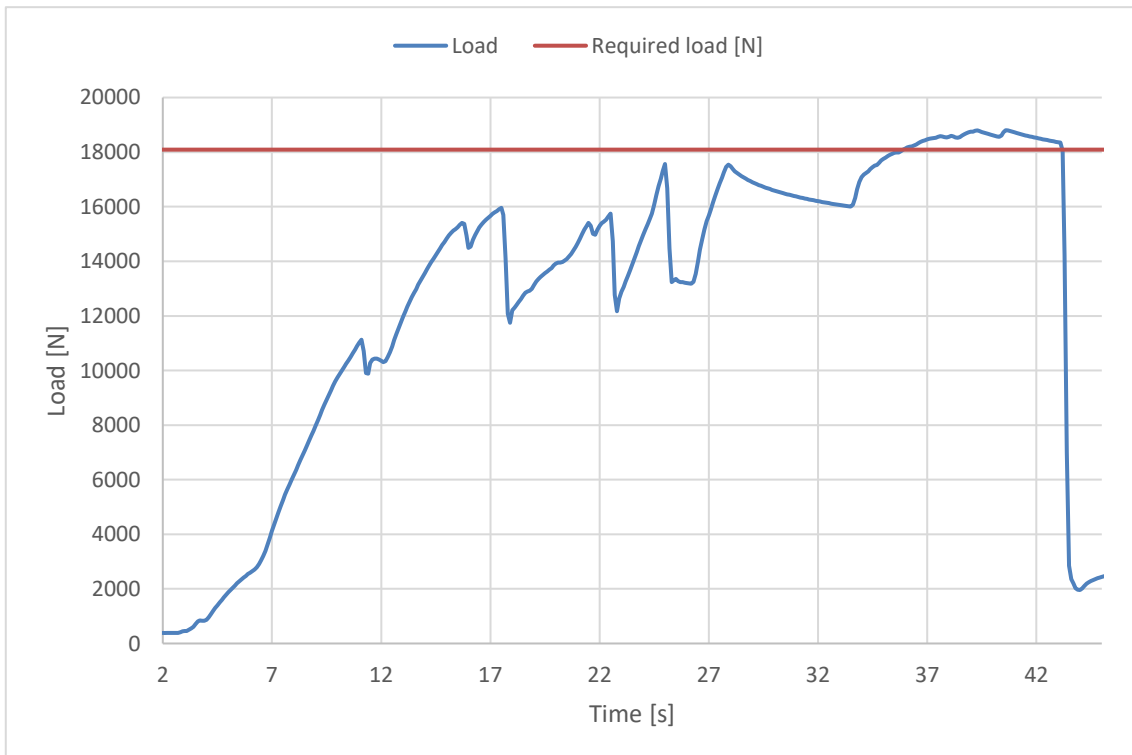
Test ID 03

Standard **EN 1651**
 Reference in standard **5.5.1.1b**
 Test setup **Positive symmetric load**
 Attachment points **Both main riser attachment (3,4)**
 Anchor points **Dummy (B1, B2)**

Test duration [s] **7.2**
 Any signs of structural failure **No**
 Slippery test OK **No**
 Test results **POSITIVE**

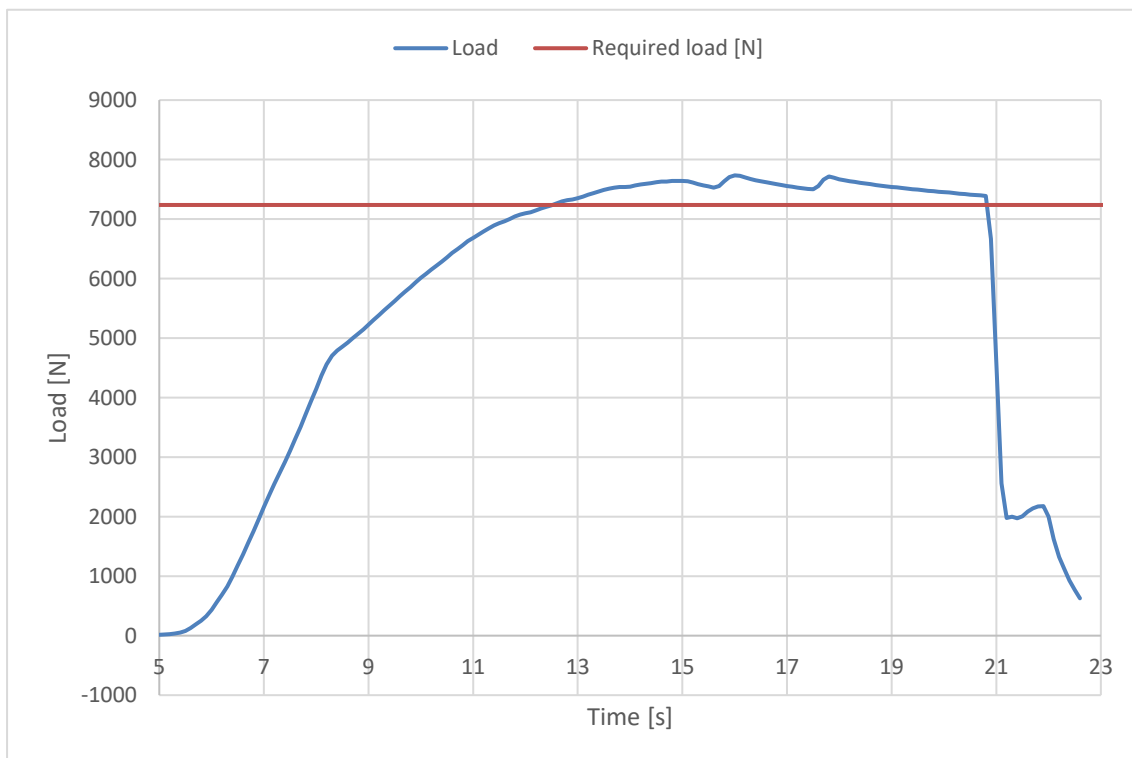
Test ID 05

Standard	EN 1651
Reference in standard	5.5.1.2
Test setup	Positive asymmetric load
Attachment points	One riser attachment (3 or 4)
Anchor points	Dummy (C)
Required load [g]	6
Required load [N]	7200
Minimum test duration [s]	5
Result	
Test duration [s]	8.3
Any signs of structural failure	No
Test results	POSITIVE

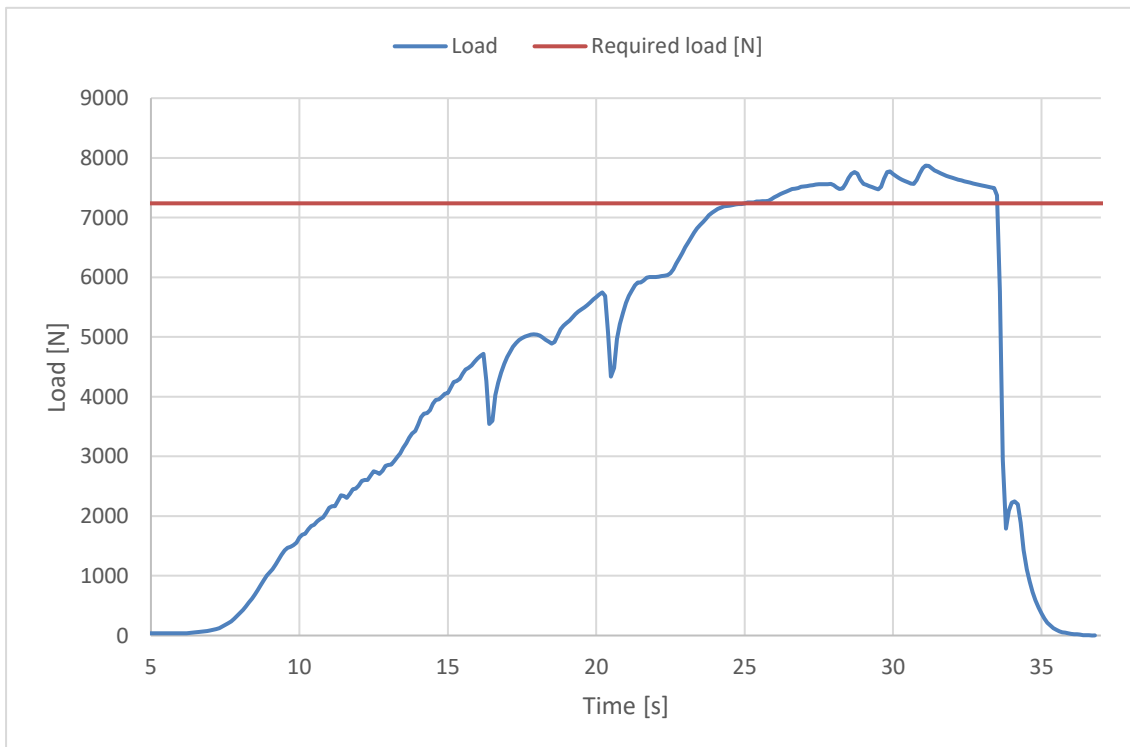
Test ID 06

Standard	EN 1651
Reference in standard	5.5.1.6
Test setup	Negative symmetric load
Attachment points	Both main riser attachment (3,4)
Anchor points	Dummy (A)
Required load [g]	6
Required load [N]	7200
Minimum test duration [s]	5
Result	
Test duration [s]	8.5
Any signs of structural failure	No
Test results	POSITIVE

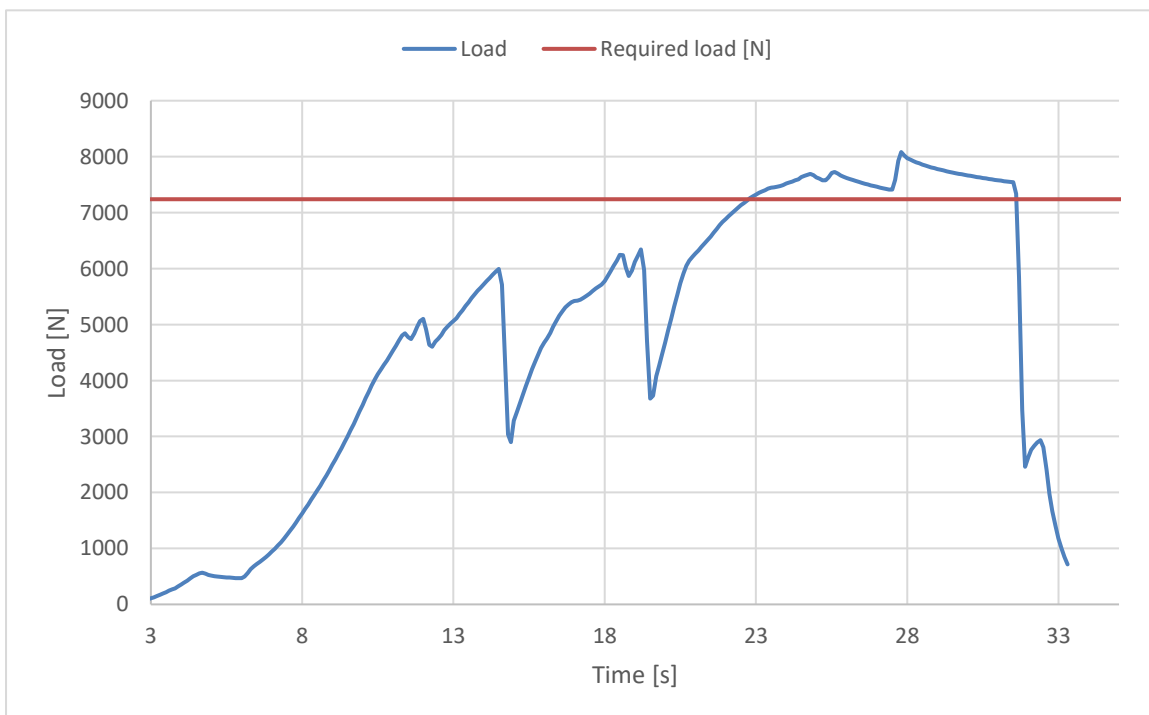
Test ID 12

Standard	EN 1651
Reference in standard	5.5.1.7
Test setup	Upright (landing) position load
Attachment points	Both main riser attachment (3, 4)
Anchor points	Both legstrap of harness (no dummy)
Required load [g]	6
Required load [N]	7200
Minimum test duration [s]	5
Harness type	type a
Result	
Test duration [s]	8.9
Any signs of structural failure	No
Slippery test OK	No
Test results	POSITIVE
