## Harness Structural test Report - LTF

Inspection certificate number: **PH\_279.2019**

Name: **Bi Pax**  
 Type: **ABS**  
 Size: **M**  
 Serial number: **1150061**  
 Impact pad type: <sup>(1)</sup> **Hybrid**  
 Clip-in weight [kg]: **120**

### Summary of Structural test

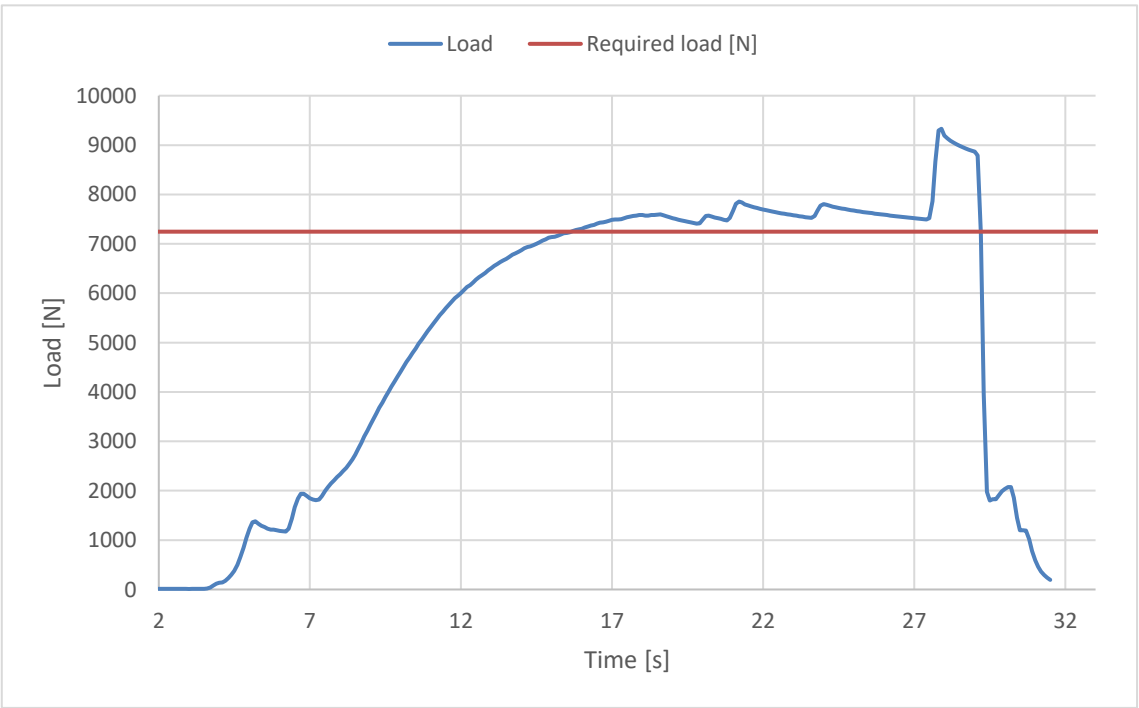
**Test ID 02**

Standard	<b>LTF NfL II 91/09</b>
Reference	<b>5.3.2.1</b>
Test setup	<b>Default flying position</b>
Attachment points	<b>Both main riser attachment (3,4)</b>
Anchor points	<b>Dummy (B1, B2)</b>
Required load [g]	<b>6</b>
Required load [N]	<b>7200</b>
Minimum test duration [s]	<b>10</b>
<b>Result</b>	
Test duration [s]	<b>13.5</b>
Any signs of structural failure	<b>No</b>
Test results	<b>POSITIVE</b>

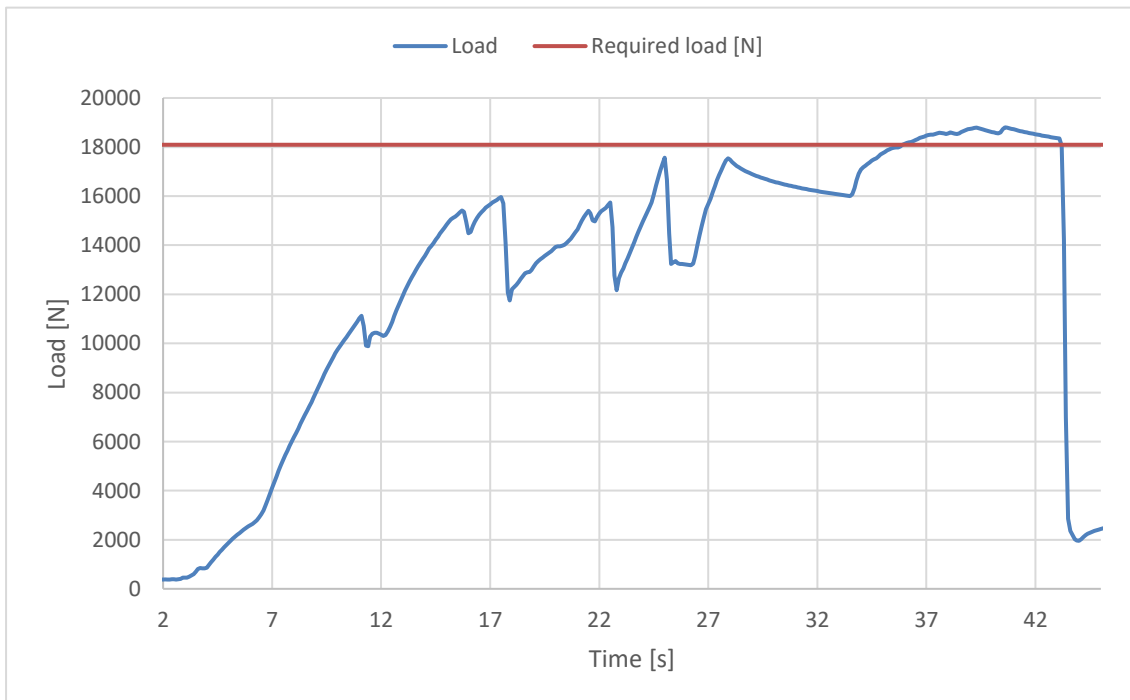
**Test ID 03**

Standard	<b>LTF NfL II 91/09</b>
Reference	<b>5.3.2.2</b>
Test setup	<b>Default flying position</b>
Attachment points	<b>Both main riser attachment (3,4)</b>
Anchor points	<b>Dummy (B1, B2)</b>
Required load [g]	<b>15</b>
Required load [N]	<b>18000</b>
Minimum test duration [s]	<b>5</b>
<b>Result</b>	
Test duration [s]	<b>7.2</b>
Any signs of structural failure	<b>No</b>
Test results	<b>POSITIVE</b>

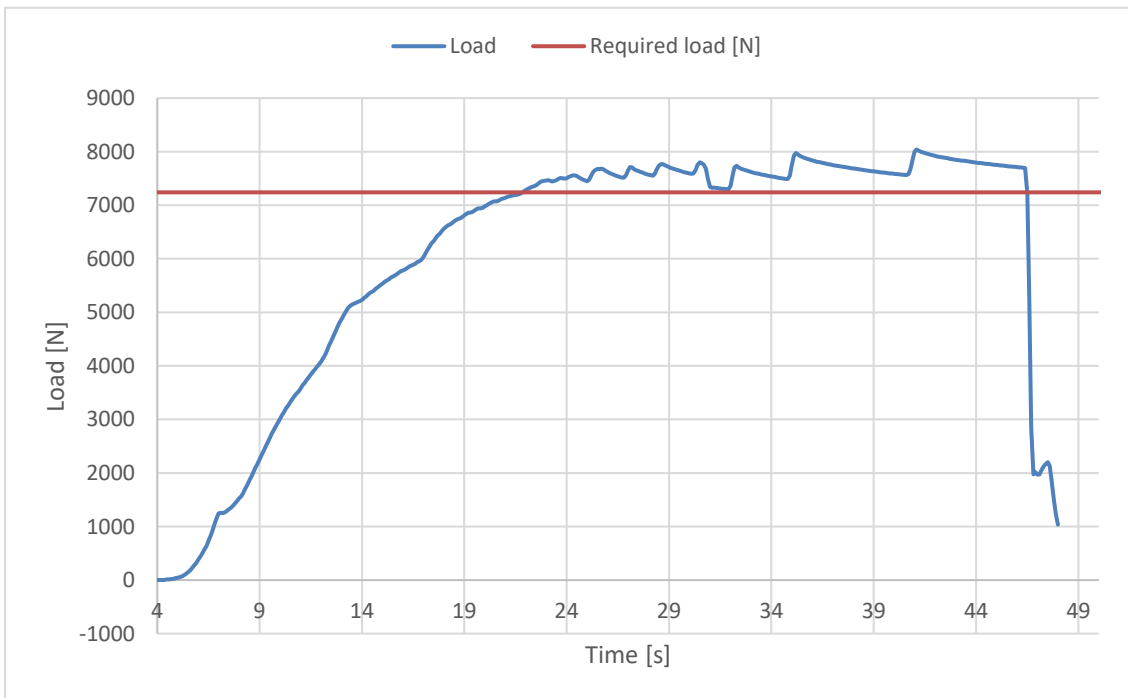
**Test ID 04**

Standard **LTF NfL II 91/09**  
 Reference **5.3.2.3**  
 Test setup **Asymmetric, one riser**  
 Attachment points **One main riser attachment (3)**  
 Anchor points **Dummy (B1,B2)**

Test duration [s] **24.6**  
 Any signs of structural failure **No**  
 Test results **POSITIVE**

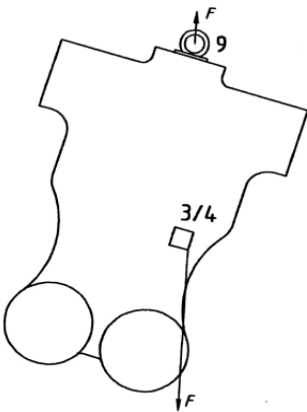
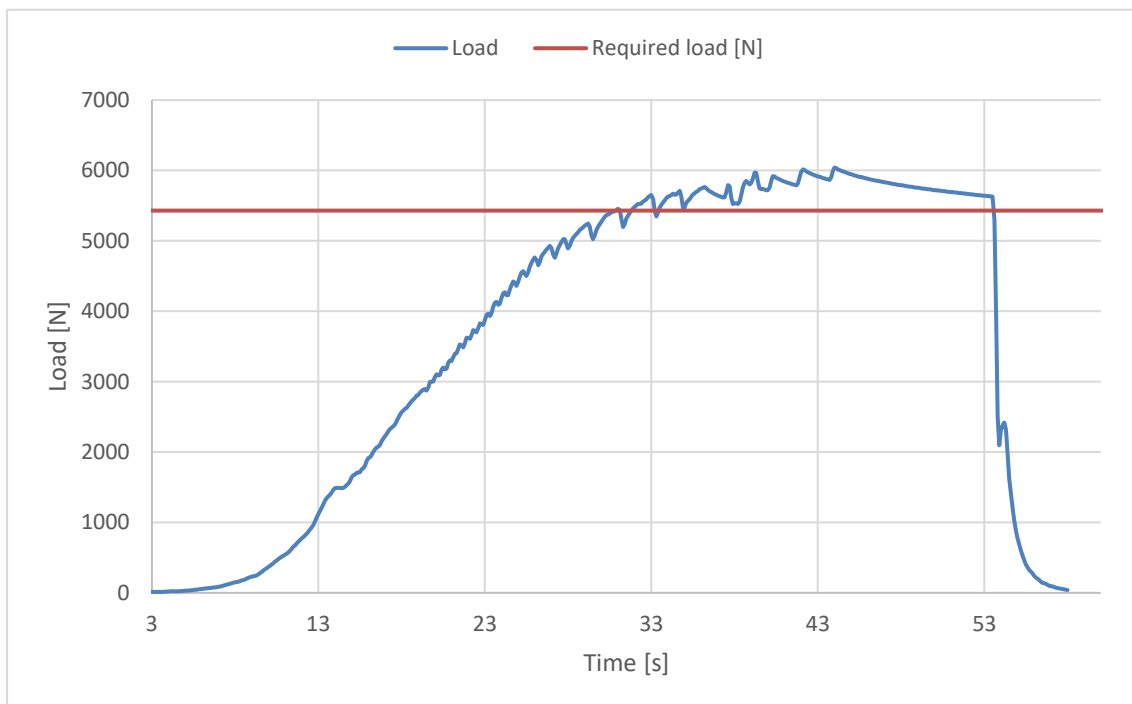
**Test ID 07**

Reference	<b>5.3.2.6</b>	
Test setup	<b>Asymmetric, negative</b>	
Attachment points	<b>One main riser attachment (3 or 4) downwards</b>	
Anchor points	<b>Dummy (9)</b>	
Required load [g]	<b>4.5</b>	
Required load [N]	<b>5400</b>	
Minimum test duration [s]	<b>10</b>	
<b>Result</b>		
Test duration [s]	<b>20.1</b>	
Any signs of structural failure	<b>No</b>	
Test results	<b>POSITIVE</b>

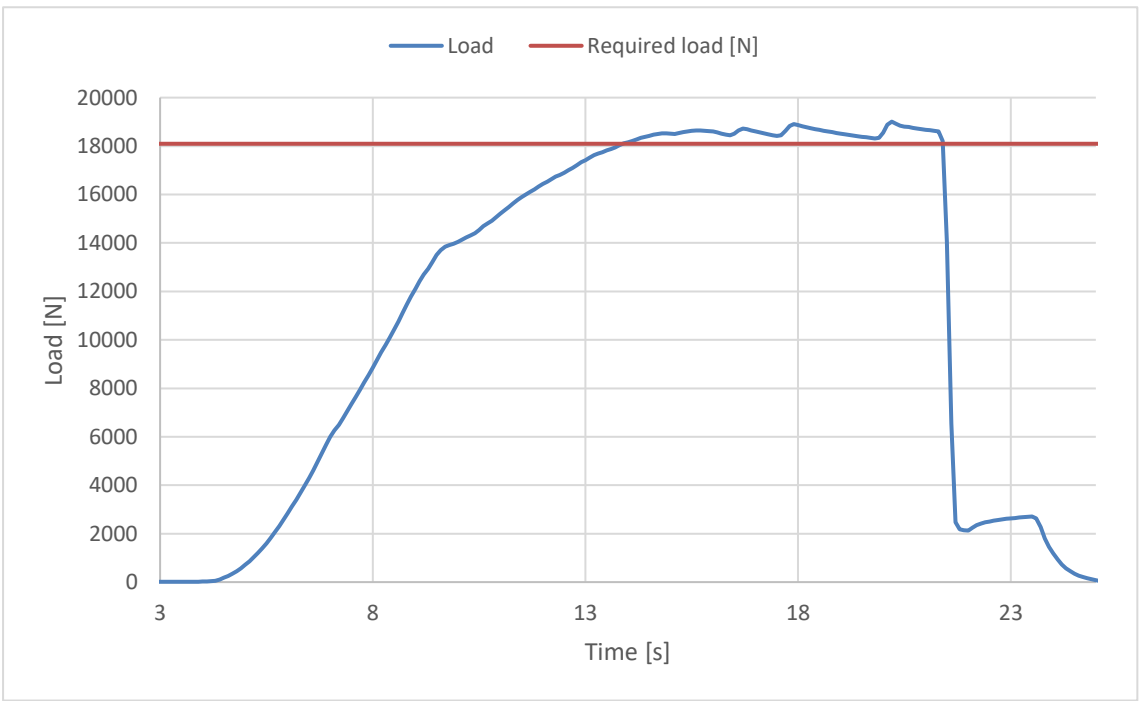
**Test ID 13**

Standard	<b>LTF NfL II 91/09</b>
Reference	<b>5.3.2.7</b>
Test setup	<b>Flying position before landing</b>
Attachment points	<b>Both main riser attachment (3,4)</b>
Anchor points	<b>Dummy (7,8)</b>
Required load [g]	<b>15</b>
Required load [N]	<b>18000</b>
Minimum test duration [s]	<b>5</b>
<b>Result</b>	
Test duration [s]	<b>7.6</b>
Any signs of structural failure	<b>No</b>
Test results	<b>POSITIVE</b>
