## Harness Structural test Report - EN

Inspection certificate number: **PH\_382.2022**

Name: **BIPAX 2**  
 Type: **ABS**  
 Size: **M**  
 Serial number: **1150061**  
 Impact pad type: <sup>(1)</sup> **Hybrid**  
 Clip-in weight [kg]: **120**

**Harness Structural test**

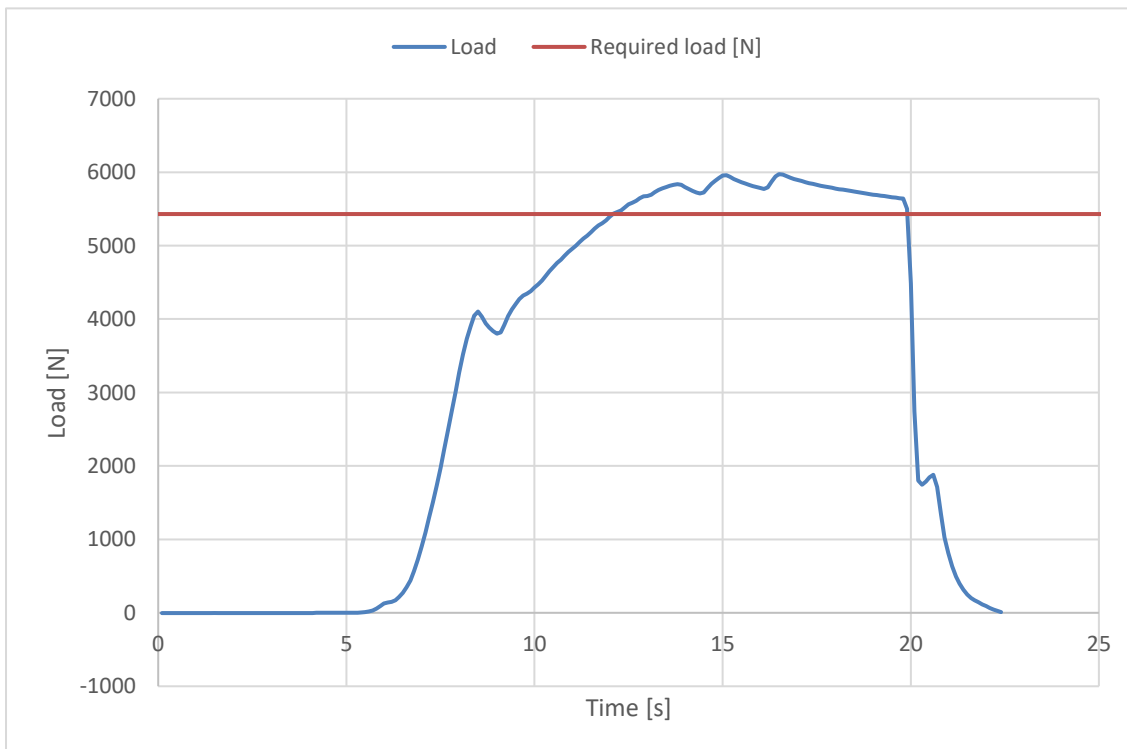
**Test ID 01**

Standard **EN 1651**  
 Reference in standard **5.5.1.1**  
 Test setup **Positive symmetric load (Slippage)**  
 Attachment points **Both main riser attachment (3,4)**  
 Anchor points **Dummy (B1, B2)**

Test duration [s] **7.9**  
 Any signs of structural failure **No**  
 Slippery test OK **Yes**  
 Test results **POSITIVE**

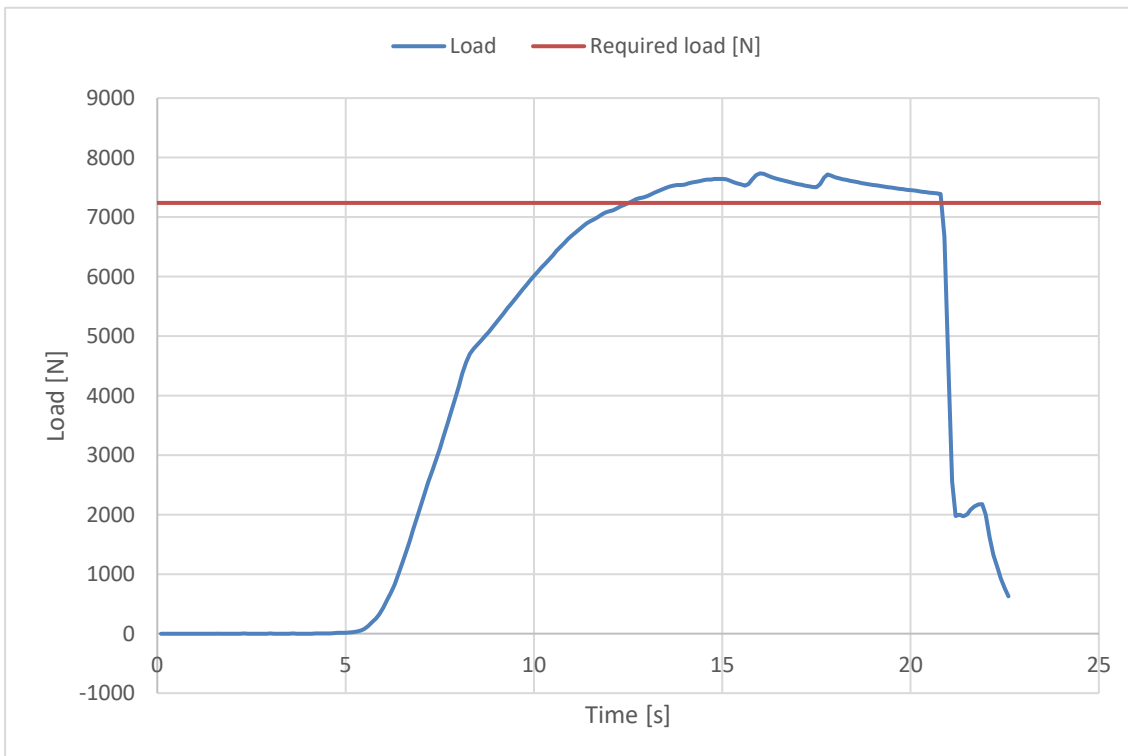
**Test ID 05**

Standard	<b>EN 1651</b>
Reference in standard	<b>5.5.1.2</b>
Test setup	<b>Positive asymmetric load</b>
Attachment points	<b>One riser attachment (3 or 4)</b>
Anchor points	<b>Dummy (C)</b>
Required load [g]	<b>6</b>
Required load [N]	<b>7200</b>
Minimum test duration [s]	<b>5</b>
<b>Result</b>	
Test duration [s]	<b>8.3</b>
Any signs of structural failure	<b>No</b>
Test results	<b>POSITIVE</b>

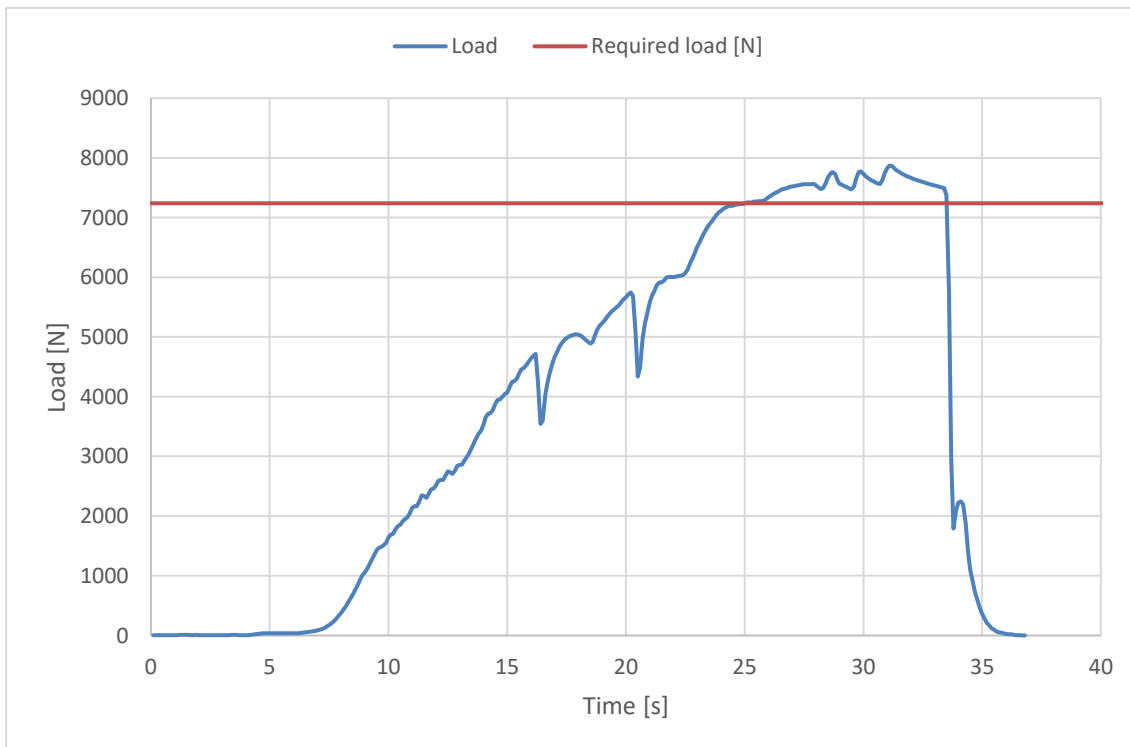
**Test ID 06**

Standard **EN 1651**  
 Reference in standard **5.5.1.6**  
 Test setup **Negative symmetric load**  
 Attachment points **Both main riser attachment (3,4)**  
 Anchor points **Dummy (A)**

Test duration [s] **8.5**  
 Any signs of structural failure **No**  
 Test results **POSITIVE**

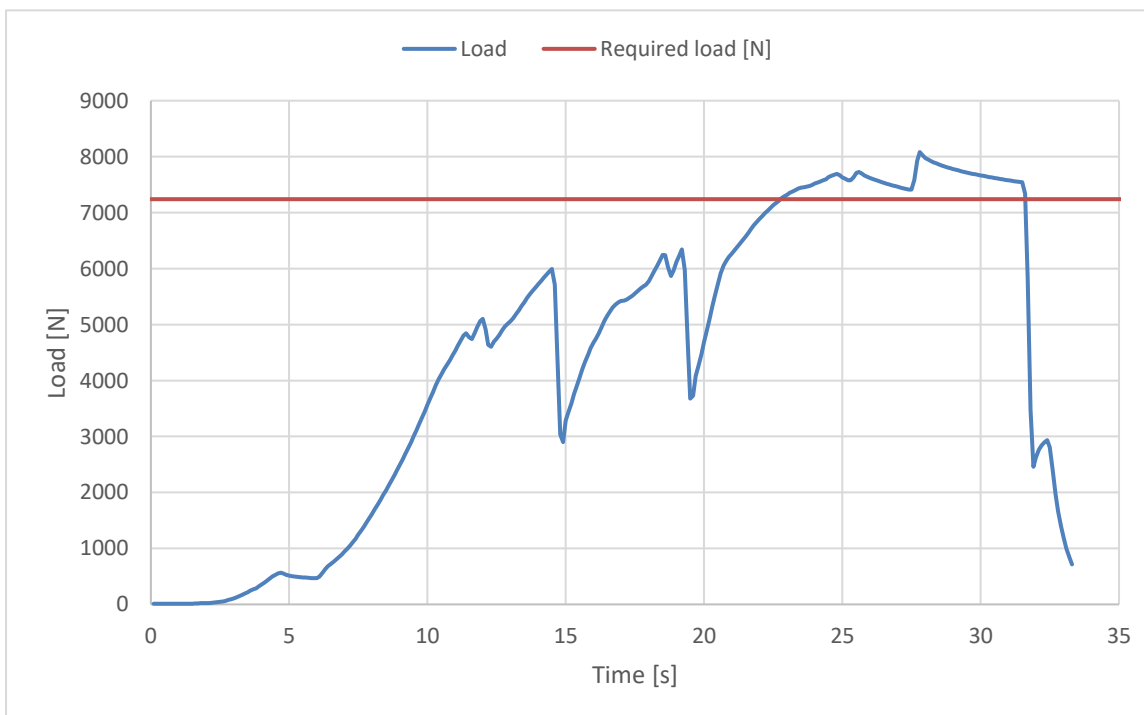
**Test ID 12**

Standard	<b>EN 1651</b>
Reference in standard	<b>5.5.1.7</b>
Test setup	<b>Upright (landing) position load</b>
Attachment points	<b>Both main riser attachment (3, 4)</b>
Anchor points	<b>Both legstrap of harness (no dummy)</b>
Required load [g]	<b>6</b>
Required load [N]	<b>7200</b>
Minimum test duration [s]	<b>5</b>
Harness type	<b>type c</b>
<b>Result</b>	
Test duration [s]	<b>8.9</b>
Any signs of structural failure	<b>No</b>
Slippery test OK	<b>Yes</b>
Test results	<b>POSITIVE</b>
