## Harness Structural test Report - NfL

Inspection certificate number: **PH\_382.2022**

Name: **BIPAX 2**  
 Type: **ABS**  
 Size: **M**  
 Serial number: **1150061**  
 Impact pad type: <sup>(1)</sup> **Hybrid**  
 Clip-in weight [kg]: **120**  
 Integrated container: **No**  
 Date of test: **21.08.2019**

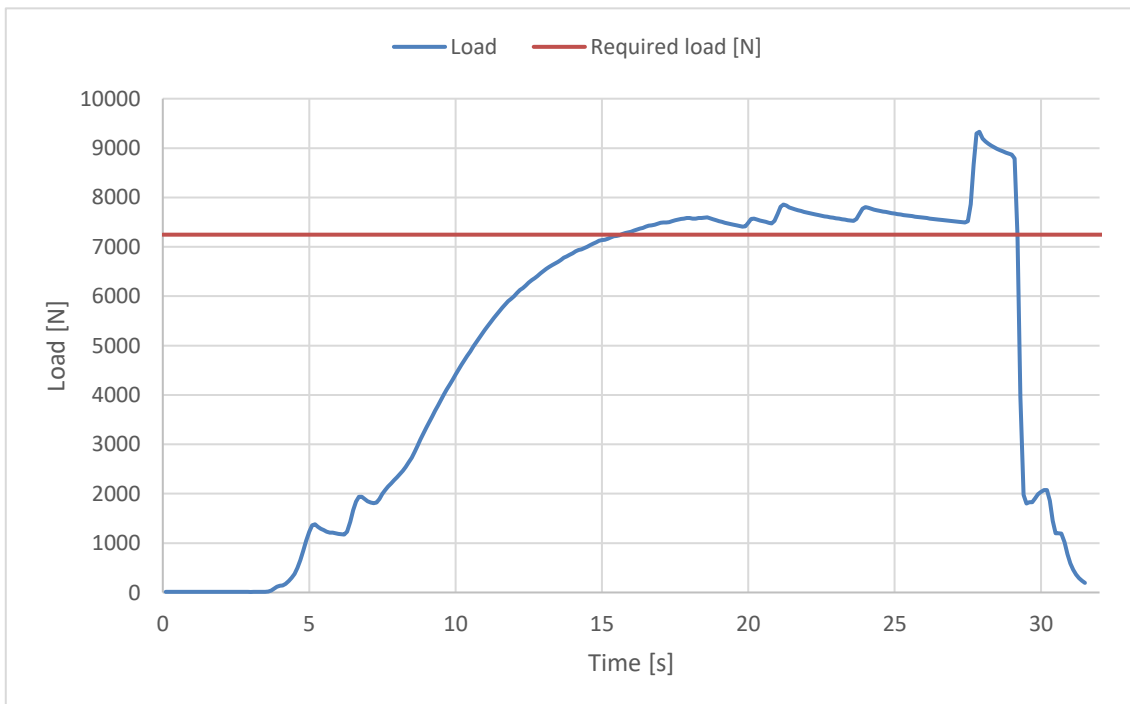
**Test ID 02**

Standard	<b>EN 1651:1999</b>
Reference	<b>5.3.2.1</b>
Test setup	<b>Default flying position</b>
Attachment points	<b>Both main riser attachment (3,4)</b>
Anchor points	<b>Dummy (B1, B2)</b>
Required load [g]	<b>6</b>
Required load [N]	<b>7200</b>
Minimum test duration [s]	<b>10</b>
<b>Result</b>	
Test duration [s]	<b>13.5</b>
Any signs of structural failure	<b>No</b>
Test results	<b>POSITIVE</b>

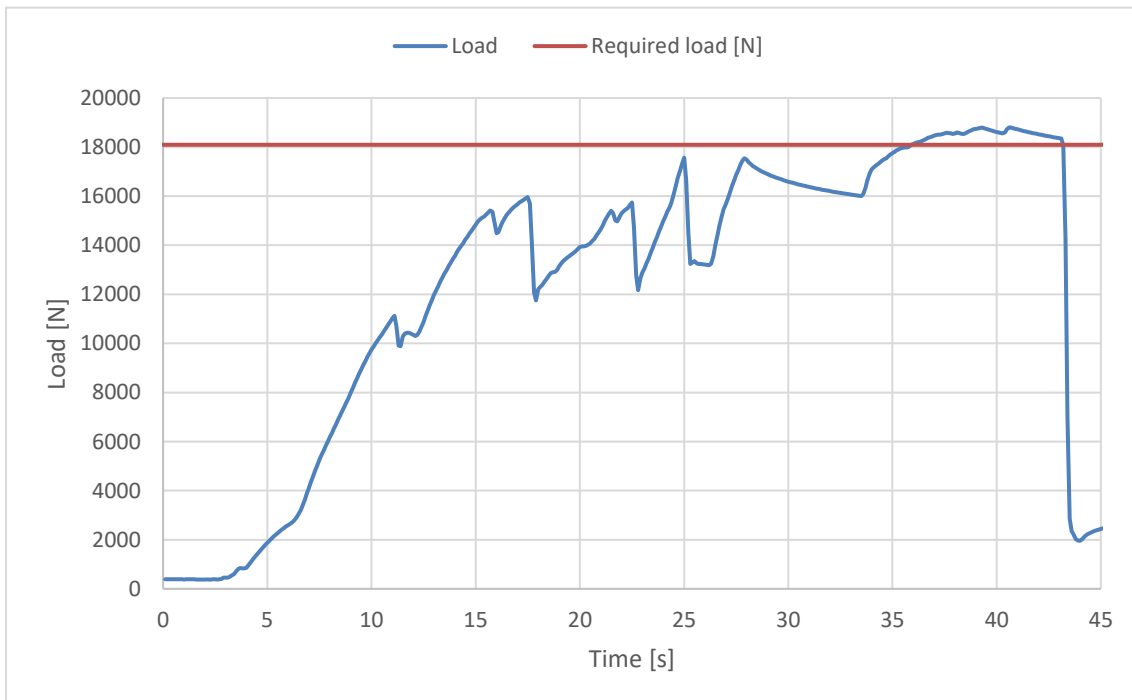
**Test ID 03**

Standard	<b>EN 1651:1999</b>
Reference	<b>5.3.2.2</b>
Test setup	<b>Default flying position</b>
Attachment points	<b>Both main riser attachment (3,4)</b>
Anchor points	<b>Dummy (B1, B2)</b>
Required load [g]	<b>15</b>
Required load [N]	<b>18000</b>
Minimum test duration [s]	<b>5</b>
<b>Result</b>	
Test duration [s]	<b>7.2</b>
Any signs of structural failure	<b>No</b>
Test results	<b>POSITIVE</b>

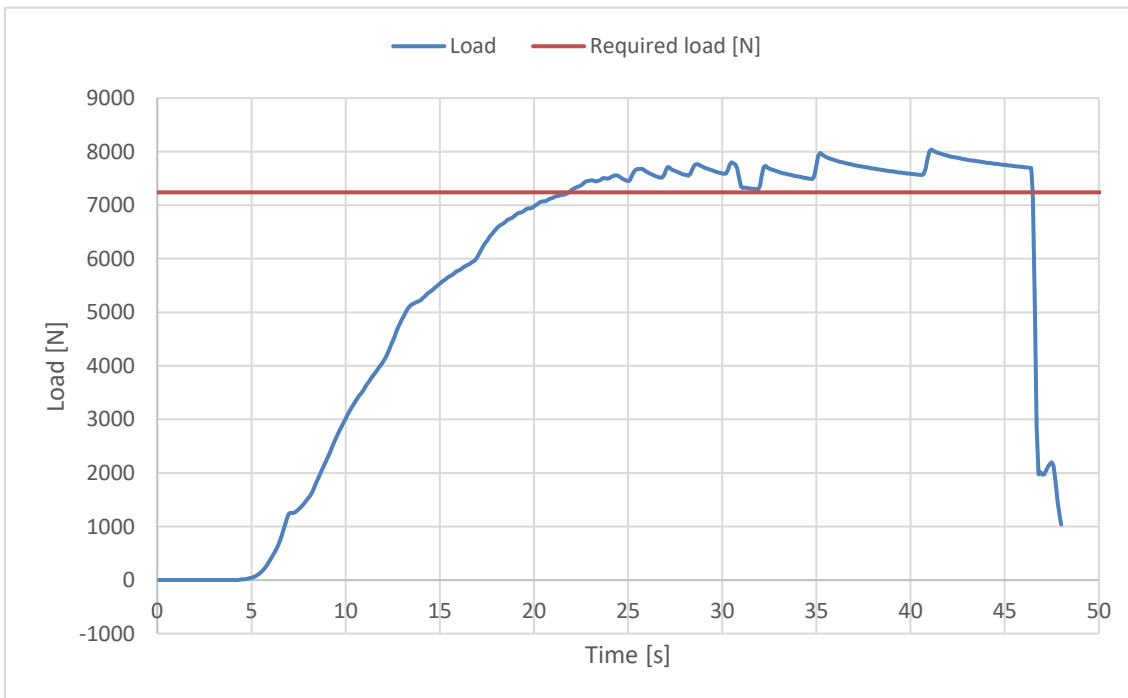
**Test ID 04**

Standard	<b>EN 1651:1999</b>
Reference	<b>5.3.2.3</b>
Test setup	<b>Asymmetric, one riser</b>
Attachment points	<b>One main riser attachment (3)</b>
Anchor points	<b>Dummy (B1,B2)</b>
Required load [g]	<b>6</b>
Required load [N]	<b>7200</b>
Minimum test duration [s]	<b>10</b>
<b>Result</b>	
Test duration [s]	<b>24.6</b>
Any signs of structural failure	<b>No</b>
Test results	<b>POSITIVE</b>

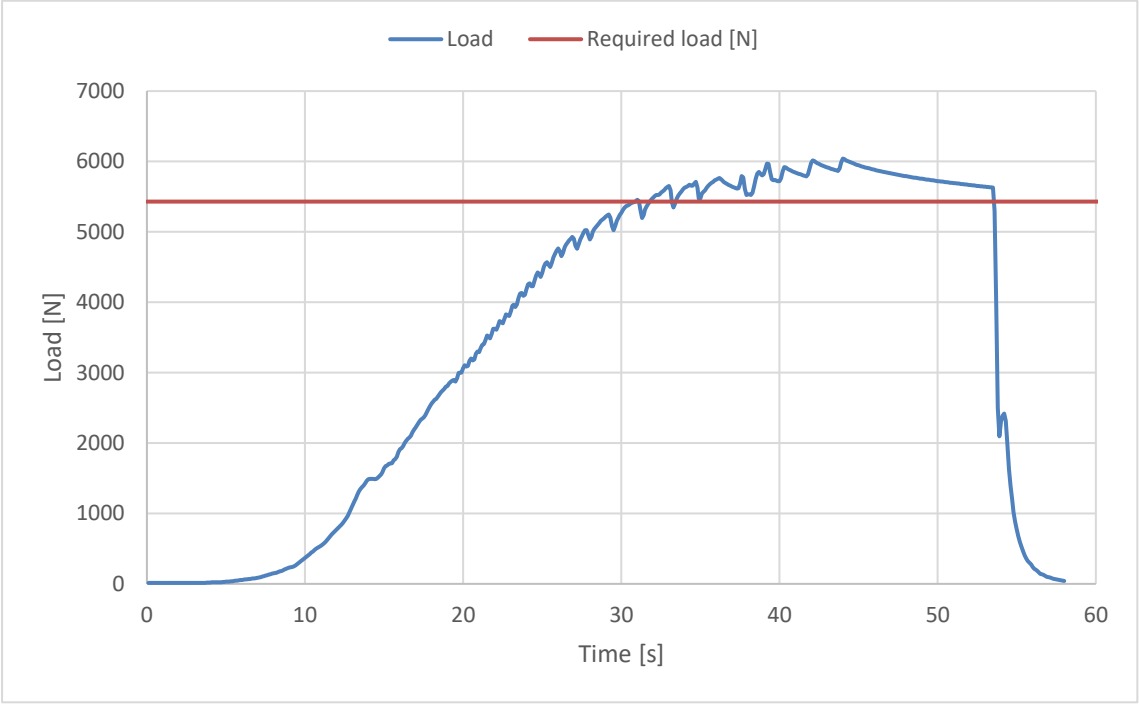
**Test ID 07**

Reference	<b>5.3.2.6</b>	
Test setup	<b>Asymmetric, negative</b>	
Attachment points	<b>One main riser attachment (3 or 4) downwards</b>	
Anchor points	<b>Dummy (9)</b>	
Required load [g]	<b>4.5</b>	
Required load [N]	<b>5400</b>	
Minimum test duration [s]	<b>10</b>	
<b>Result</b>		
Test duration [s]	<b>20.1</b>	
Any signs of structural failure	<b>No</b>	
Test results	<b>POSITIVE</b>

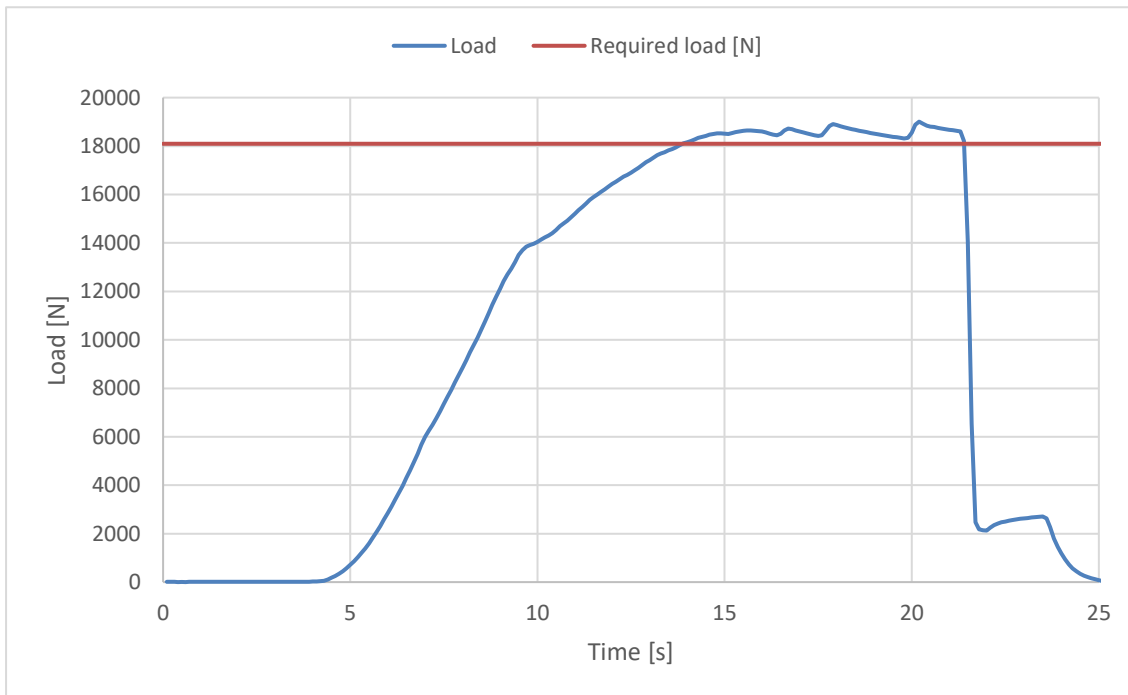
**Test ID 13**

Standard **EN 1651:1999**  
 Reference **5.3.2.7**  
 Test setup **Flying position before landing**  
 Attachment points **Both main riser attachment (3,4)**  
 Anchor points **Dummy (7,8)**

Test duration [s] **7.6**  
 Any signs of structural failure **No**  
 Test results **POSITIVE**
