Harness Structural test Report

Inspection certificate number: **PH_259.2019**
Manufacturer data:

Name: **Lightness 3 XALPS 19**
 Type: **ABS**
 Size: **M**
 Serial number: **1150722**
 Impact pad type: ⁽¹⁾ **Foam**
 Clip-in weight [kg]: **100**

Summary of Structural test

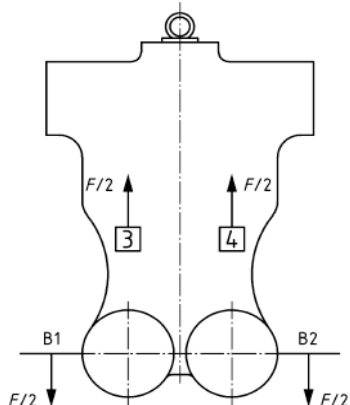
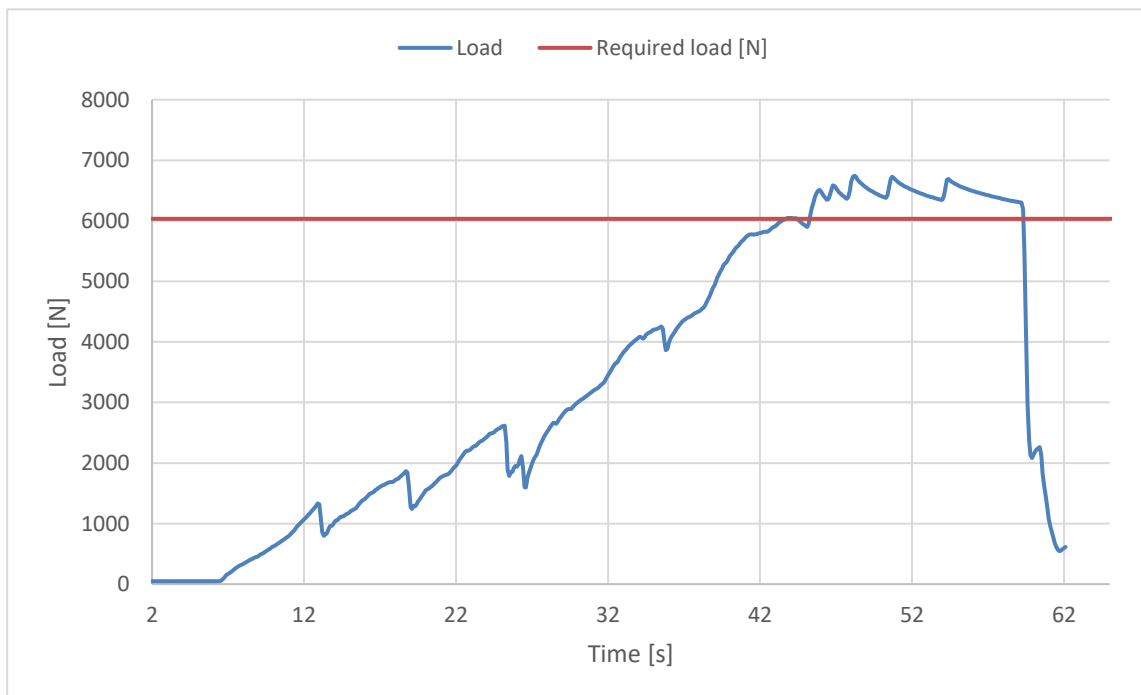
Test ID R0

Reference in standard	5.3.2.1	
Test setup	Default flying position	
Attachment points	Both main riser attachment (3,4)	
Anchor points	Dummy (B1, B2)	
Required load [g]	6	
Required load [N]	6000	
Minimum test duration [s]	10	
Result		
Test duration [s]	14.1	
Any signs of structural failure	No	
Test results	POSITIVE

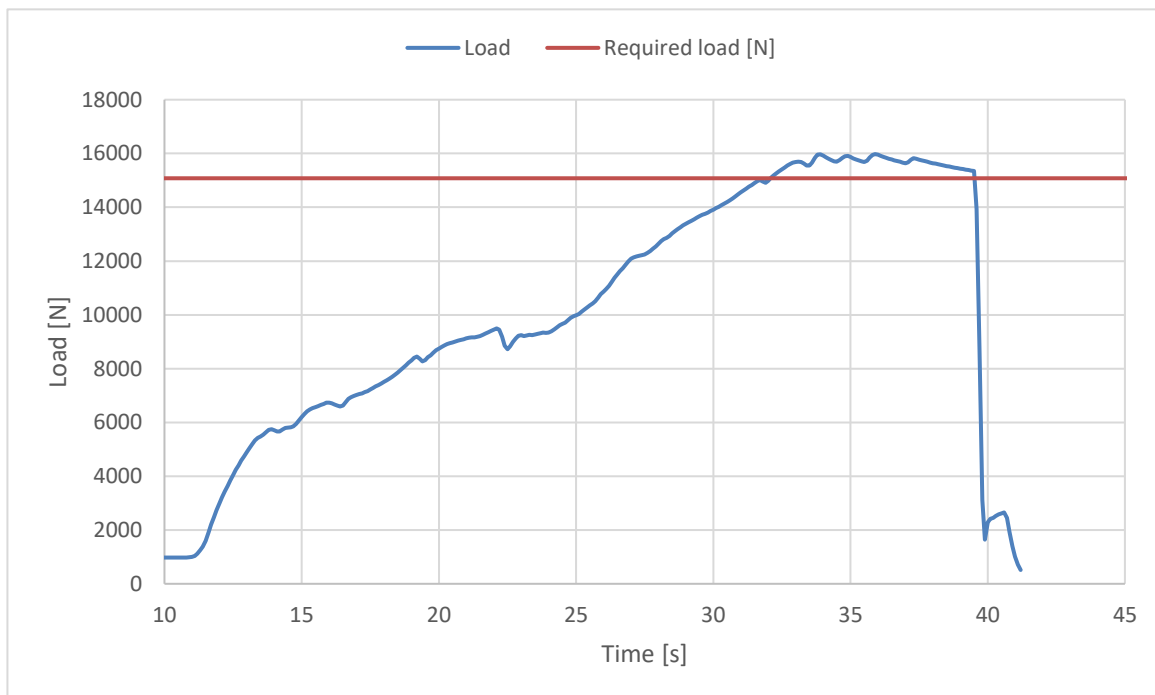
Test ID R2

Standard	EN 1651:1999
Reference in standard	5.3.2.2
Test setup	Default flying position
Attachment points	Both main riser attachment (3,4)
Anchor points	Dummy (B1, B2)
Required load [g]	15
Required load [N]	15000
Minimum test duration [s]	5
Result	
Test duration [s]	7.5
Any signs of structural failure	No
Test results	POSITIVE

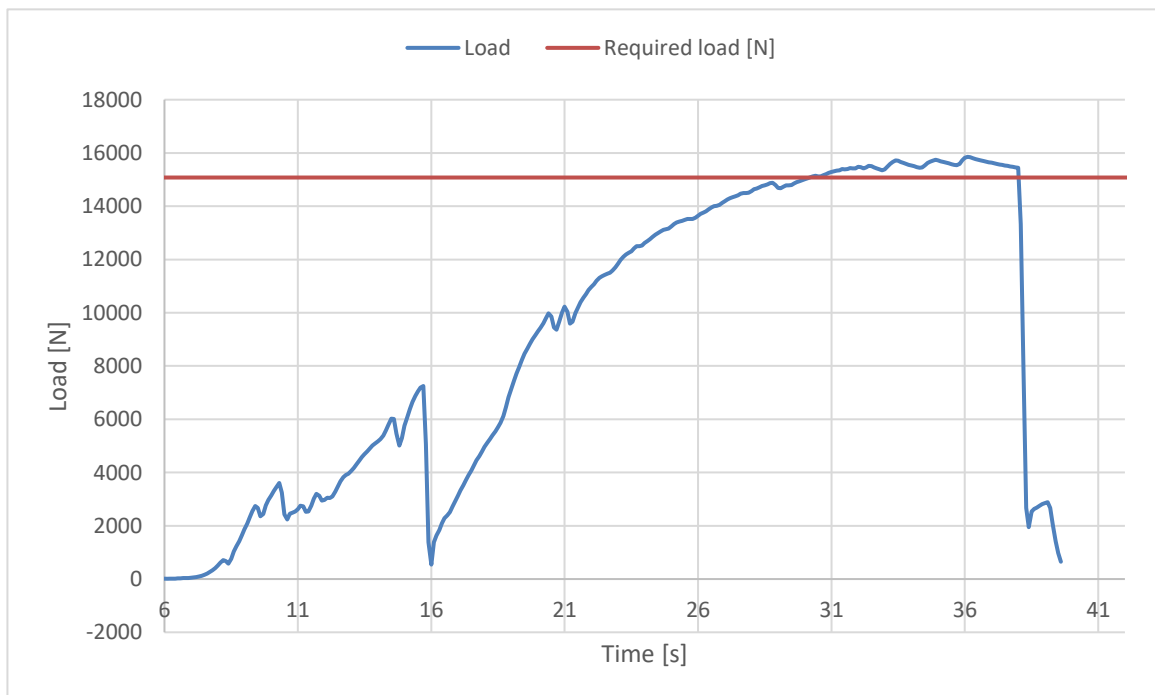
Test ID R4

Standard	EN 1651:1999
Reference in standard	5.3.2.7
Test setup	Flying position before landing
Attachment points	Both main riser attachment (3,4)
Anchor points	Dummy (7,8)
Required load [g]	15
Required load [N]	15000
Minimum test duration [s]	5
Result	
Test duration [s]	7.9
Any signs of structural failure	No
Test results	POSITIVE

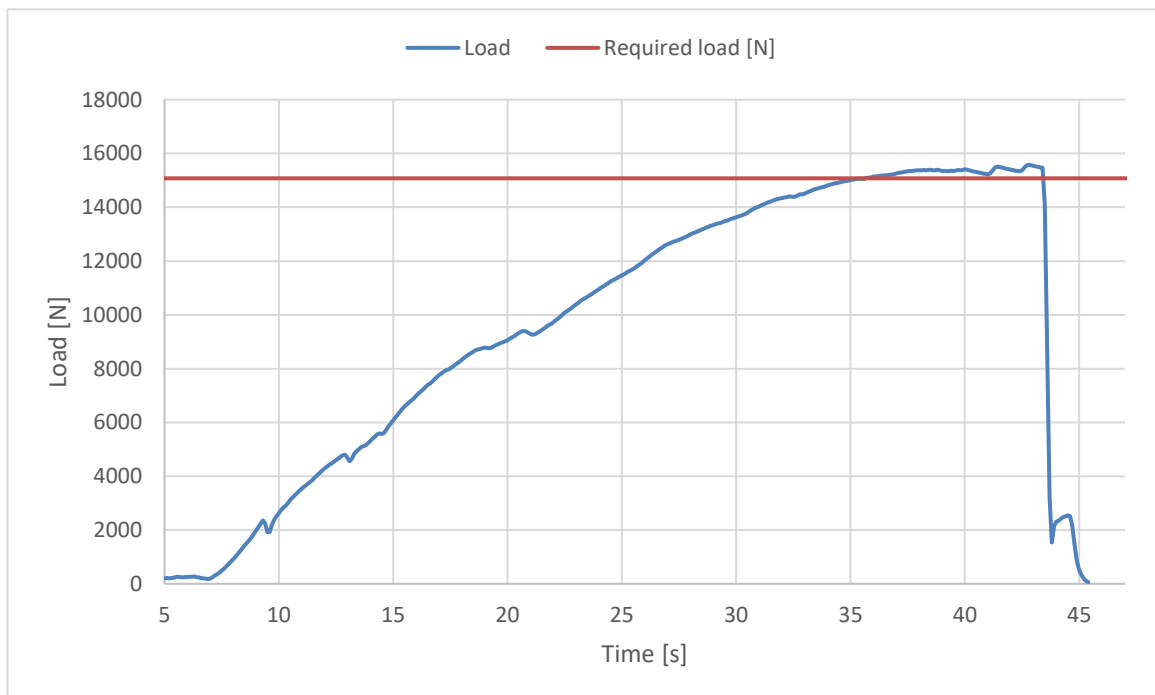
Test ID R6

Standard	EN 1651:1999
Reference in standard	5.3.2.4
Test setup	Rescue attachments
Attachment points	Rescue riser attachment (1,2)
Anchor points	Dummy (B1,B2)
Required load [g]	15
Required load [N]	15000
Minimum test duration [s]	5
Result	
Test duration [s]	7.8
Any signs of structural failure	No
Test results	POSITIVE

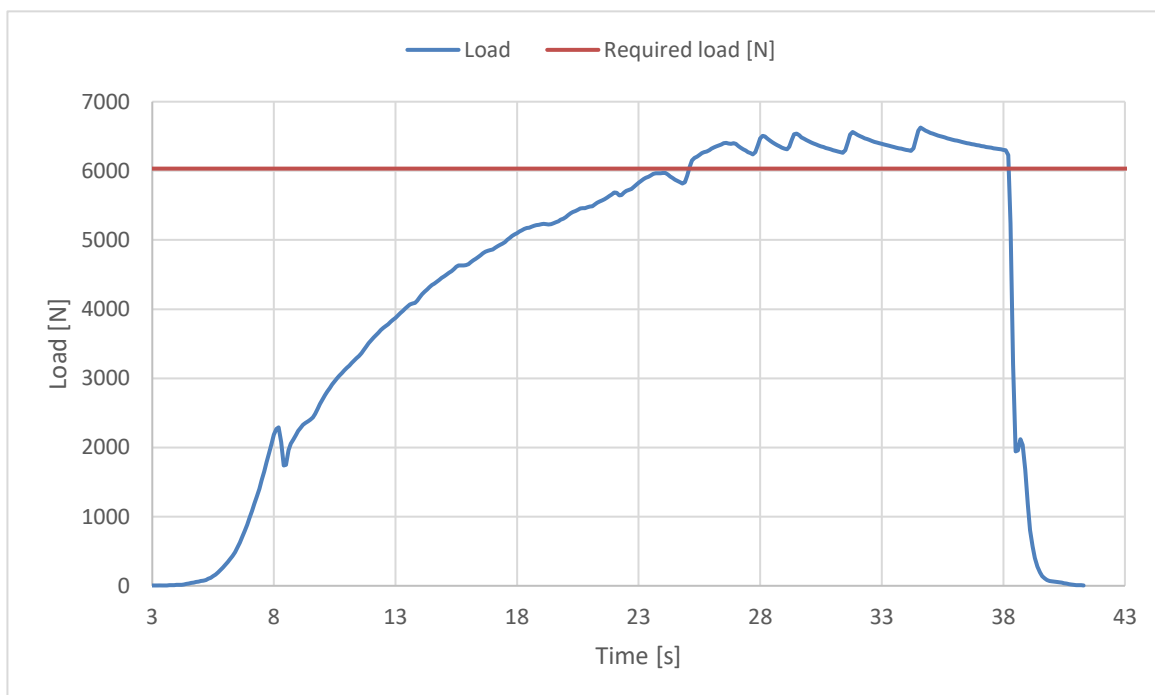
Test ID R8

Standard	EN 1651:1999
Reference in standard	5.3.2.3
Test setup	Asymmetric, one riser
Attachment points	One main riser attachment (3)
Anchor points	Dummy (B1,B2)
Required load [g]	6
Required load [N]	6000
Minimum test duration [s]	10
Result	
Test duration [s]	13.2
Any signs of structural failure	No
Test results	POSITIVE

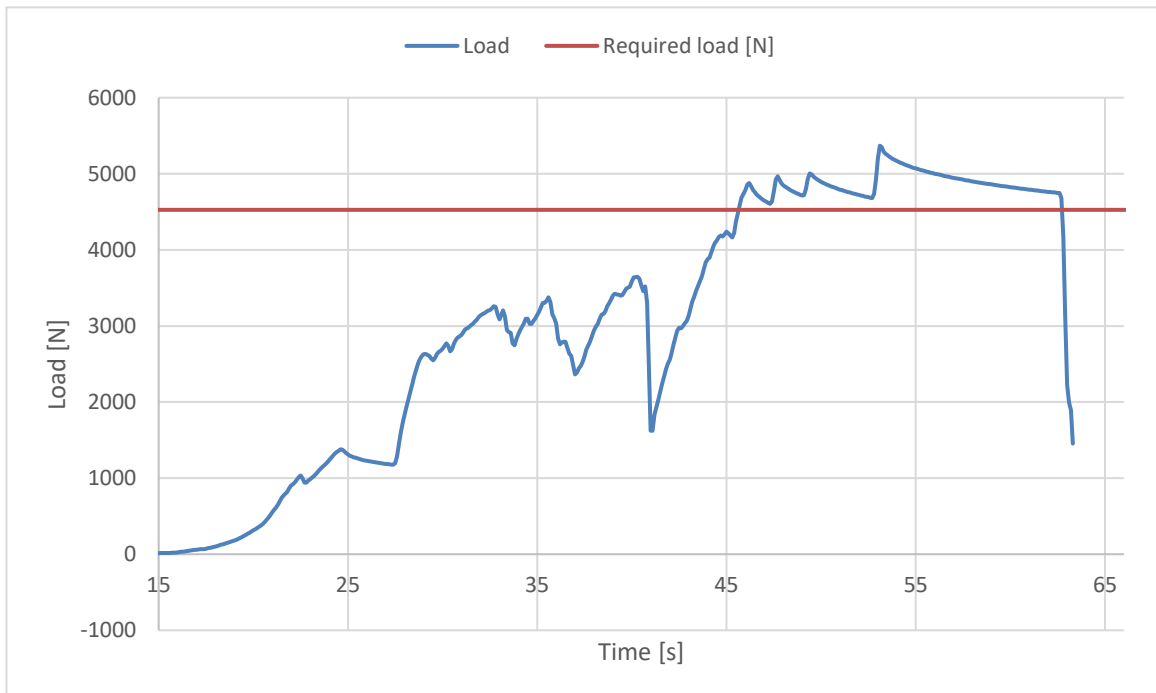
Test ID R10

Reference in standard	5.3.2.6	
Test setup	Asymmetric, negative	
Attachment points	One main riser attachment (3 or 4) downwards	
Anchor points	Dummy (9)	
Required load [g]	4.5	
Required load [N]	4500	
Minimum test duration [s]	10	
Result		
Test duration [s]	17.1	
Any signs of structural failure	No	
Test results	POSITIVE

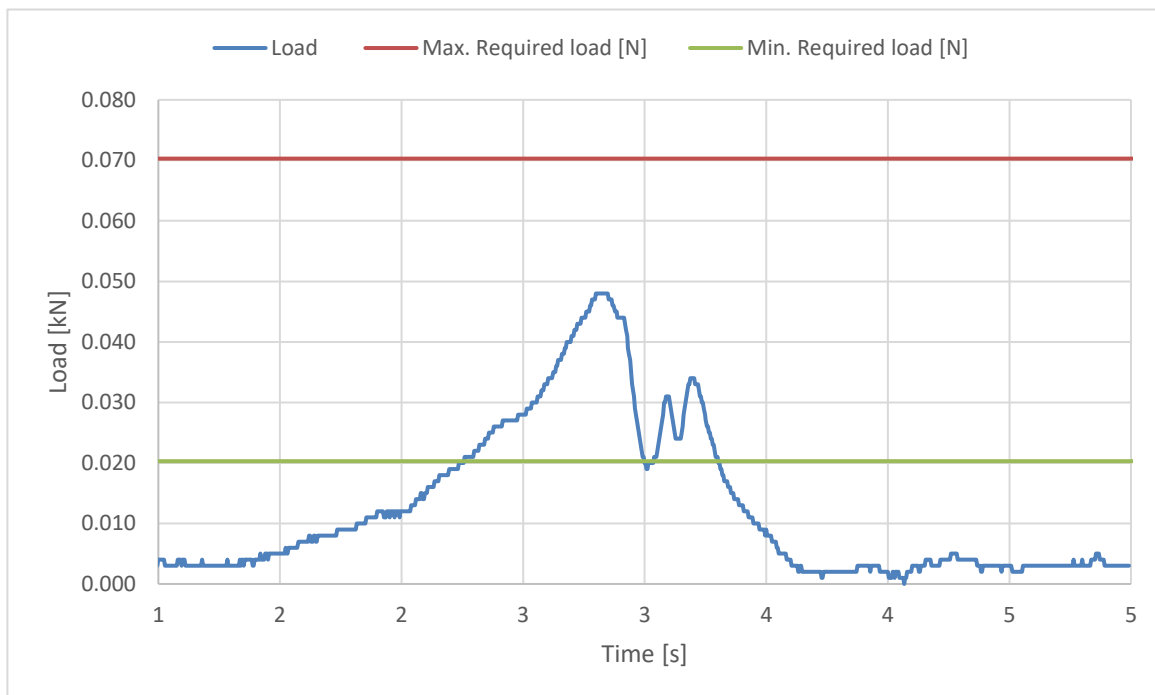
Test ID RRDT

Standard	LTF NfL II 91/09
Reference in standard	6.1.5
Test setup	Default flying position
Attachment points	Sensor connect to handle, and pull in opening direction
	The test is to simulate the load required to open the emergency parachute(1st action).
Min. Required load [N]	20
Max. Required load [N]	70
Result	
Load for first action [N]	47.71
Test results	POSITIVE

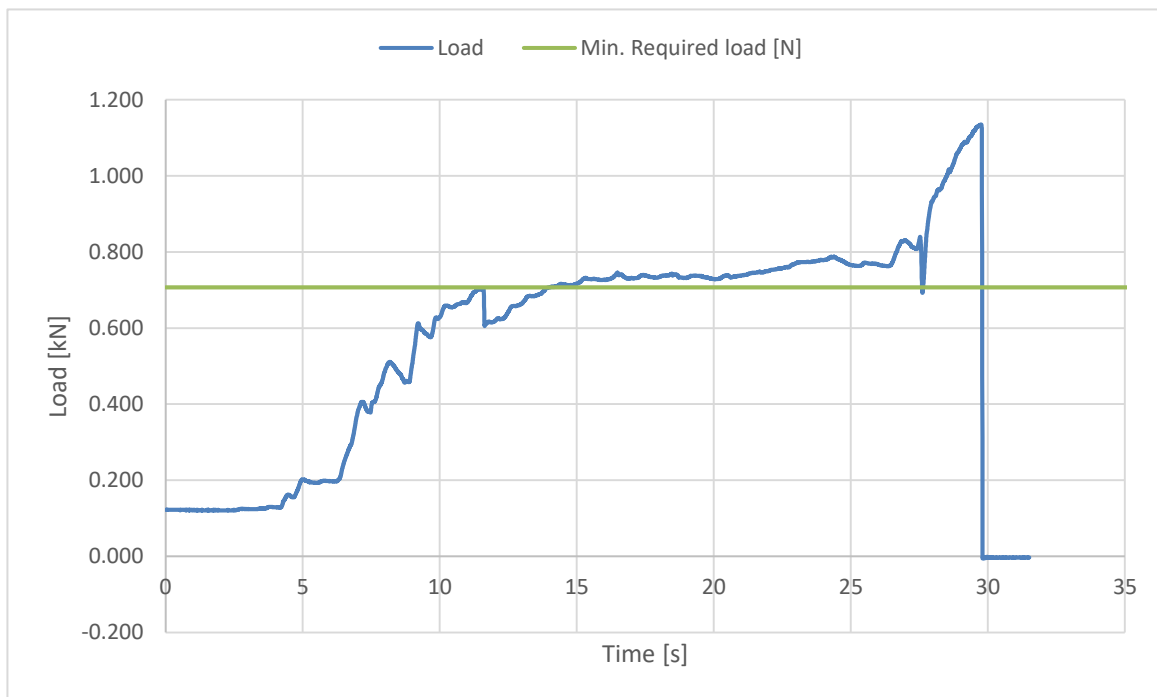
Test ID RRST

Standard	EN12491:2015
Reference in standard	5.3.2
Test setup	Two end points of handle
Attachment points	Sensor connect to end of handle, pull on the other side
	The handle must support min 700 N for 10 s, after measure breaking strength
Min. Required load [N]	700
Minimum test duration [s]	10
Result	
Test duration [s]:	13.5
Breaking strength [N]	1128.18
Test results	POSITIVE
