Harness Structural test Report - EN

Inspection certificate number: **PH_321.2020**
Manufacturer data:

Name: **Lightness 3 Xalps 21**
 Type: **ABS**
 Size: **M**
 Serial number: **116040**
 Impact pad type: ⁽¹⁾ **Koroyd**
 Clip-in weight [kg]: **120**

model: **Lightness 3 Xalps 21**

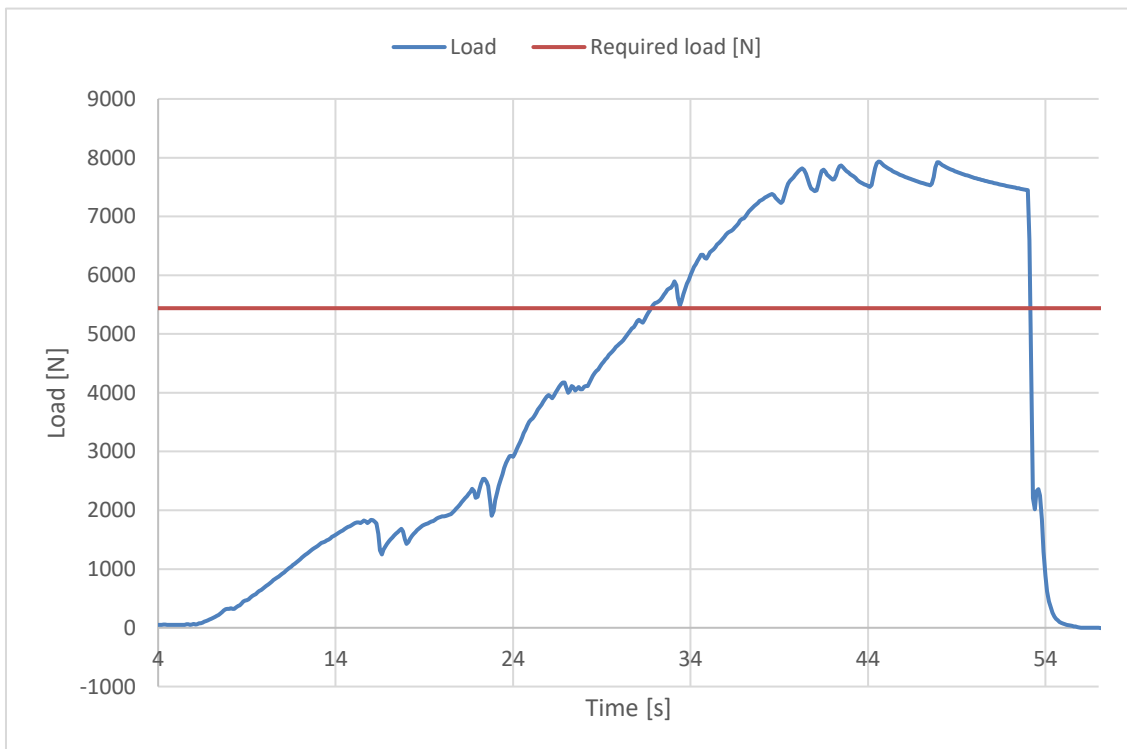
Test ID 01

Standard **EN 1651**
 Reference in standard **5.5.1.1**
 Test setup **Positive symmetric load (Slippage)**
 Attachment points **Both main riser attachment (3,4)**
 Anchor points **Dummy (B1, B2)**

Test duration [s] **21.4**
 Any signs of structural failure **No**
 Slippery test OK **Yes**
 Test results **POSITIVE**

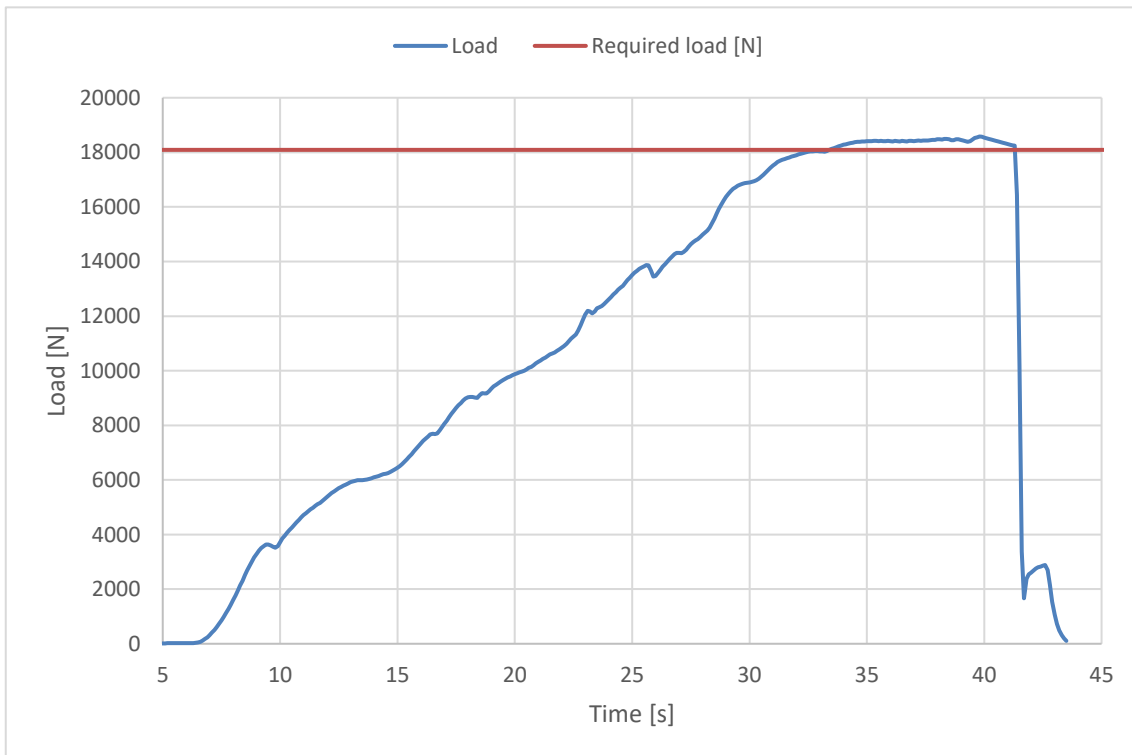
Test ID 03

Standard	EN 1651
Reference in standard	5.5.1.1b
Test setup	Positive symmetric load
Attachment points	Both main riser attachment (3,4)
Anchor points	Dummy (B1, B2)
Required load [g]	15
Required load [N]	18000
Minimum test duration [s]	5
Result	
Test duration [s]	7.9
Any signs of structural failure	No
Slippery test OK	Yes
Test results	POSITIVE

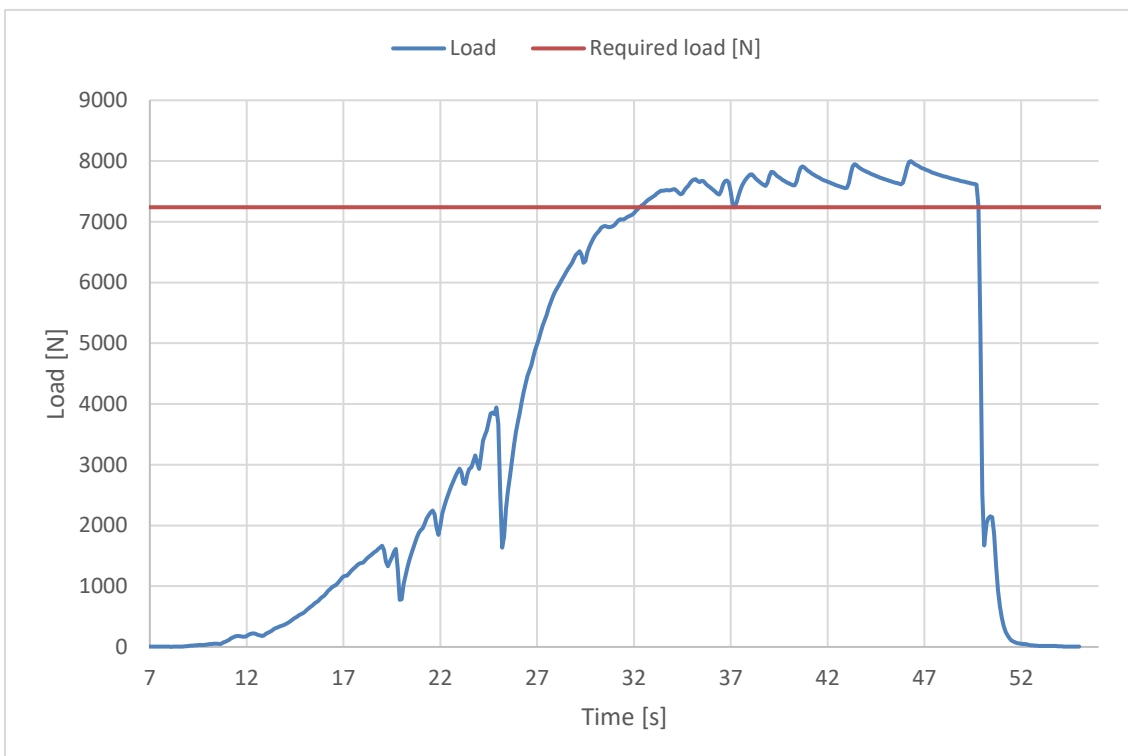
Test ID 05

Standard	EN 1651
Reference in standard	5.5.1.2
Test setup	Positive asymmetric load
Attachment points	One riser attachment (3 or 4)
Anchor points	Dummy (C)
Required load [g]	6
Required load [N]	7200
Minimum test duration [s]	5
Result	
Test duration [s]	12.6
Any signs of structural failure	No
Test results	POSITIVE

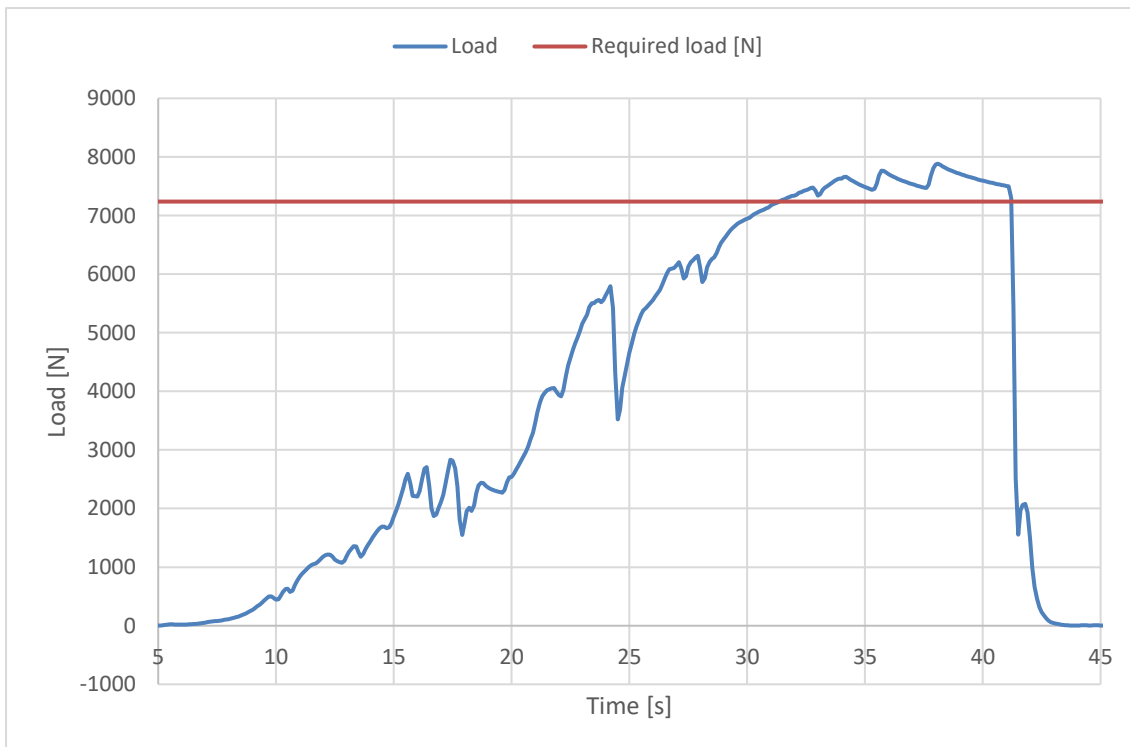
Test ID 06

Standard	EN 1651
Reference in standard	5.5.1.6
Test setup	Negative symmetric load
Attachment points	Both main riser attachment (3,4)
Anchor points	Dummy (A)
Required load [g]	6
Required load [N]	7200
Minimum test duration [s]	5
Result	
Test duration [s]	9.9
Any signs of structural failure	No
Test results	POSITIVE

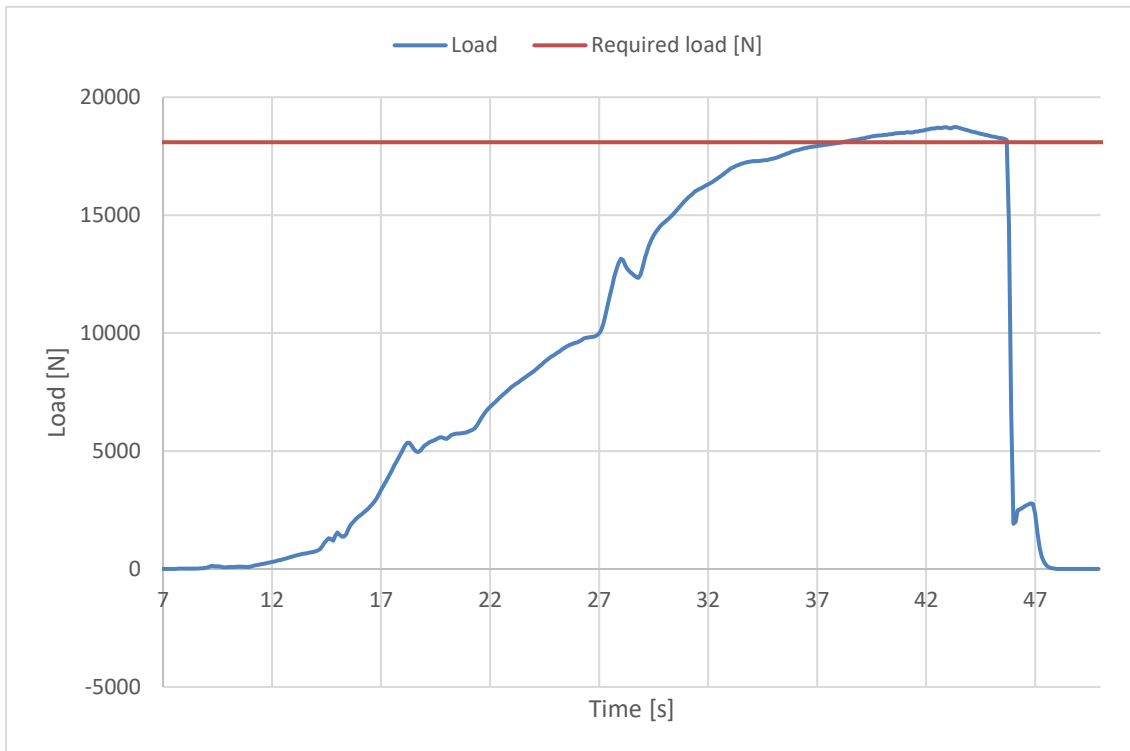
Test ID 09

Standard	EN 1651
Reference in standard	5.5.1.3
Test setup	Positive symmetric load rescue points
Attachment points	Both main riser attachment (1,2)
Anchor points	Dummy (B1,B2)
Required load [g]	15
Required load [N]	18000
Minimum test duration [s]	5
Result	
Test duration [s]	7.6
Any signs of structural failure	No
Slippery test OK	Yes
Test results	POSITIVE

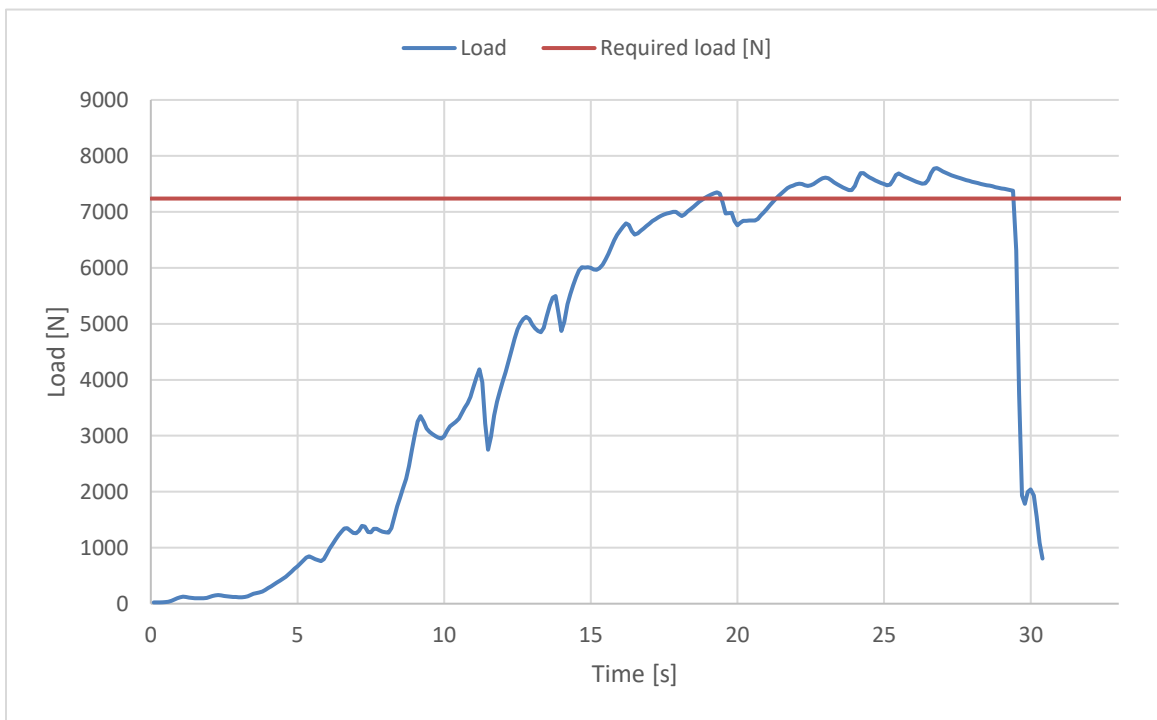
Test ID 12

Standard	EN 1651
Reference in standard	5.5.1.7
Test setup	Upright (landing) position load
Attachment points	Both main riser attachment (3, 4)
Anchor points	Both legstrap of harness (no dummy)
Required load [g]	6
Required load [N]	7200
Minimum test duration [s]	5
Harness type	type b
Result	
Test duration [s]	8.1
Any signs of structural failure	No
Slippery test OK	No
Test results	POSITIVE

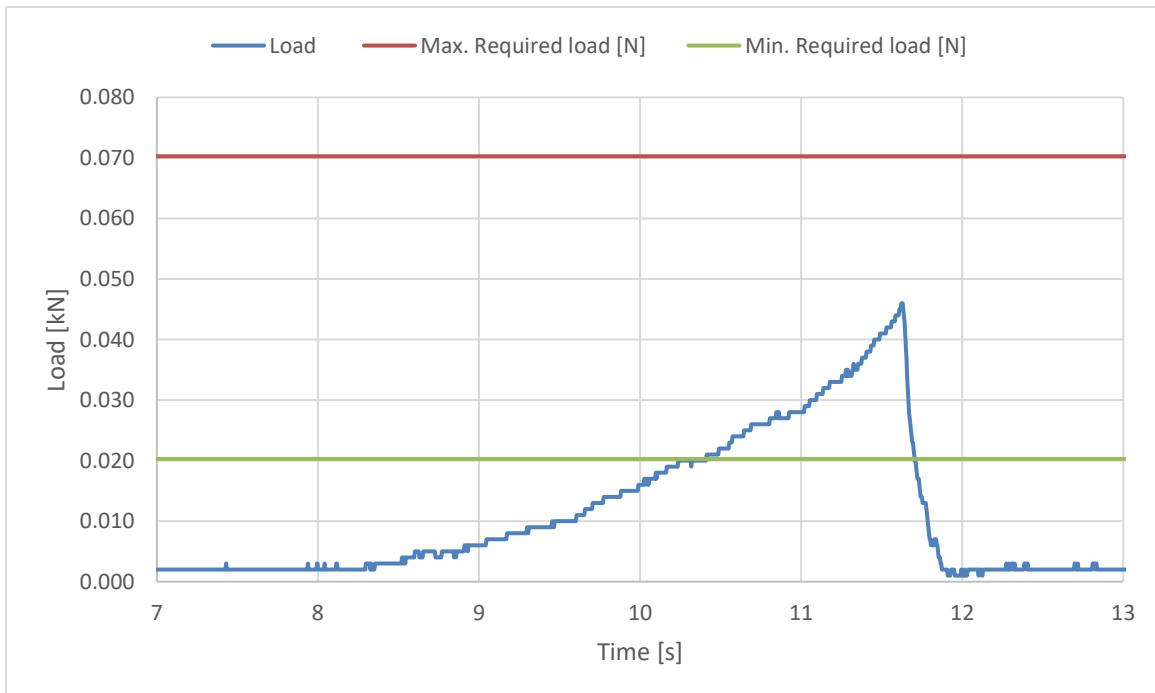
Test ID RRDT

Standard	LTF NfL II 91/09
Reference in standard	6.1.5
Test setup	Default flying position
Attachment points	Sensor connect to handle, and pull in opening direction
	The test is to simulate the load required to open the emergency parachute(1st action).
Min. Required load [N]	20
Max. Required load [N]	70
Result	
Load for first action [N]	45.72
Test results	POSITIVE

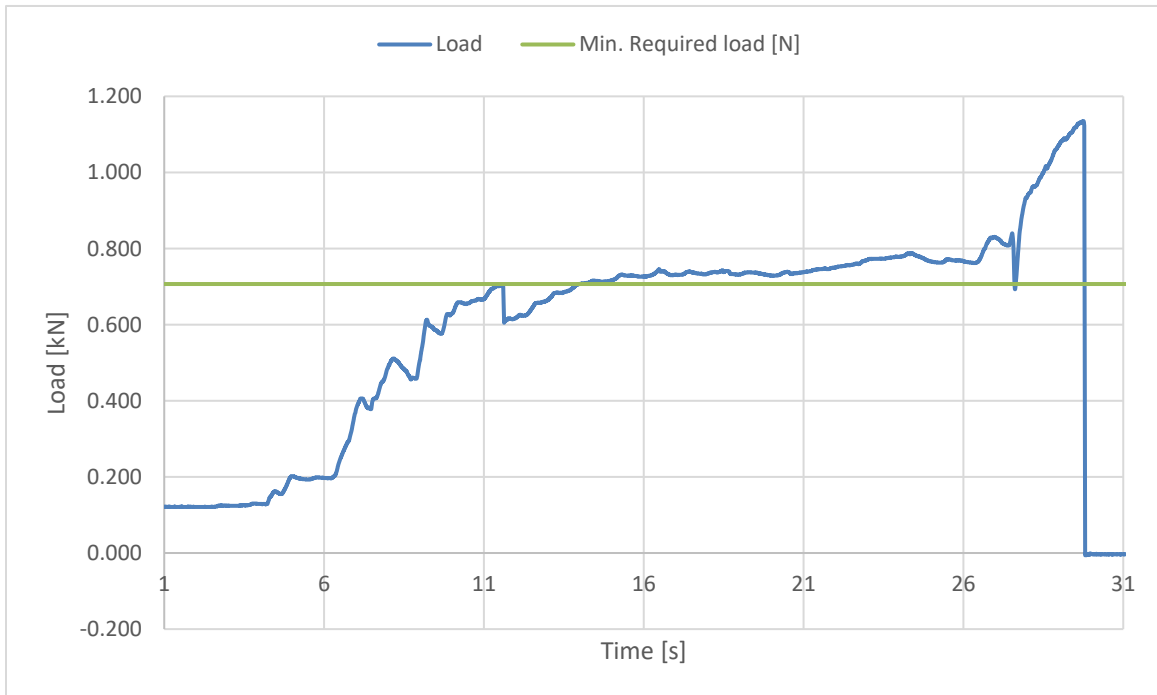
Test ID RRST

Standard	EN12491:2015
Reference in standard	5.3.2
Test setup	Two end points of handle
Attachment points	Sensor connect to end of handle, pull on the other side
	The handle must support min 700 N for 10 s, after measure breaking strength
Min. Required load [N]	700
Minimum test duration [s]	10
Result	
Test duration [s]:	13.5
Breaking strength [N]	1128.18
Test results	POSITIVE
