Harness Structural test Report - LTF

Inspection certificate number: **PH_321.2020**

Name: **Lightness 3 Xalps 21**
 Type: **ABS**
 Size: **M**
 Serial number: **116040**
 Impact pad type: ⁽¹⁾ **Koroyd**
 Clip-in weight [kg]: **120**

Date of test: **02.10.2020**

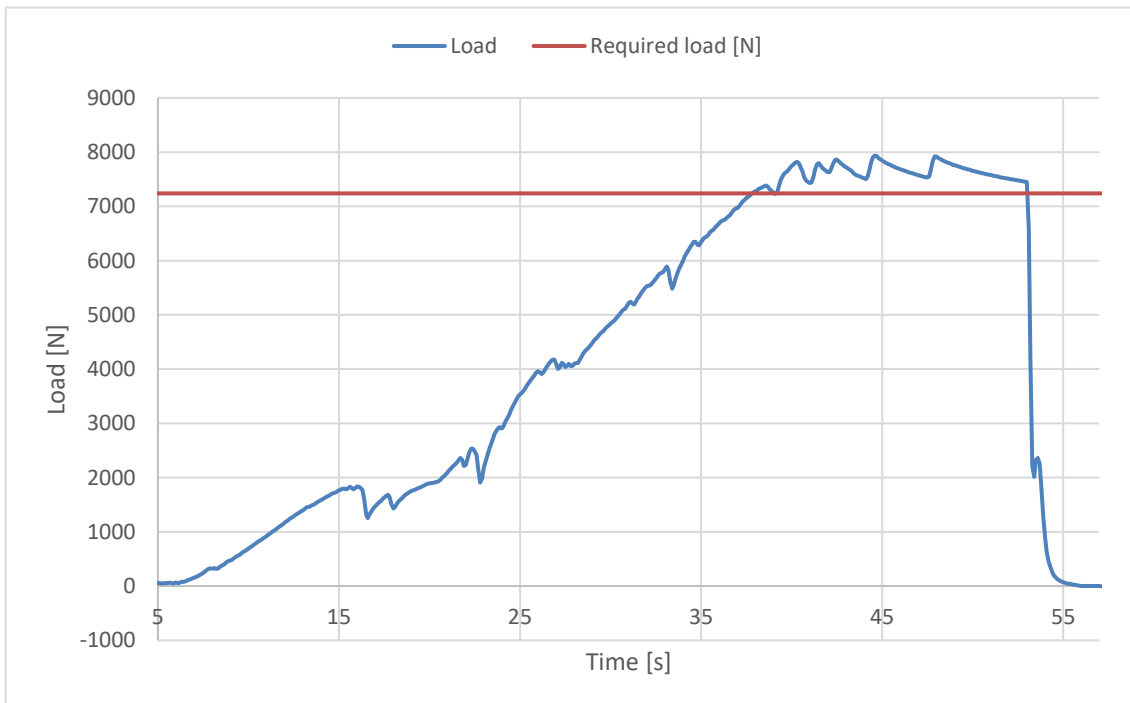
Test ID 02

Standard	LTF NfL II 91/09
Reference	5.3.2.1
Test setup	Default flying position
Attachment points	Both main riser attachment (3,4)
Anchor points	Dummy (B1, B2)
Required load [g]	6
Required load [N]	7200
Minimum test duration [s]	10
Result	
Test duration [s]	13.9
Any signs of structural failure	No
Test results	POSITIVE

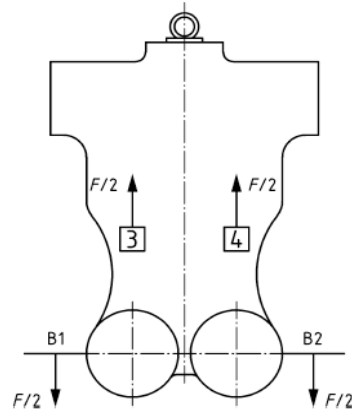
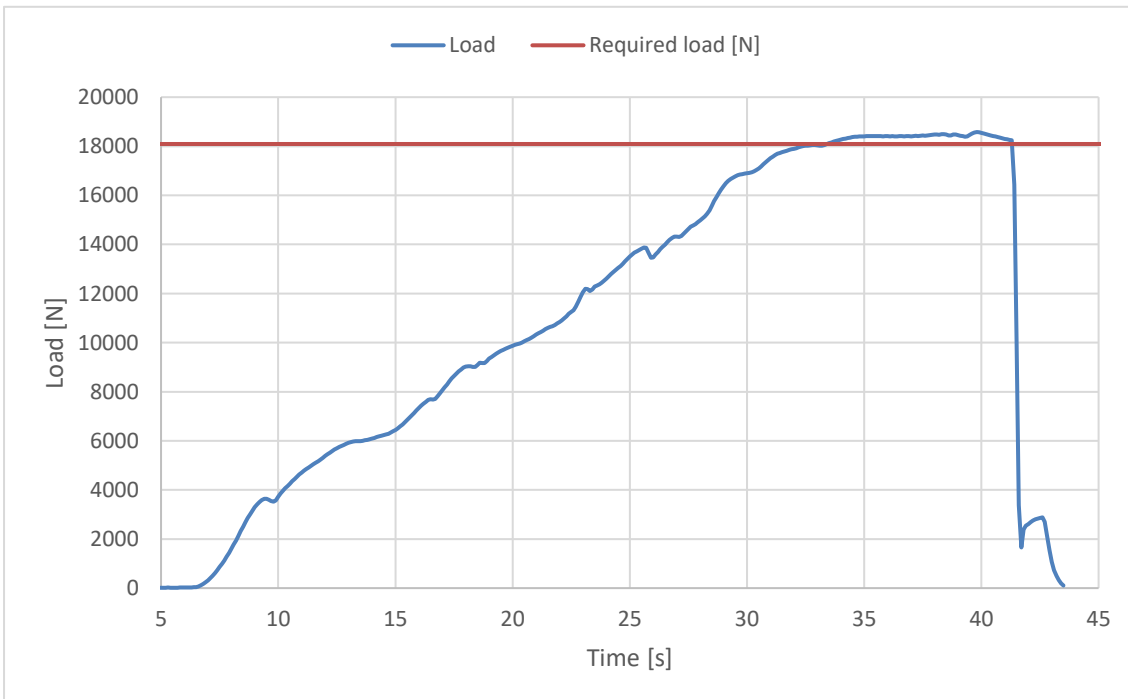
Test ID 03

Standard **LTF NfL II 91/09**
 Reference **5.3.2.2**
 Test setup **Default flying position**
 Attachment points **Both main riser attachment (3,4)**
 Anchor points **Dummy (B1, B2)**

Test duration [s] **7.9**
 Any signs of structural failure **No**
 Test results **POSITIVE**

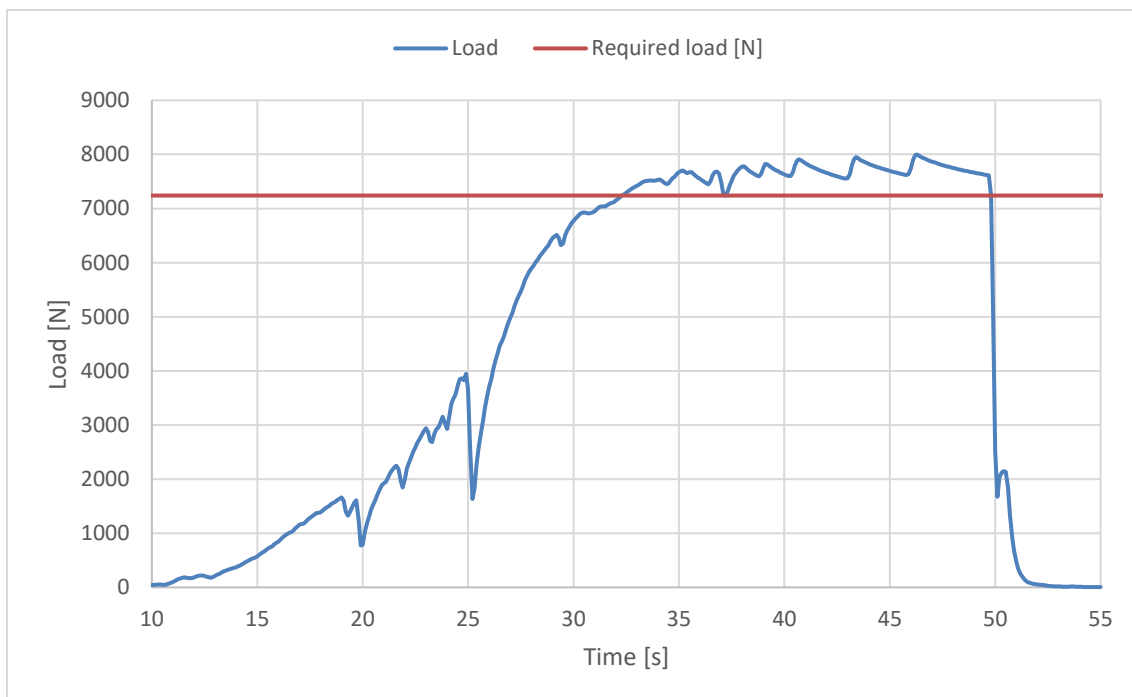
Test ID 04

Standard	LTF NfL II 91/09
Reference	5.3.2.3
Test setup	Asymmetric, one riser
Attachment points	One main riser attachment (3)
Anchor points	Dummy (B1,B2)
Required load [g]	6
Required load [N]	7200
Minimum test duration [s]	10
Result	
Test duration [s]	12.6
Any signs of structural failure	No
Test results	POSITIVE

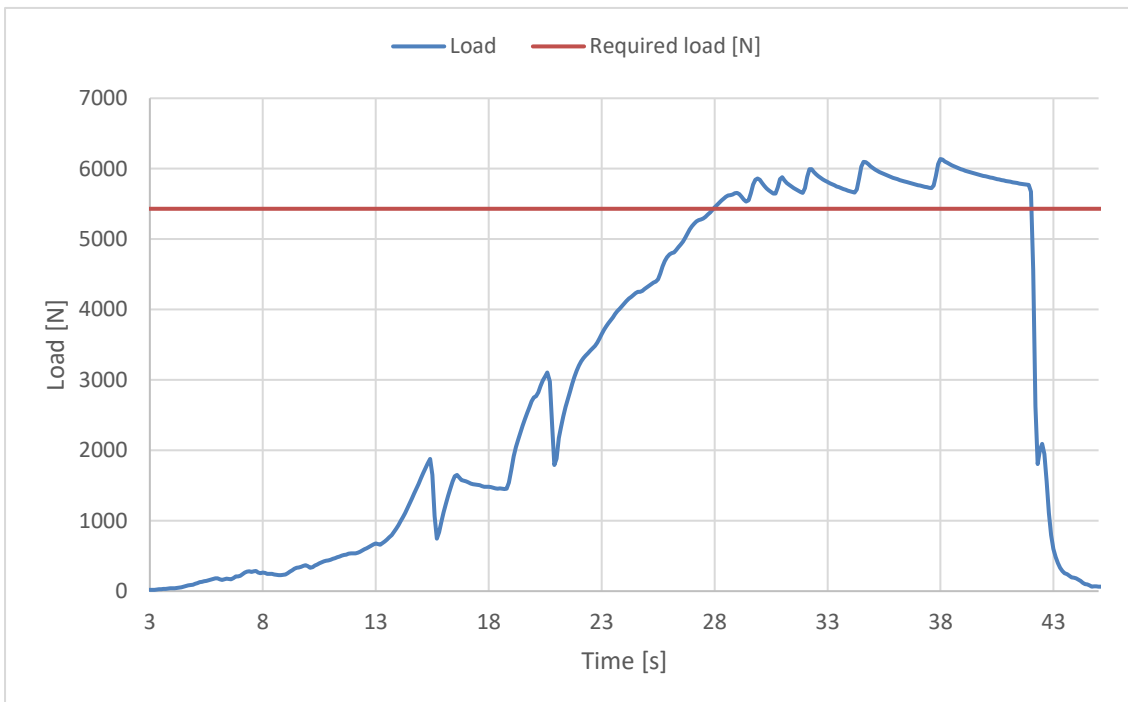
Test ID 07

Reference	5.3.2.6	
Test setup	Asymmetric, negative	
Attachment points	One main riser attachment (3 or 4) downwards	
Anchor points	Dummy (9)	
Required load [g]	4.5	
Required load [N]	5400	
Minimum test duration [s]	10	
Result		
Test duration [s]	14.1	
Any signs of structural failure	No	
Test results	POSITIVE

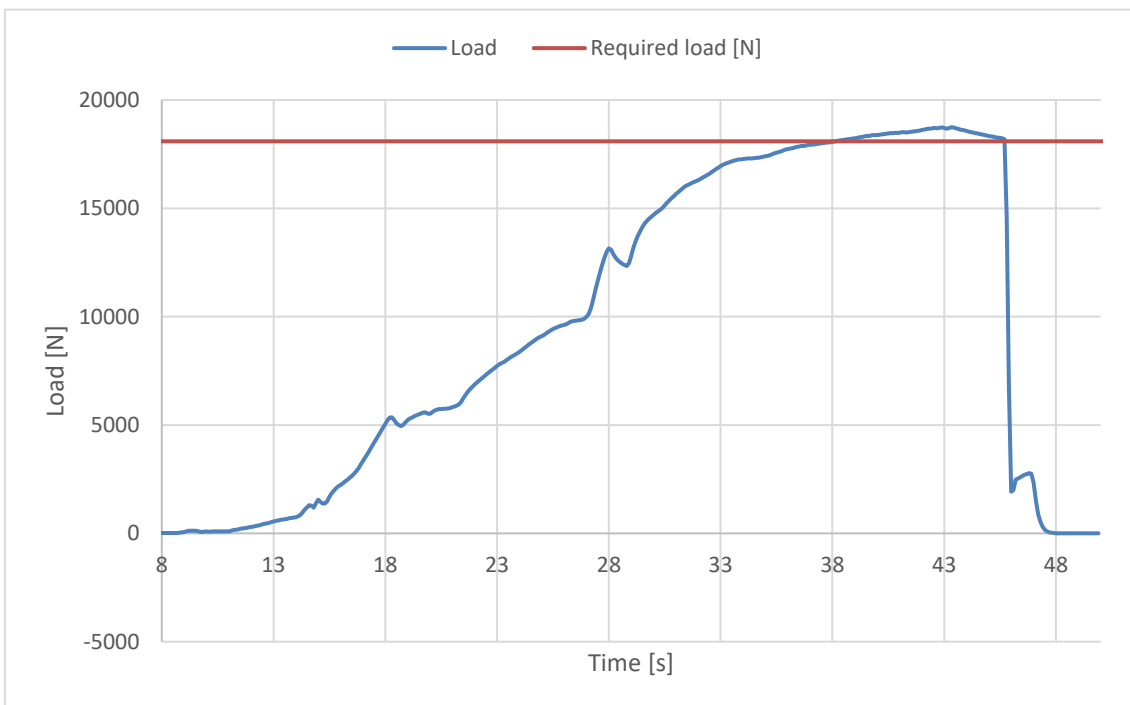
Test ID 09

Standard	LTF NfL II 91/09
Reference	5.3.2.4
Test setup	Rescue attachments
Attachment points	Rescue riser attachment (1,2)
Anchor points	Dummy (B1,B2)
Required load [g]	15
Required load [N]	18000
Minimum test duration [s]	5
Result	
Test duration [s]	7.6
Any signs of structural failure	No
Test results	POSITIVE

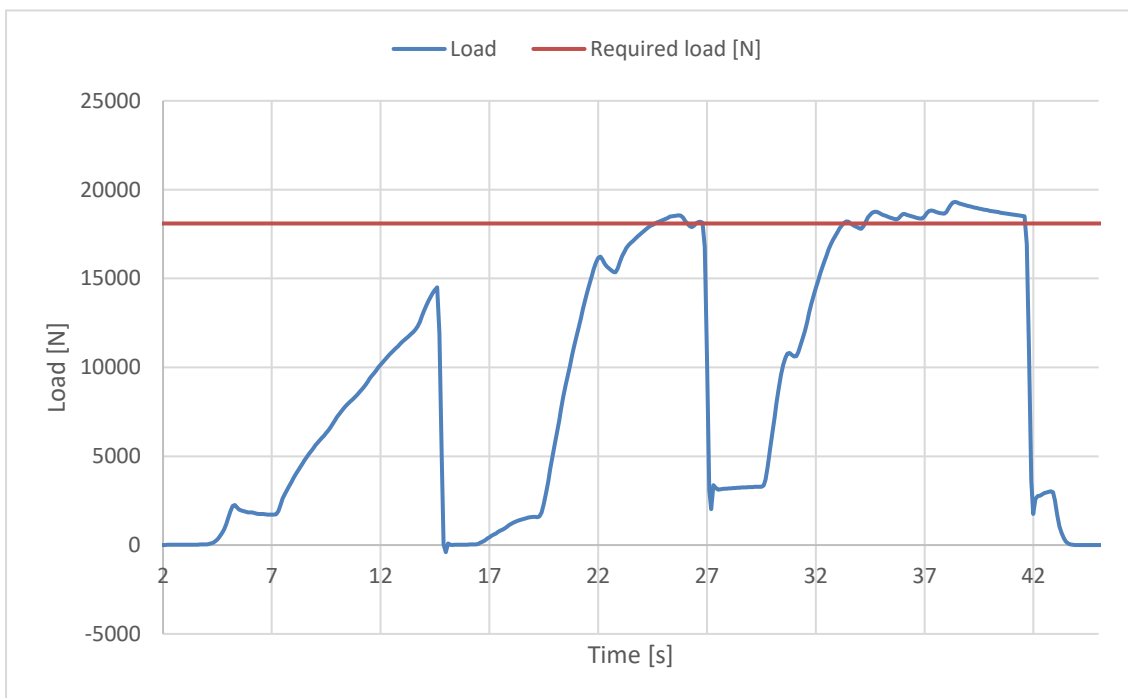
Test ID 13

Standard **LTF NfL II 91/09**
 Reference **5.3.2.7**
 Test setup **Flying position before landing**
 Attachment points **Both main riser attachment (3,4)**
 Anchor points **Dummy (7,8)**

Test duration [s] **7.4**
 Any signs of structural failure **No**
 Test results **POSITIVE**

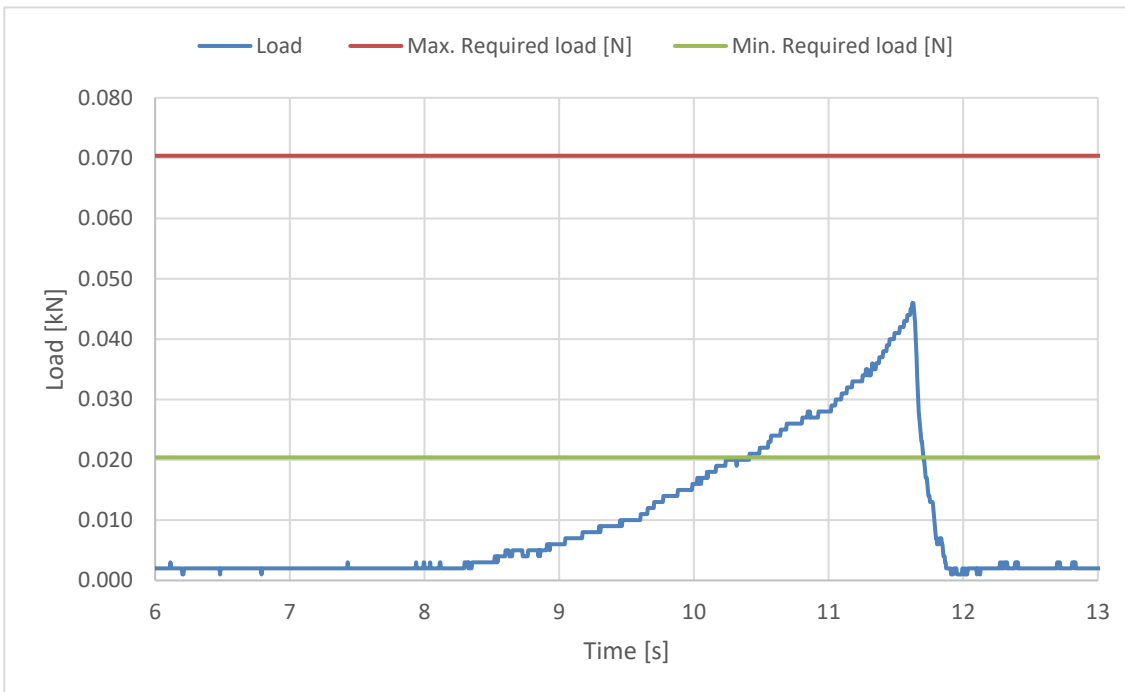
Test ID RRDT

Standard	LTF NfL II 91/09
Reference	6.1.5
Test setup	Default flying position
Attachment points	Sensor connect to handle, and pull in opening direction
	The test is to simulate the load required to open the emergency parachute(1st action).
Min. Required load [N]	20
Max. Required load [N]	70
Result	
Load for first action [N]	45.60
Test results	POSITIVE

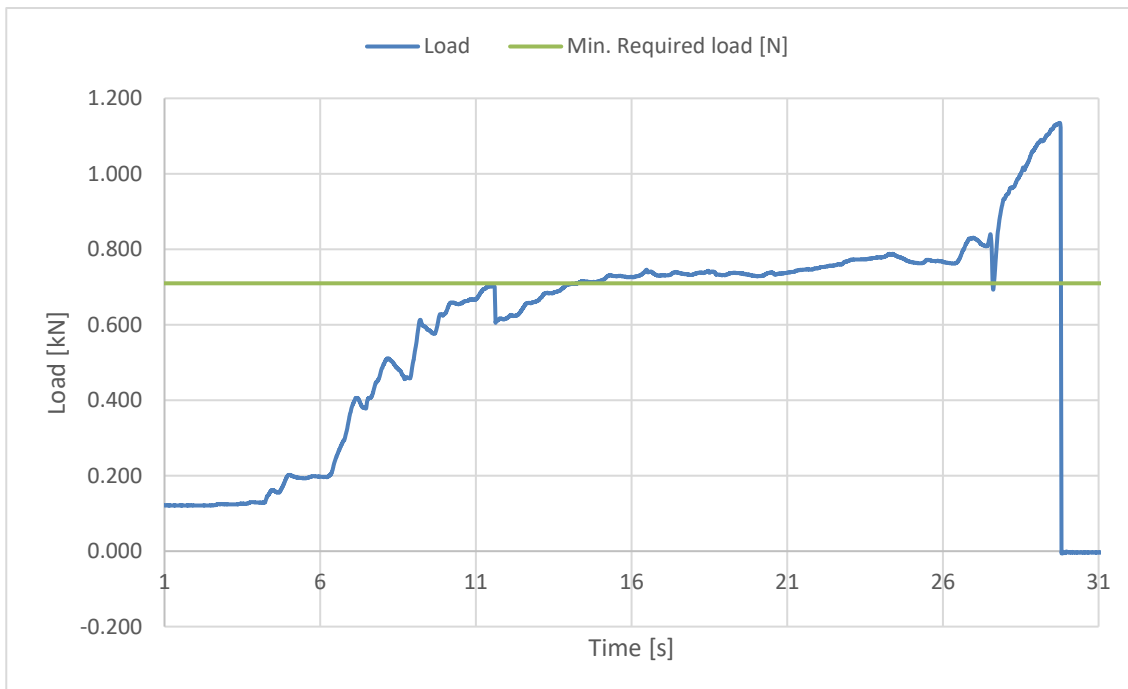
Test ID RRST

Standard	EN12491:2015
Reference in standard	5.3.2
Test setup	Two end points of handle
Attachment points	Sensor connect to end of handle, pull on the other side
	The handle must support min 700 N for 10 s, after measure breaking strength
Min. Required load [N]	700
Minimum test duration [s]	10
Result	
Test duration [s]:	13.3
Breaking strength [N]	1125.16
Test results	POSITIVE
