# Harness Structural test Report

Inspection certificate number: **PH\_231.2018**
**Manufacturer data:**

Name: **Lightness 3**  
 Type: **ABS**  
 Size: **M**  
 Serial number: **1145939**  
 Impact pad type: <sup>(1)</sup> **Foam**  
 Clip-in weight [kg]: **120**

**Summary of Structural test**

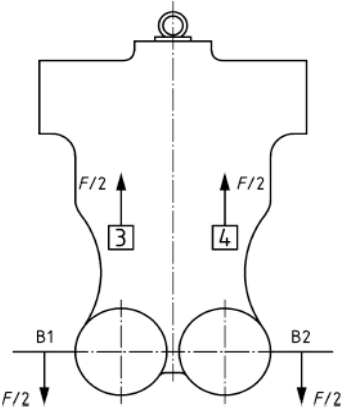
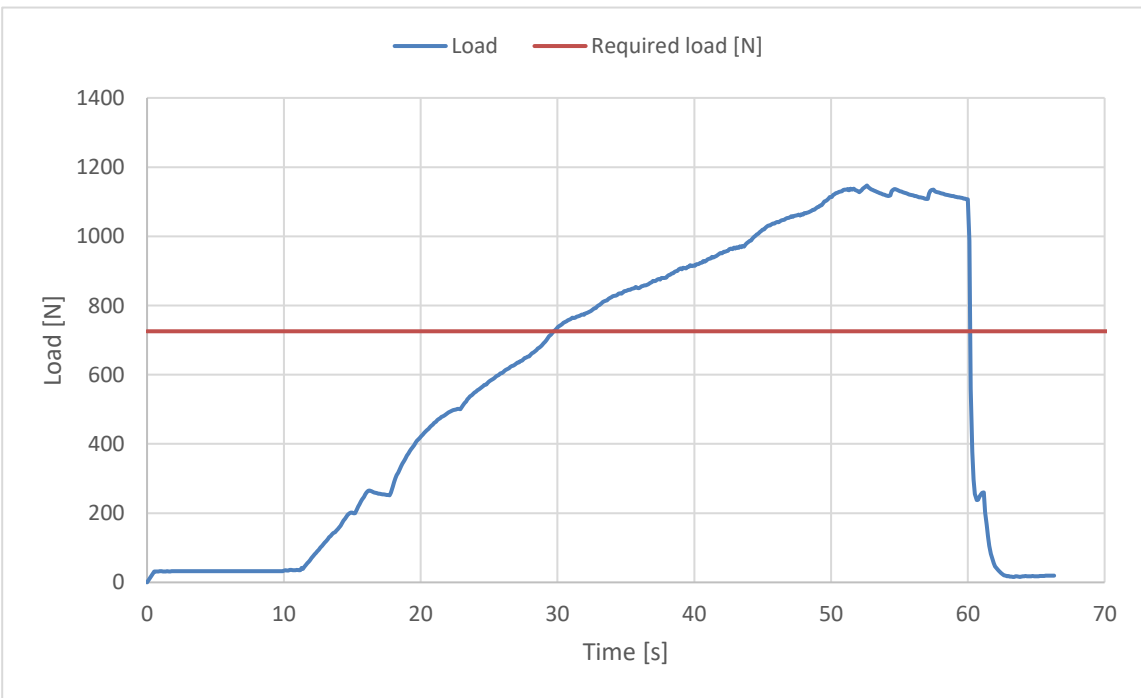
**Test ID R0**

Standard	<b>EN 1651:1999</b>
Reference in standard	<b>5.3.2.1</b>
Test setup	<b>Default flying position</b>
Attachment points	<b>Both main riser attachment (3,4)</b>
Anchor points	<b>Dummy (B1, B2)</b>
Required load [g]	<b>6</b>
Required load [N]	<b>720</b>
Minimum test duration [s]	<b>10</b>
<b>Result</b>	
Test duration [s]	<b>28.8</b>
Any signs of structural failure	<b>No</b>
Test results	<b>POSITIVE</b>

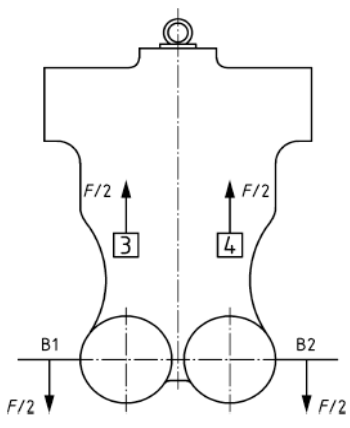
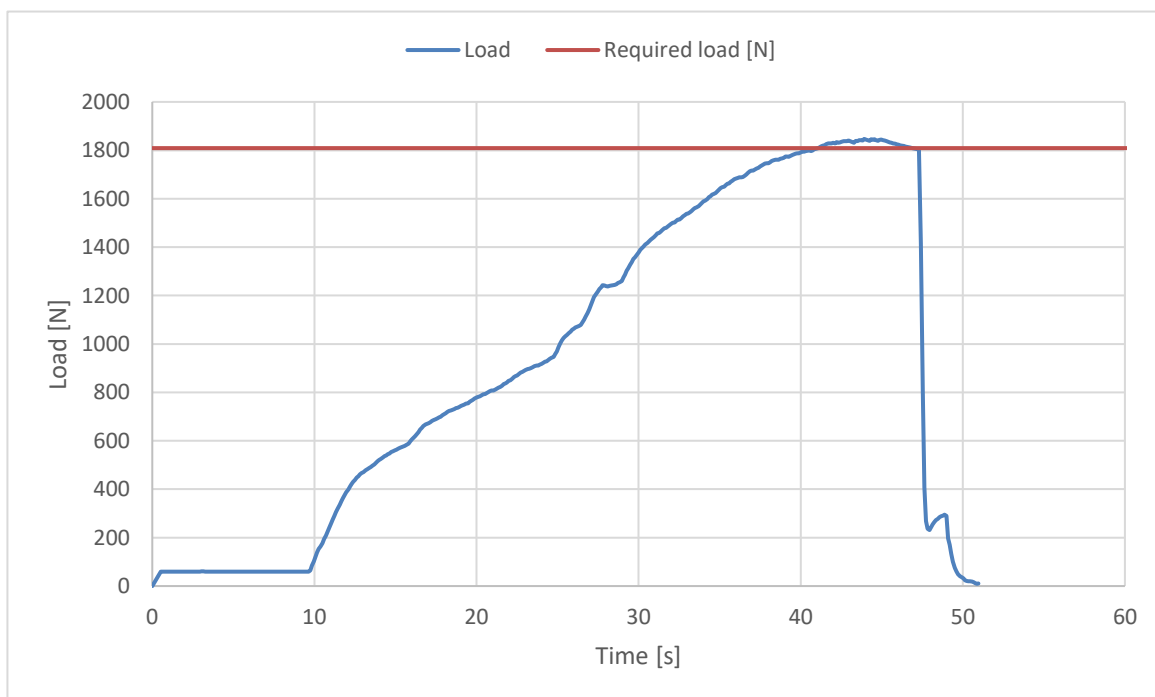
**Test ID R2**

Reference in standard	<b>5.3.2.2</b>	
Test setup	<b>Default flying position</b>	
Attachment points	<b>Both main riser attachment (3,4)</b>	
Anchor points	<b>Dummy (B1, B2)</b>	
Required load [g]	<b>15</b>	
Required load [N]	<b>1800</b>	
Minimum test duration [s]	<b>5</b>	
<b>Result</b>		
Test duration [s]	<b>5.6</b>	
Any signs of structural failure	<b>No</b>	
Test results	<b>POSITIVE</b>

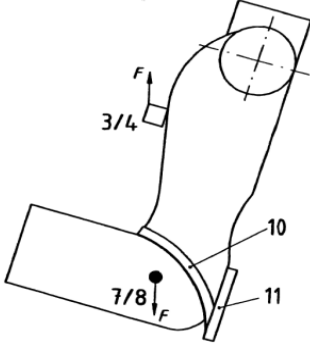
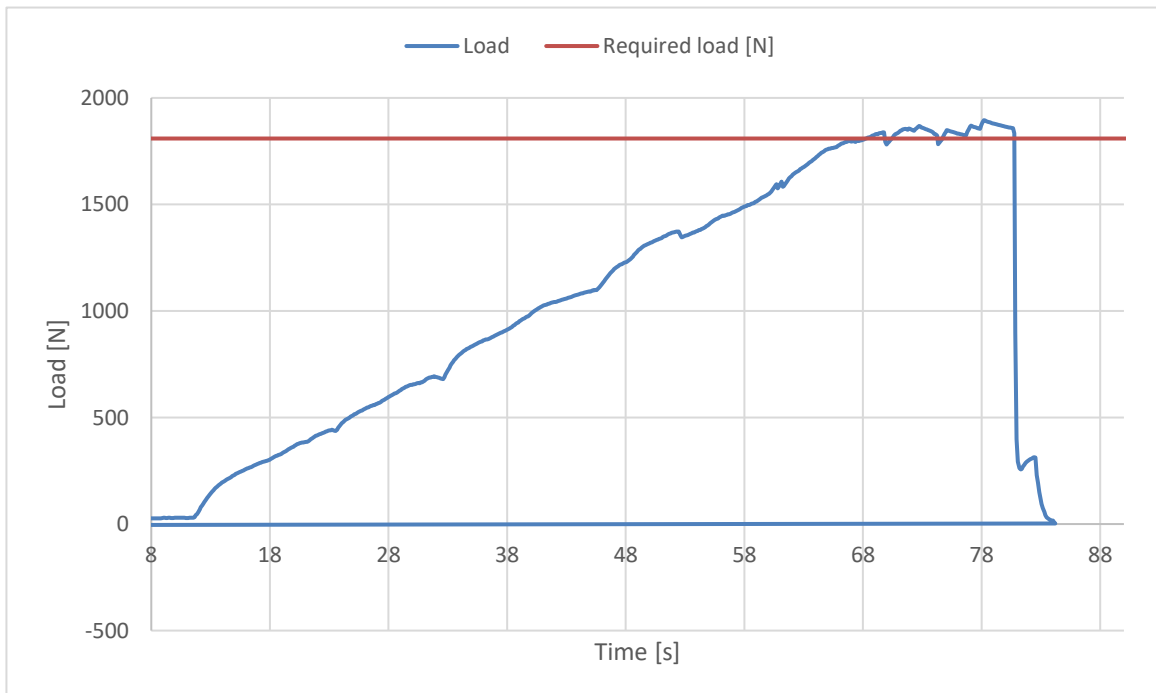
**Test ID R4**

Standard	<b>EN 1651:1999</b>
Reference in standard	<b>5.3.2.7</b>
Test setup	<b>Flying position before landing</b>
Attachment points	<b>Both main riser attachment (3,4)</b>
Anchor points	<b>Dummy (7,8)</b>
Required load [g]	<b>15</b>
Required load [N]	<b>1800</b>
Minimum test duration [s]	<b>5</b>
<b>Result</b>	
Test duration [s]	<b>5.7</b>
Any signs of structural failure	<b>No</b>
Test results	<b>POSITIVE</b>

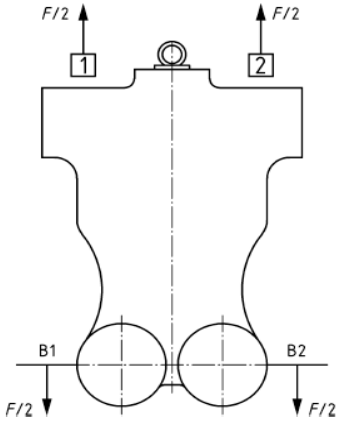
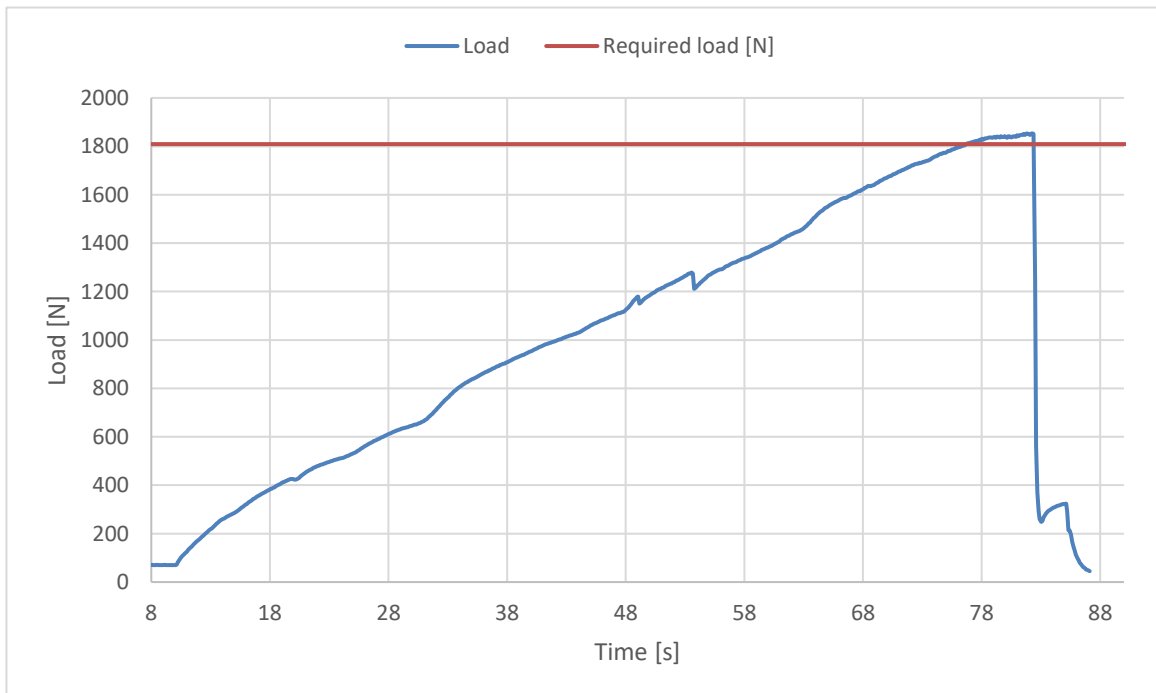
**Test ID R6**

Standard	<b>EN 1651:1999</b>
Reference in standard	<b>5.3.2.4</b>
Test setup	<b>Rescue attachments</b>
Attachment points	<b>Rescue riser attachment (1,2)</b>
Anchor points	<b>Dummy (B1,B2)</b>
Required load [g]	<b>15</b>
Required load [N]	<b>1800</b>
Minimum test duration [s]	<b>5</b>
<b>Result</b>	
Test duration [s]	<b>5.4</b>
Any signs of structural failure	<b>No</b>
Test results	<b>POSITIVE</b>

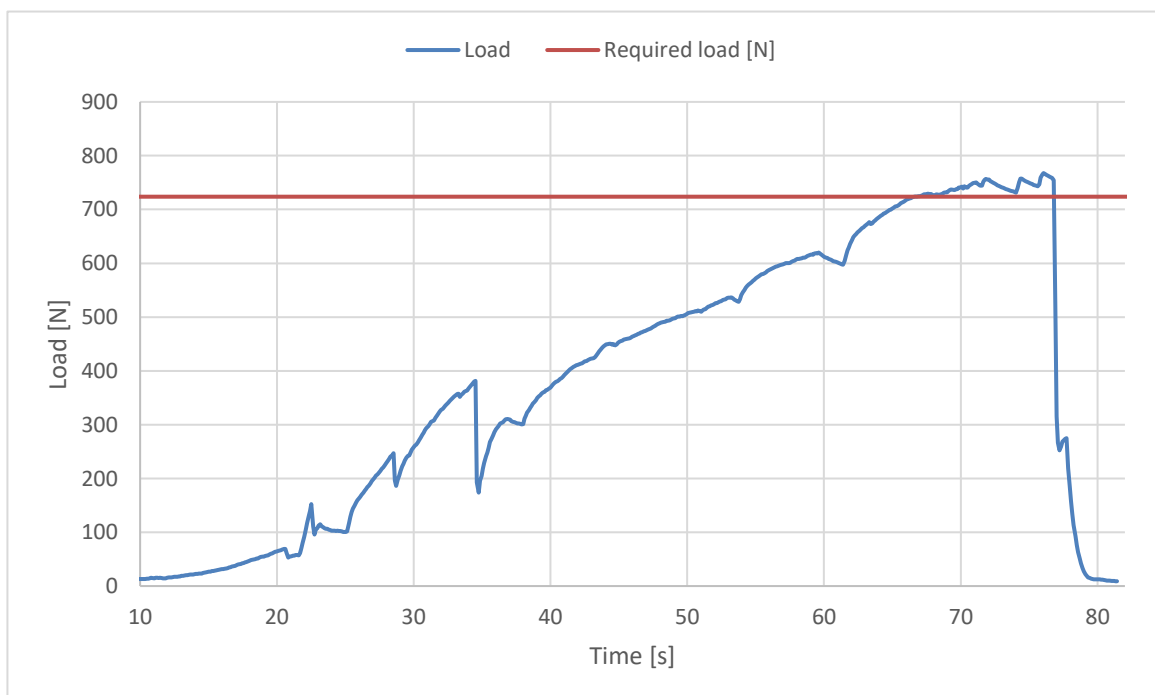
**Test ID R8**

Standard	<b>EN 1651:1999</b>
Reference in standard	<b>5.3.2.3</b>
Test setup	<b>Asymmetric, one riser</b>
Attachment points	<b>One main riser attachment (3)</b>
Anchor points	<b>Dummy (B1,B2)</b>
Required load [g]	<b>6</b>
Required load [N]	<b>720</b>
Minimum test duration [s]	<b>10</b>
<b>Result</b>	
Test duration [s]	<b>9.7</b>
Any signs of structural failure	<b>No</b>
Test results	<b>POSITIVE</b>

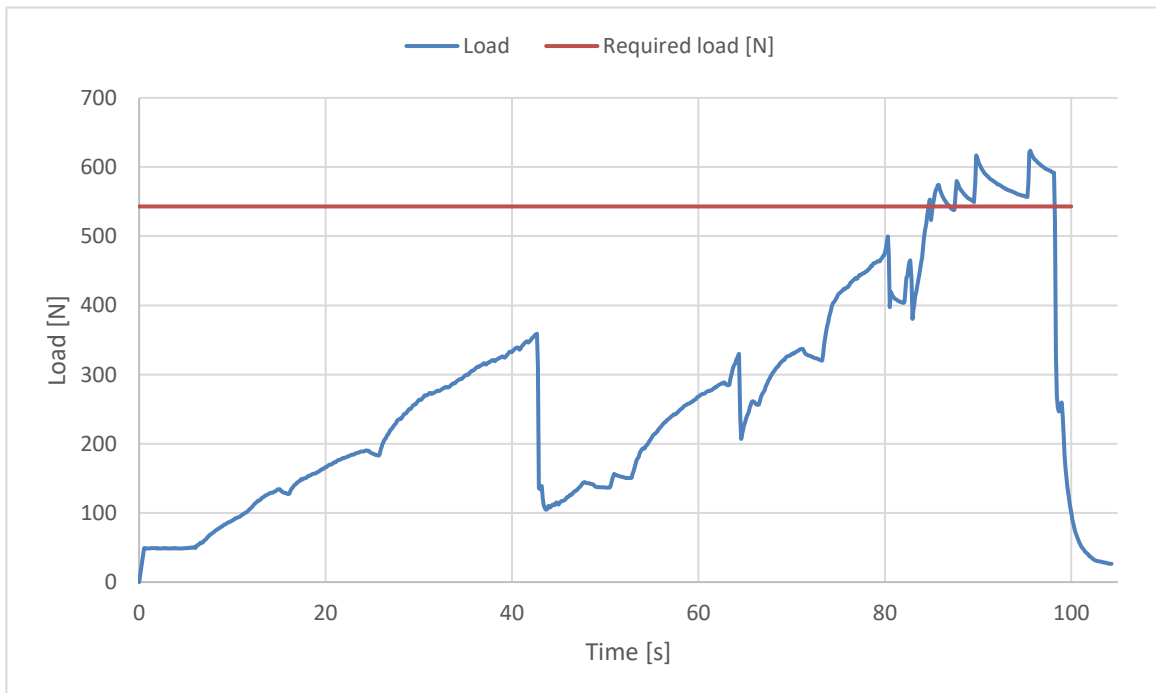
**Test ID R10**

Reference in standard	<b>5.3.2.6</b>	
Test setup	<b>Asymmetric, negative</b>	
Attachment points	<b>One main riser attachment (3 or 4) downwards</b>	
Anchor points	<b>Dummy (9)</b>	
Required load [g]	<b>4.5</b>	
Required load [N]	<b>540</b>	
Minimum test duration [s]	<b>10</b>	
<b>Result</b>		
Test duration [s]	<b>10.1</b>	
Any signs of structural failure	<b>No</b>	
Test results	<b>POSITIVE</b>

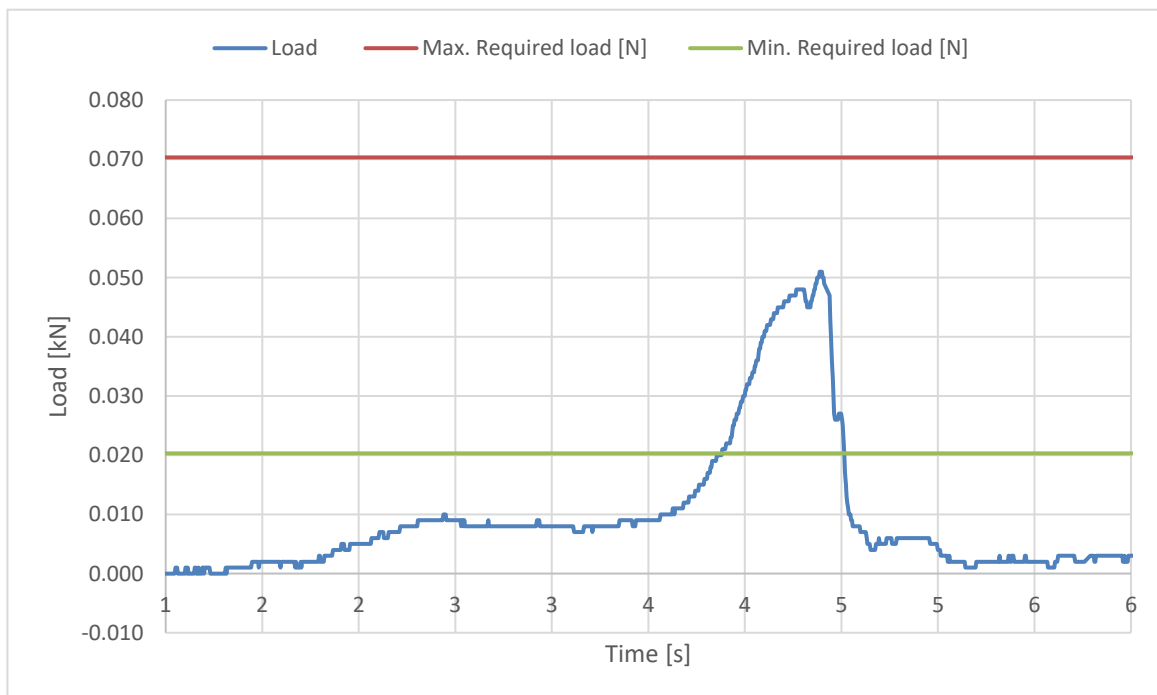
**Test ID RRDT**

Standard	<b>LTF NfL II 91/09</b>
Reference in standard	<b>6.1.5</b>
Test setup	<b>Default flying position</b>
Attachment points	<b>Sensor connect to handle, and pull in opening direction</b>
	The test is to simulate the load required to open the emergency parachute(1st action).
Min. Required load [N]	<b>20</b>
Max. Required load [N]	<b>70</b>
<b>Result</b>	
Load for first action [N]	<b>50.69</b>
Test results	<b>POSITIVE</b>

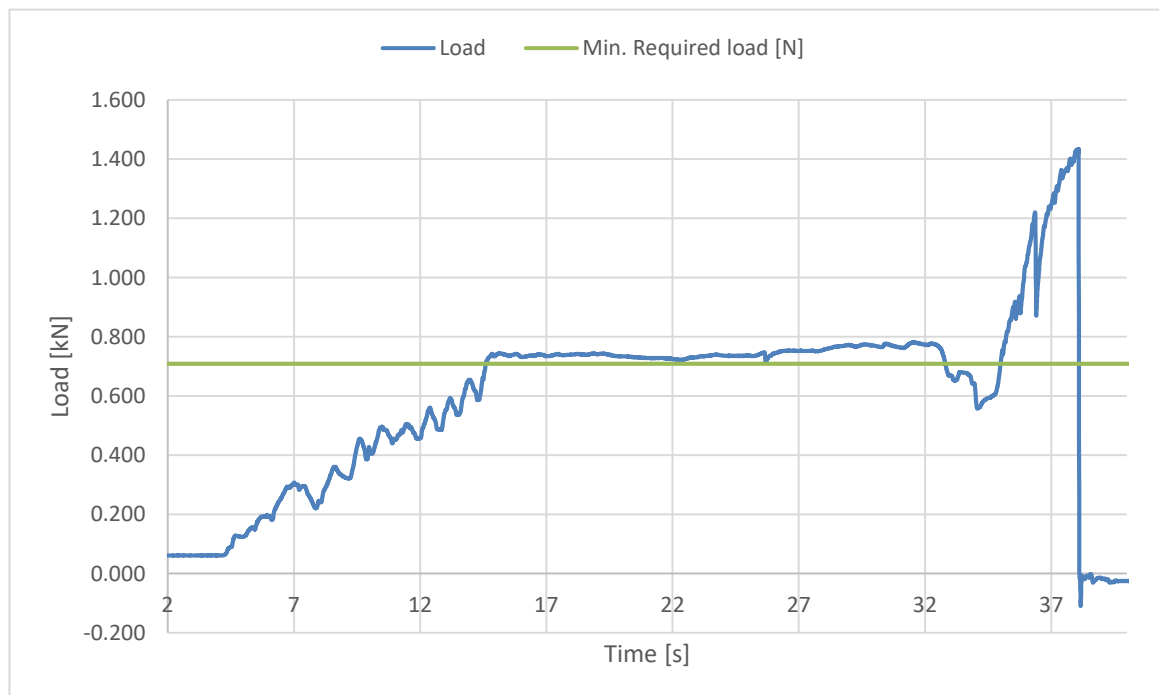
**Test ID RRST**

Standard	<b>EN12491:2015</b>
Reference in standard	<b>5.3.2</b>
Test setup	<b>Two end points of handle</b>
Attachment points	<b>Sensor connect to end of handle, pull on the other side</b>
	The handle must support min 700 N for 10 s, after measure breaking strength
Min. Required load [N]	<b>700</b>
Minimum test duration [s]	<b>10</b>
<b>Result</b>	
Test duration [s]:	<b>18.2</b>
Breaking strength [N]	<b>1425.38</b>
Test results	<b>POSITIVE</b>
