Harness Structural test Report

Inspection certificate number: **PH_265.2019**
Manufacturer data:

Name: **Strapless 2**
 Type: **ABS**
 Size: **M**
 Serial number: **1150228**
 Impact pad type: ⁽¹⁾ **n/a**
 Clip-in weight [kg]: **110**

Summary of Structural test

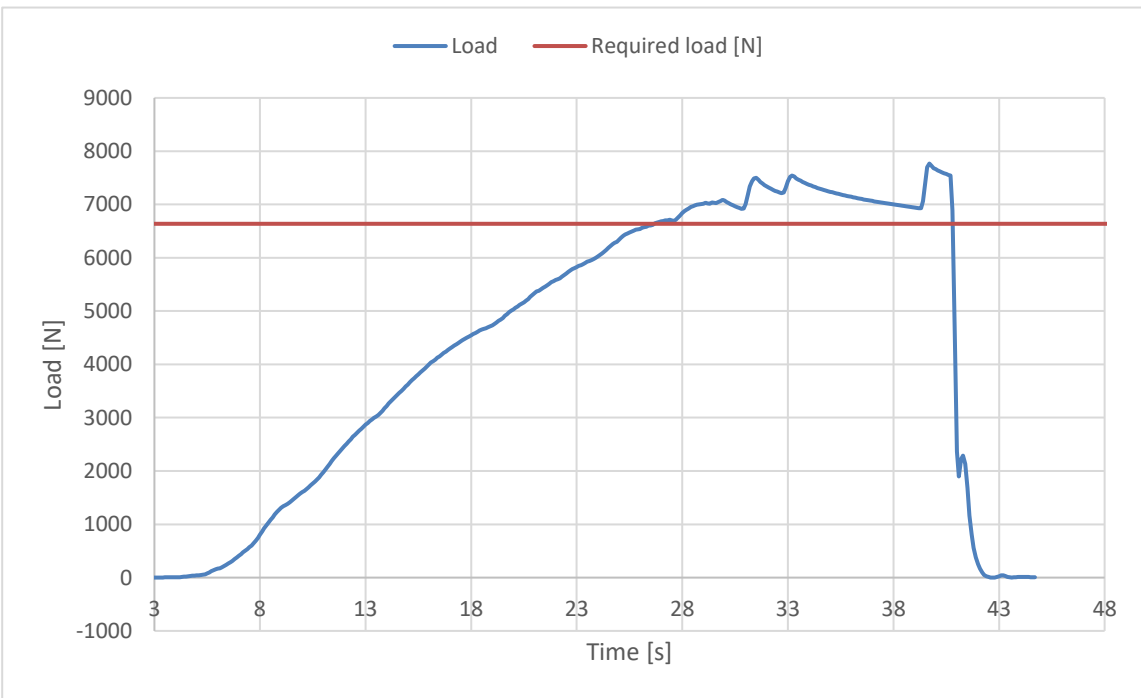
Test ID R0

Reference in standard	5.3.2.1	
Test setup	Default flying position	
Attachment points	Both main riser attachment (3,4)	
Anchor points	Dummy (B1, B2)	
Required load [g]	6	
Required load [N]	6600	
Minimum test duration [s]	10	
Result		
Test duration [s]	14.2	
Any signs of structural failure	No	
Test results	POSITIVE

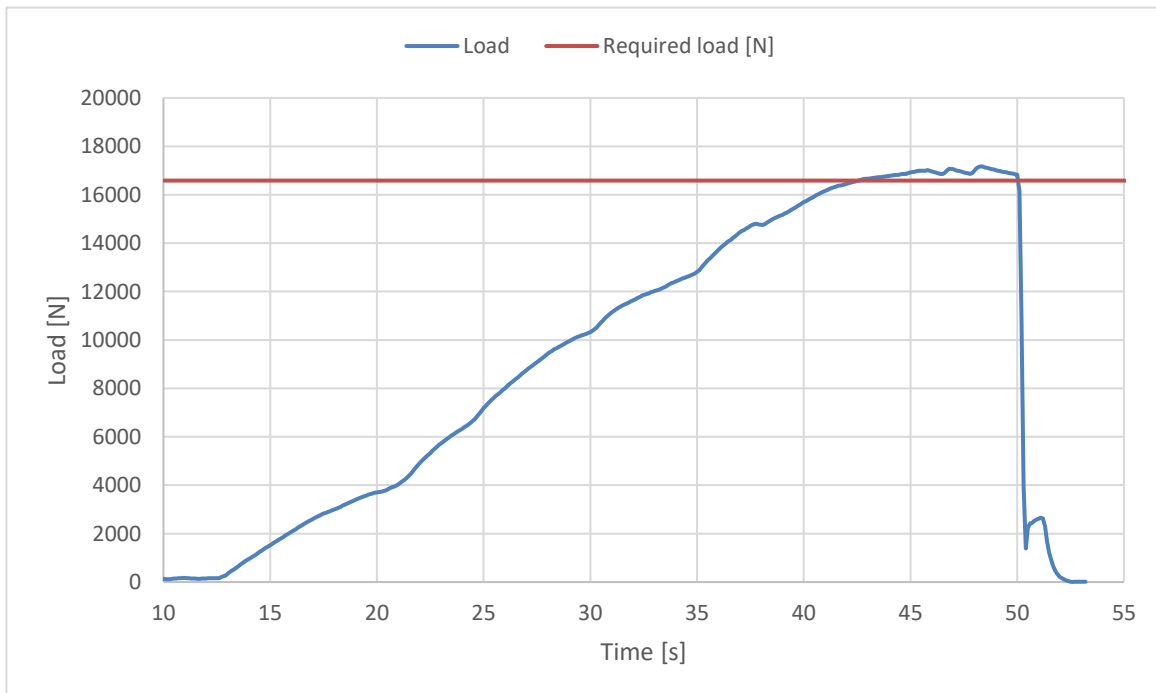
Test ID R2

Standard	EN 1651:1999
Reference in standard	5.3.2.2
Test setup	Default flying position
Attachment points	Both main riser attachment (3,4)
Anchor points	Dummy (B1, B2)
Required load [g]	15
Required load [N]	16500
Minimum test duration [s]	5
Result	
Test duration [s]	7.5
Any signs of structural failure	No
Test results	POSITIVE

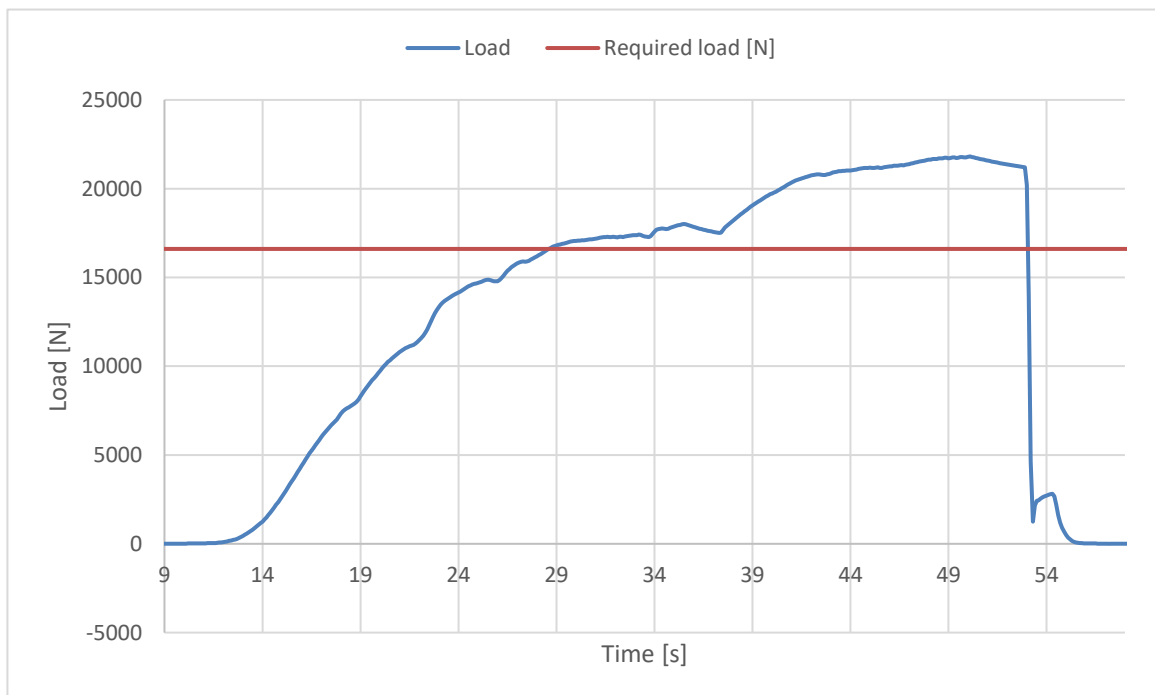
Test ID R4

Standard	EN 1651:1999
Reference in standard	5.3.2.7
Test setup	Flying position before landing
Attachment points	Both main riser attachment (3,4)
Anchor points	Dummy (7,8)
Required load [g]	15
Required load [N]	16500
Minimum test duration [s]	5
Result	
Test duration [s]	24.4
Any signs of structural failure	No
Test results	POSITIVE

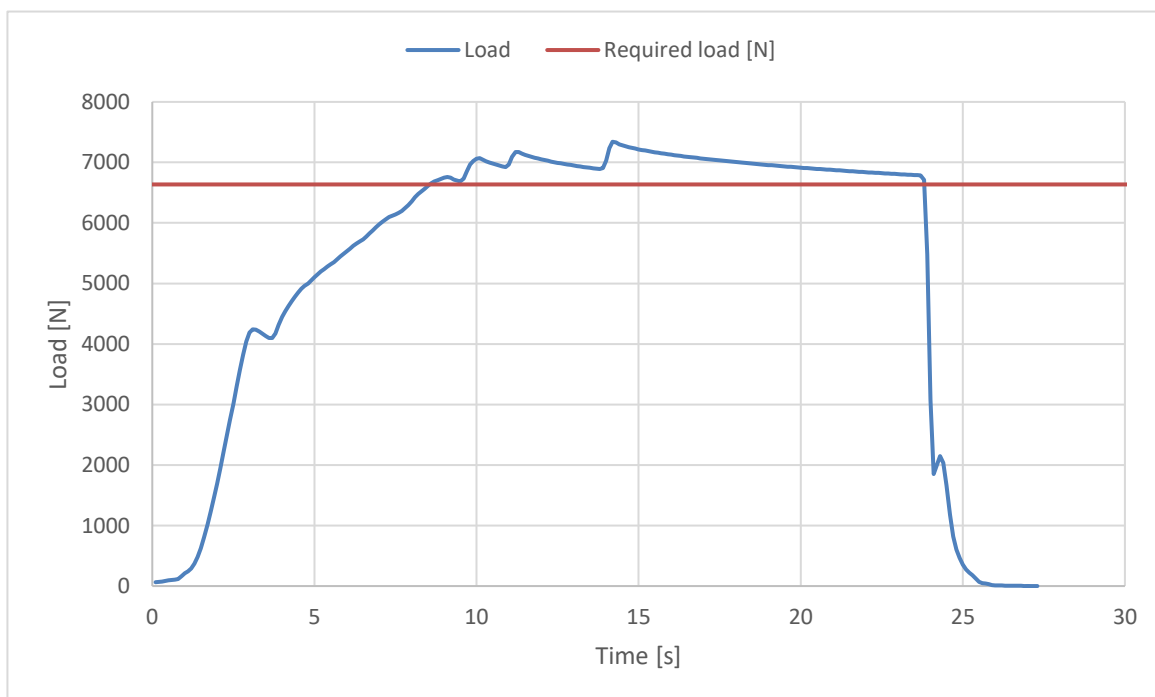
Test ID R8

Reference in standard	5.3.2.3	
Test setup	Asymmetric, one riser	
Attachment points	One main riser attachment (3)	
Anchor points	Dummy (B1,B2)	
Required load [g]	6	
Required load [N]	6600	
Minimum test duration [s]	10	
Result		
Test duration [s]	15.3	
Any signs of structural failure	No	
Test results	POSITIVE

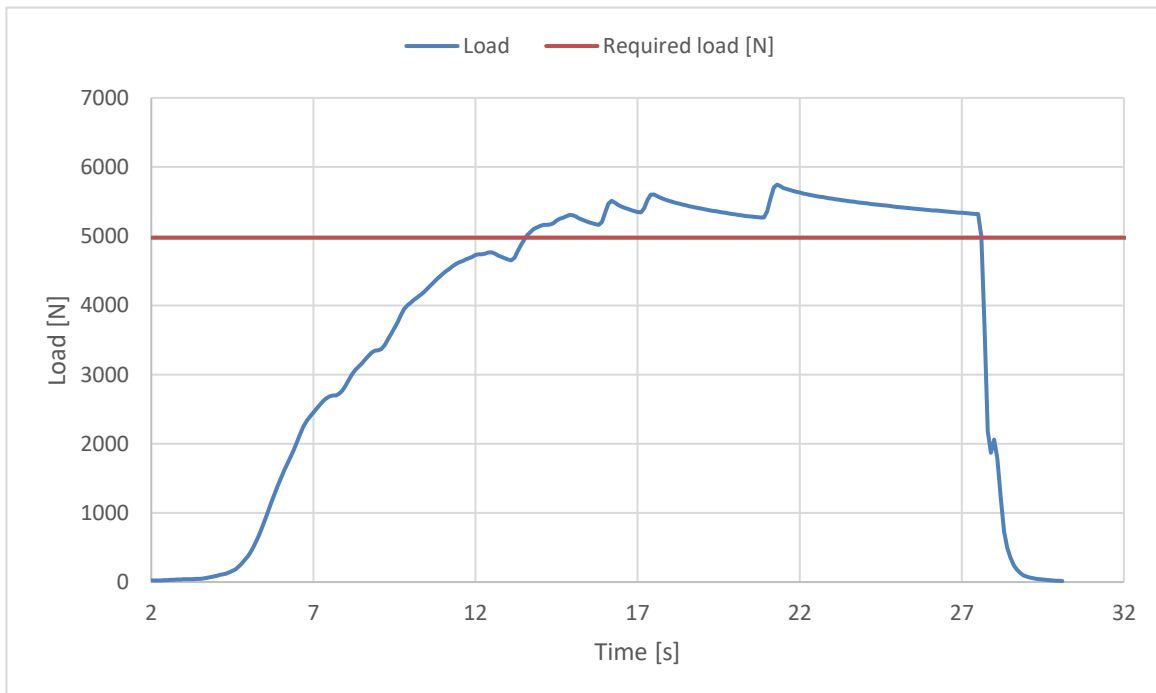
Test ID R10

Reference in standard	5.3.2.6	
Test setup	Asymmetric, negative	
Attachment points	One main riser attachment (3 or 4) downwards	
Anchor points	Dummy (9)	
Required load [g]	4.5	
Required load [N]	4950	
Minimum test duration [s]	10	
Result		
Test duration [s]	14.1	
Any signs of structural failure	No	
Test results	POSITIVE
