Harness Structural test Report - LTF

Inspection certificate number: **PH_318.2020**

Name: **Sucess 5**
 Type: **ABS**
 Size: **L**
 Serial number: **1162030**
 Impact pad type: ⁽¹⁾ **Hybrid**
 Clip-in weight [kg]: **120**

Date of test: **27.06.2016**

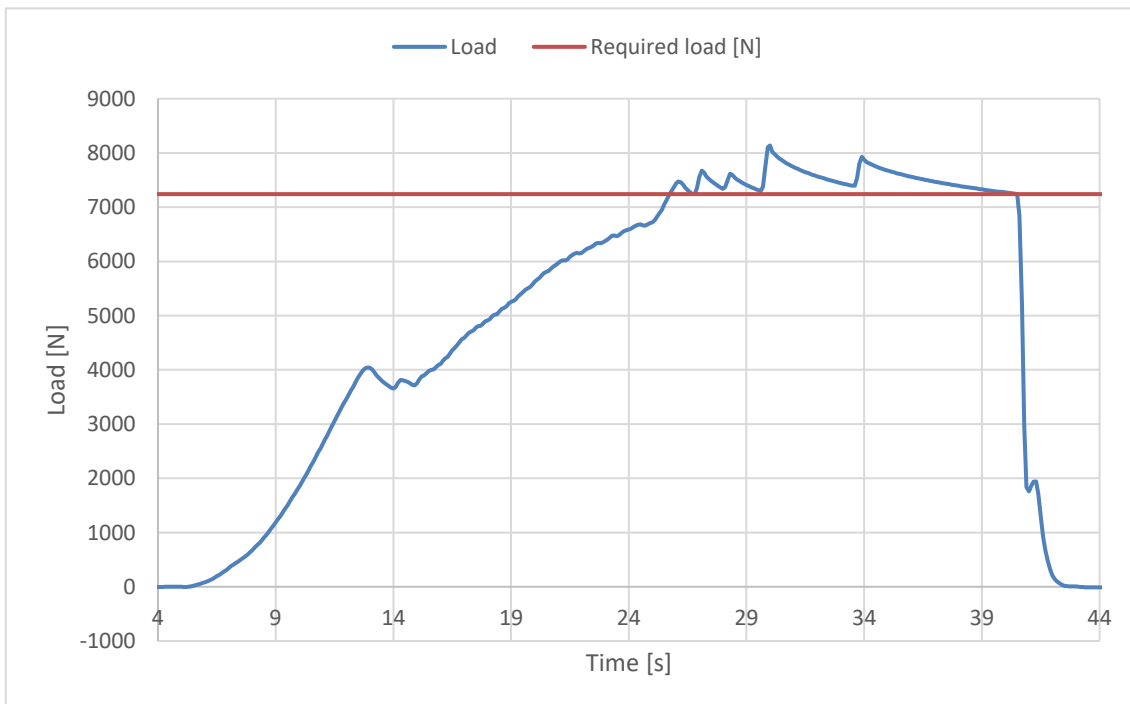
Test ID 02

Standard	LTF NfL II 91/09
Reference	5.3.2.1
Test setup	Default flying position
Attachment points	Both main riser attachment (3,4)
Anchor points	Dummy (B1, B2)
Required load [g]	6
Required load [N]	7200
Minimum test duration [s]	10
Result	
Test duration [s]	14.8
Any signs of structural failure	No
Test results	POSITIVE

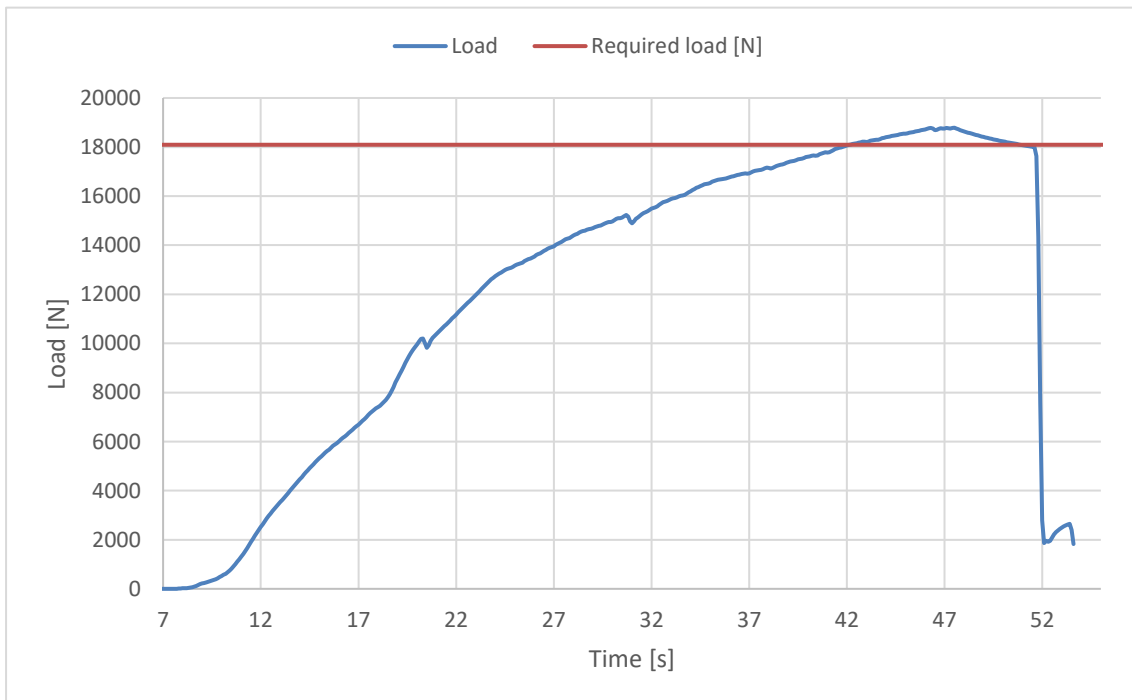
Test ID 03

Standard	LTF NfL II 91/09
Reference	5.3.2.2
Test setup	Default flying position
Attachment points	Both main riser attachment (3,4)
Anchor points	Dummy (B1, B2)
Required load [g]	15
Required load [N]	18000
Minimum test duration [s]	5
Result	
Test duration [s]	8.7
Any signs of structural failure	No
Test results	POSITIVE

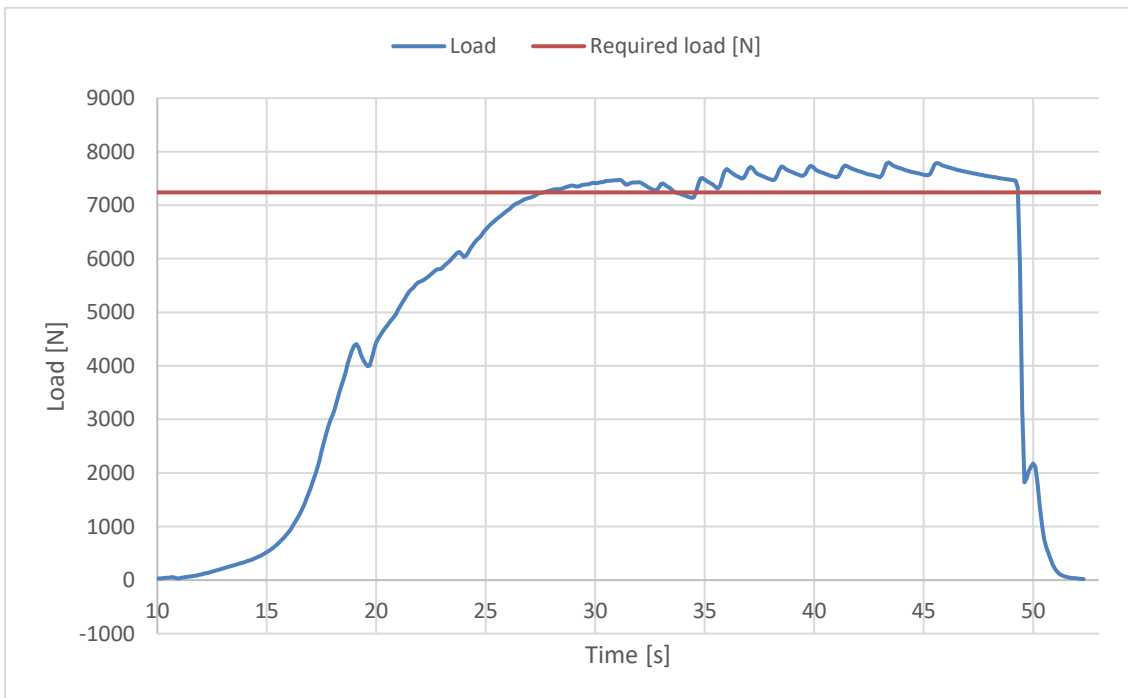
Test ID 04

Standard **LTF NfL II 91/09**
 Reference **5.3.2.3**
 Test setup **Asymmetric, one riser**
 Attachment points **One main riser attachment (3)**
 Anchor points **Dummy (B1,B2)**

Test duration [s] **14.7**
 Any signs of structural failure **No**
 Test results **POSITIVE**

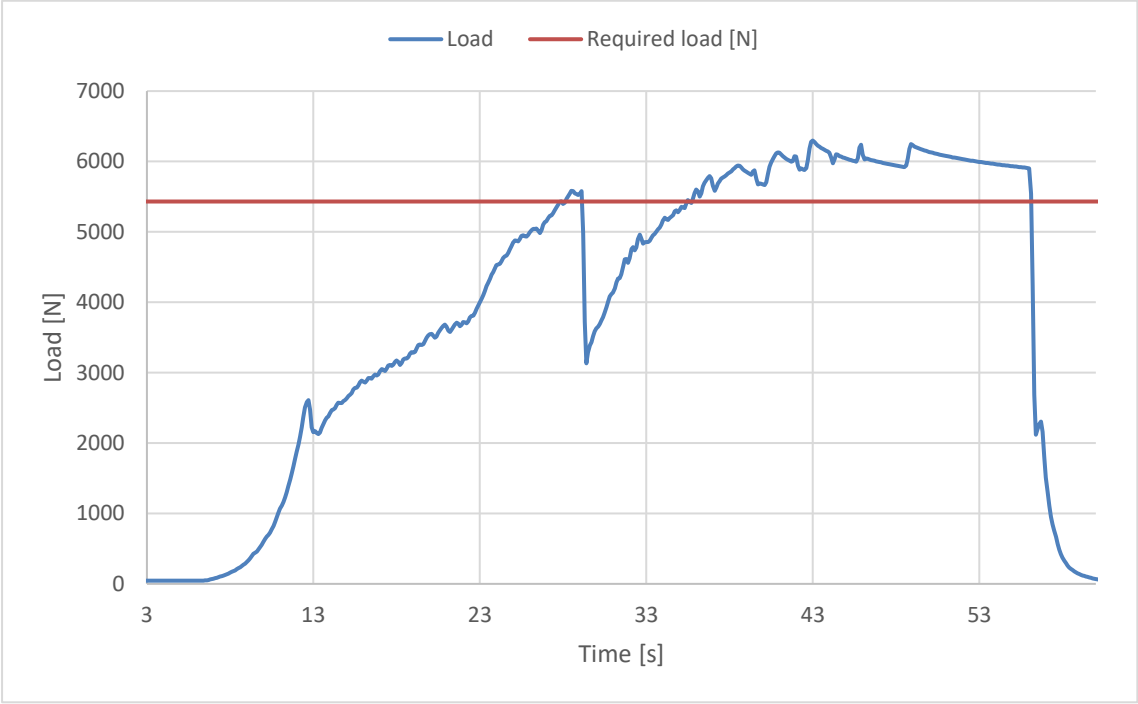
Test ID 07

Reference	5.3.2.6	
Test setup	Asymmetric, negative	
Attachment points	One main riser attachment (3 or 4) downwards	
Anchor points	Dummy (9)	
Required load [g]	4.5	
Required load [N]	5400	
Minimum test duration [s]	10	
Result		
Test duration [s]	20.4	
Any signs of structural failure	No	
Test results	POSITIVE

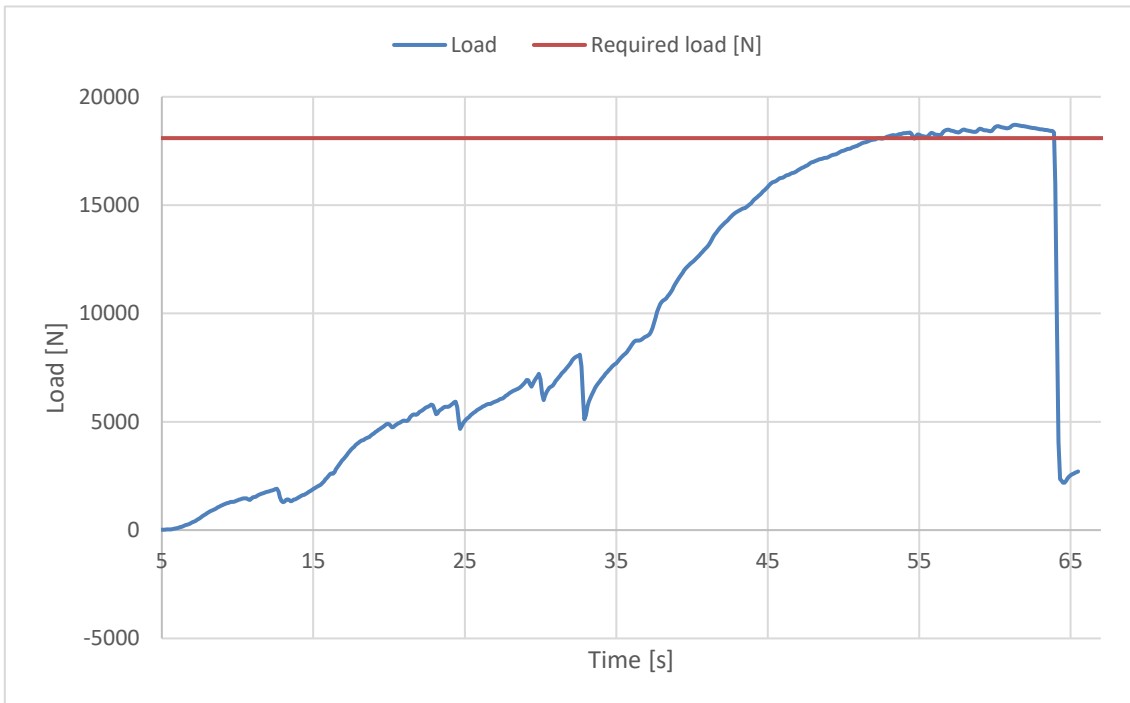
Test ID 09

Standard **LTF NfL II 91/09**
 Reference **5.3.2.4**
 Test setup **Rescue attachments**
 Attachment points **Rescue riser attachment (1,2)**
 Anchor points **Dummy (B1,B2)**

Test duration [s] **9.2**
 Any signs of structural failure **No**
 Test results **POSITIVE**

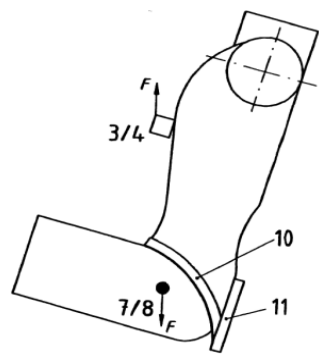
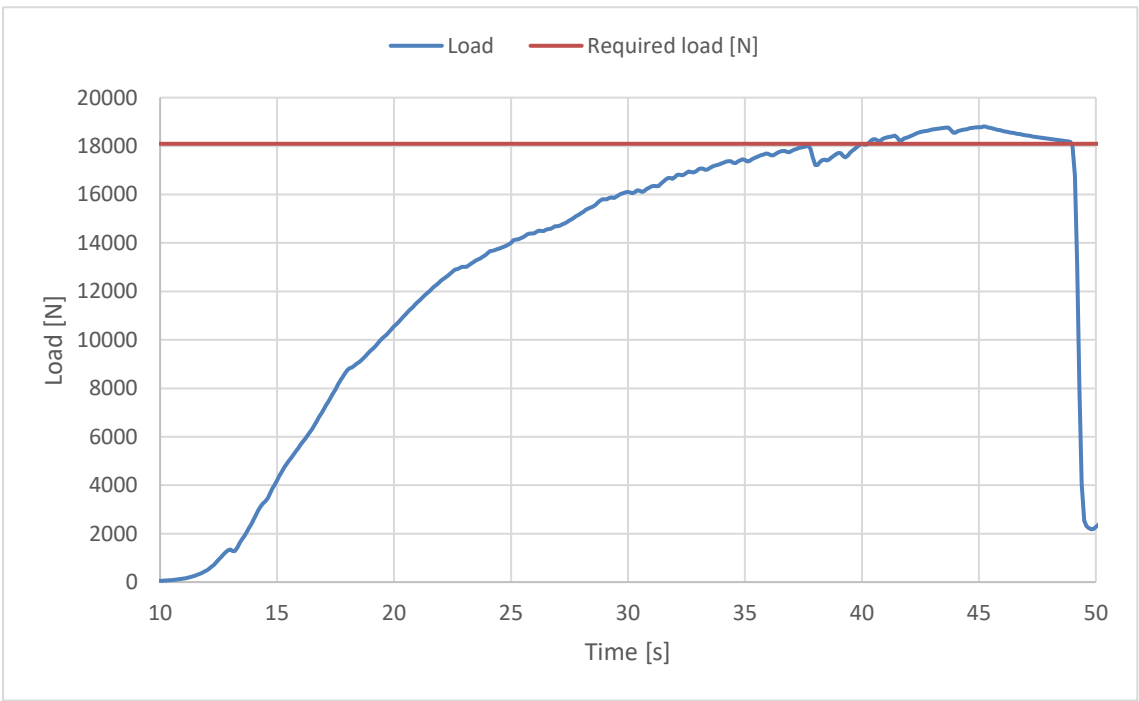
Test ID 13

Standard	LTF NfL II 91/09
Reference	5.3.2.7
Test setup	Flying position before landing
Attachment points	Both main riser attachment (3,4)
Anchor points	Dummy (7,8)
Required load [g]	15
Required load [N]	18000
Minimum test duration [s]	5
Result	
Test duration [s]	8.7
Any signs of structural failure	No
Test results	POSITIVE

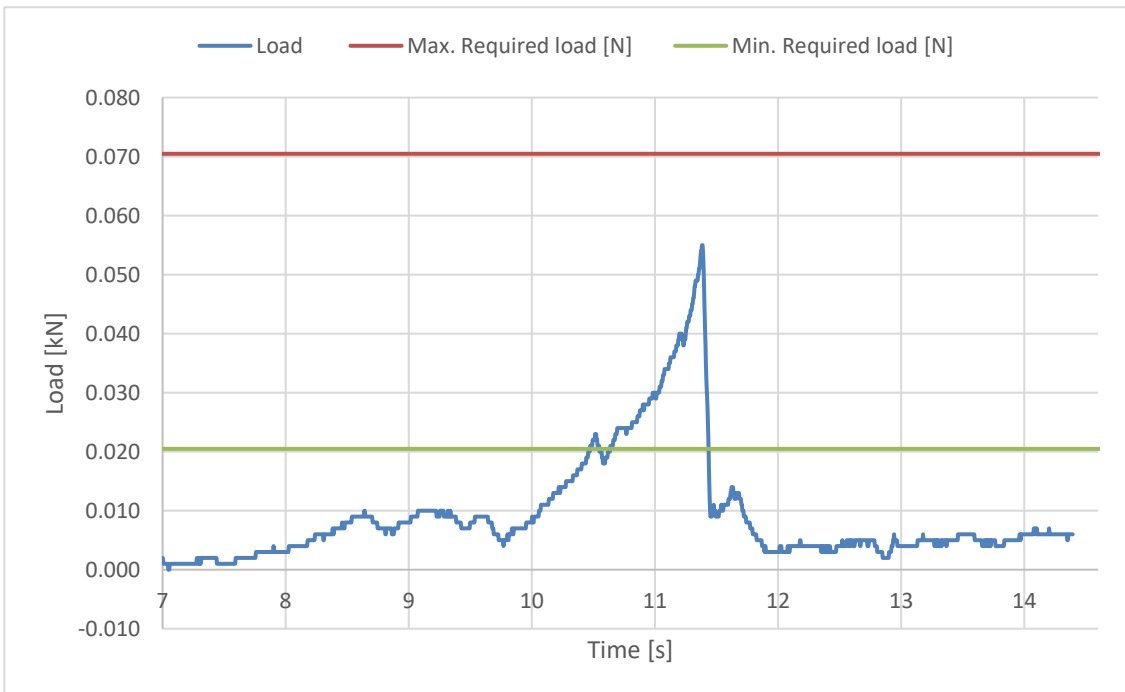
Test ID RRDT

Standard	LTF NfL II 91/09
Reference	6.1.5
Test setup	Default flying position
Attachment points	Sensor connect to handle, and pull in opening direction
	The test is to simulate the load required to open the emergency parachute(1st action).
Min. Required load [N]	20
Max. Required load [N]	70
Result	
Load for first action [N]	54.52
Test results	POSITIVE

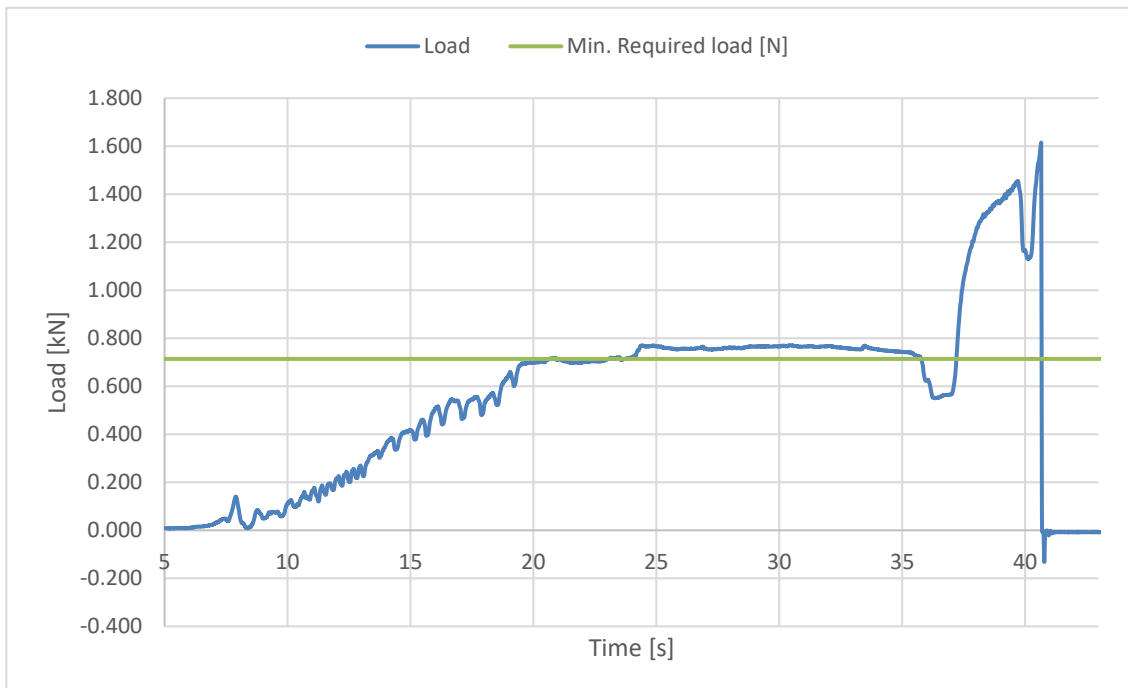
Test ID RRST

Standard	EN12491:2015
Reference in standard	5.3.2
Test setup	Two end points of handle
Attachment points	Sensor connect to end of handle, pull on the other side
	The handle must support min 700 N for 10 s, after measure breaking strength
Min. Required load [N]	700
Minimum test duration [s]	10
Result	
Test duration [s]:	12.0
Breaking strength [N]	1601.00
Test results	POSITIVE
