Harness Structural test Report - LTF

Inspection certificate number: **PH_285.2019**

Name: **Koncept**
 Type: **ABS**
 Size: **One size**
 Serial number: **S-S-001**
 Impact pad type: ⁽¹⁾ **Airbag**
 Clip-in weight [kg]: **120**

Air Turquoise SA, having thoroughly assessed the sample mentioned above, declare it was found conform with European Standard **EN1651 :1999**, and **EN12491:2015** - Airworthiness Requirements **LTF NfL II 91/09**

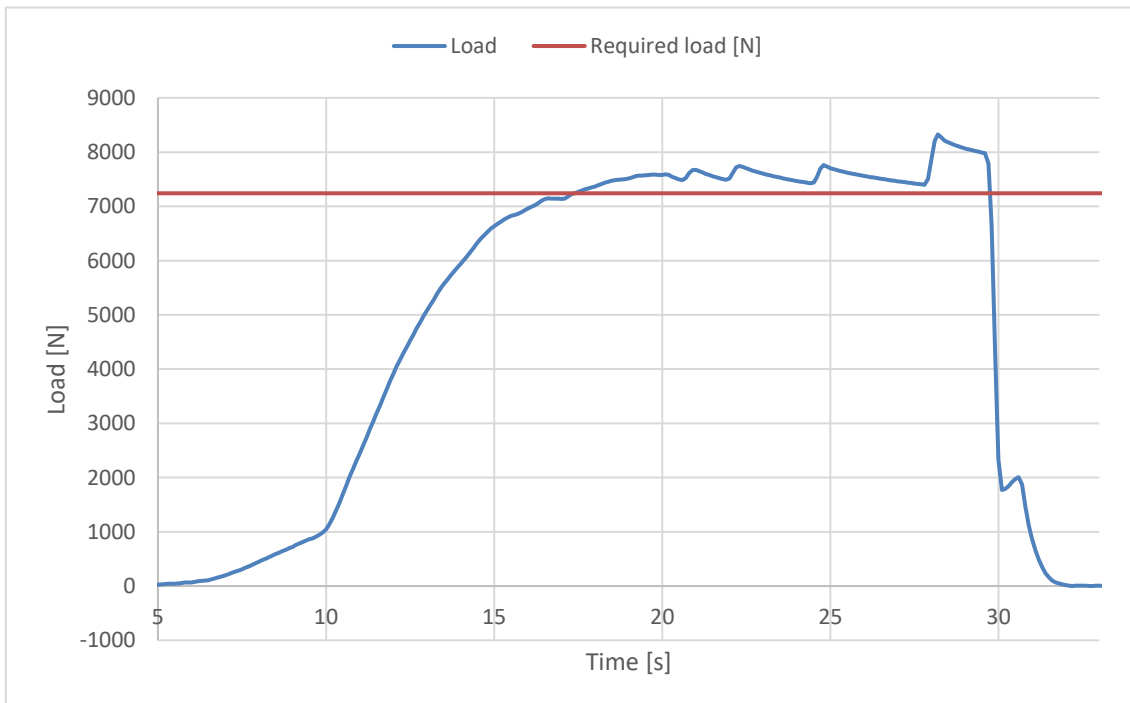
Test ID 02

Test duration [s] **12.4**
 Any signs of structural failure **No**
 Test results **POSITIVE**

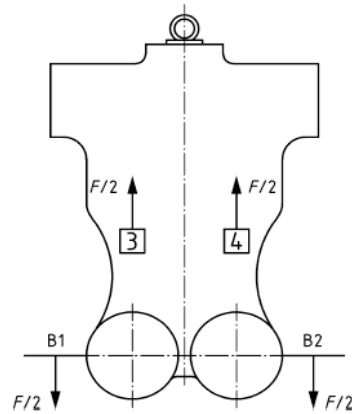
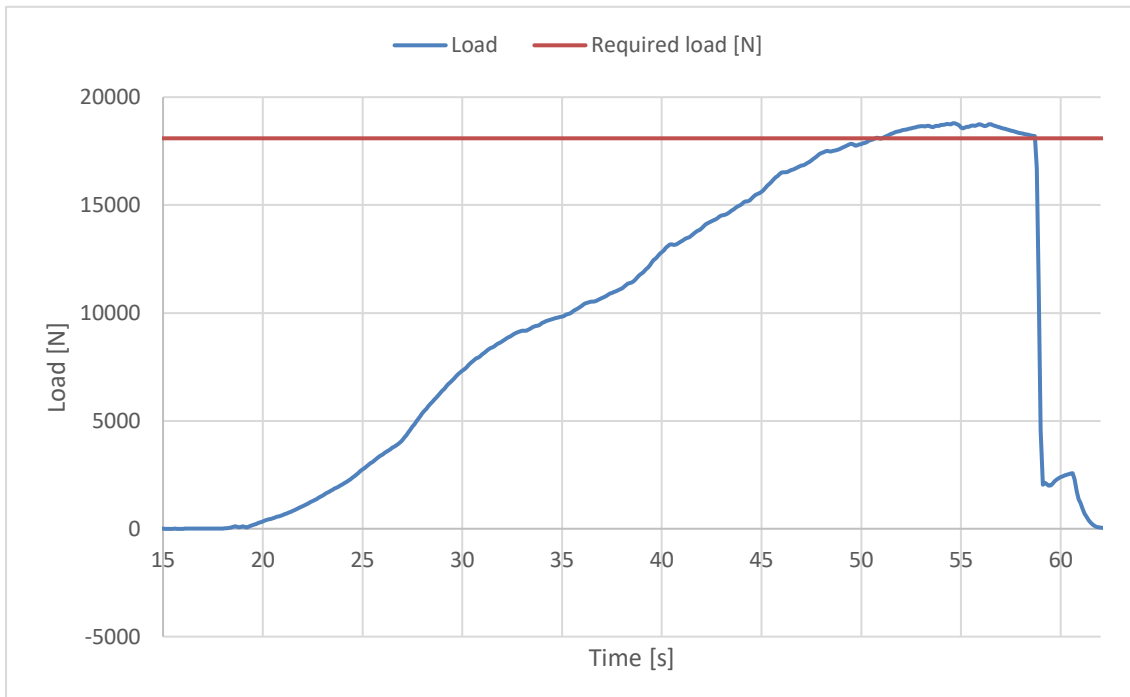
Test ID 03

Test duration [s] **7.7**
 Any signs of structural failure **No**
 Test results **POSITIVE**

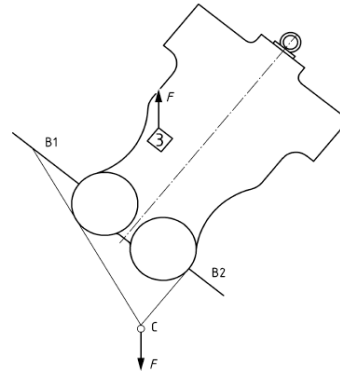
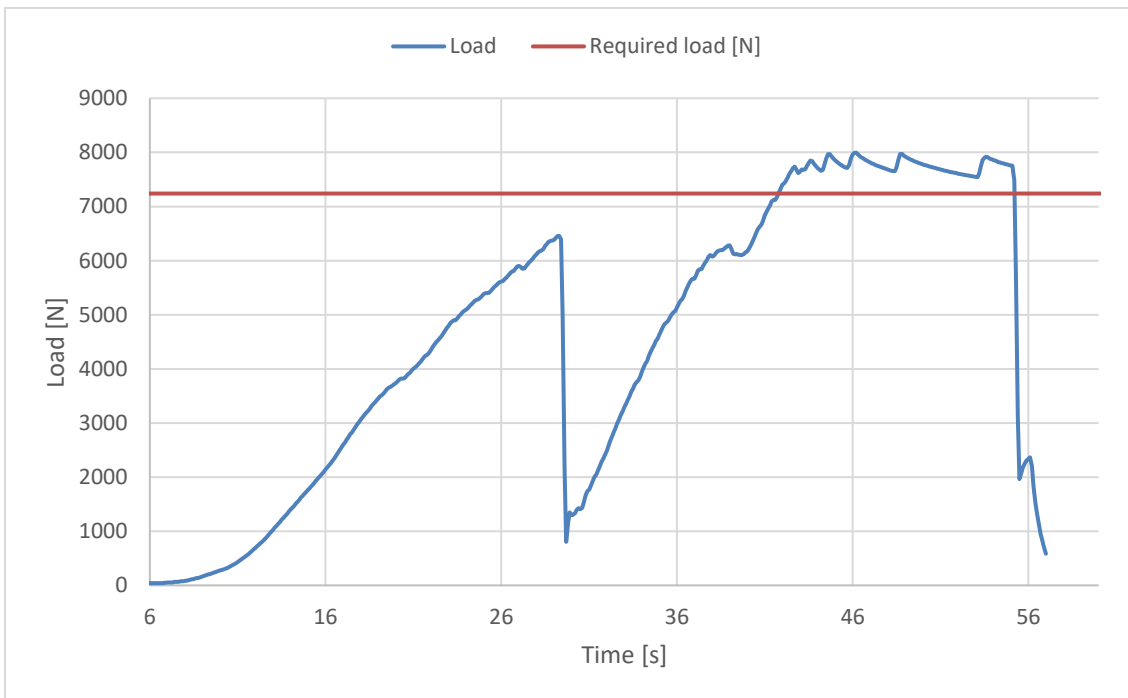
Test ID 04

Test duration [s] **13.5**
 Any signs of structural failure **No**
 Test results **POSITIVE**

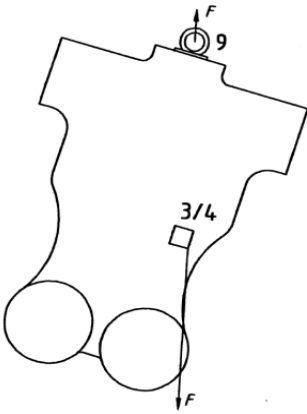
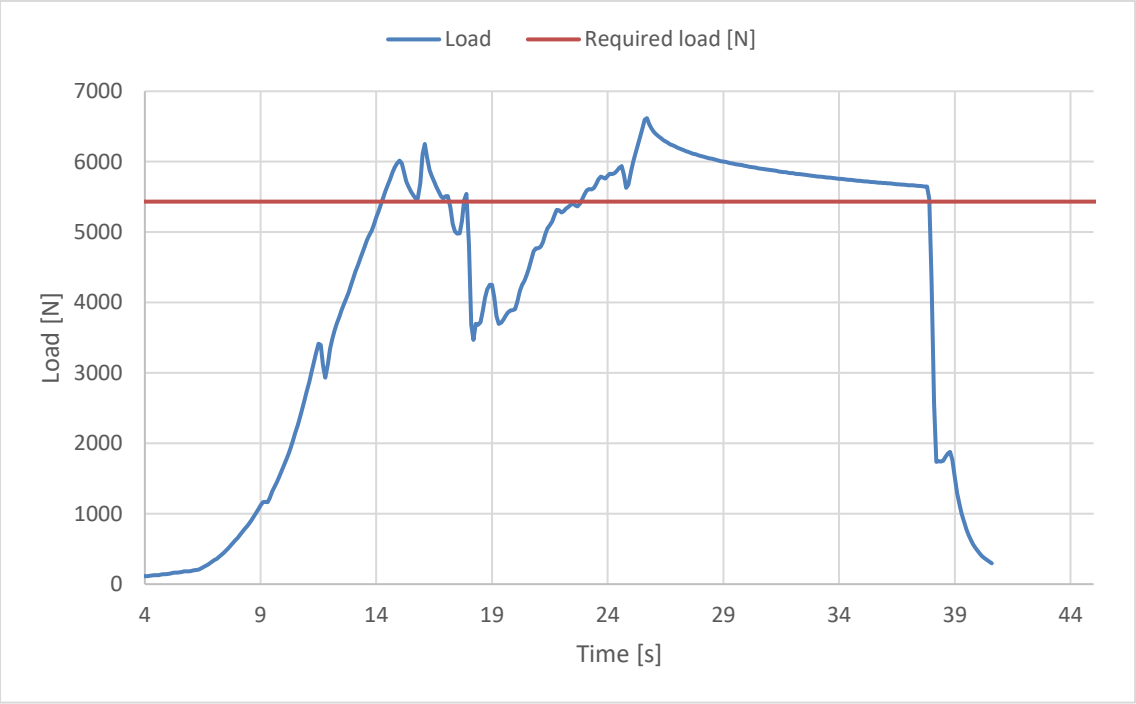
Test ID 07

Reference in standard	5.3.2.6	
Test setup	Asymmetric, negative	
Attachment points	One main riser attachment (3 or 4) downwards	
Anchor points	Dummy (9)	
Required load [g]	4.5	
Required load [N]	5400	
Minimum test duration [s]	10	
Result		
Test duration [s]	15.1	
Any signs of structural failure	No	
Test results	POSITIVE

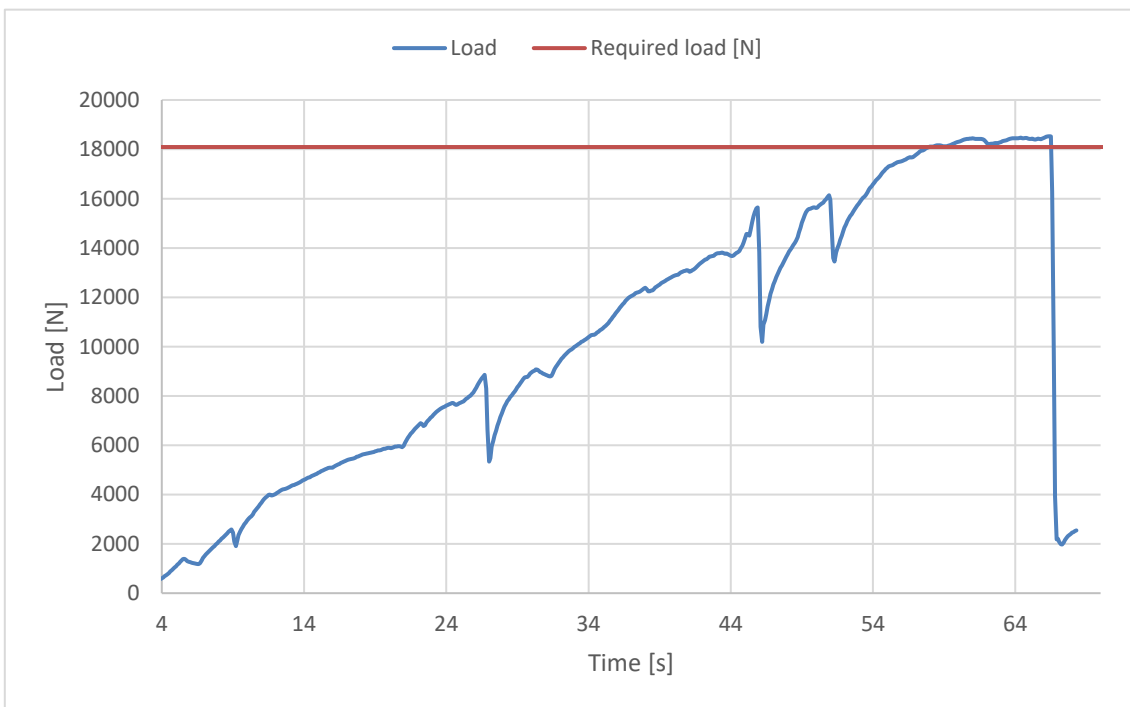
Test ID 09

Reference in standard	5.3.2.4	
Test setup	Rescue attachments	
Attachment points	Rescue riser attachment (1,2)	
Anchor points	Dummy (B1,B2)	
Required load [g]	15	
Required load [N]	18000	
Minimum test duration [s]	5	
Result		
Test duration [s]	8.6	
Any signs of structural failure	No	
Test results	POSITIVE

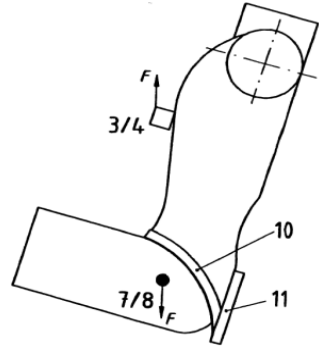
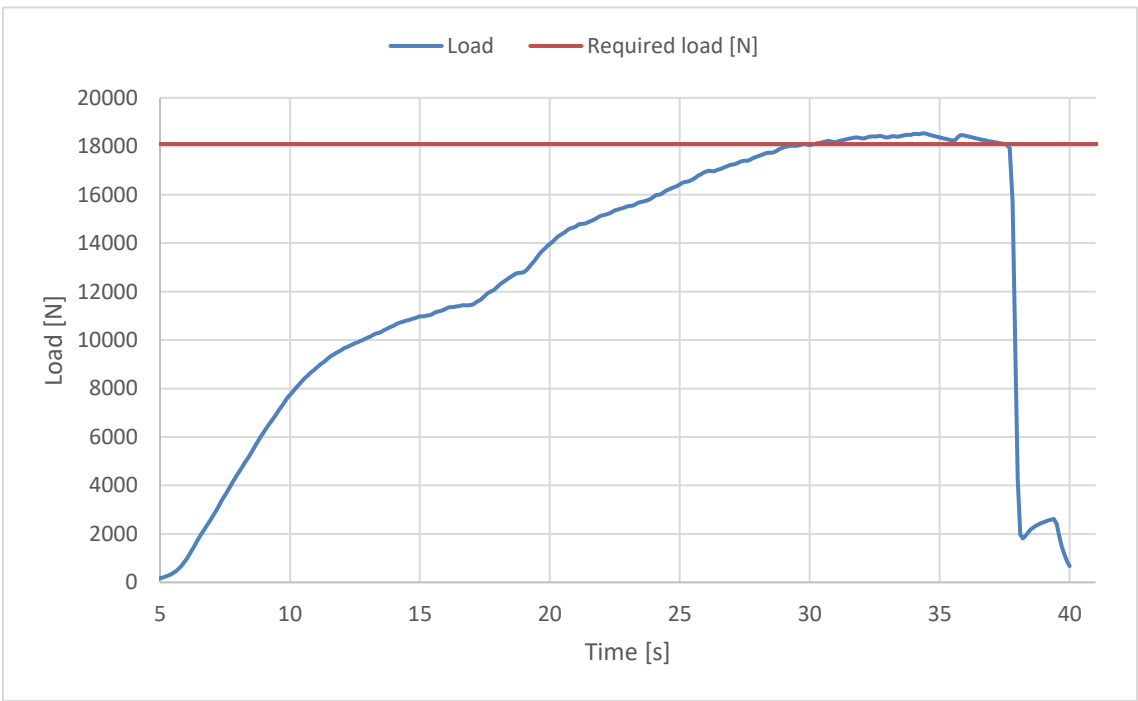
Test ID 13

Standard	EN 1651:1999
Reference in standard	5.3.2.7
Test setup	Flying position before landing
Attachment points	Both main riser attachment (3,4)
Anchor points	Dummy (7,8)
Required load [g]	15
Required load [N]	18000
Minimum test duration [s]	5
Result	
Test duration [s]	7.3
Any signs of structural failure	Yes
Test results	POSITIVE
