Harness Structural test Report

Inspection certificate number: **PH_252.2018**
Manufacturer data:

Name: **Kruyer 3**
 Type: **ABS**
 Size: **M**
 Serial number: **S091801**
 Impact pad type: ⁽¹⁾ **Airbag**
 Clip-in weight [kg]: **120**

Summary of Structural test

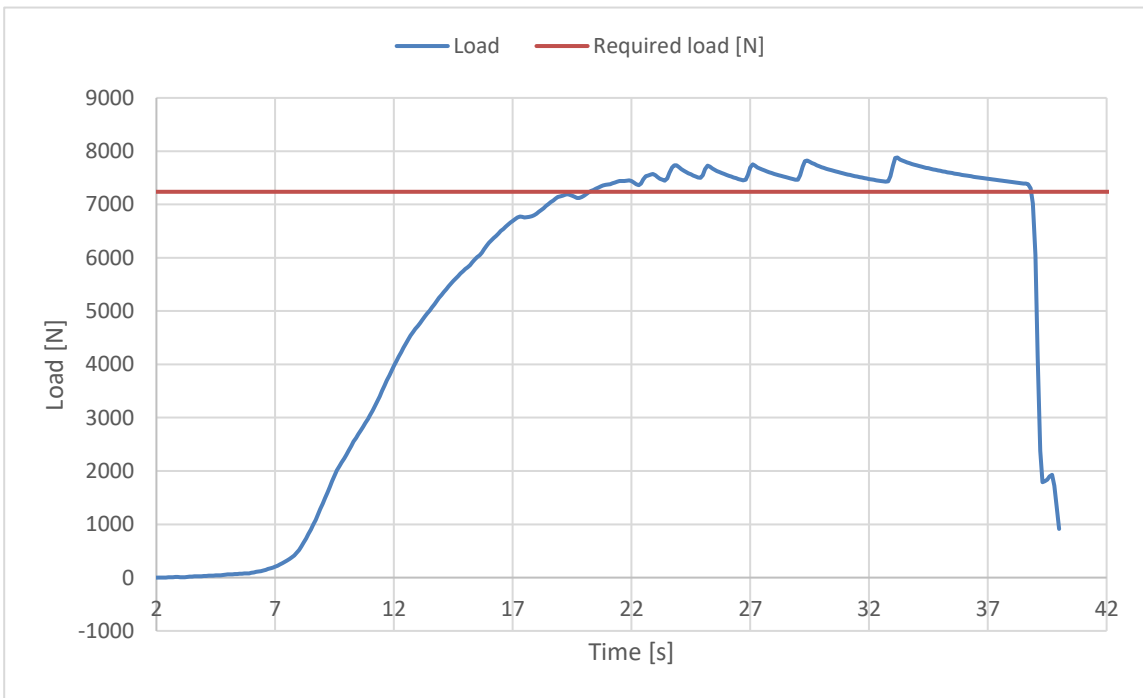
Test ID R0

Standard	EN 1651:1999	
Reference in standard	5.3.2.1	
Test setup	Default flying position	
Attachment points	Both main riser attachment (3,4)	
Anchor points	Dummy (B1, B2)	
Required load [g]	6	
Required load [N]	7200	
Minimum test duration [s]	10	
Result		
Test duration [s]	18.6	
Any signs of structural failure	No	
Test results	POSITIVE

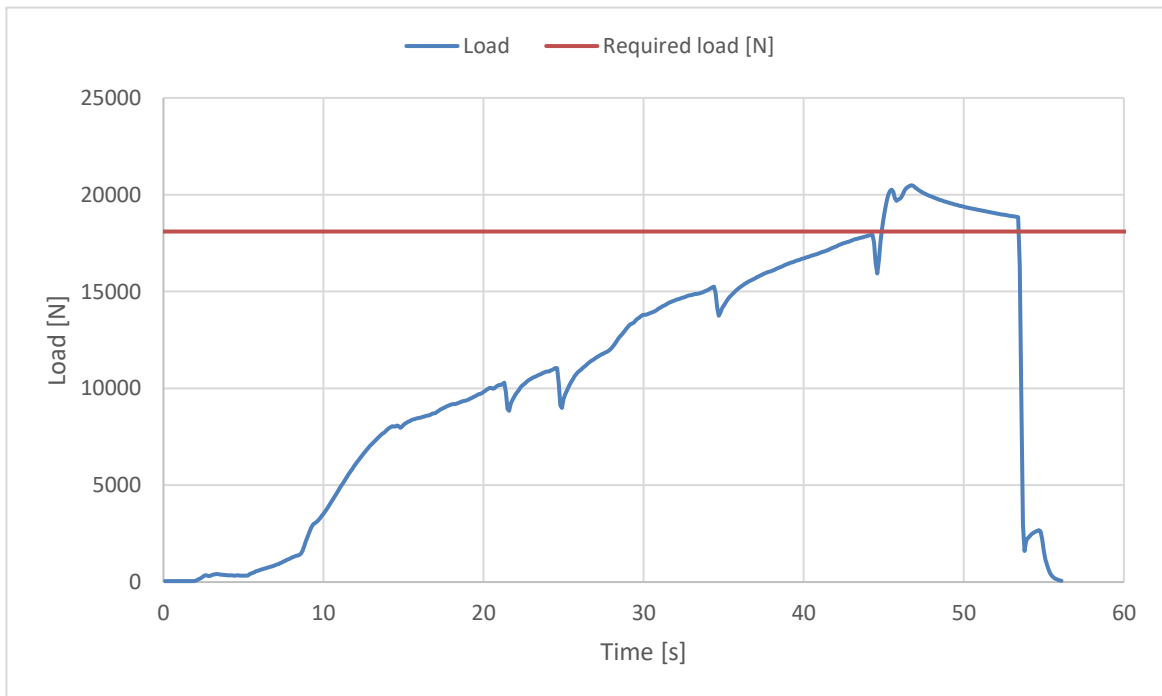
Test ID R2

Reference in standard	5.3.2.2	
Test setup	Default flying position	
Attachment points	Both main riser attachment (3,4)	
Anchor points	Dummy (B1, B2)	
Required load [g]	15	
Required load [N]	18000	
Minimum test duration [s]	5	
Result		
Test duration [s]	10.2	
Any signs of structural failure	No	
Test results	POSITIVE

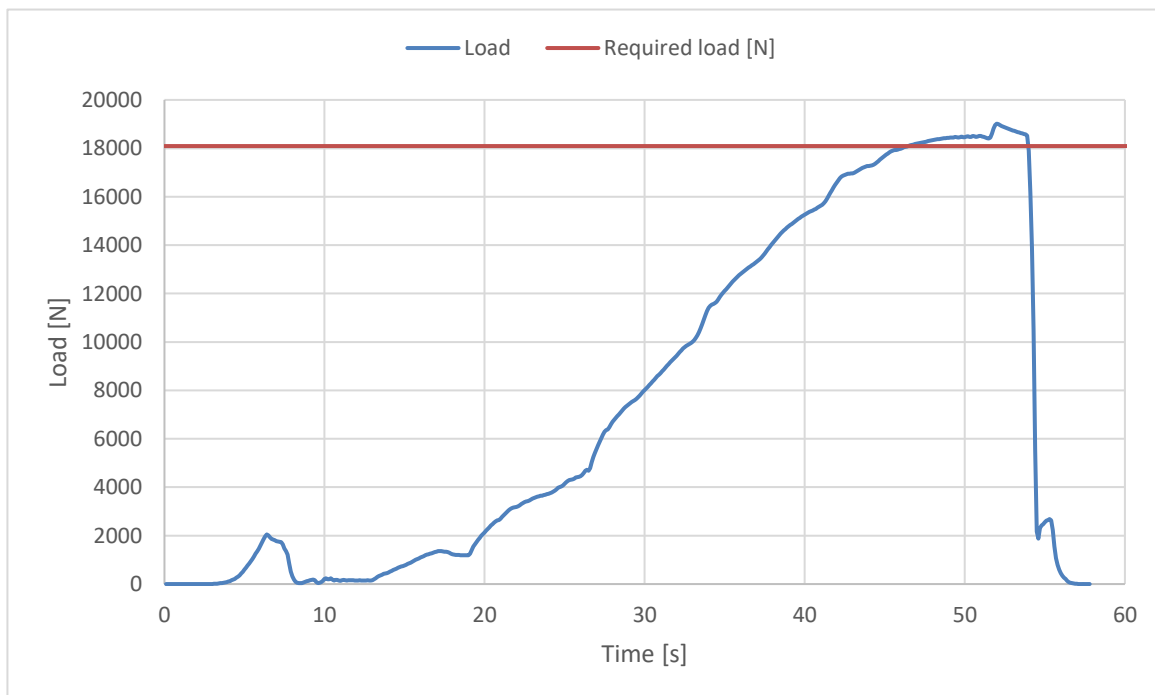
Test ID R4

Standard	EN 1651:1999
Reference in standard	5.3.2.7
Test setup	Flying position before landing
Attachment points	Both main riser attachment (3,4)
Anchor points	Dummy (7,8)
Required load [g]	15
Required load [N]	18000
Minimum test duration [s]	5
Result	
Test duration [s]	7.5
Any signs of structural failure	No
Test results	POSITIVE

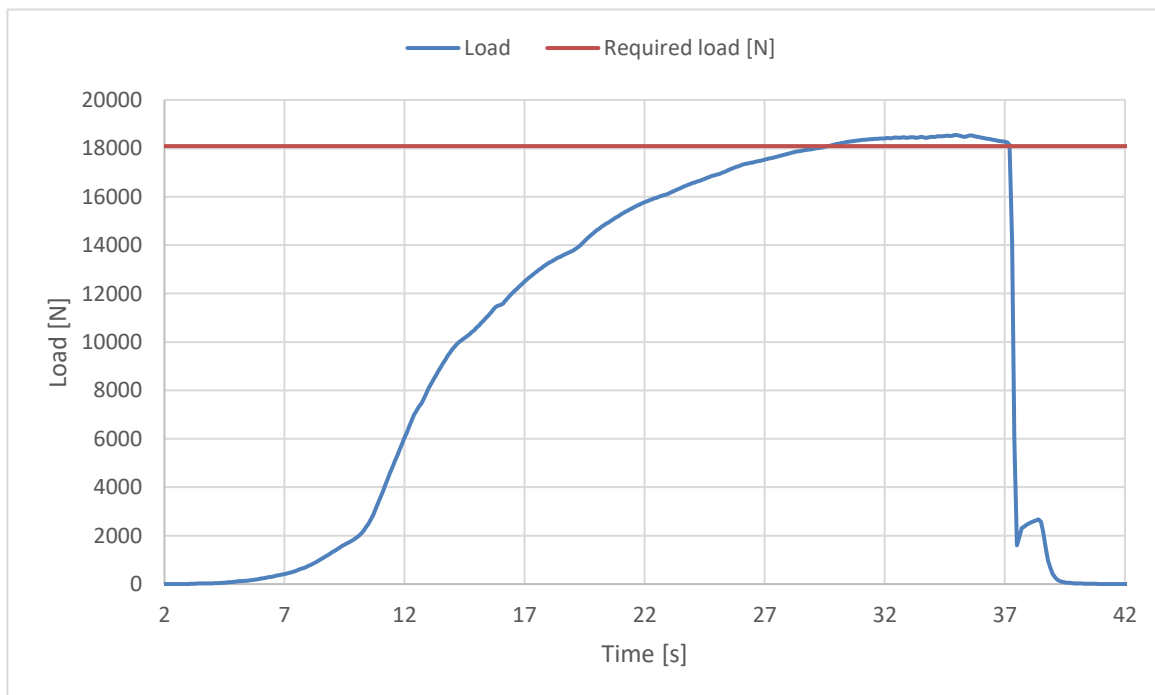
Test ID R6

Standard	EN 1651:1999	
Reference in standard	5.3.2.4	
Test setup	Rescue attachments	
Attachment points	Rescue riser attachment (1,2)	
Anchor points	Dummy (B1,B2)	
Required load [g]	15	
Required load [N]	18000	
Minimum test duration [s]	5	
Result		
Test duration [s]	7.6	
Any signs of structural failure	No	
Test results	POSITIVE

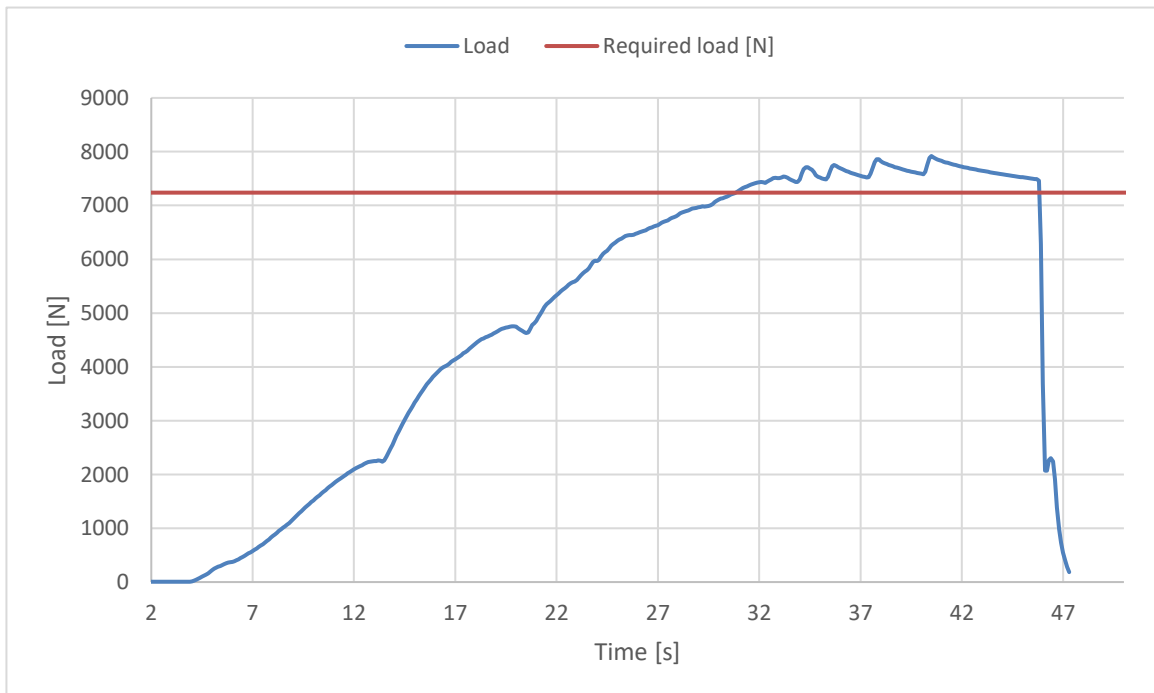
Test ID R8

Standard	EN 1651:1999	
Reference in standard	5.3.2.3	
Test setup	Asymmetric, one riser	
Attachment points	One main riser attachment (3)	
Anchor points	Dummy (B1,B2)	
Required load [g]	6	
Required load [N]	7200	
Minimum test duration [s]	10	
Result		
Test duration [s]	15	
Any signs of structural failure	No	
Test results	POSITIVE

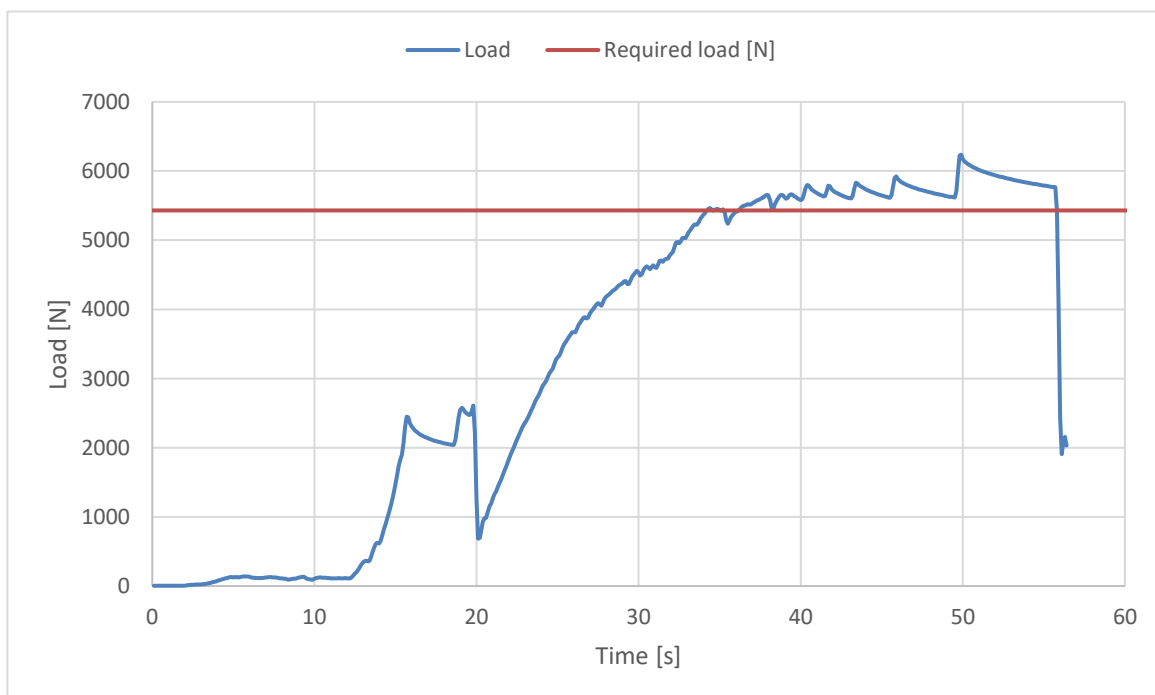
Test ID R10

Reference in standard	5.3.2.6	
Test setup	Asymmetric, negative	
Attachment points	One main riser attachment (3 or 4) downwards	
Anchor points	Dummy (9)	
Required load [g]	4.5	
Required load [N]	5400	
Minimum test duration [s]	10	
Result		
Test duration [s]	19.7	
Any signs of structural failure	No	
Test results	POSITIVE
