## Harness Structural test Report - NfL

Inspection certificate number: **PH\_408.2023**

Name: **Le Slip 2**  
 Type: **ABS**  
 Size: **M**  
 Serial number: **AN23045047-0**  
 Impact pad type: <sup>(1)</sup> **Airbag**  
 Clip-in weight [kg]: **120**  
 Integrated container: **No**  
 Date of test: **25.05.2023**

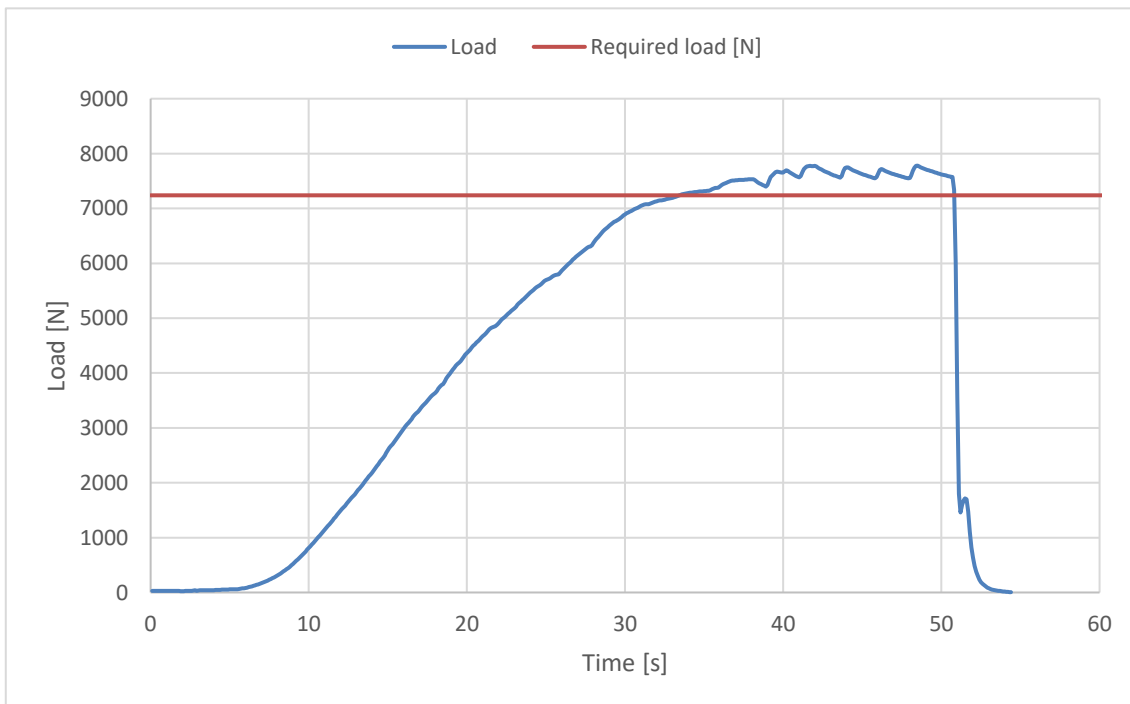
**Test ID 02**

Standard	<b>EN 1651:1999</b>
Reference	<b>5.3.2.1</b>
Test setup	<b>Default flying position</b>
Attachment points	<b>Both main riser attachment (3,4)</b>
Anchor points	<b>Dummy (B1, B2)</b>
Required load [g]	<b>6</b>
Required load [N]	<b>7200</b>
Minimum test duration [s]	<b>10</b>
<b>Result</b>	
Test duration [s]	<b>17.4</b>
Any signs of structural failure	<b>No</b>
Test results	<b>POSITIVE</b>

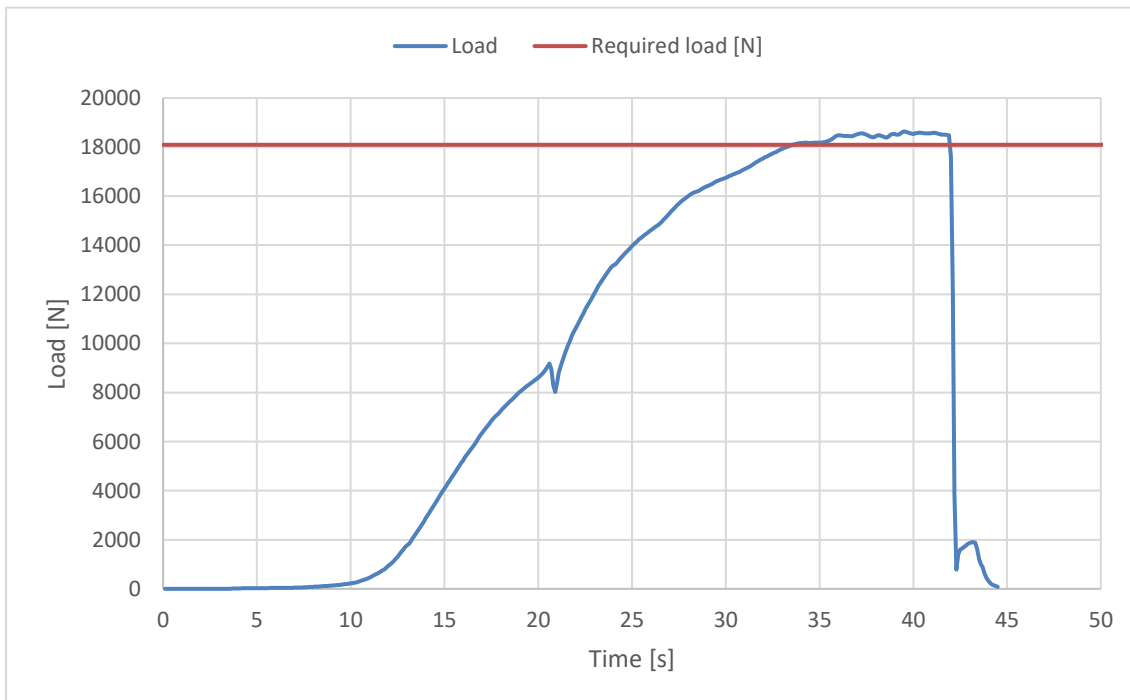
**Test ID 03**

Standard	<b>EN 1651:1999</b>
Reference	<b>5.3.2.2</b>
Test setup	<b>Default flying position</b>
Attachment points	<b>Both main riser attachment (3,4)</b>
Anchor points	<b>Dummy (B1, B2)</b>
Required load [g]	<b>15</b>
Required load [N]	<b>18000</b>
Minimum test duration [s]	<b>5</b>
<b>Result</b>	
Test duration [s]	<b>8.4</b>
Any signs of structural failure	<b>No</b>
Test results	<b>POSITIVE</b>

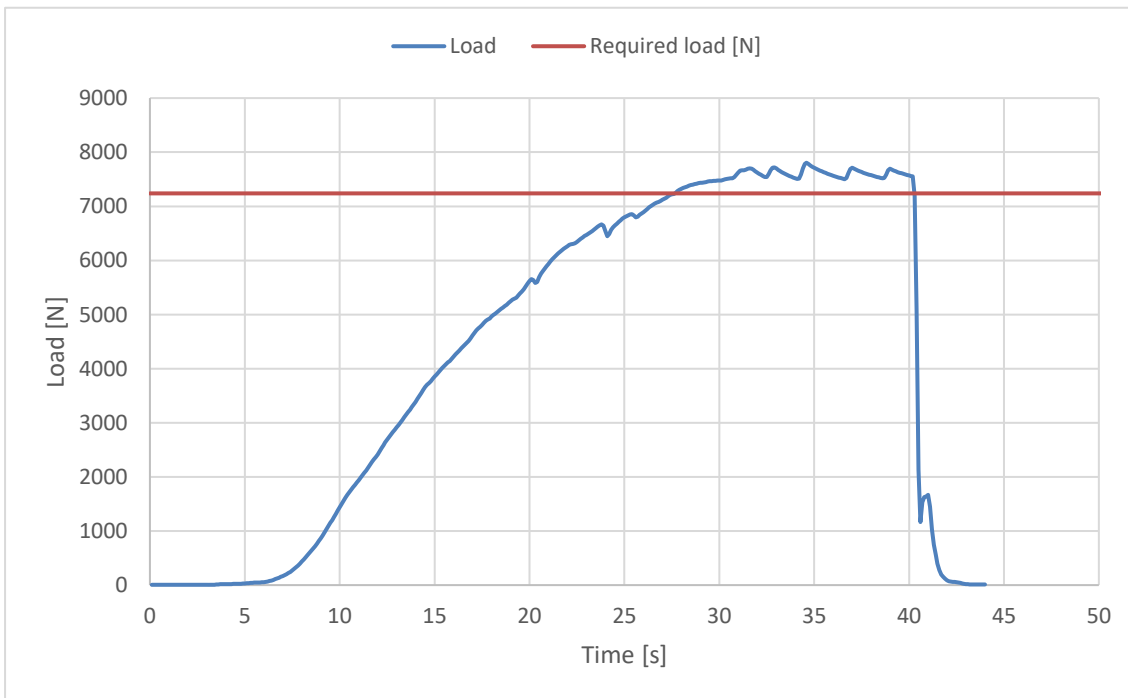
**Test ID 04**

Standard **EN 1651:1999**  
 Reference **5.3.2.3**  
 Test setup **Asymmetric, one riser**  
 Attachment points **One main riser attachment (3)**  
 Anchor points **Dummy (B1,B2)**

Test duration [s] **12.6**  
 Any signs of structural failure **No**  
 Test results **POSITIVE**

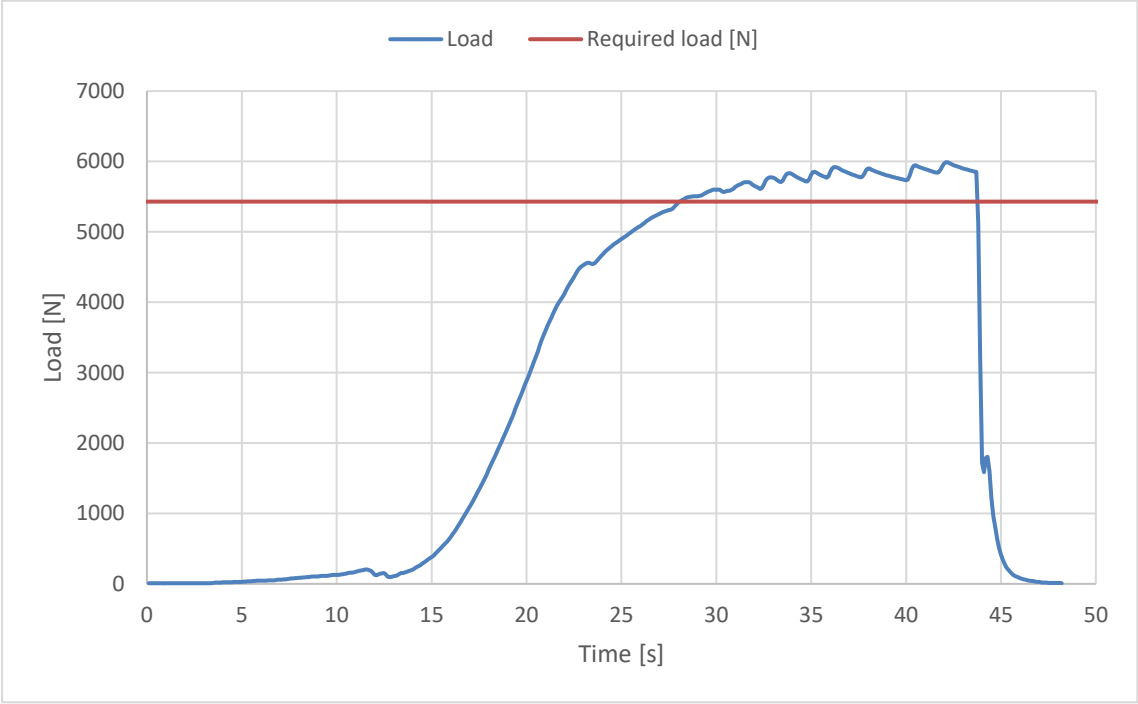
**Test ID 07**

Reference	<b>5.3.2.6</b>	
Test setup	<b>Asymmetric, negative</b>	
Attachment points	<b>One main riser attachment (3 or 4) downwards</b>	
Anchor points	<b>Dummy (9)</b>	
Required load [g]	<b>4.5</b>	
Required load [N]	<b>5400</b>	
Minimum test duration [s]	<b>10</b>	
<b>Result</b>		
Test duration [s]	<b>15.7</b>	
Any signs of structural failure	<b>No</b>	
Test results	<b>POSITIVE</b>

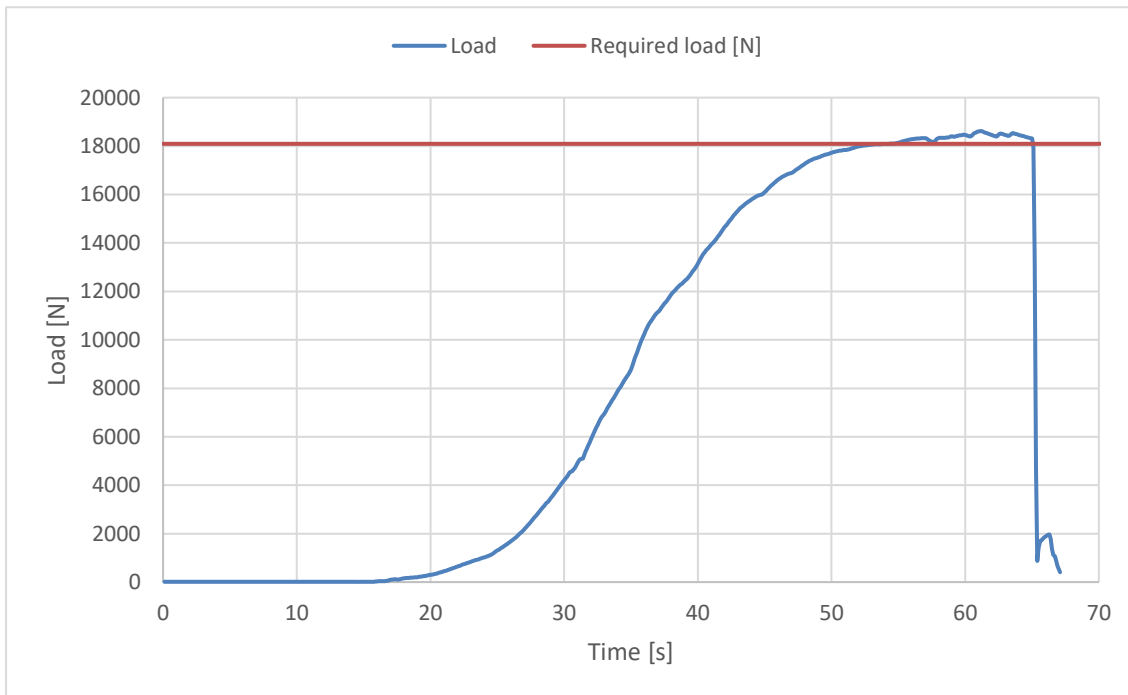
**Test ID 13**

Standard **EN 1651:1999**  
 Reference **5.3.2.7**  
 Test setup **Flying position before landing**  
 Attachment points **Both main riser attachment (3,4)**  
 Anchor points **Dummy (7,8)**

Test duration [s] **10.7**  
 Any signs of structural failure **No**  
 Test results **POSITIVE**
