Harness Structural test Report - NfL

Inspection certificate number: PH_371.2022

Name: **The Sock**
 Type: **ABS**
 Size: **L**
 Serial number: **Proto#5**
 Impact pad type: ⁽¹⁾ **Inflatable**
 Clip-in weight [kg]: **120**
 Integrated container: **Yes**
 Date of test: **08.02.2022**

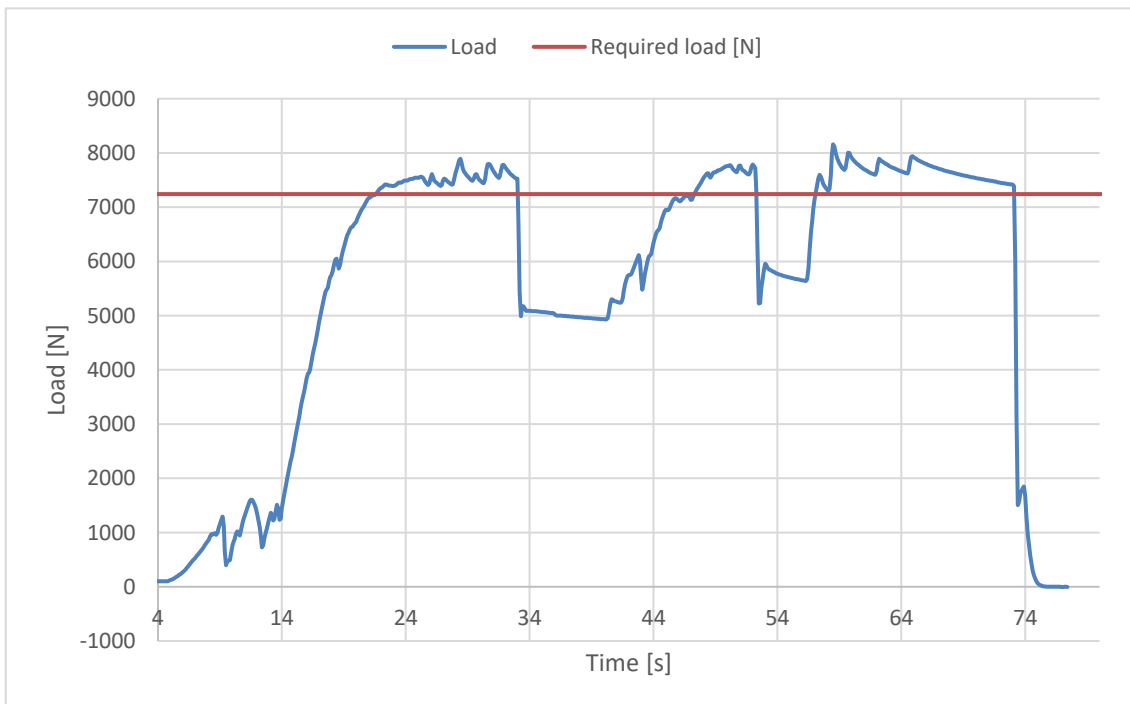
Test ID 02

Standard	NfL 2-565-20
Reference	5.3.2.1
Test setup	Default flying position
Attachment points	Both main riser attachment (3,4)
Anchor points	Dummy (B1, B2)
Required load [g]	6
Required load [N]	7200
Minimum test duration [s]	10
Result	
Test duration [s]	16.1
Any signs of structural failure	No
Test results	POSITIVE

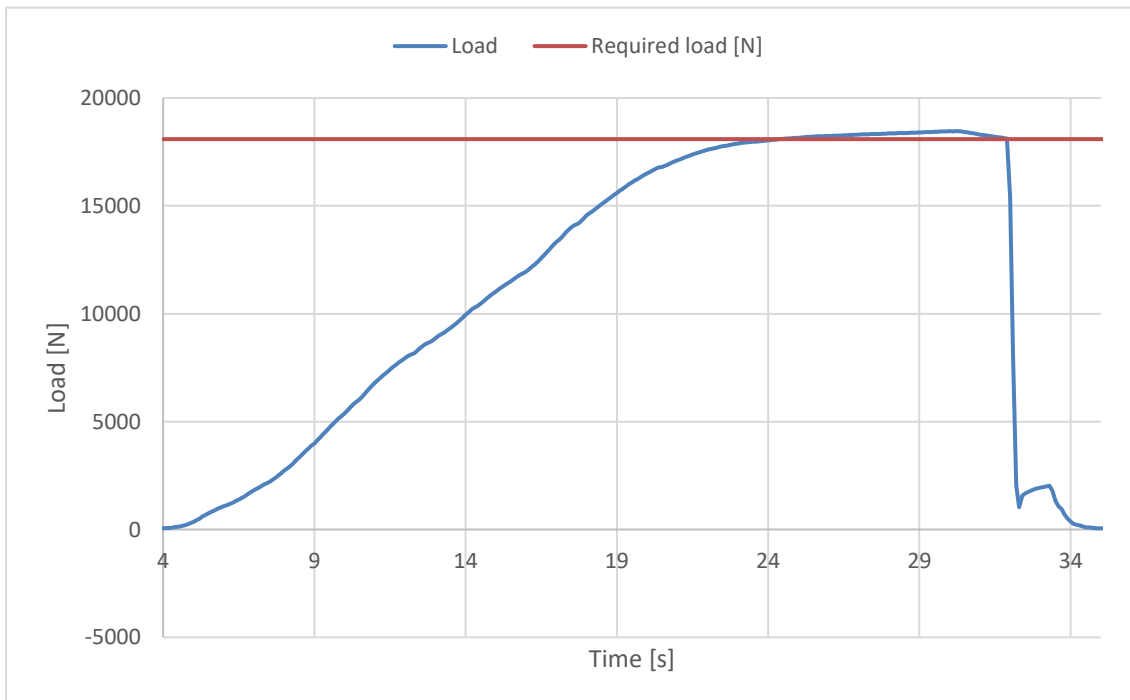
Test ID 03

Reference	5.3.2.2	
Test setup	Default flying position	
Attachment points	Both main riser attachment (3,4)	
Anchor points	Dummy (B1, B2)	
Required load [g]	15	
Required load [N]	18000	
Minimum test duration [s]	5	
Result		
Test duration [s]	7.5	
Any signs of structural failure	No	
Test results	POSITIVE

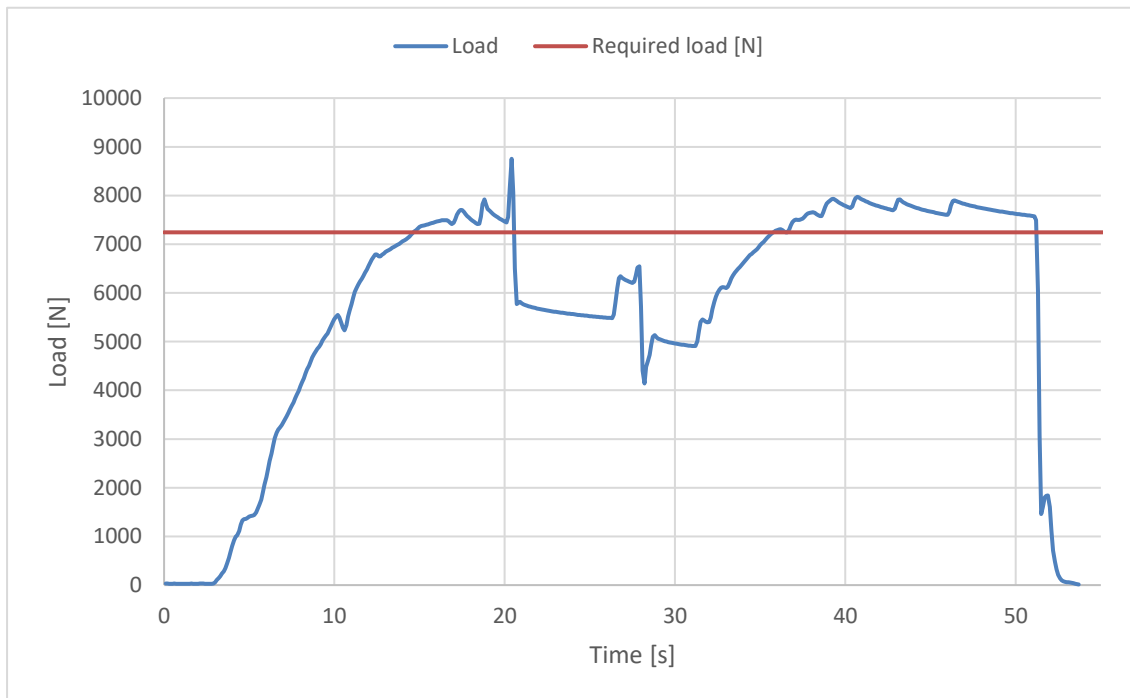
Test ID 04

Standard	NfL 2-565-20
Reference	5.3.2.3
Test setup	Asymmetric, one riser
Attachment points	One main riser attachment (3)
Anchor points	Dummy (B1,B2)
Required load [g]	6
Required load [N]	7200
Minimum test duration [s]	10
Result	
Test duration [s]	14.7
Any signs of structural failure	No
Test results	POSITIVE

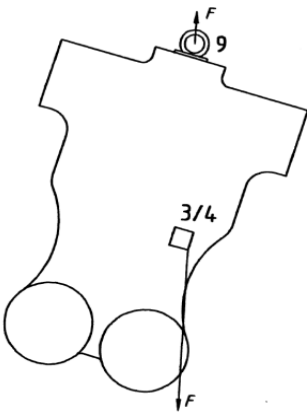
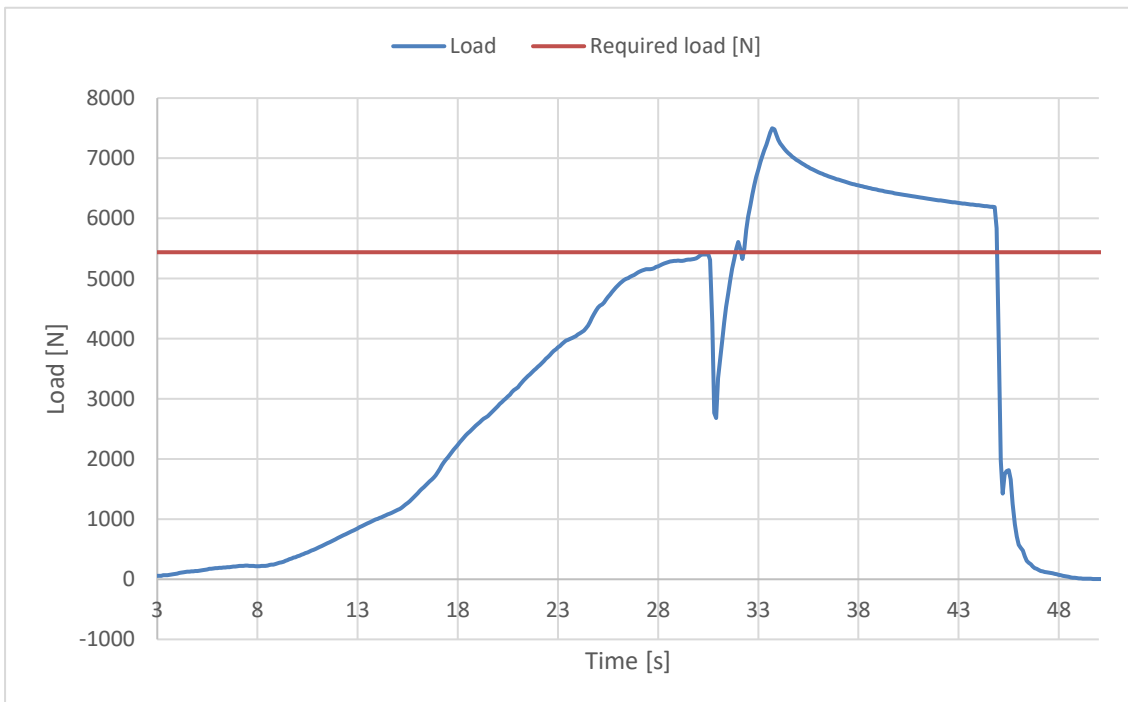
Test ID 07

Reference	5.3.2.6	
Test setup	Asymmetric, negative	
Attachment points	One main riser attachment (3 or 4) downwards	
Anchor points	Dummy (9)	
Required load [g]	4.5	
Required load [N]	5400	
Minimum test duration [s]	10	
Result		
Test duration [s]	12.7	
Any signs of structural failure	No	
Test results	POSITIVE

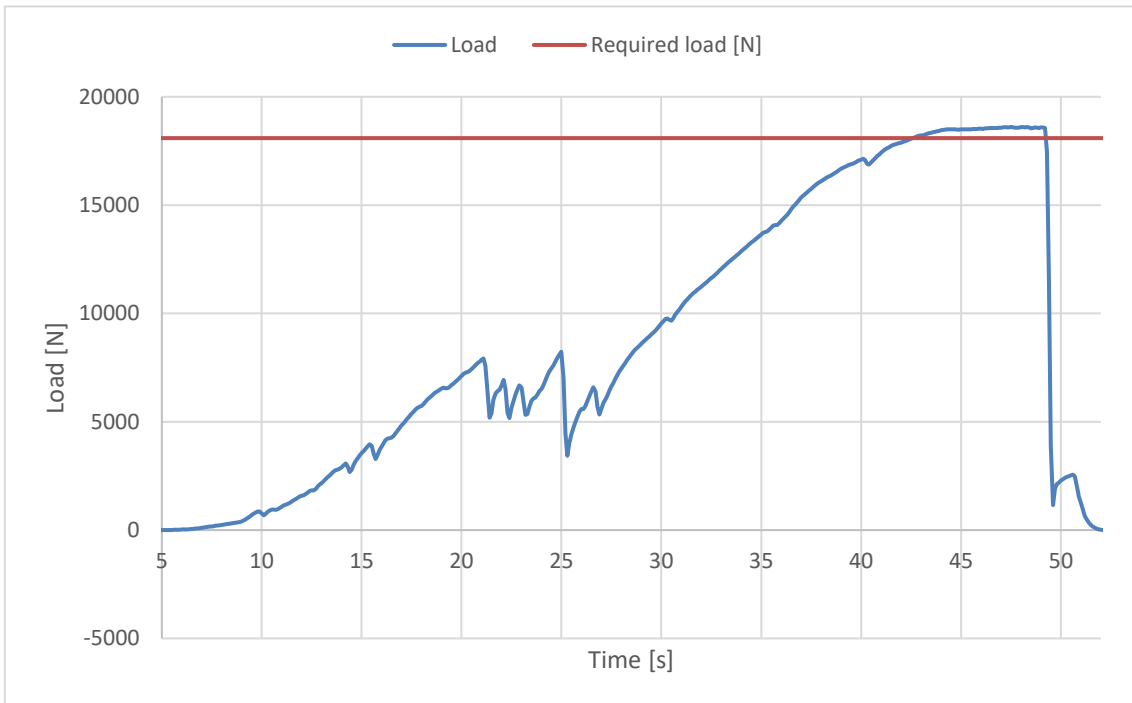
Test ID 09

Standard	NfL 2-565-20
Reference	5.3.2.4
Test setup	Rescue attachments
Attachment points	Rescue riser attachment (1,2)
Anchor points	Dummy (B1,B2)
Required load [g]	15
Required load [N]	18000
Minimum test duration [s]	5
Result	
Test duration [s]	6.7
Any signs of structural failure	No
Test results	POSITIVE

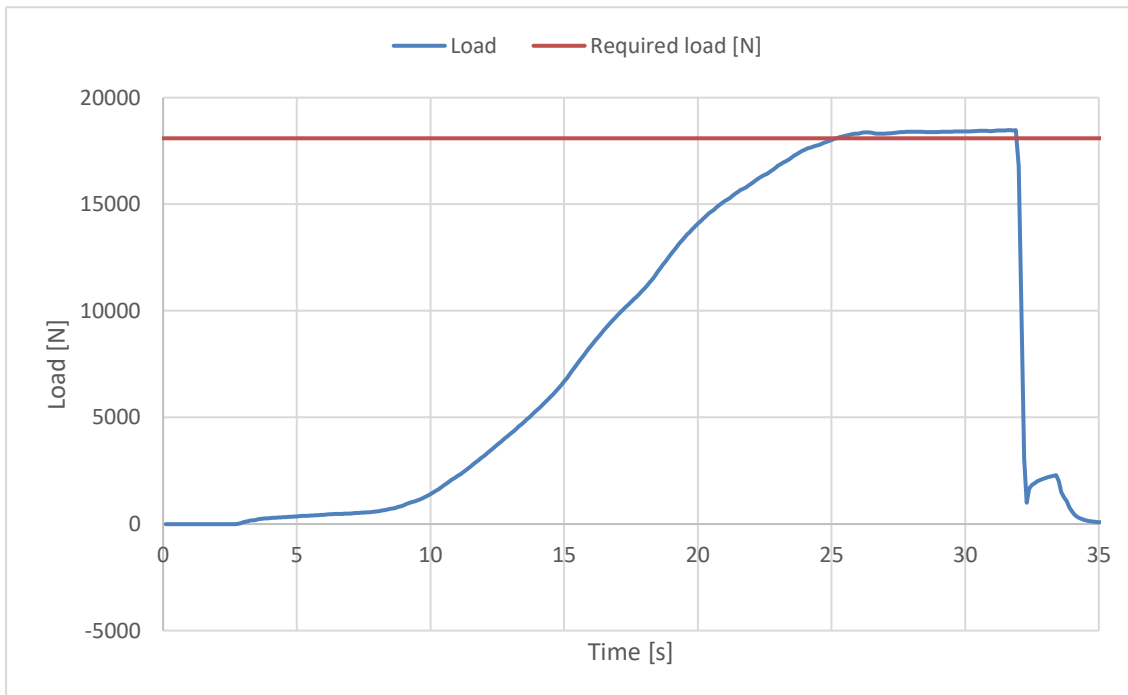
Test ID 13

Test duration [s] **6.8**
 Any signs of structural failure **No**
 Test results **POSITIVE**

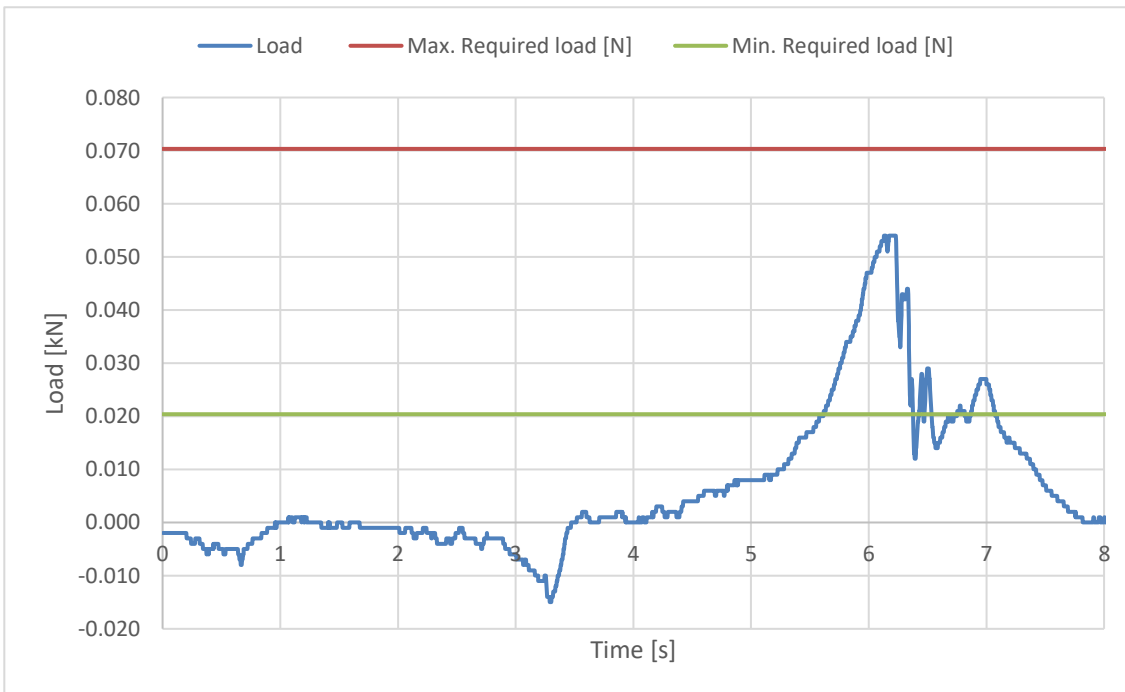
Test ID RRDT

Load for first action [N] **53.64**
 Test results **POSITIVE**

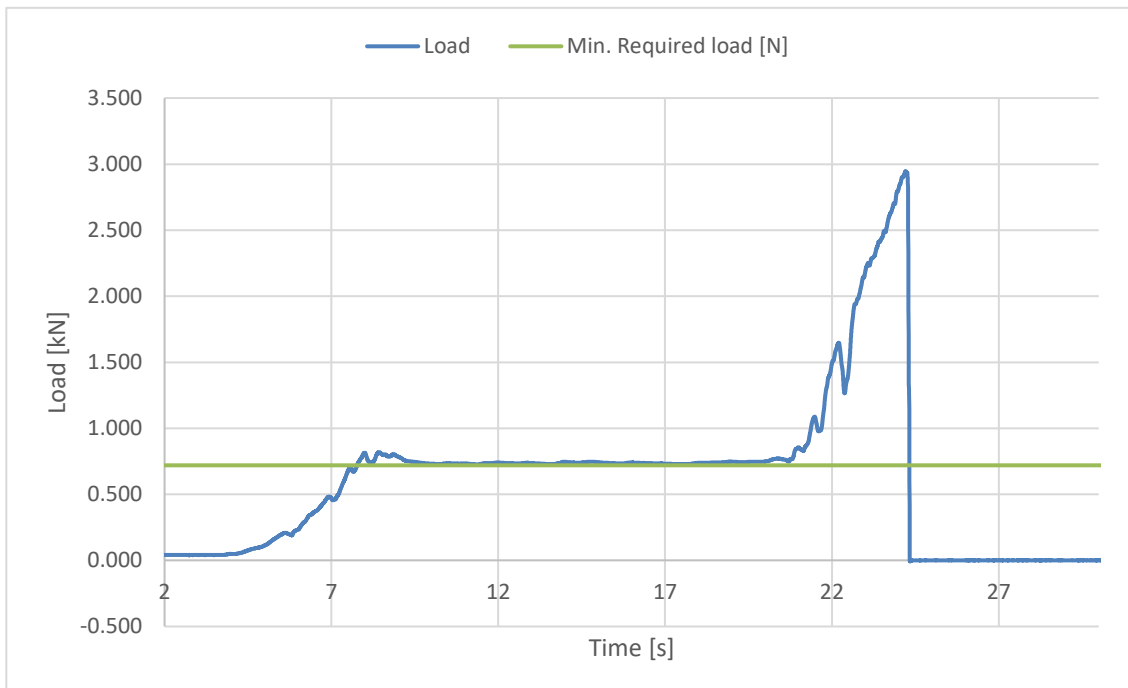
Test ID RRST

Standard	EN12491:2015
Reference in standard	5.3.2
Test setup	Two end points of handle
Attachment points	Sensor connect to end of handle, pull on the other side
	The handle must support min 700 N for 10 s, after measure breaking strength
Min. Required load [N]	700
Minimum test duration [s]	10
Result	
Test duration [s]:	16.5
Breaking strength [N]	2926.43
Test results	POSITIVE
