Harness Structural test Report - EN

Inspection certificate number: **PH_333.2021**

Name: **Link Passenger**
 Type: **ABS**
 Size: **One size**
 Serial number: **BG0823102F**
 Impact pad type: ⁽¹⁾ **Foam**
 Clip-in weight [kg]: **120**
 Date of test: **07.09.2020**

model: **Link Passenger**

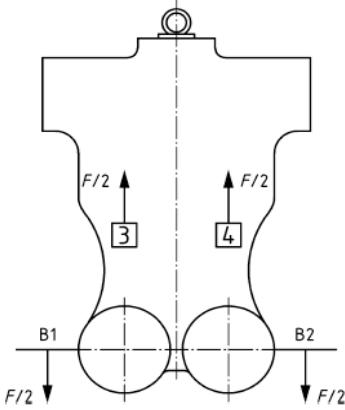
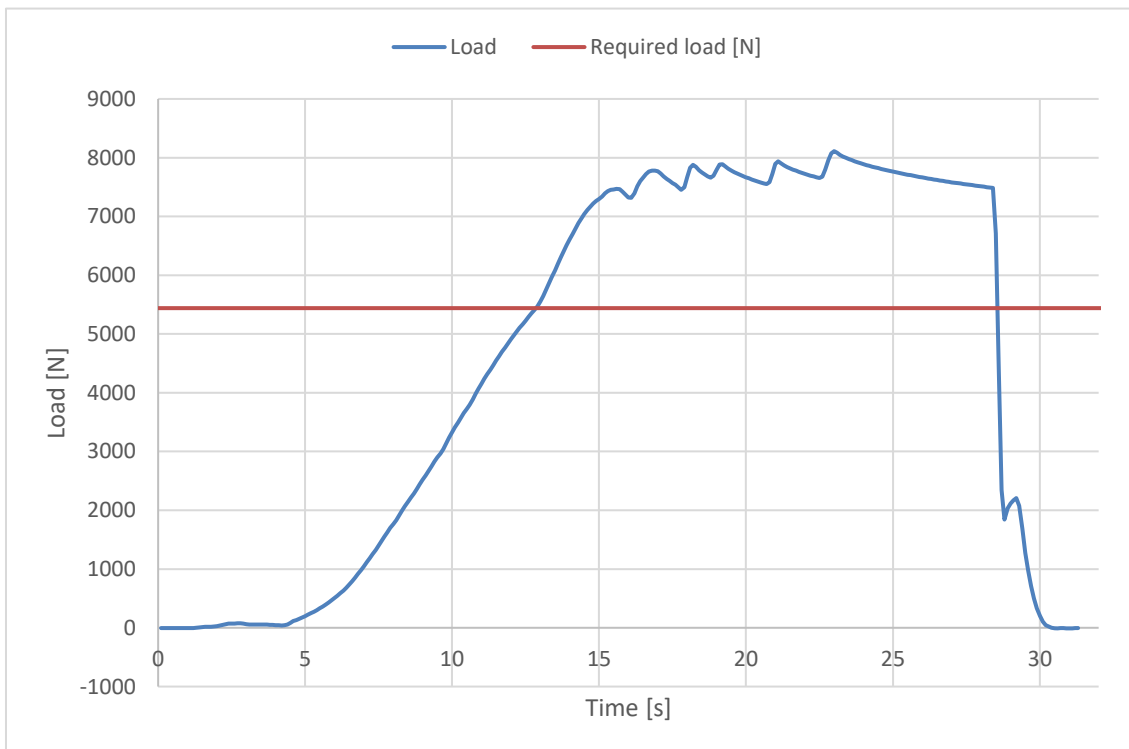
Test ID 01

Standard	EN 1651
Reference in standard	5.5.1.1
Test setup	Positive symmetric load (Slippage)
Attachment points	Both main riser attachment (3,4)
Anchor points	Dummy (B1, B2)
Required load [g]	4.5
Required load [N]	5400
Minimum test duration [s]	5
Result	
Test duration [s]	15.7
Any signs of structural failure	No
Slippery test OK	Yes
Test results	POSITIVE

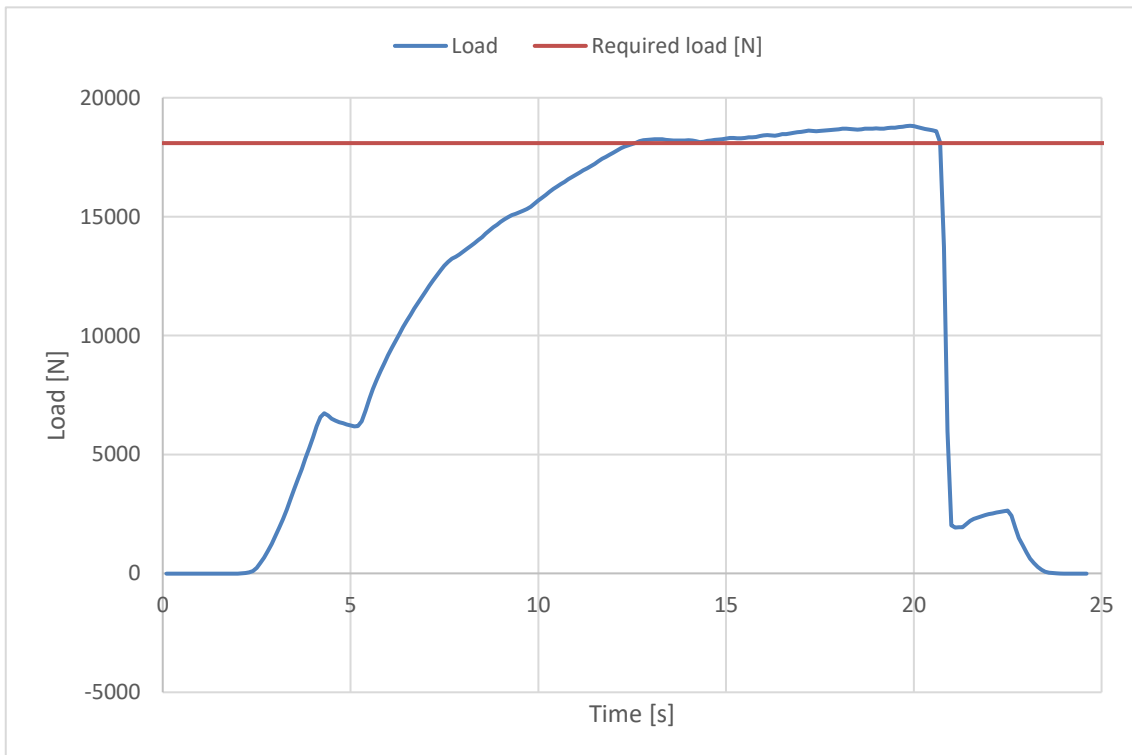
Test ID 03

Standard **EN 1651**
 Reference in standard **5.5.1.1b**
 Test setup **Positive symmetric load**
 Attachment points **Both main riser attachment (3,4)**
 Anchor points **Dummy (B1, B2)**

Test duration [s] **8.2**
 Any signs of structural failure **No**
 Slippery test OK **Yes**
 Test results **POSITIVE**

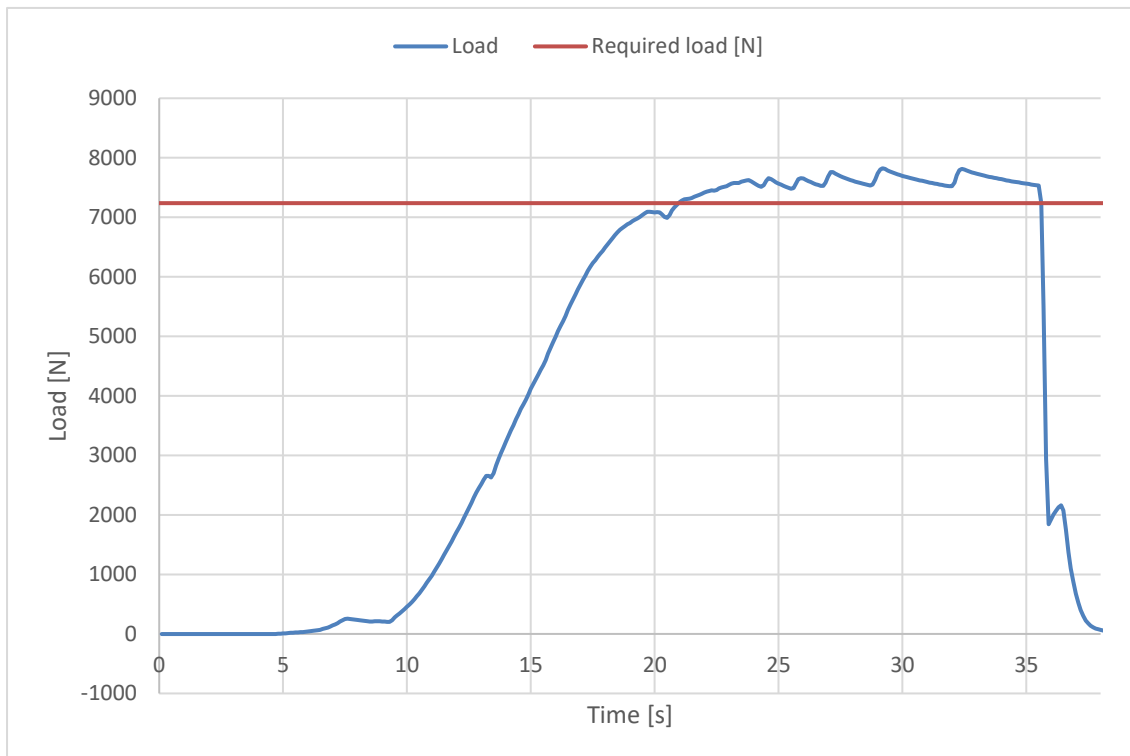
Test ID 05

Standard	EN 1651
Reference in standard	5.5.1.2
Test setup	Positive asymmetric load
Attachment points	One riser attachment (3 or 4)
Anchor points	Dummy (C)
Required load [g]	6
Required load [N]	7200
Minimum test duration [s]	5
Result	
Test duration [s]	14.6
Any signs of structural failure	No
Test results	POSITIVE

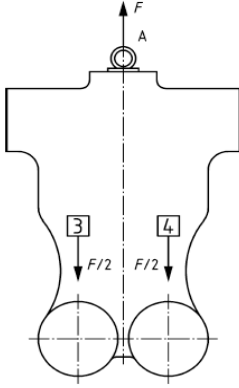
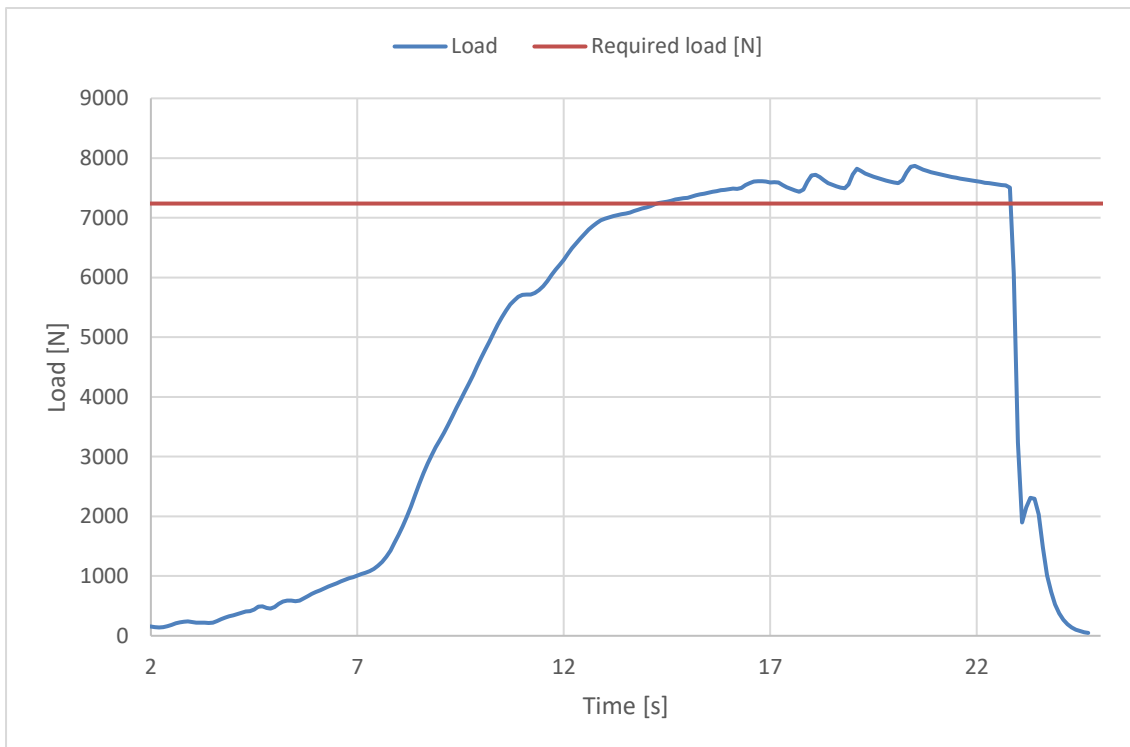
Test ID 06

Standard	EN 1651
Reference in standard	5.5.1.6
Test setup	Negative symmetric load
Attachment points	Both main riser attachment (3,4)
Anchor points	Dummy (A)
Required load [g]	6
Required load [N]	7200
Minimum test duration [s]	5
Result	
Test duration [s]	8.6
Any signs of structural failure	No
Test results	POSITIVE

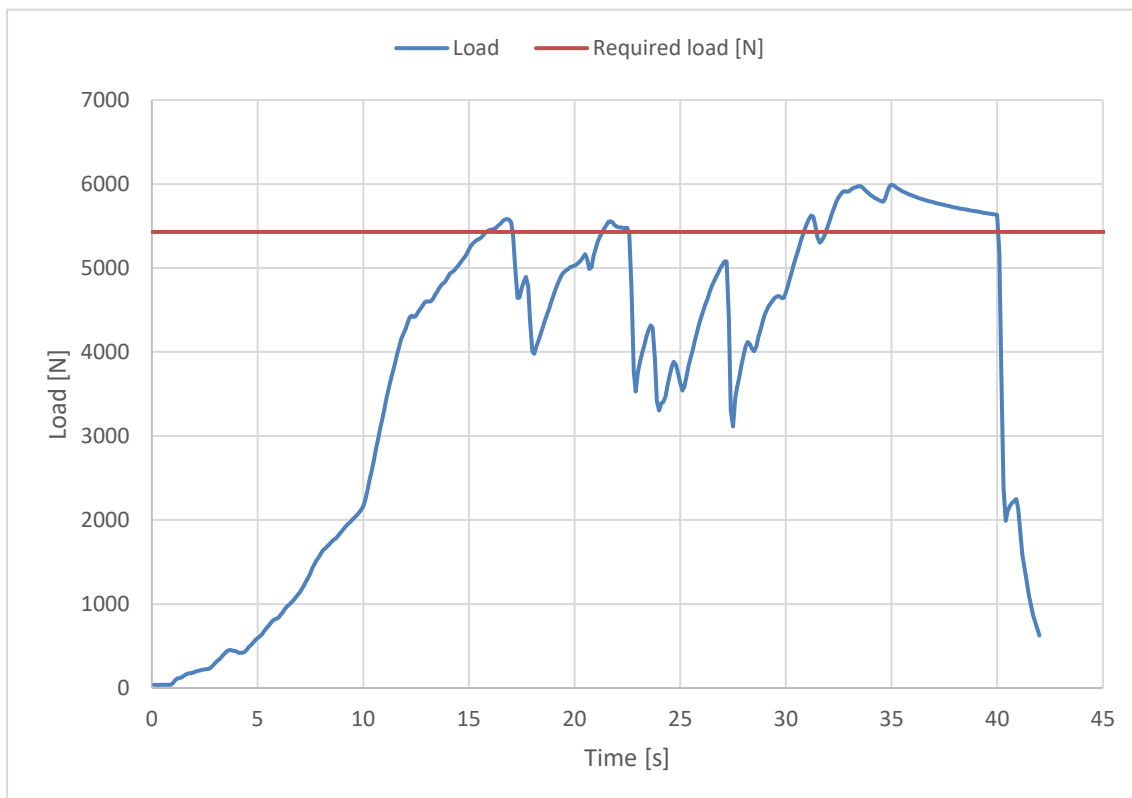
Test ID 08

Standard	EN 1651
Reference in standard	5.5.1.9
Test setup	Anti falling-out system
Attachment points	Around anti falling-out system
Anchor points	Both main riser attachment (no dummy)
Required load [g]	4.5
Required load [N]	5400
Minimum test duration [s]	5
Result	
Test duration [s]	8.2
Any signs of structural failure	No
Test results	POSITIVE

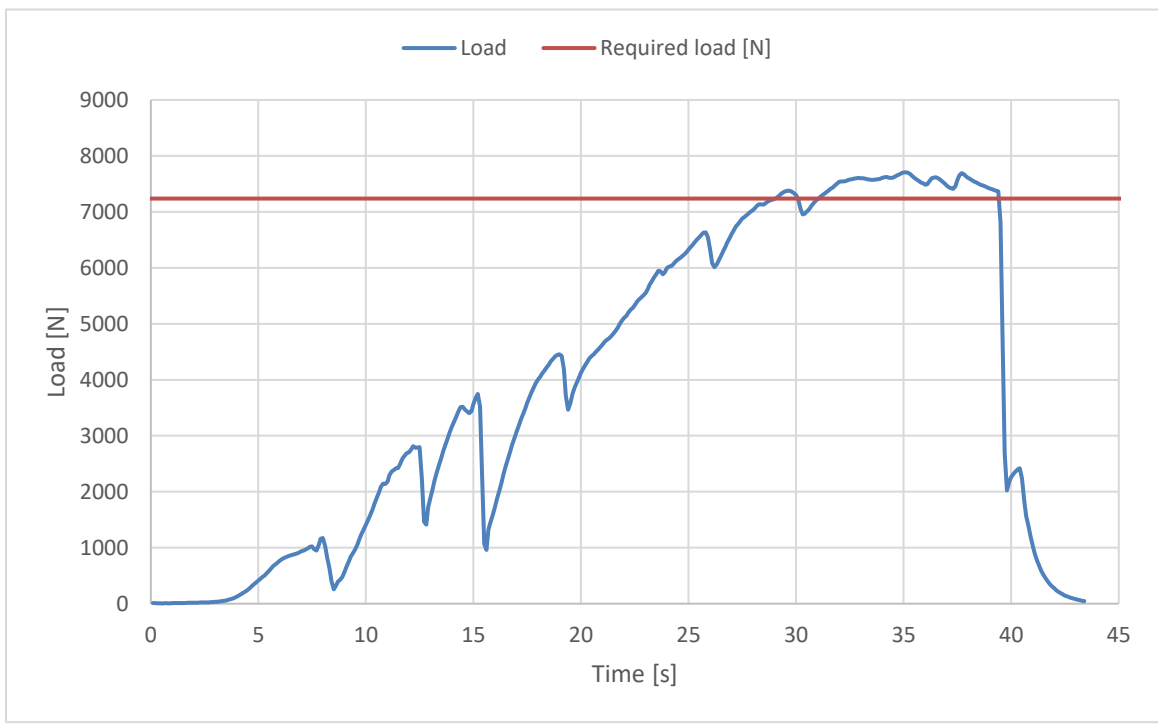
Test ID 12

Standard	EN 1651
Reference in standard	5.5.1.7
Test setup	Upright (landing) position load
Attachment points	Both main riser attachment (3, 4)
Anchor points	Both legstrap of harness (no dummy)
Required load [g]	6
Required load [N]	7200
Minimum test duration [s]	5
Harness type	type a
Result	
Test duration [s]	8.4
Any signs of structural failure	No
Slippery test OK	Yes
Test results	POSITIVE
