Harness Structural test Report - LTF

Inspection certificate number: **PH_333.2021**

Name: **Link Passenger**
 Type: **ABS**
 Size: **One size**
 Serial number: **BG0823102F**
 Impact pad type: ⁽¹⁾ **Foam**
 Clip-in weight [kg]: **120**

Summary of Structural test

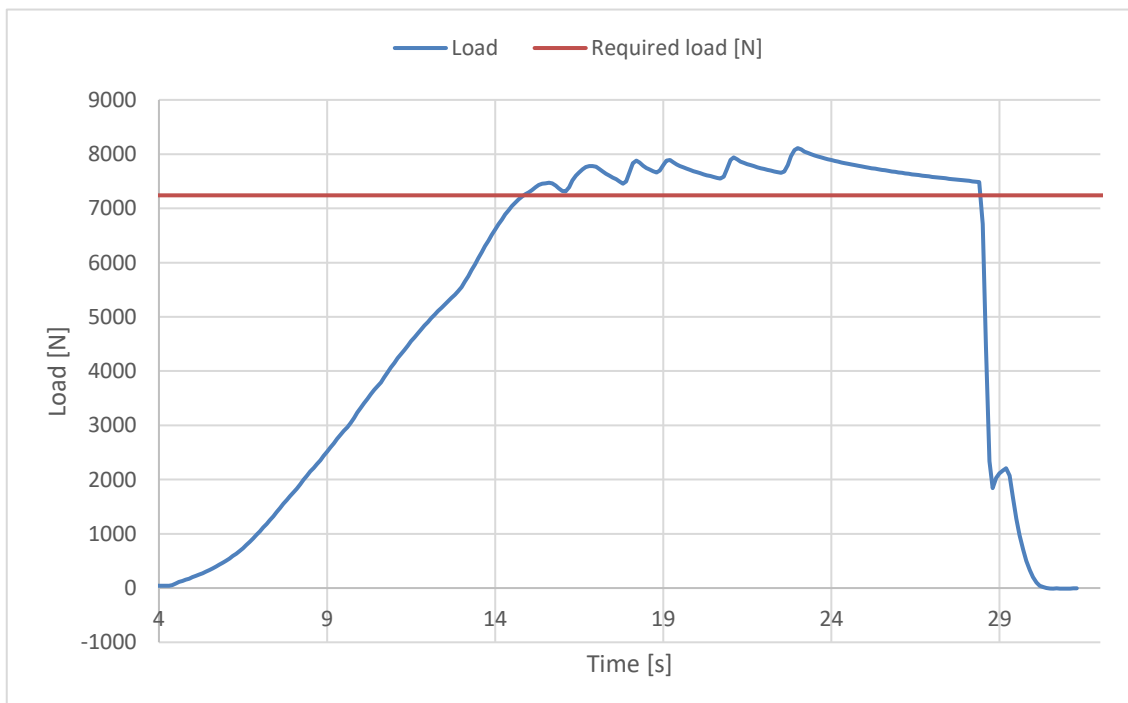
Test ID 02

Standard	LTF NfL II 91/09
Reference	5.3.2.1
Test setup	Default flying position
Attachment points	Both main riser attachment (3,4)
Anchor points	Dummy (B1, B2)
Required load [g]	6
Required load [N]	7200
Minimum test duration [s]	10
Result	
Test duration [s]	13.6
Any signs of structural failure	No
Test results	POSITIVE

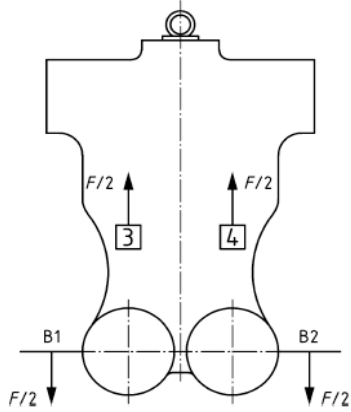
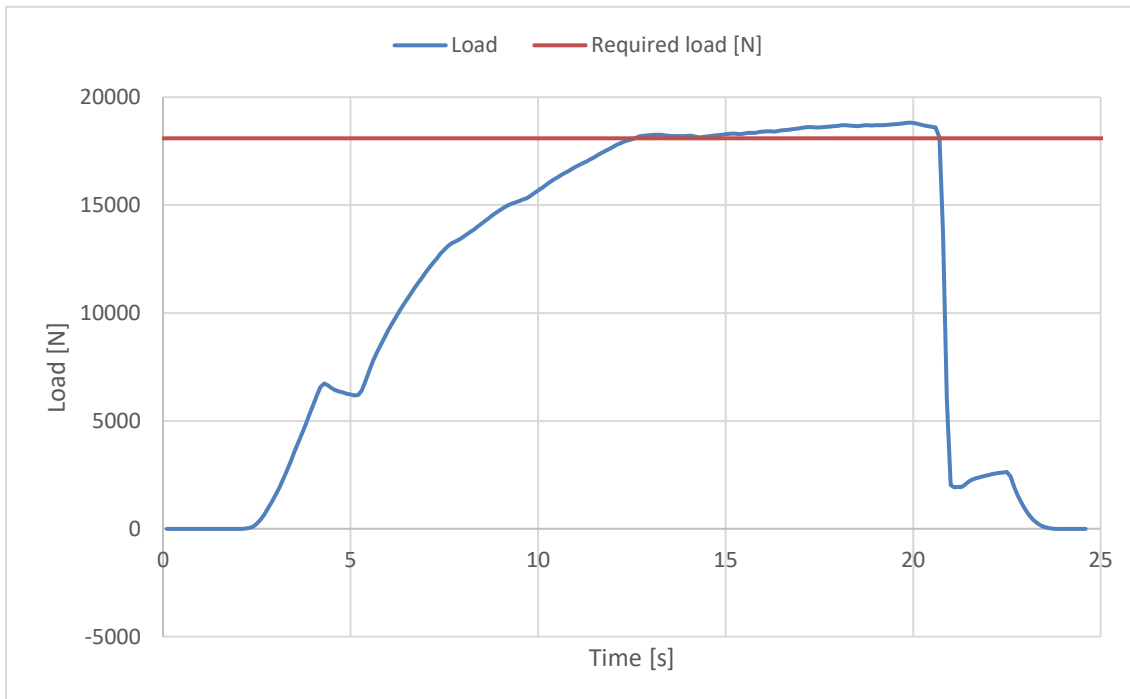
Test ID 03

Standard	LTF NfL II 91/09
Reference	5.3.2.2
Test setup	Default flying position
Attachment points	Both main riser attachment (3,4)
Anchor points	Dummy (B1, B2)
Required load [g]	15
Required load [N]	18000
Minimum test duration [s]	5
Result	
Test duration [s]	8.2
Any signs of structural failure	No
Test results	POSITIVE

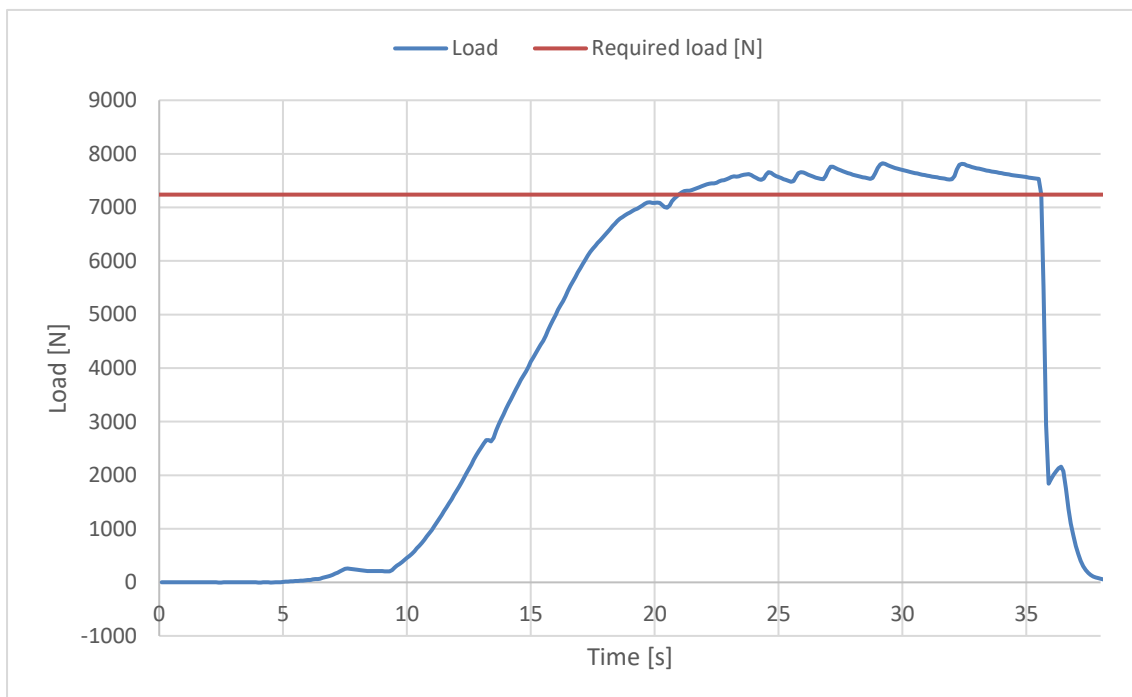
Test ID 04

Standard	LTF NfL II 91/09
Reference	5.3.2.3
Test setup	Asymmetric, one riser
Attachment points	One main riser attachment (3)
Anchor points	Dummy (B1,B2)
Required load [g]	6
Required load [N]	7200
Minimum test duration [s]	10
Result	
Test duration [s]	14.6
Any signs of structural failure	No
Test results	POSITIVE

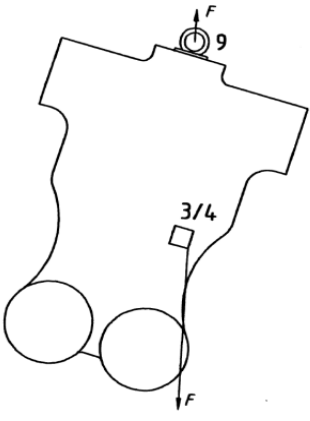
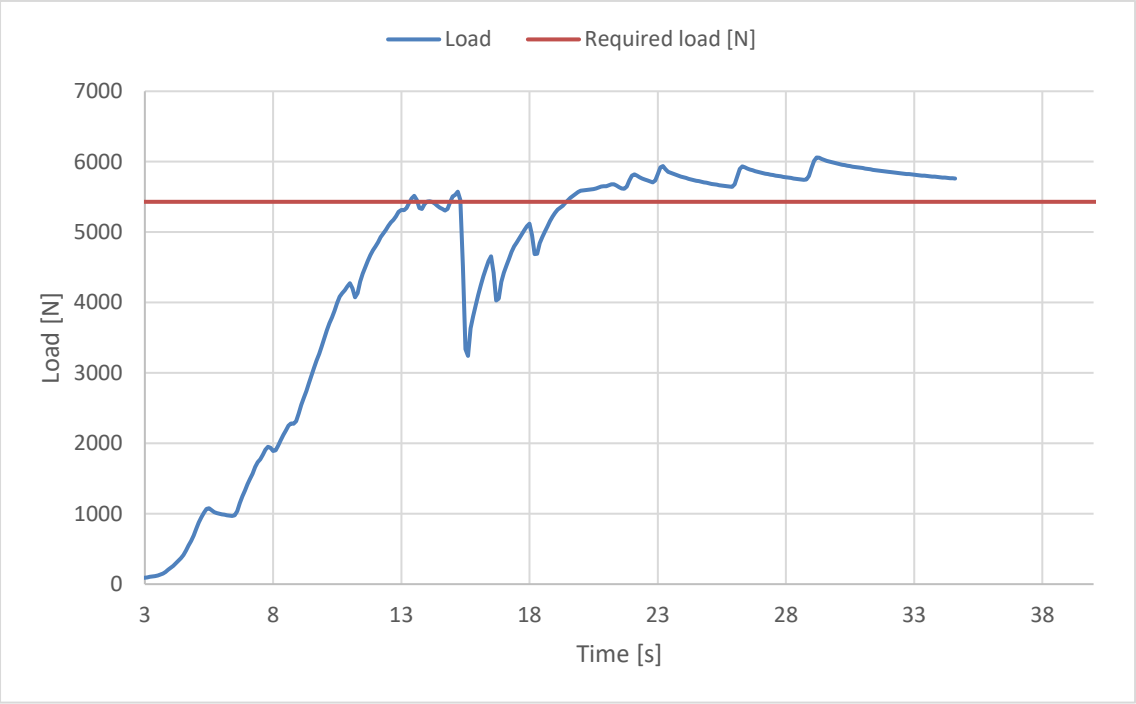
Test ID 07

Reference	5.3.2.6	
Test setup	Asymmetric, negative	
Attachment points	One main riser attachment (3 or 4) downwards	
Anchor points	Dummy (9)	
Required load [g]	4.5	
Required load [N]	5400	
Minimum test duration [s]	10	
Result		
Test duration [s]	15.2	
Any signs of structural failure	No	
Test results	POSITIVE

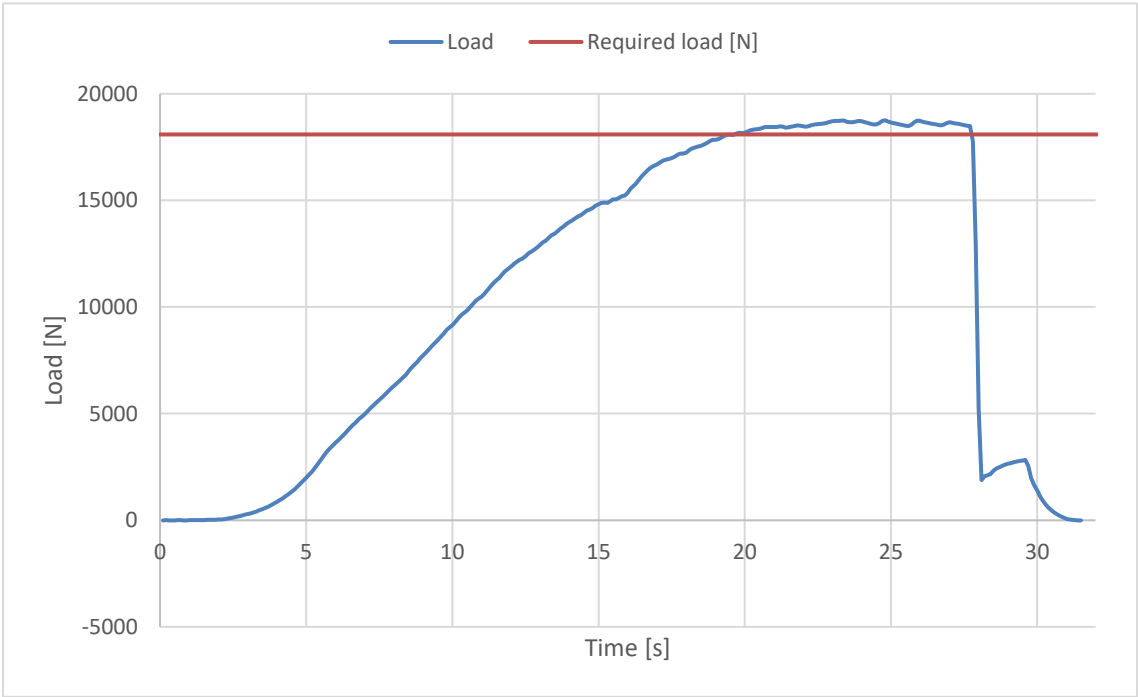
Test ID 13

Standard	LTF NfL II 91/09
Reference	5.3.2.7
Test setup	Flying position before landing
Attachment points	Both main riser attachment (3,4)
Anchor points	Dummy (7,8)
Required load [g]	15
Required load [N]	18000
Minimum test duration [s]	5
Result	
Test duration [s]	8.1
Any signs of structural failure	No
Test results	POSITIVE
