Harness Structural test Report

Inspection certificate number: **PH_355.2022**

Name: **Cody**
 Type: **Full body (type C)**
 Size: **M-L**
 Serial number: **2112120205**

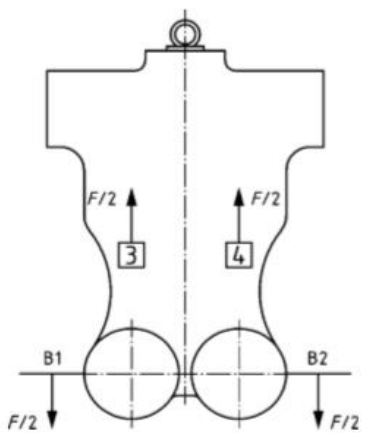
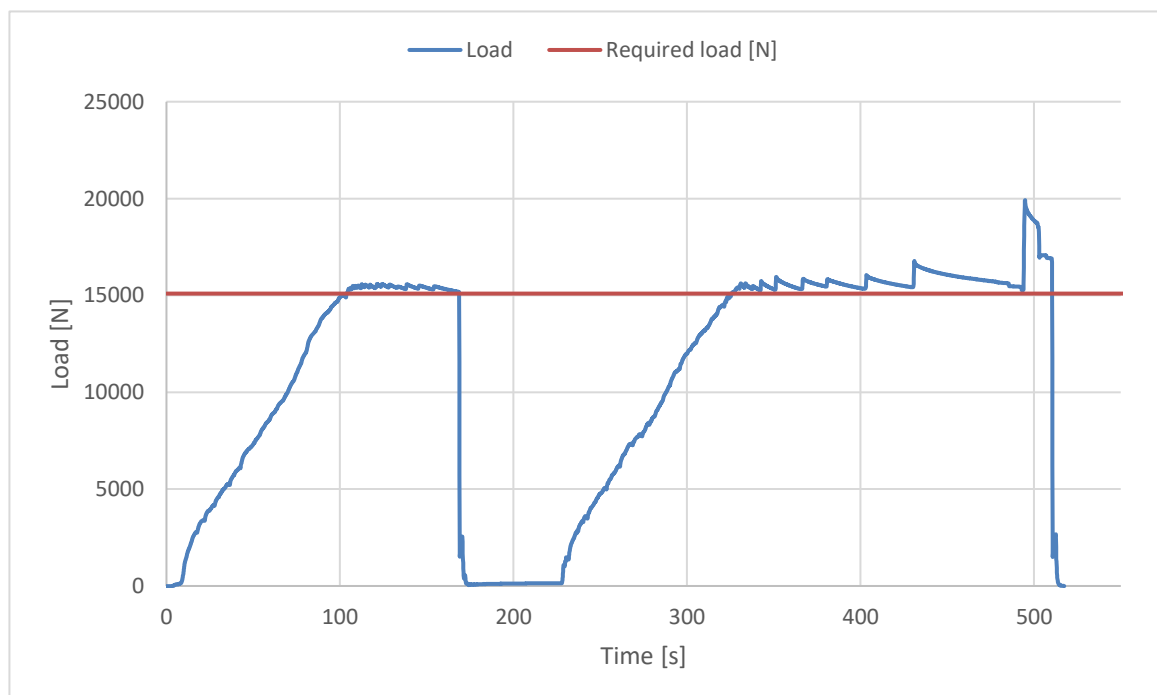
Test ID 1

Standard	EN 12277	
Reference in standard	5.2.5.2	
Test setup	Head up position	
Attachment points	Main attachment point (Hard pt 1)	
Anchor points	Dummy (B1, B2)	
	1st loading	2nd loading
Required load [N]	15000	15000
Minimum test duration [s]	60	180
Result		
Slippery test OK	Yes	
Any signs of structural failure	No	
Test results	POSITIVE

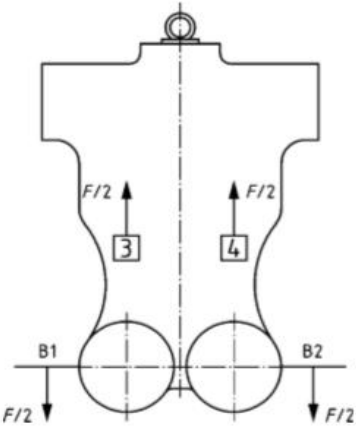
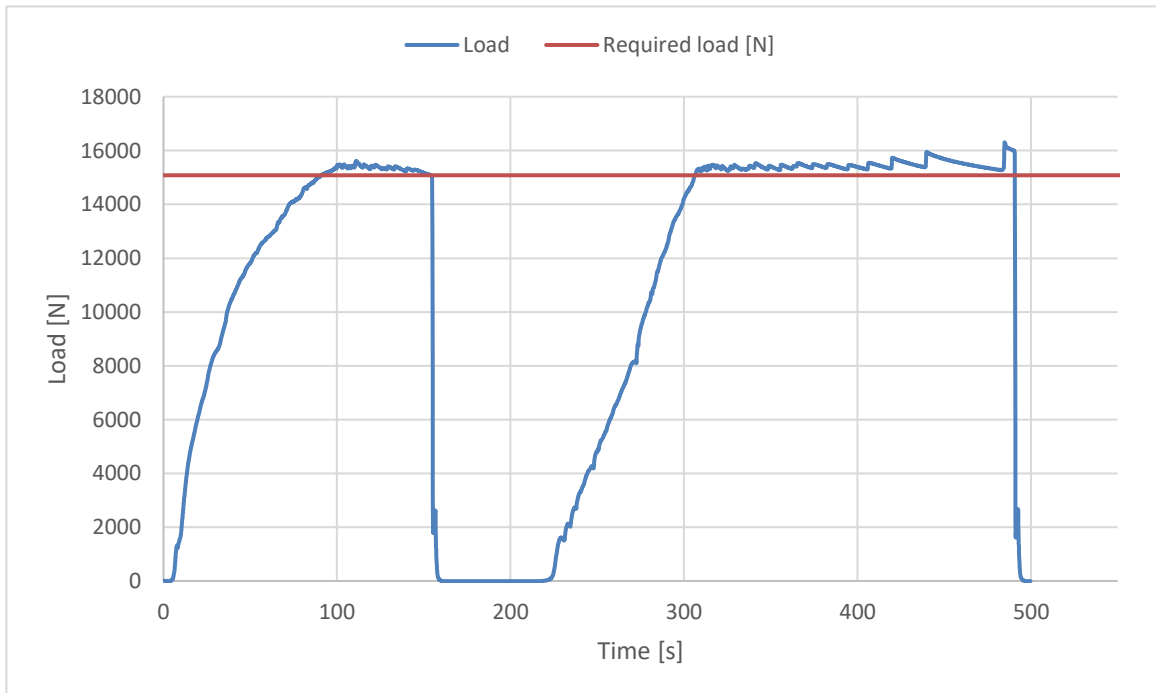
Test ID 2

Standard	EN 12277	
Reference in standard	5.2.5.2	
Test setup	Head up position	
Attachment points	Main attachment point (Hard pt 2)	
Anchor points	Dummy (B1, B2)	
	1st loading	2nd loading
Required load [N]	15000	15000
Minimum test duration [s]	60	180
Result		
Slippery test OK	Yes	
Any signs of structural failure	No	
Test results	POSITIVE

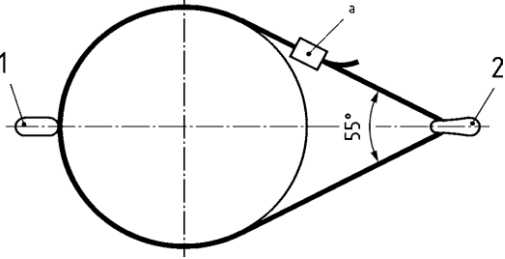
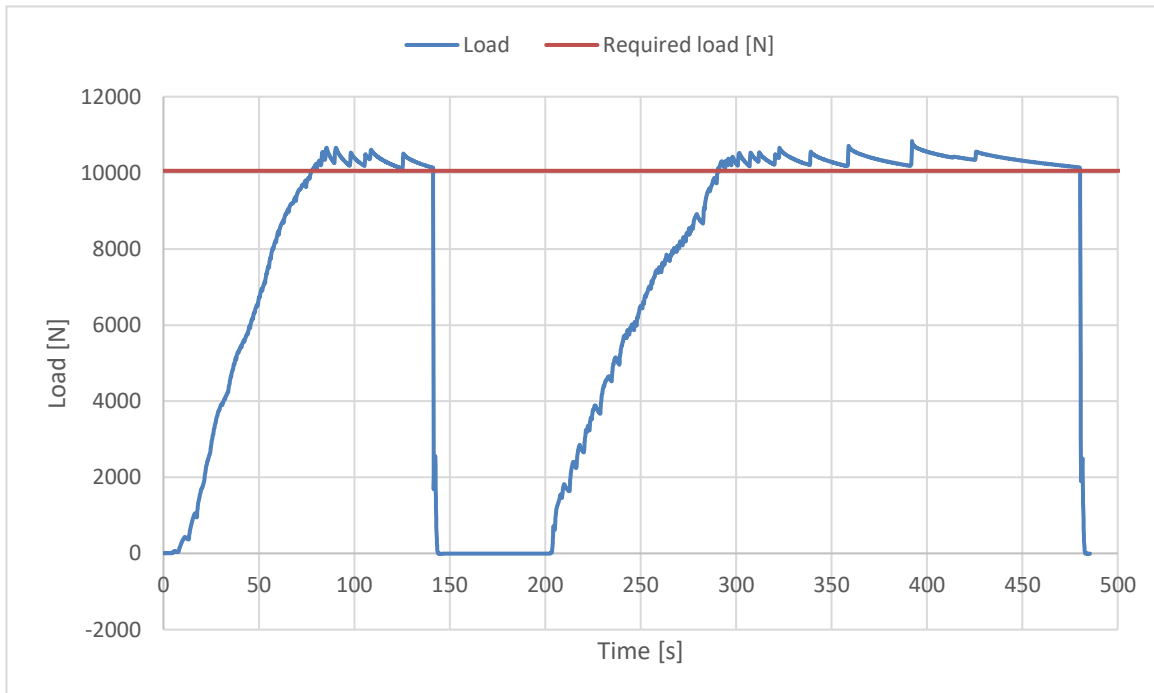
Test ID 3

Standard	EN 12277	
Reference in standard	5.2.5.3	
Test setup	Belt testing	
Attachment points	Main attachment point (Hard pt 1)	
Anchor points	Belt (1)	
	1st loading	2nd loading
Required load [N]	10000	10000
Minimum test duration [s]	60	180

Result	
Slippery test OK	Yes
Any signs of structural failure	No
Test results	POSITIVE

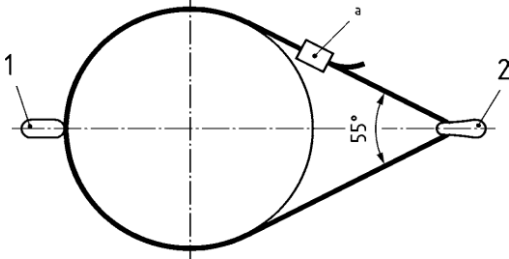
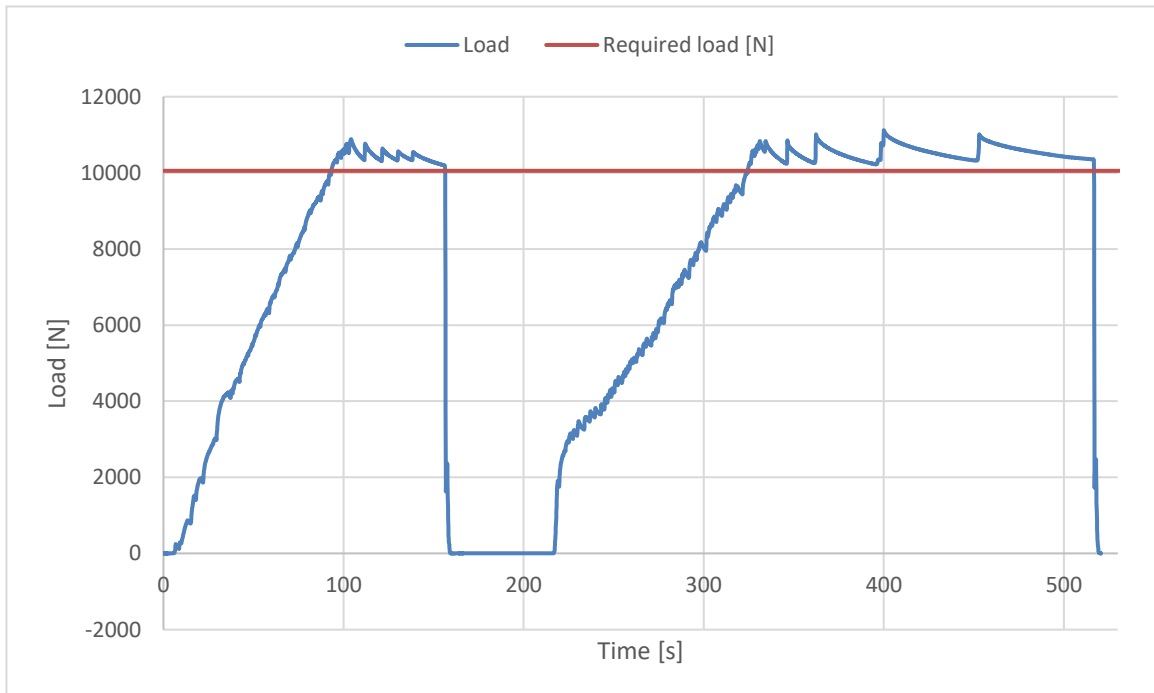
Test ID 4

Standard	EN 12277	
Reference in standard	5.2.5.3	
Test setup	Belt testing	
Attachment points	Main attachment point (Hard pt 2)	
Anchor points	Belt (1)	
	1st loading	2nd loading
Required load [N]	10000	10000
Minimum test duration [s]	60	180
Result		
Slippery test OK	Yes	
Any signs of structural failure	No	
Test results	POSITIVE
