Harness Structural test Report

Inspection certificate number: **PH_276.2019**

Name: **Walltee**
 Type: **Zip Harness**
 Size: **M**
 Serial number: **0521910201**

Date of test: **20.06.2019**

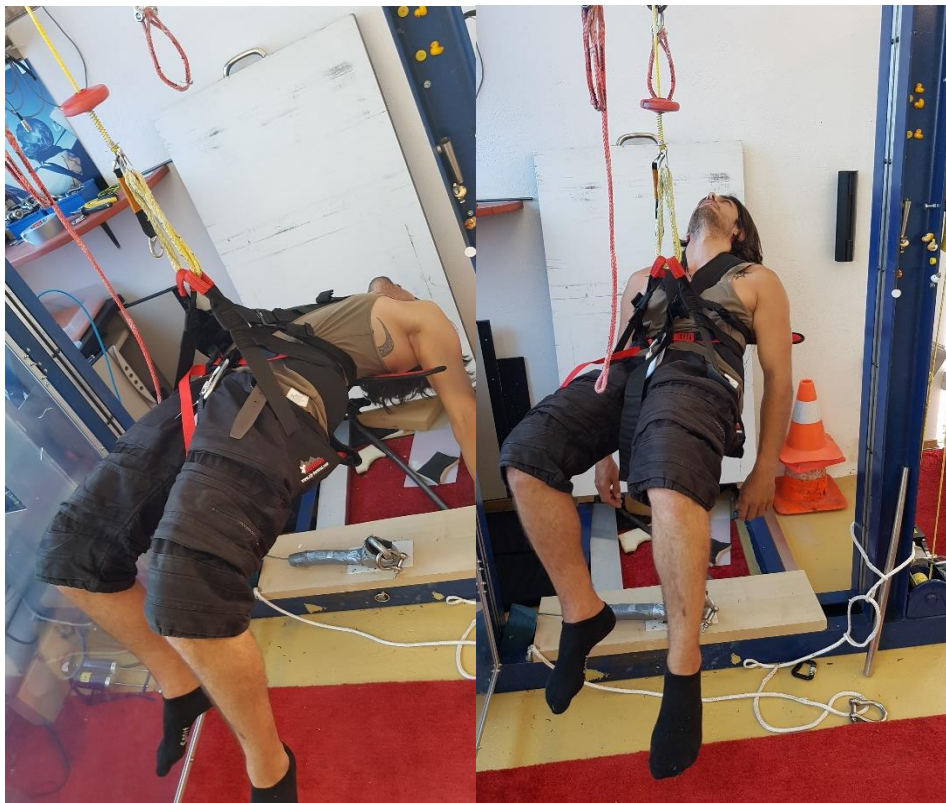
Test ID 1

This test shows that an unconscious person doesn't turn upside down

Any signs of structural failure **No**

Test results **POSITIVE**

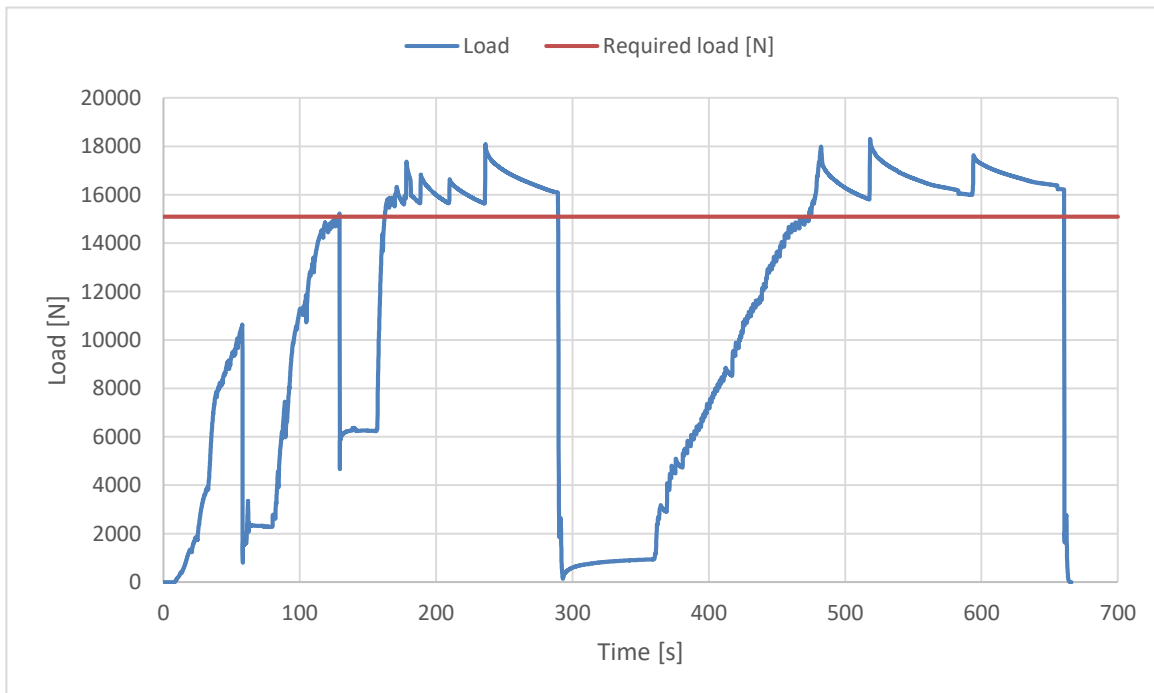
Test ID 2

Standard	EN 12277	
Reference in standard	5.2.3.2	
Test setup	Setup	
Attachment points	Both main attachment point (3,4)	
Anchor points	Dummy (B1, B2)	
	1st loading	2nd loading
Required load [N]	15000	15000
Minimum test duration [s]	60	180
Result		
Any signs of structural failure	No	
Test results	POSITIVE

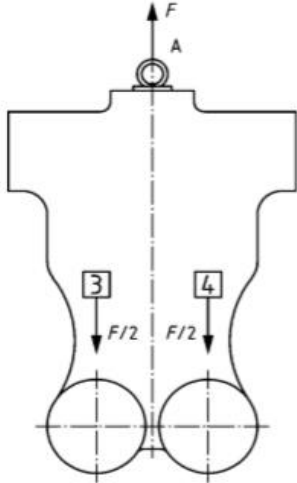
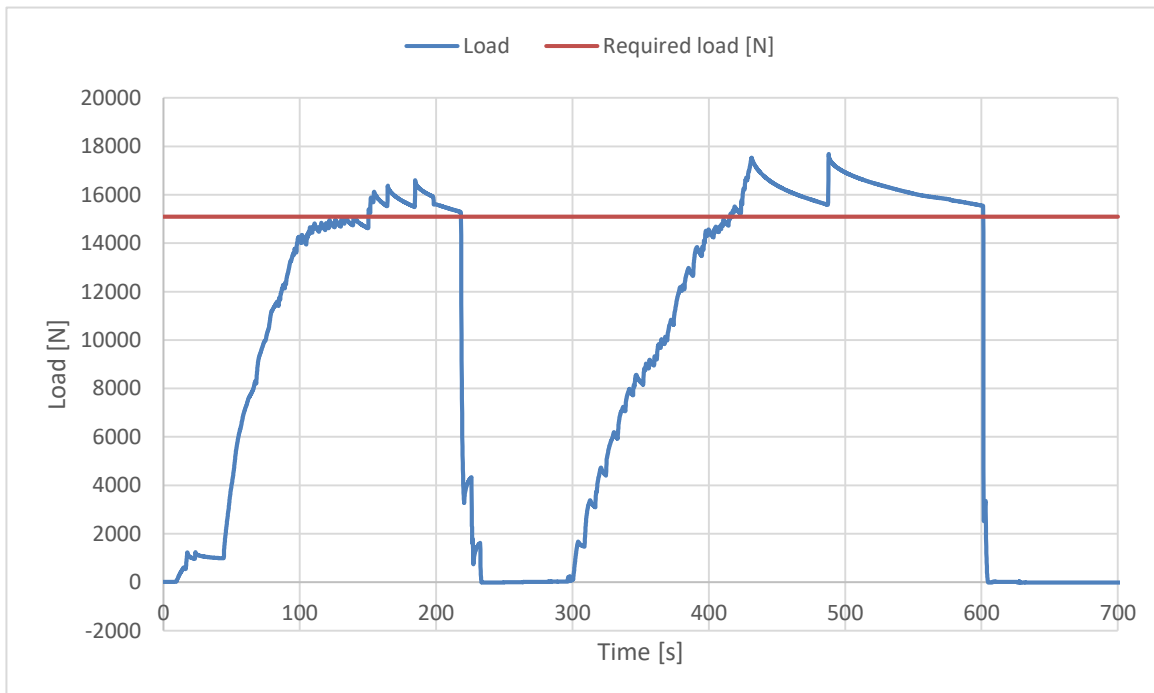
Test ID 4

Reference in standard	5.2.3.3		
Test setup	Setup		
Attachment points	Both main attachment point (3,4)		
Anchor points	Dummy (A)		
	1st loading	2nd loading	
Required load [N]	15000	15000	
Minimum test duration [s]	60	180	
Result			
Any signs of structural failure	No		
Test results	POSITIVE
