Harness Structural test Report

Inspection certificate number: **PH_226.2018**
Manufacturer data:

Name: **Jazz 2018**
 Type: **ABS**
 Size: **M**
 Serial number: **H-05984**
 Impact pad type: ⁽¹⁾ **Foam**
 Clip-in weight [kg]: **100**

model: **Jazz 2018 M**

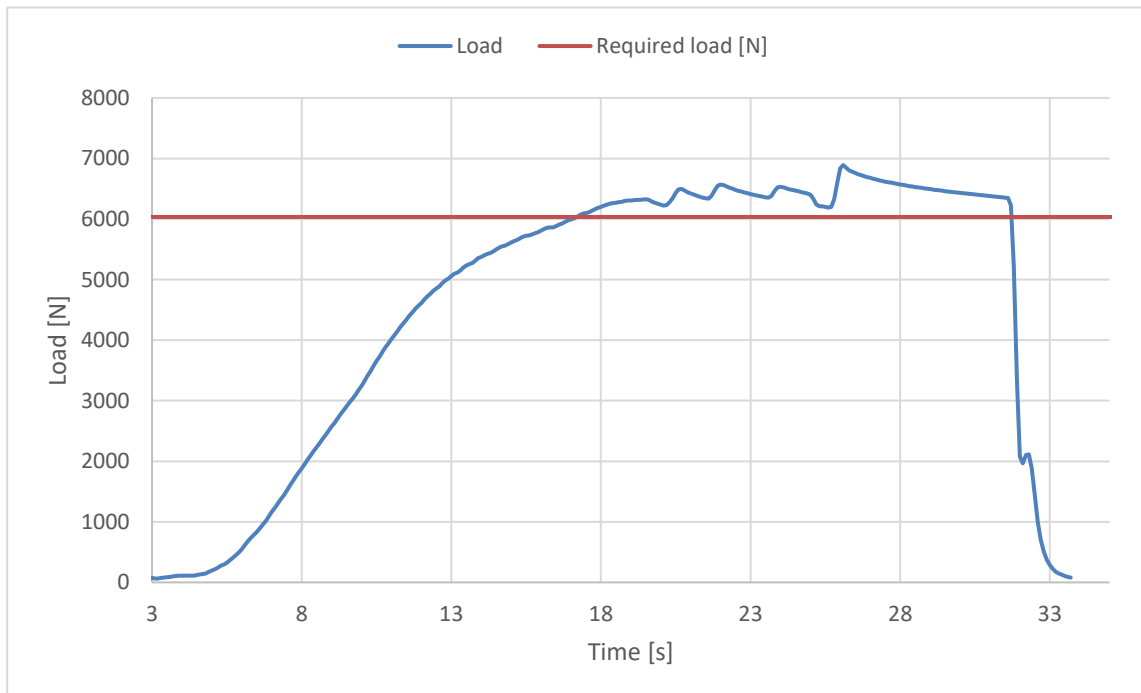
Test ID R0

Standard	EN 1651:1999
Reference in standard	5.3.2.1
Test setup	Default flying position
Attachment points	Both main riser attachment (3,4)
Anchor points	Dummy (B1, B2)
Required load [g]	6
Required load [N]	6000
Minimum test duration [s]	10
Result	
Test duration [s]	14.6
Any signs of structural failure	No
Test results	POSITIVE

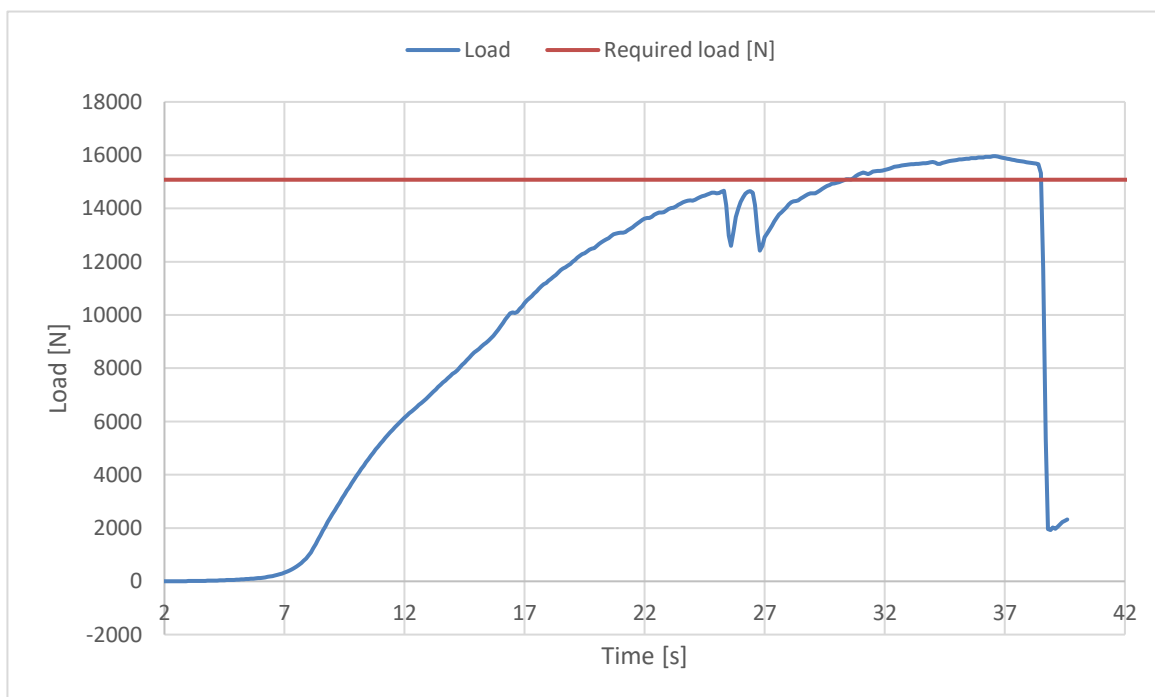
Test ID R2

Standard	EN 1651:1999
Reference in standard	5.3.2.2
Test setup	Default flying position
Attachment points	Both main riser attachment (3,4)
Anchor points	Dummy (B1, B2)
Required load [g]	15
Required load [N]	15000
Minimum test duration [s]	5
Result	
Test duration [s]	8.2
Any signs of structural failure	No
Test results	POSITIVE

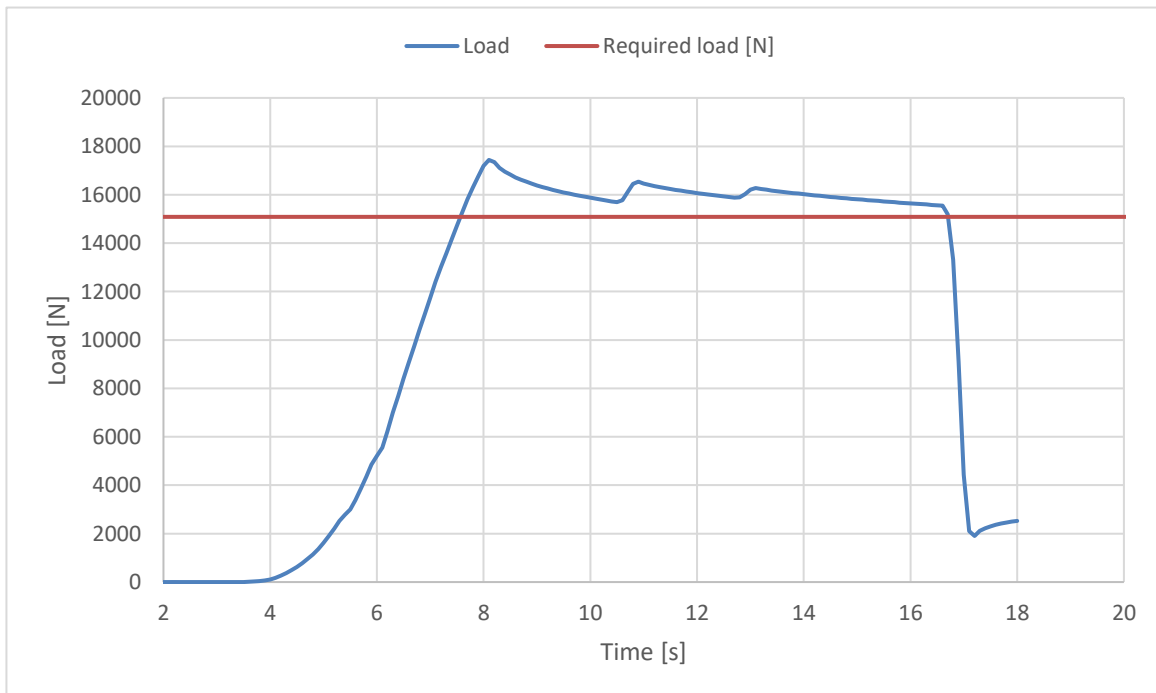
Test ID R4

Standard	EN 1651:1999
Reference in standard	5.3.2.7
Test setup	Flying position before landing
Attachment points	Both main riser attachment (3,4)
Anchor points	Dummy (7,8)
Required load [g]	15
Required load [N]	15000
Minimum test duration [s]	5
Result	
Test duration [s]	9.2
Any signs of structural failure	No
Test results	POSITIVE

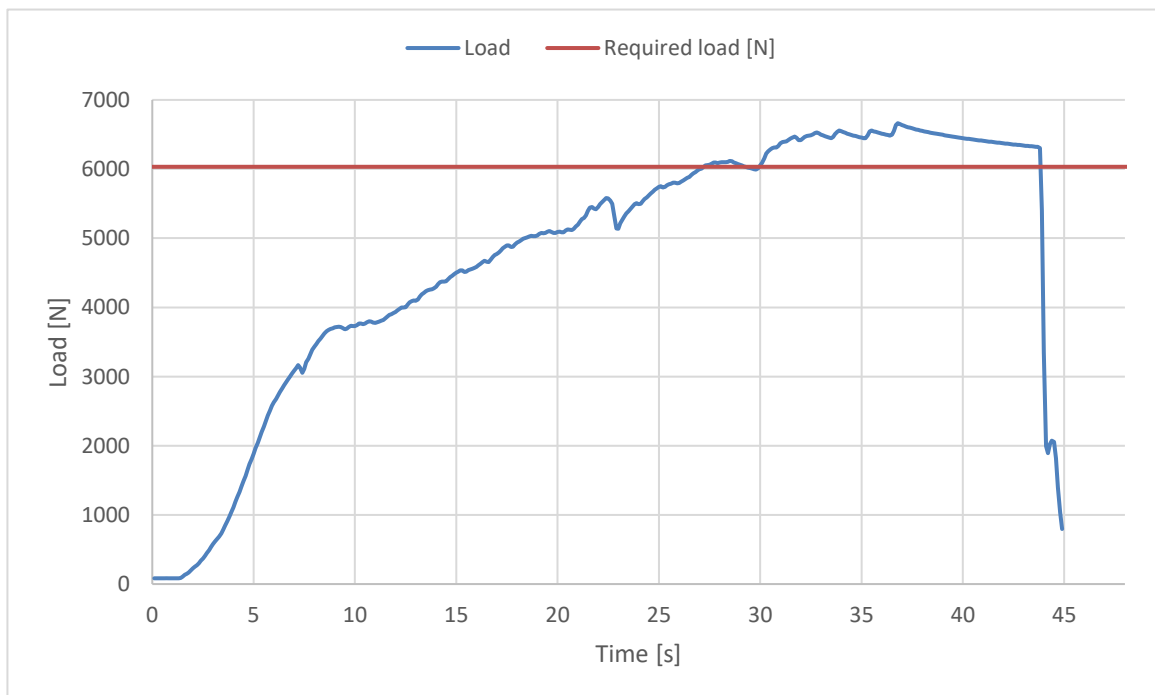
Test ID R8

Standard	EN 1651:1999	
Reference in standard	5.3.2.3	
Test setup	Asymmetric, one riser	
Attachment points	One main riser attachment (3)	
Anchor points	Dummy (B1,B2)	
Required load [g]	6	
Required load [N]	6000	
Minimum test duration [s]	10	
Result		
Test duration [s]	13.9	
Any signs of structural failure	No	
Test results	POSITIVE

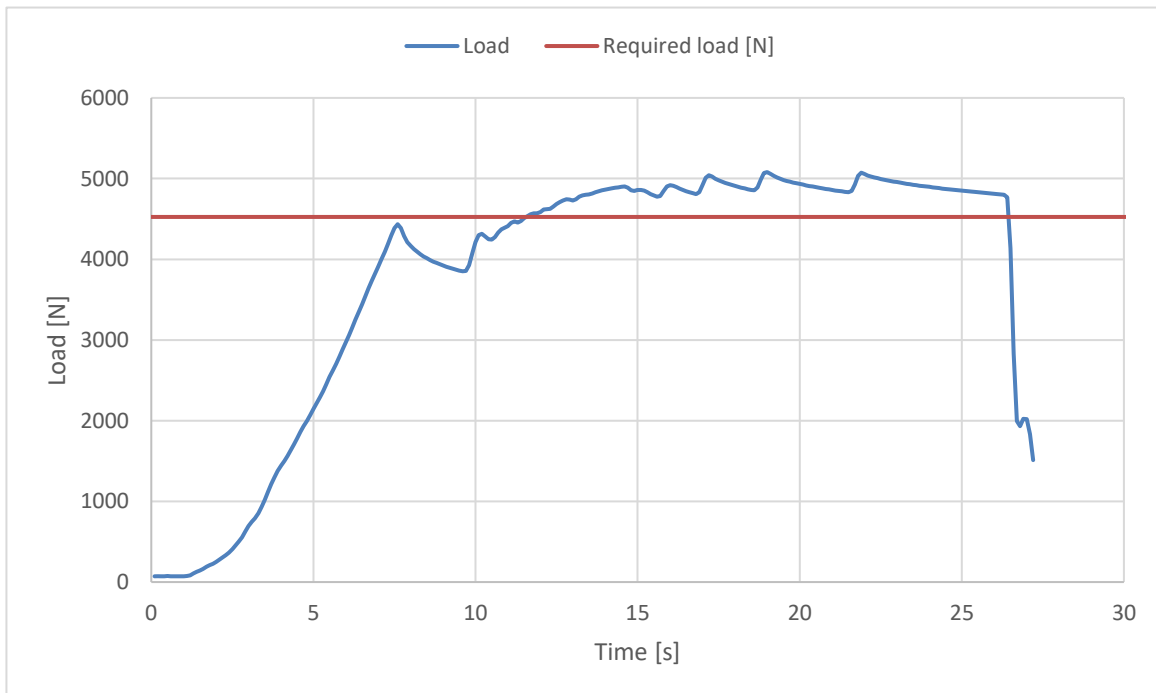
Test ID R10

Reference in standard	5.3.2.6	
Test setup	Asymmetric, negative	
Attachment points	One main riser attachment (3 or 4) downwards	
Anchor points	Dummy (9)	
Required load [g]	4.5	
Required load [N]	4500	
Minimum test duration [s]	10	
Result		
Test duration [s]	14.9	
Any signs of structural failure	No	
Test results	POSITIVE

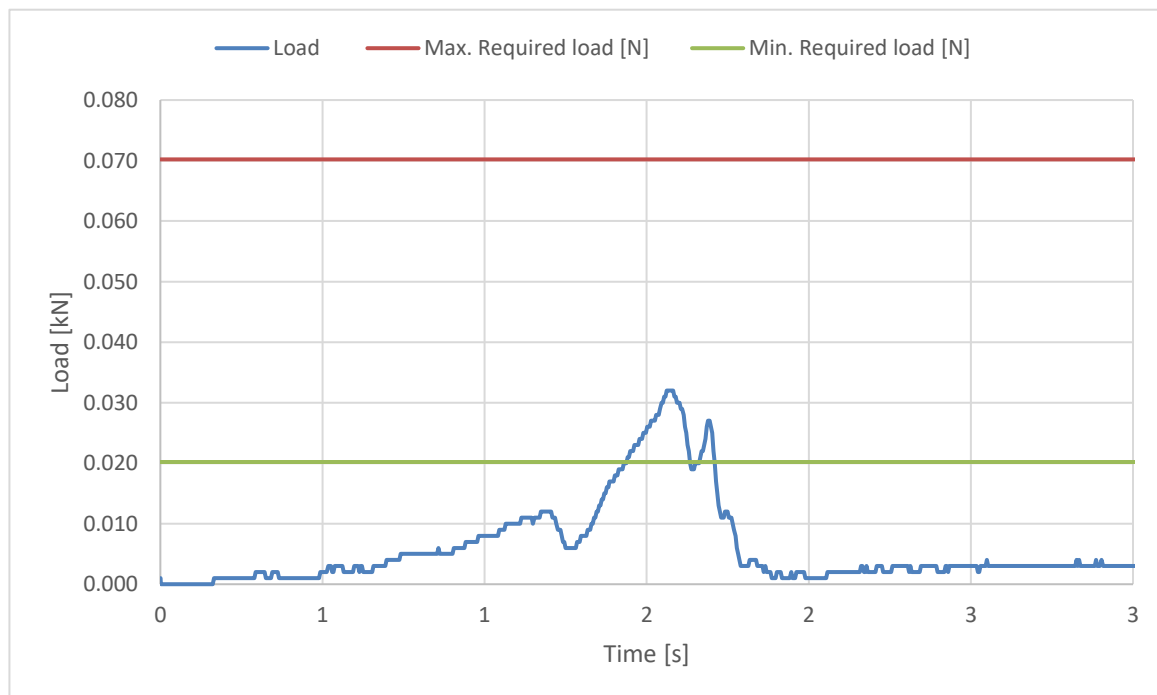
Test ID RRDT

Standard	LTF NfL II 91/09
Reference in standard	6.1.5
Test setup	Default flying position
Attachment points	Sensor connect to handle, and pull in opening direction
	The test is to simulate the load required to open the emergency parachute(1st action).
Min. Required load [N]	20
Max. Required load [N]	70
Result	
Load for first action [N]	31.81
Test results	POSITIVE

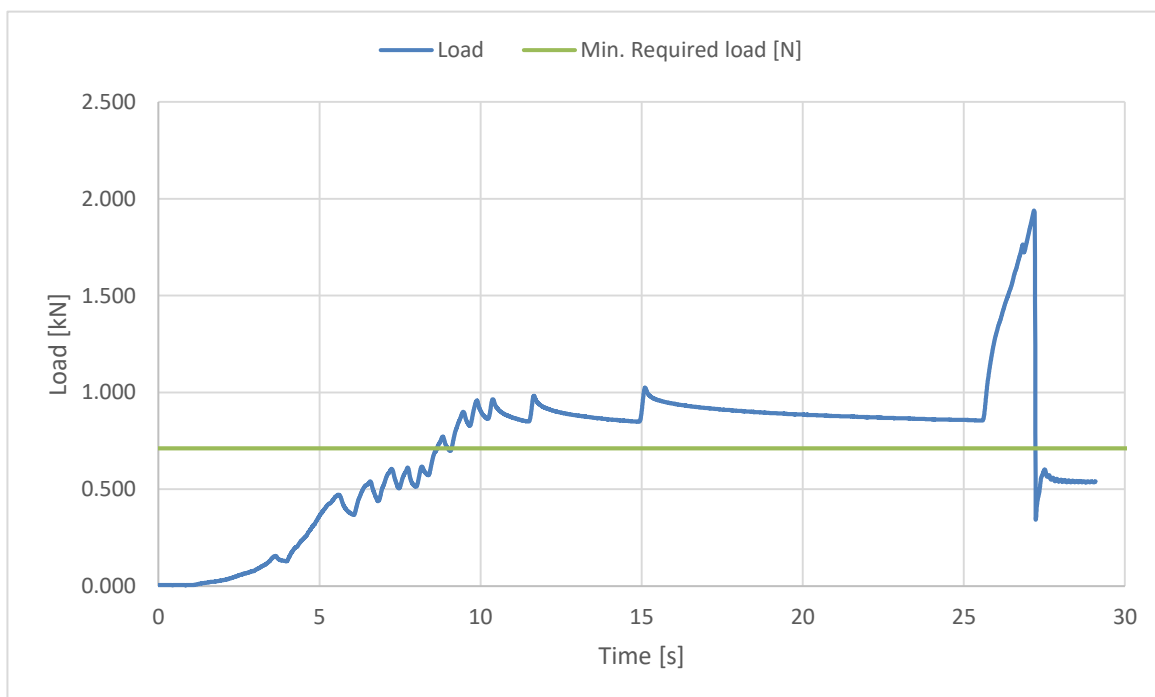
Test ID RRST

Standard	EN12491:2015
Reference in standard	5.3.2
Test setup	Two end points of handle
Attachment points	Sensor connect to end of handle, pull on the other side
	The handle must support min 700 N for 10 s, after measure breaking strength
Min. Required load [N]	700
Minimum test duration [s]	10
Result	
Test duration [s]:	18.0
Breaking strength [N]	1927.35
Test results	POSITIVE
