Harness Structural test Report - NfL

Inspection certificate number: **PH_338.2021**

Name: **Powerseat Light**
 Type: **ABS**
 Size: **L**
 Serial number: **H-13061**
 Impact pad type: ⁽¹⁾ **n/a**
 Clip-in weight [kg]: **120**
 Integrated container: **Yes**
 Date of test: **19.05.2021**

Summary of Structural test

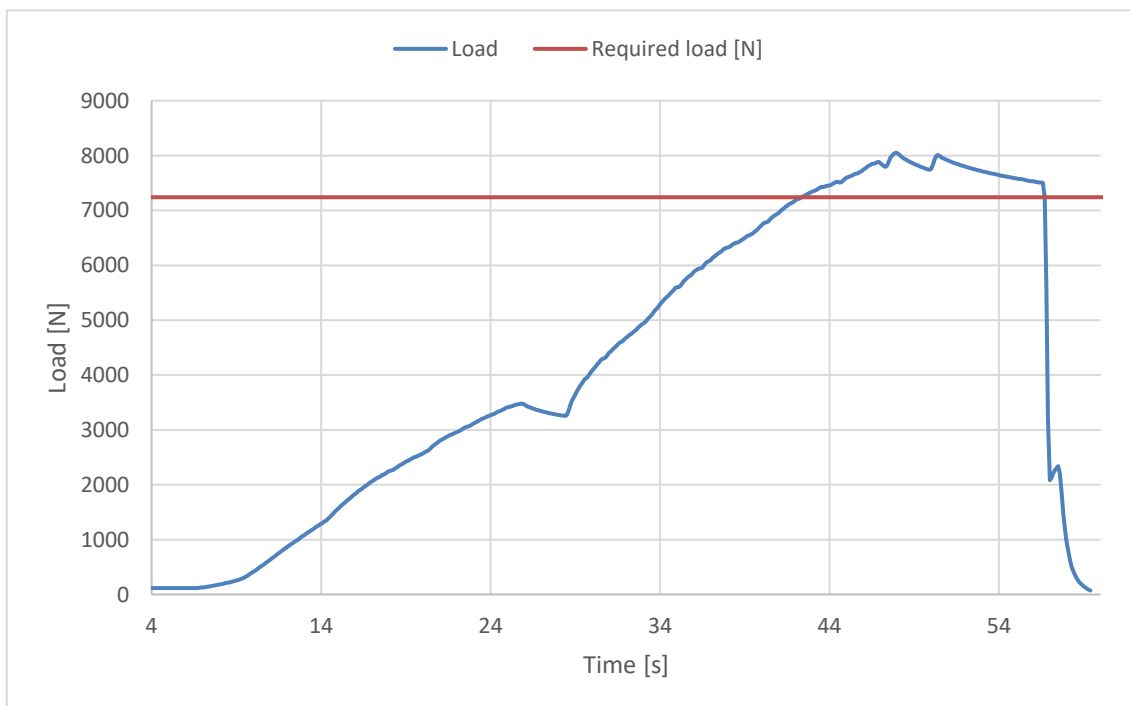
Test ID 02

Standard	NfL 2-565-20
Reference	5.3.2.1
Test setup	Default flying position
Attachment points	Both main riser attachment (3,4)
Anchor points	Dummy (B1, B2)
Required load [g]	6
Required load [N]	7200
Minimum test duration [s]	10
Result	
Test duration [s]	14.3
Any signs of structural failure	No
Test results	POSITIVE

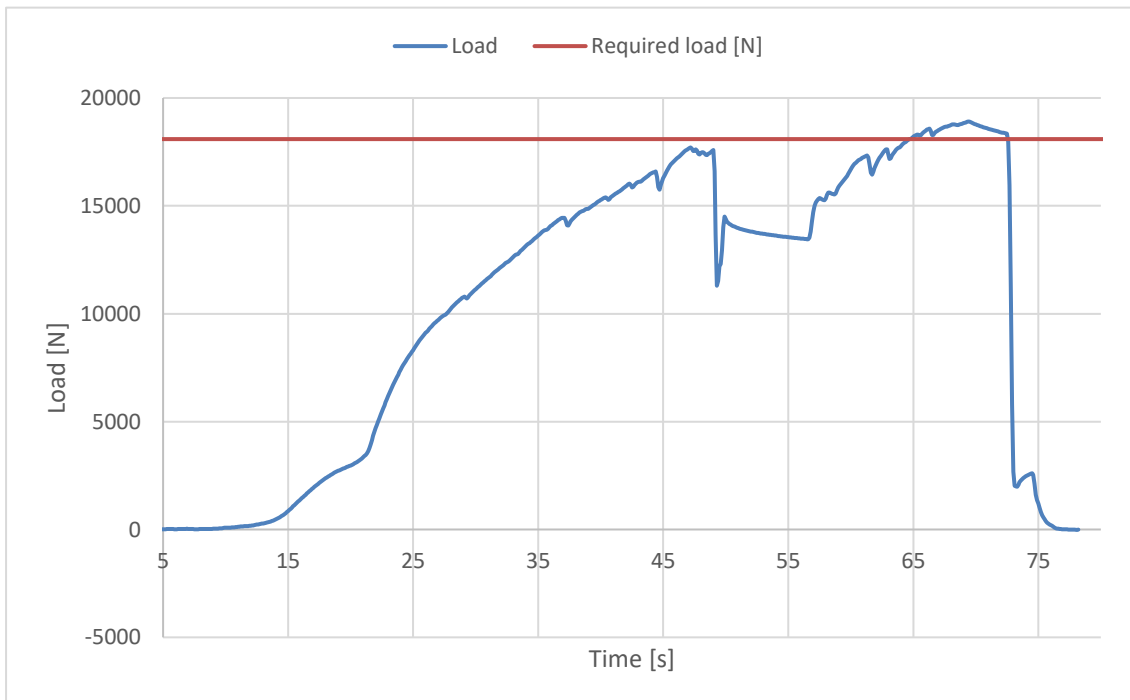
Test ID 03

Reference	5.3.2.2	
Test setup	Default flying position	
Attachment points	Both main riser attachment (3,4)	
Anchor points	Dummy (B1, B2)	
Required load [g]	15	
Required load [N]	18000	
Minimum test duration [s]	5	
Result		
Test duration [s]	7.8	
Any signs of structural failure	No	
Test results	POSITIVE

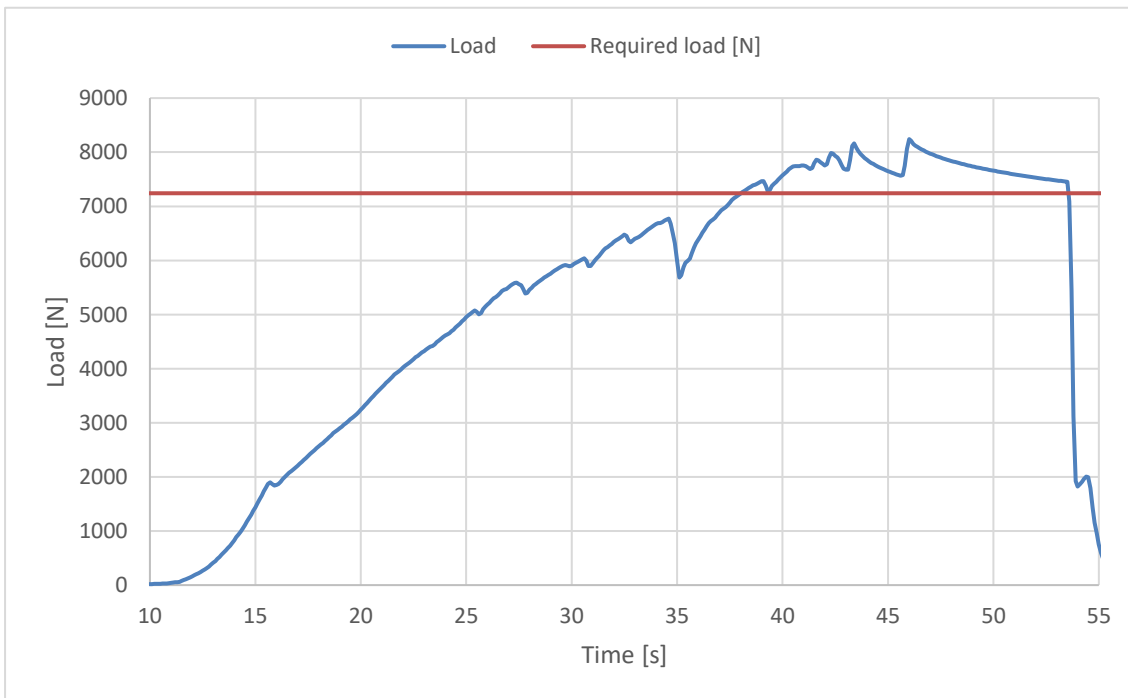
Test ID 04

Standard **NfL 2-565-20**
 Reference **5.3.2.3**
 Test setup **Asymmetric, one riser**
 Attachment points **One main riser attachment (3)**
 Anchor points **Dummy (B1,B2)**

Test duration [s] **15.5**
 Any signs of structural failure **No**
 Test results **POSITIVE**

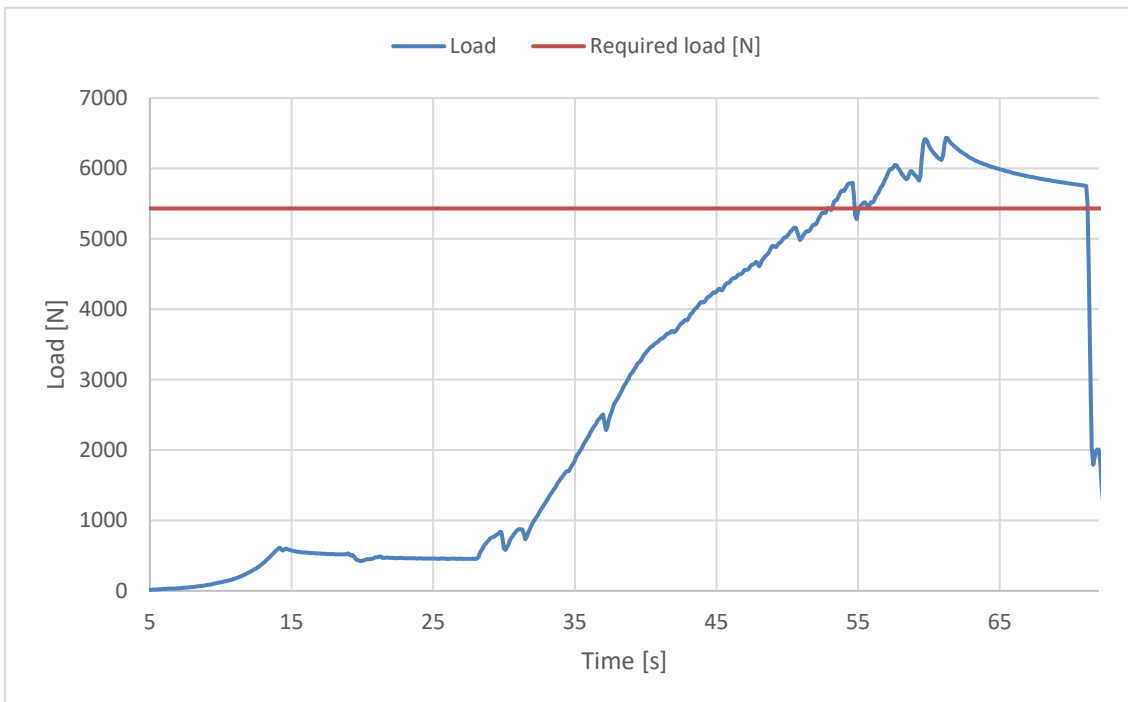
Test ID 07

Standard	NfL 2-565-20
Reference	5.3.2.6
Test setup	Asymmetric, negative
Attachment points	One main riser attachment (3 or 4) downwards
Anchor points	Dummy (9)
Required load [g]	4.5
Required load [N]	5400
Minimum test duration [s]	10
Result	
Test duration [s]	16.2
Any signs of structural failure	No
Test results	POSITIVE

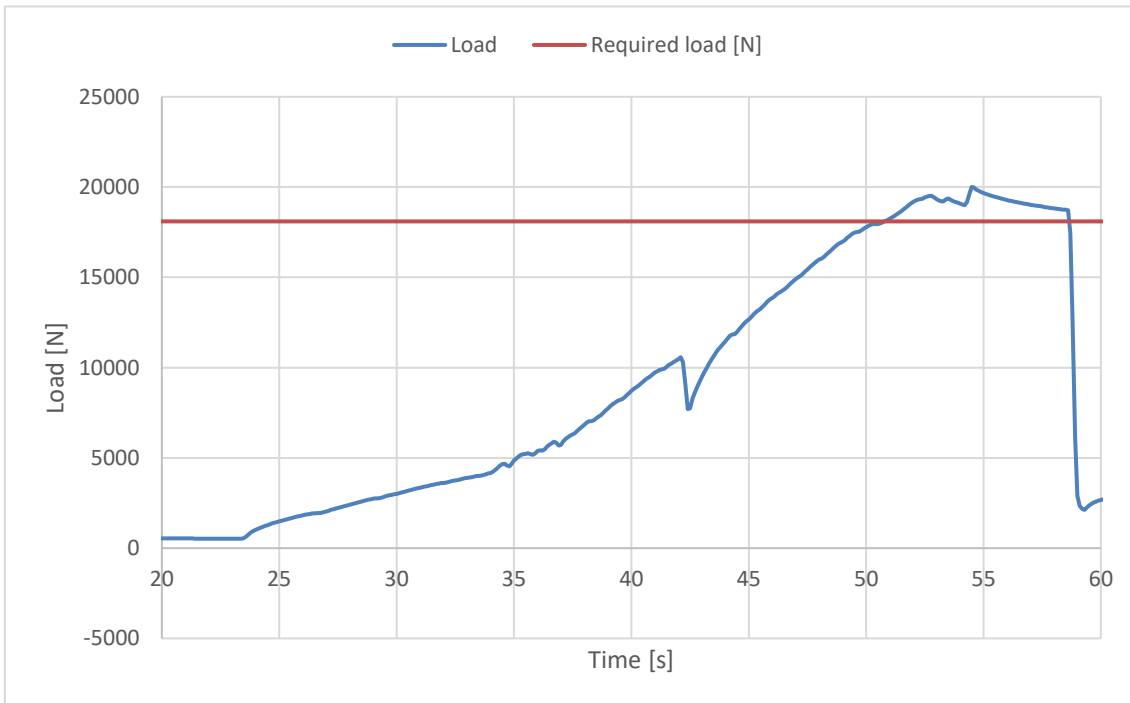
Test ID 09

Standard **NfL 2-565-20**
 Reference **5.3.2.4**
 Test setup **Rescue attachments**
 Attachment points **Rescue riser attachment (1,2)**
 Anchor points **Dummy (B1,B2)**

Test duration [s] **7.9**
 Any signs of structural failure **No**
 Test results **POSITIVE**

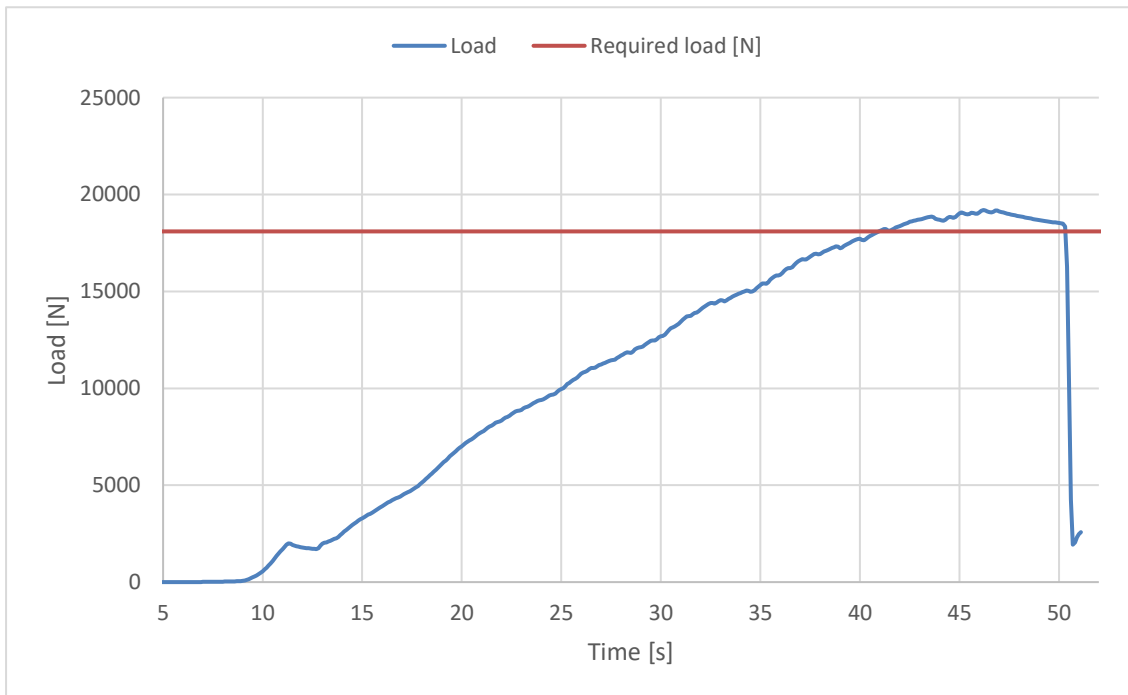
Test ID 13

Standard	NfL 2-565-20
Reference	5.3.2.7
Test setup	Flying position before landing
Attachment points	Both main riser attachment (3,4)
Anchor points	Dummy (7,8)
Required load [g]	15
Required load [N]	18000
Minimum test duration [s]	5
Result	
Test duration [s]	9.4
Any signs of structural failure	No
Test results	POSITIVE

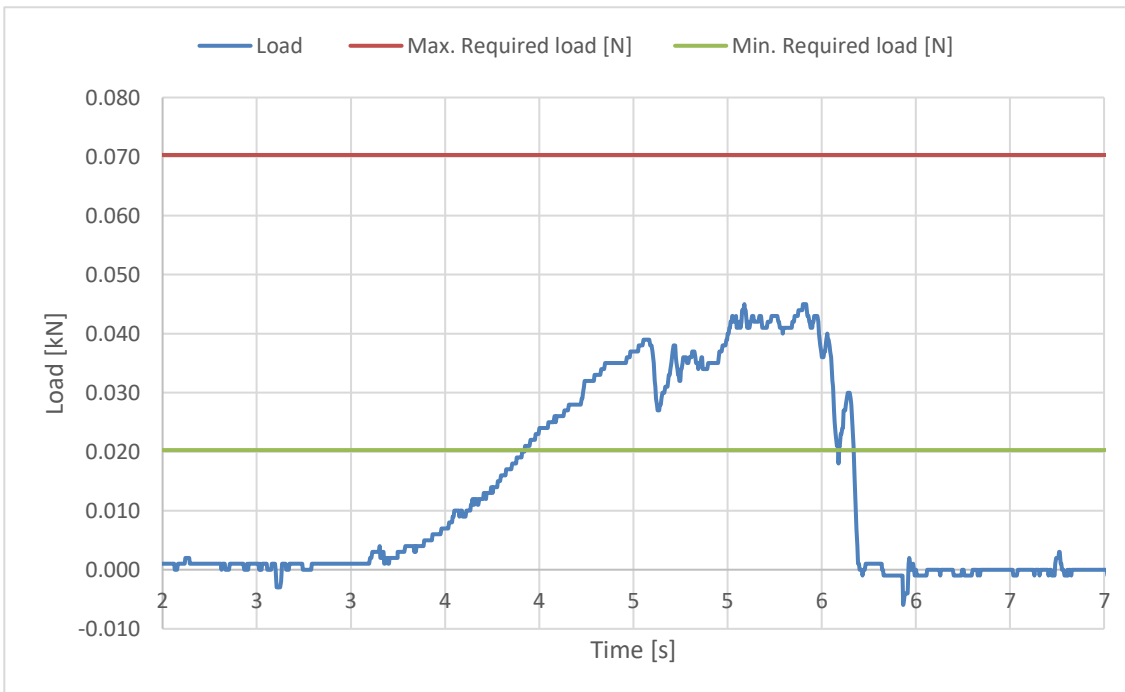
Test ID RRDT

Standard **NfL 2-565-20**
 Reference **6.1.5**
 Test setup **Default flying position**
 Attachment points **Sensor connect to handle, and pull in opening direction**
 The test is to simulate the load required to open the emergency parachute(1st action).

Load for first action [N] **44.70**
 Test results **POSITIVE**

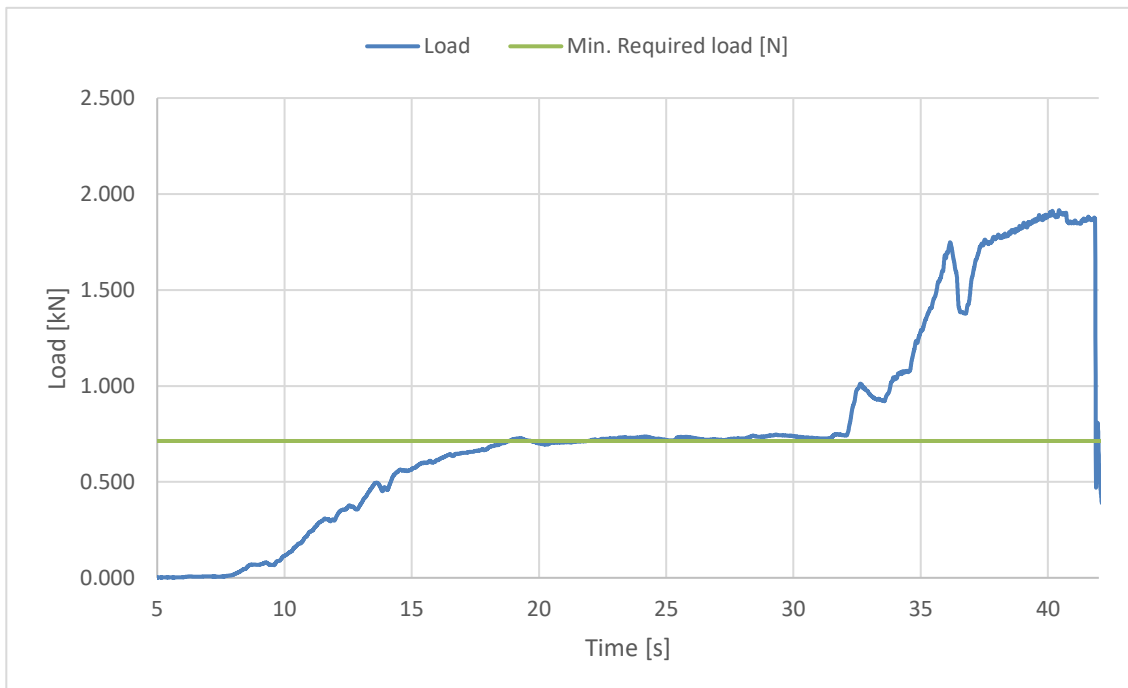
Test ID RRST

Standard	EN12491:2015
Reference in standard	5.3.2
Test setup	Two end points of handle
Attachment points	Sensor connect to end of handle, pull on the other side
	The handle must support min 700 N for 10 s, after measure breaking strength
Min. Required load [N]	700
Minimum test duration [s]	10
Result	
Test duration [s]:	20.0
Breaking strength [N]	1903.27
Test results	POSITIVE
