Harness Structural test Report - EN

Inspection certificate number: PH_439.2024

Name: **Edel Zip-EVO**
 Type: **ABS**
 Size: **XL**
 Serial number: **EHD03-ZI271019**
 Impact pad type: ⁽¹⁾ **n/a**
 Clip-in weight [kg]: **120**

EN1651:2018+A1:2020⁽⁶⁾ and EN12491:2015+A1:2021⁽⁶⁾

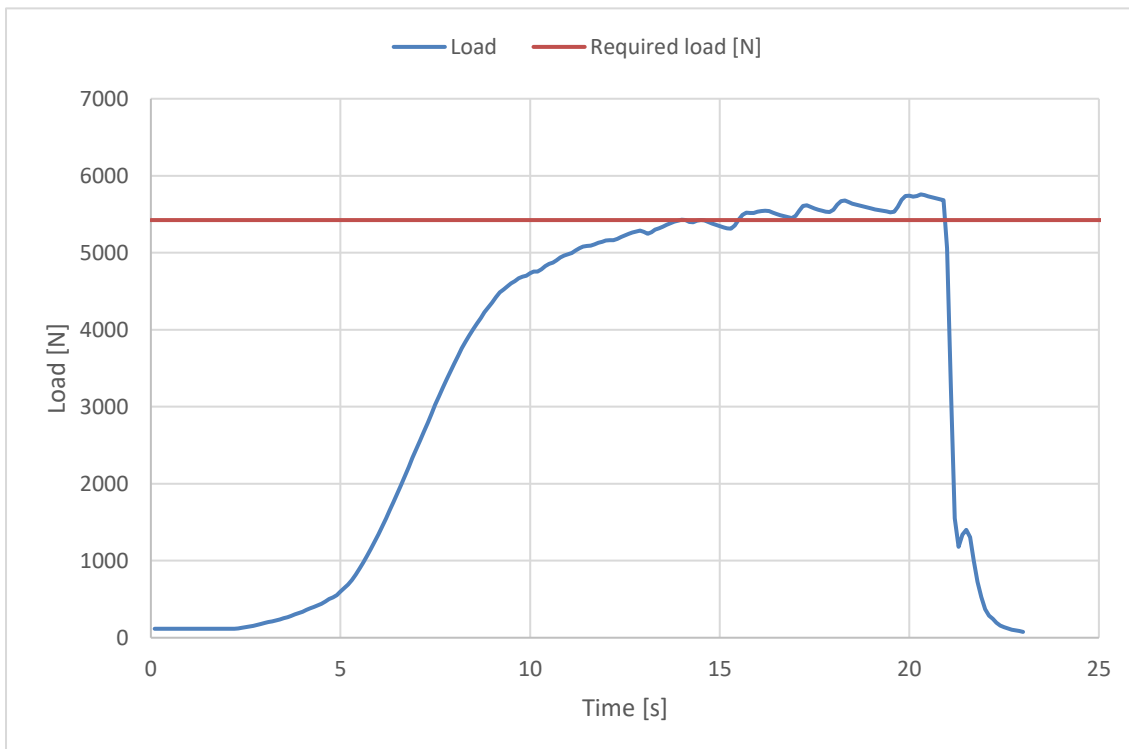
Test ID 01

Standard	EN 1651
Reference in standard	5.5.1.1
Test setup	Positive symmetric load (Slippage)
Attachment points	Both main riser attachment (3,4)
Anchor points	Dummy (B1, B2)
Required load [g]	4.5
Required load [N]	5400
Minimum test duration [s]	5
Result	
Test duration [s]	5.5
Any signs of structural failure	No
Slippery test OK	Yes
Test results	POSITIVE

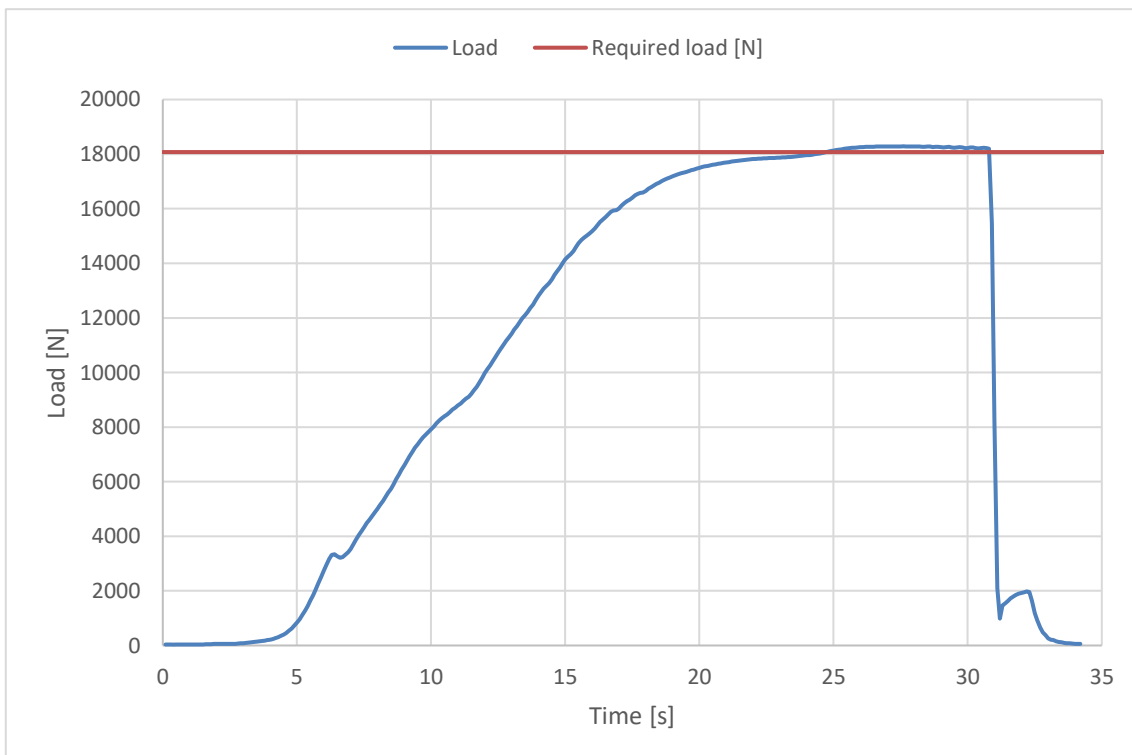
Test ID 03

Standard	EN 1651
Reference in standard	5.5.1.1b
Test setup	Positive symmetric load
Attachment points	Both main riser attachment (3,4)
Anchor points	Dummy (B1, B2)
Required load [g]	15
Required load [N]	18000
Minimum test duration [s]	5
Result	
Test duration [s]	6.1
Any signs of structural failure	No
Slippery test OK	Yes
Test results	POSITIVE

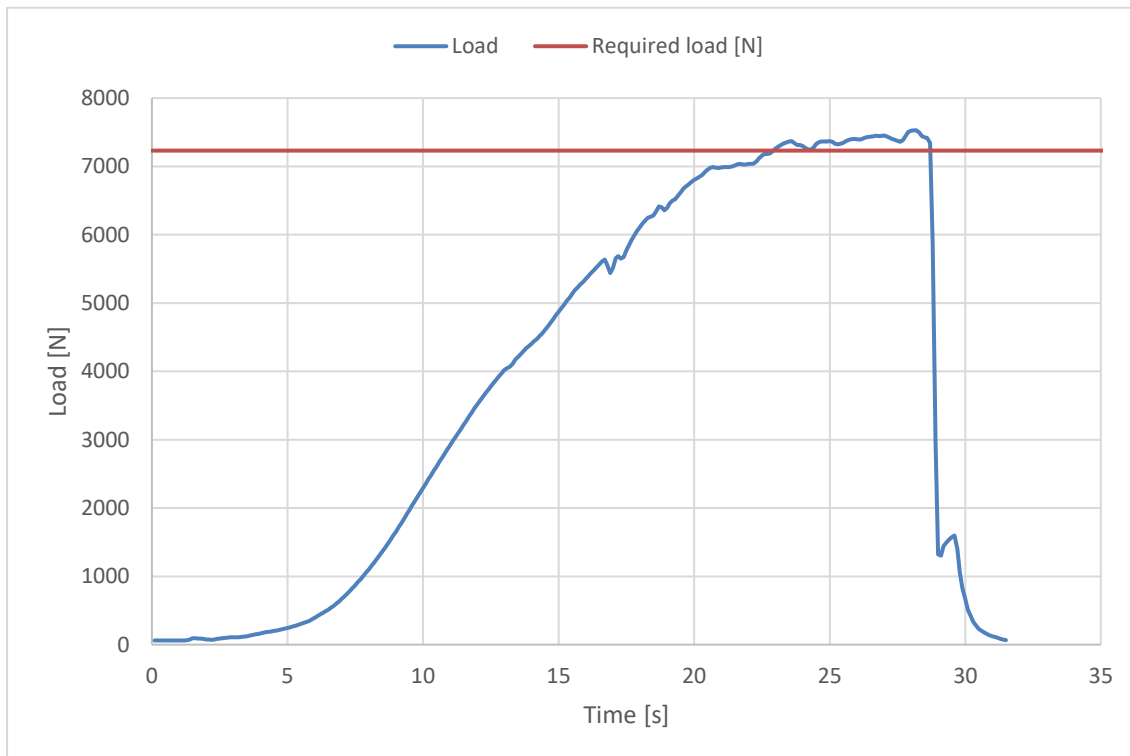
Test ID 05

Standard	EN 1651
Reference in standard	5.5.1.2
Test setup	Positive asymmetric load
Attachment points	One riser attachment (3 or 4)
Anchor points	Dummy (C)
Required load [g]	6
Required load [N]	7200
Minimum test duration [s]	5
Result	
Test duration [s]	5.8
Any signs of structural failure	No
Test results	POSITIVE

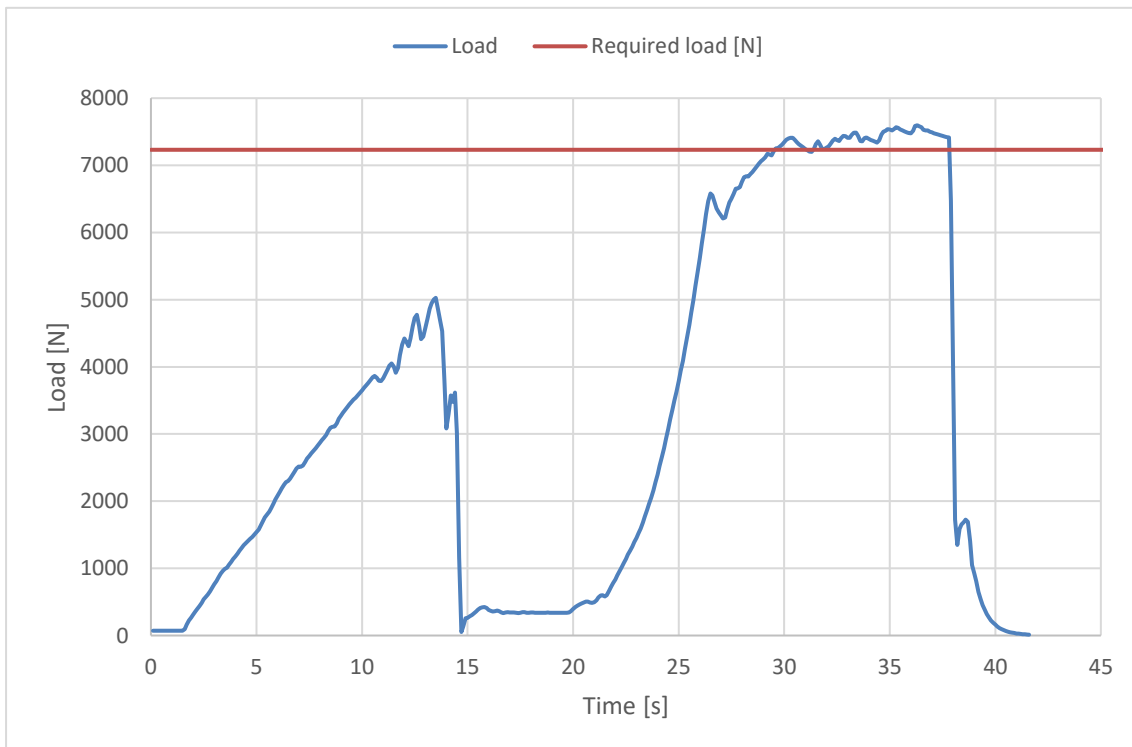
Test ID 06

Standard	EN 1651
Reference in standard	5.5.1.6
Test setup	Negative symmetric load
Attachment points	Both main riser attachment (3,4)
Anchor points	Dummy (A)
Required load [g]	6
Required load [N]	7200
Minimum test duration [s]	5
Result	
Test duration [s]	6.5
Any signs of structural failure	No
Test results	POSITIVE

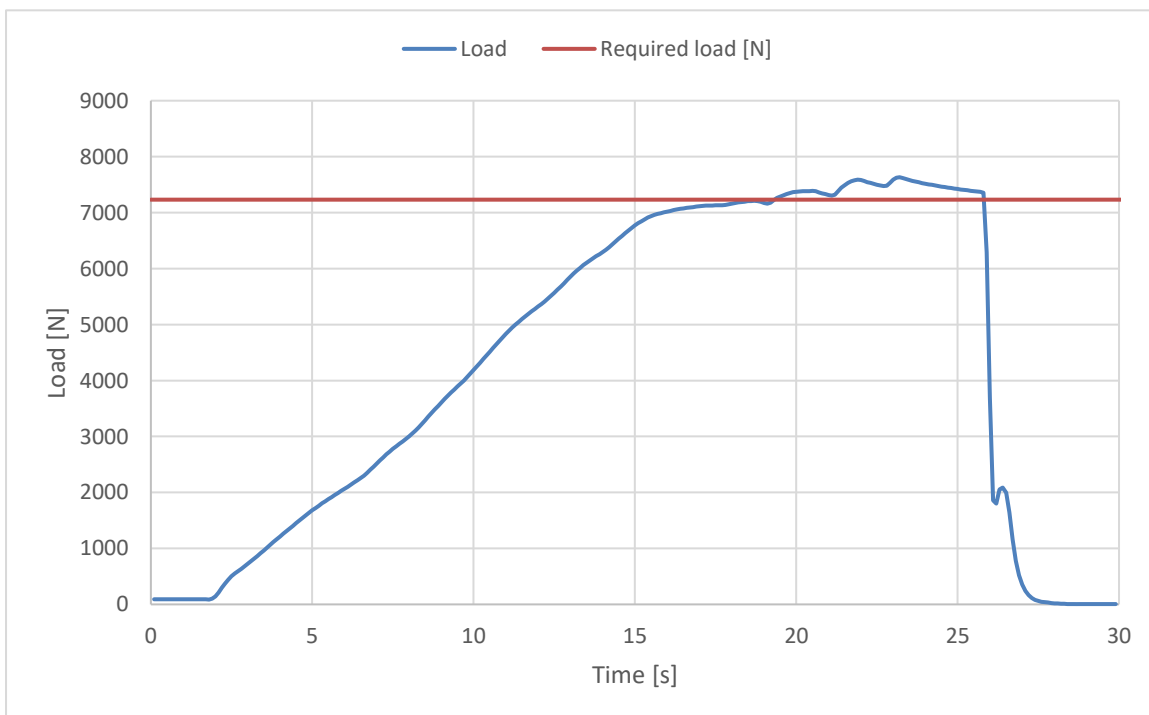
Test ID 12

Standard	EN 1651
Reference in standard	5.5.1.7
Test setup	Upright (landing) position load
Attachment points	Both main riser attachment (3, 4)
Anchor points	Both legstrap of harness (no dummy)
Required load [g]	6
Required load [N]	7200
Minimum test duration [s]	5
Harness type	type c
Result	
Test duration [s]	6.5
Any signs of structural failure	No
Slippery test OK	Yes
Test results	POSITIVE
