Harness Structural test Report - EN

Inspection certificate number: **PH_496.2026**

Name: **Sitta**
 Type: **ABS**
 Size: **L**
 Serial number: **2859-23-6495**
 Impact pad type: ⁽¹⁾ **n/a**
 Clip-in weight [kg]: **120**

EN1651:2018+A1:2020 and EN12491:2015+A1:2021

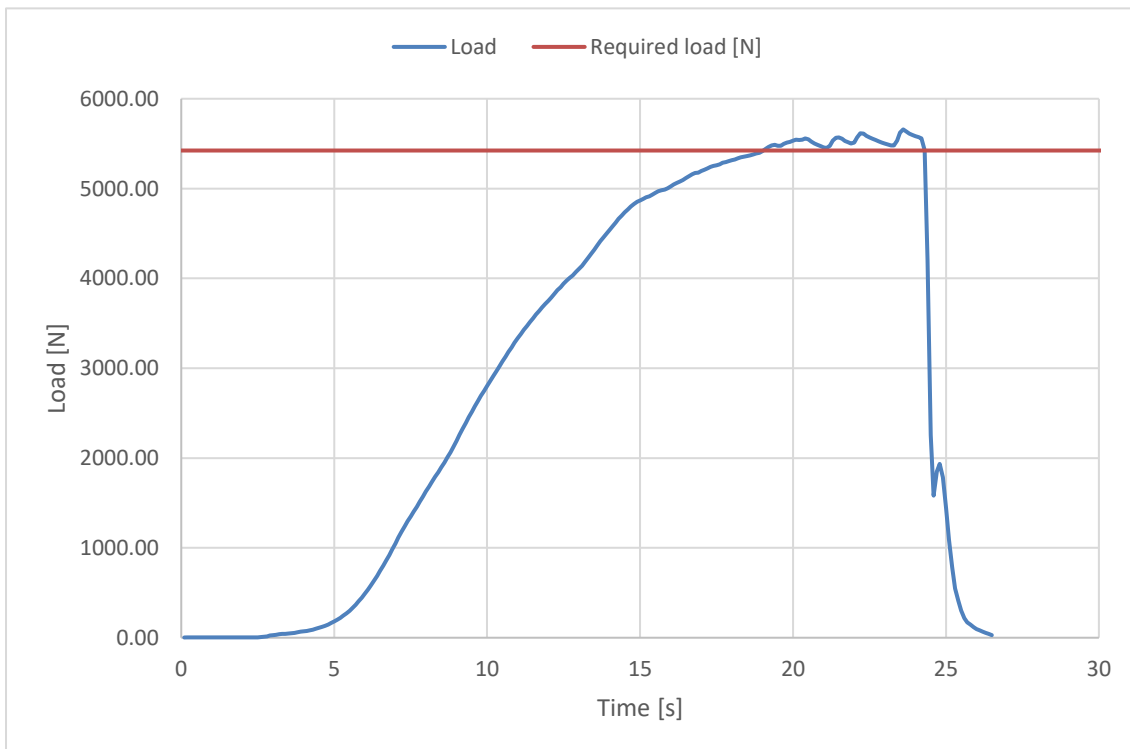
Test ID 01

Standard	EN 1651
Reference in standard	5.5.1.1
Test setup	Positive symmetric load (Slippage)
Attachment points	Both main riser attachment (3,4)
Anchor points	Dummy (B1, B2)
Required load [g]	4.5
Required load [N]	5400
Minimum test duration [s]	5
Result	
Test duration [s]	5.3
Any signs of structural failure	No 20
Slippery test OK	Yes 51
Test results	POSITIVE 1011

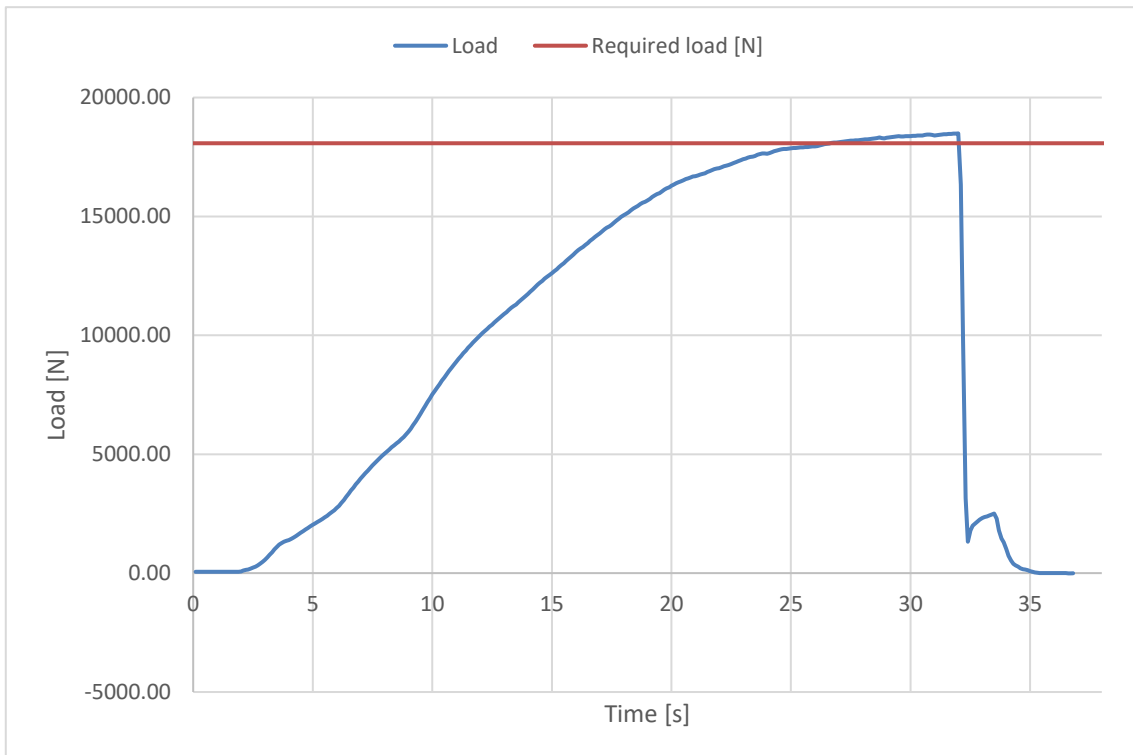
Test ID 03

Standard	EN 1651	
Reference in standard	5.5.1.1b	
Test setup	Positive symmetric load	
Attachment points	Both main riser attachment (3,4)	
Anchor points	Dummy (B1, B2)	
Required load [g]	15	
Required load [N]	18000	
Minimum test duration [s]	5	
Result		
Test duration [s]	5.4	
Any signs of structural failure	No	20
Slippery test OK	Yes	51
Test results	POSITIVE	1011

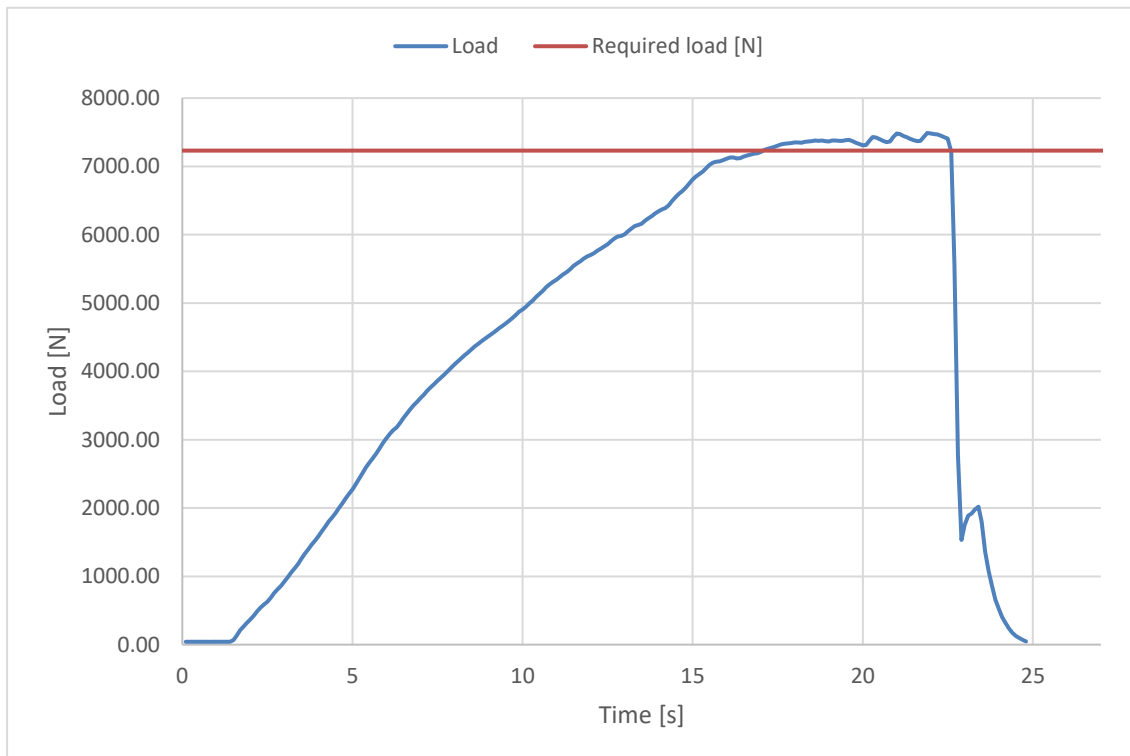
Test ID 05

Standard	EN 1651
Reference in standard	5.5.1.2
Test setup	Positive asymmetric load
Attachment points	One riser attachment (3 or 4)
Anchor points	Dummy (C)
Required load [g]	6
Required load [N]	7200
Minimum test duration [s]	5
Result	
Test duration [s]	5.5
Any signs of structural failure	No 20
Test results	POSITIVE 51
	1011

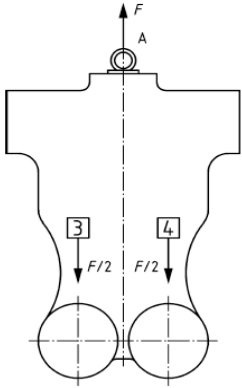
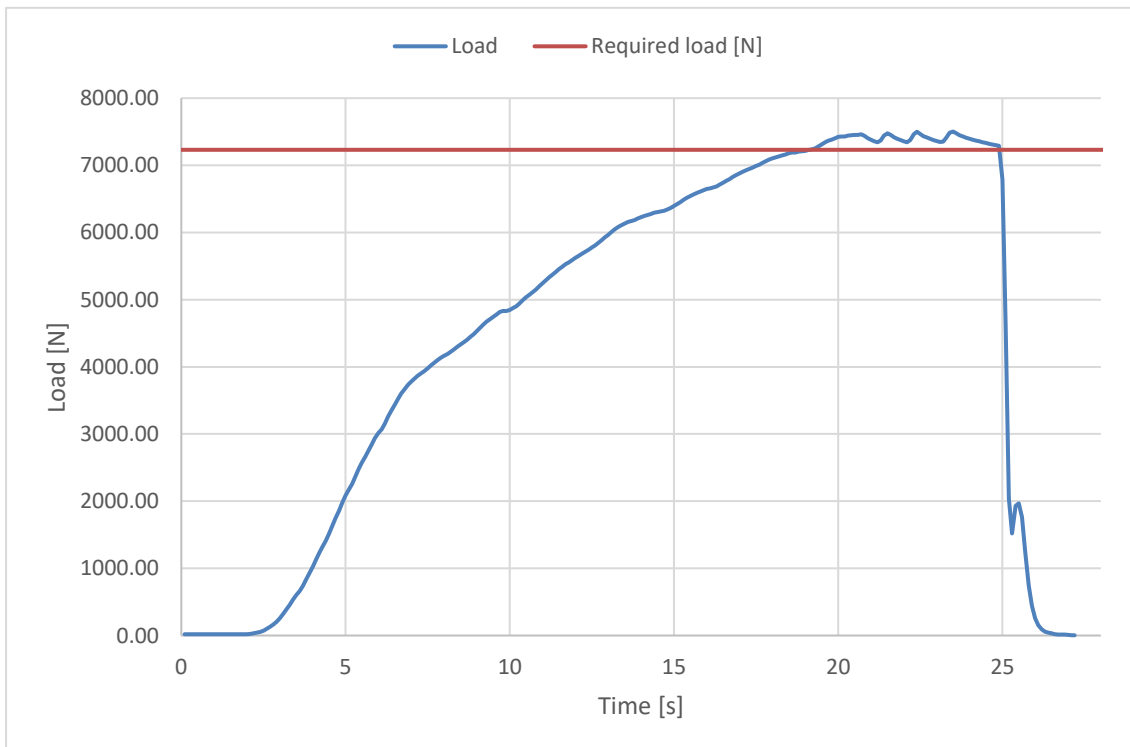
Test ID 06

Standard	EN 1651	
Reference in standard	5.5.1.6	
Test setup	Negative symmetric load	
Attachment points	Both main riser attachment (3,4)	
Anchor points	Dummy (A)	
Required load [g]	6	
Required load [N]	7200	
Minimum test duration [s]	5	
Result		
Test duration [s]	5.8	
Any signs of structural failure	No	20
Test results	POSITIVE	51
		1011

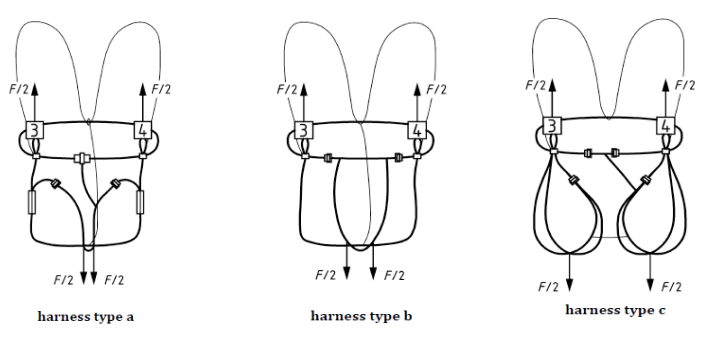
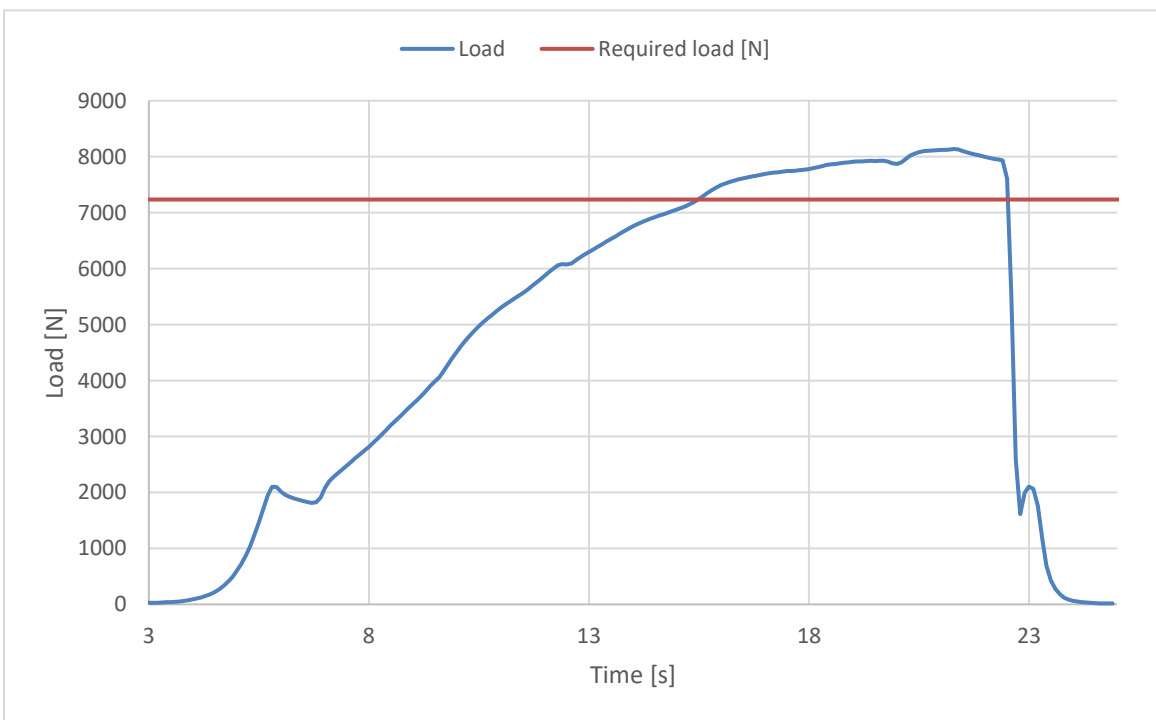
Test ID 12

Standard	EN 1651	
Reference in standard	5.5.1.7	
Test setup	Upright (landing) position load	
Attachment points	Both main riser attachment (3, 4)	
Anchor points	Both legstrap of harness (no dummy)	
Required load [g]	6	
Required load [N]	7200	
Minimum test duration [s]	5	
Harness type	type a	
Result		
Test duration [s]	7.1	20
Any signs of structural failure	No	51
Slippery test OK	Yes	1011
Test results	POSITIVE
