## Harness Structural test Report

Inspection certificate number: **PH\_277.2019**

Name: **Genie Lite 3**  
 Type: **ABS**  
 Size: **One Size**  
 Serial number: **GLM1906-00002**  
 Impact pad type: <sup>(1)</sup> **Koroyd**  
 Clip-in weight [kg]: **120**

**Harness Structural test**

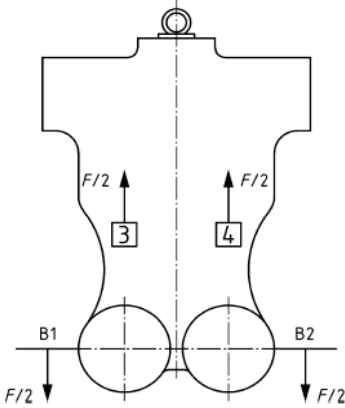
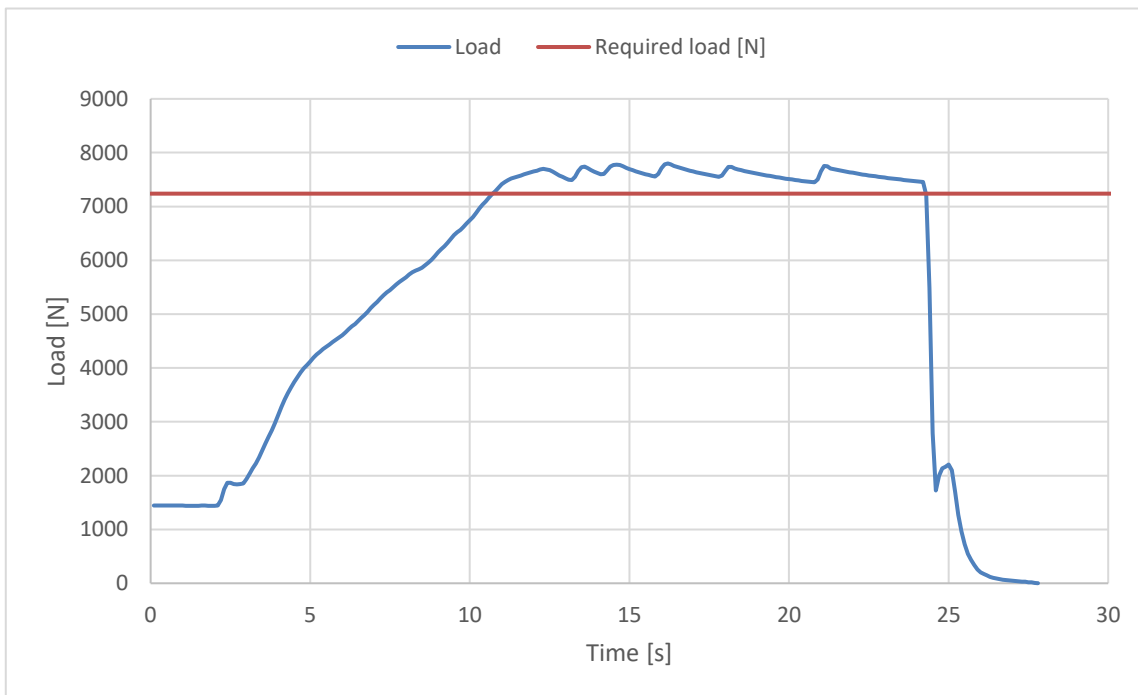
**Test ID 02**

Reference in standard	<b>5.3.2.1</b>	
Test setup	<b>Default flying position</b>	
Attachment points	<b>Both main riser attachment (3,4)</b>	
Anchor points	<b>Dummy (B1, B2)</b>	
Required load [g]	<b>6</b>	
Required load [N]	<b>7200</b>	
Minimum test duration [s]	<b>10</b>	
<b>Result</b>		
Test duration [s]	<b>13.5</b>	
Any signs of structural failure	<b>No</b>	
Test results	<b>POSITIVE</b>

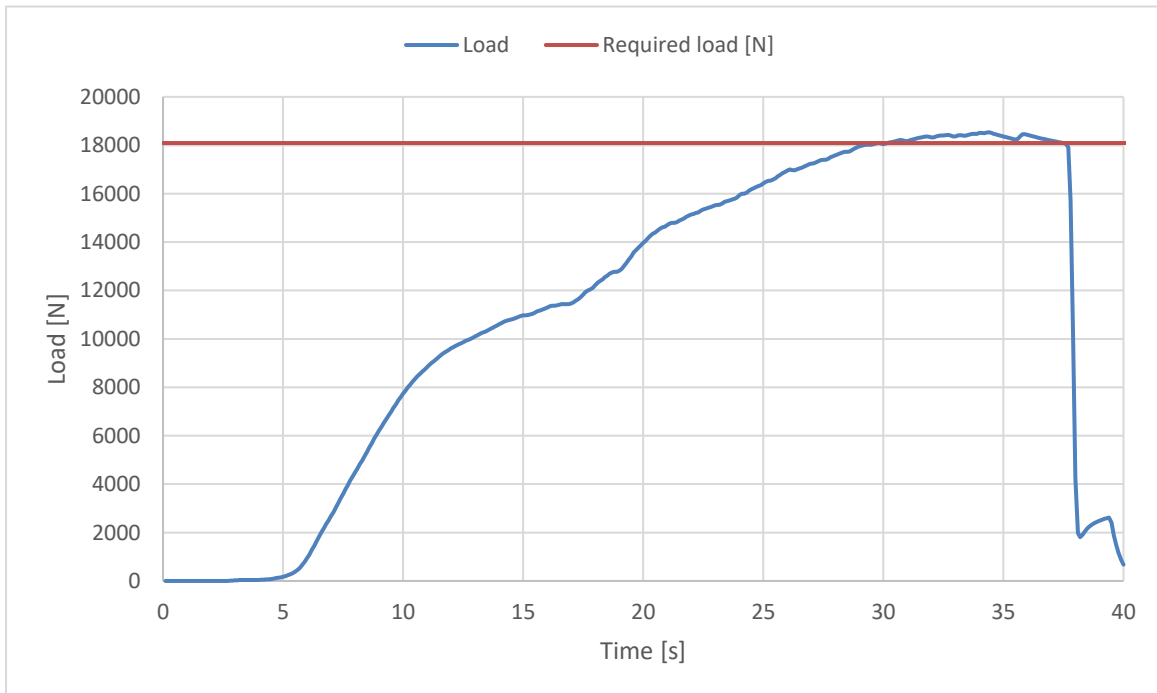
**Test ID 03**

Reference in standard	<b>5.3.2.2</b>	
Test setup	<b>Default flying position</b>	
Attachment points	<b>Both main riser attachment (3,4)</b>	
Anchor points	<b>Dummy (B1, B2)</b>	
Required load [g]	<b>15</b>	
Required load [N]	<b>18000</b>	
Minimum test duration [s]	<b>5</b>	
<b>Result</b>		
Test duration [s]	<b>7.3</b>	
Any signs of structural failure	<b>No</b>	
Test results	<b>POSITIVE</b>

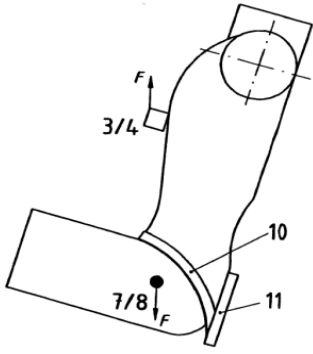
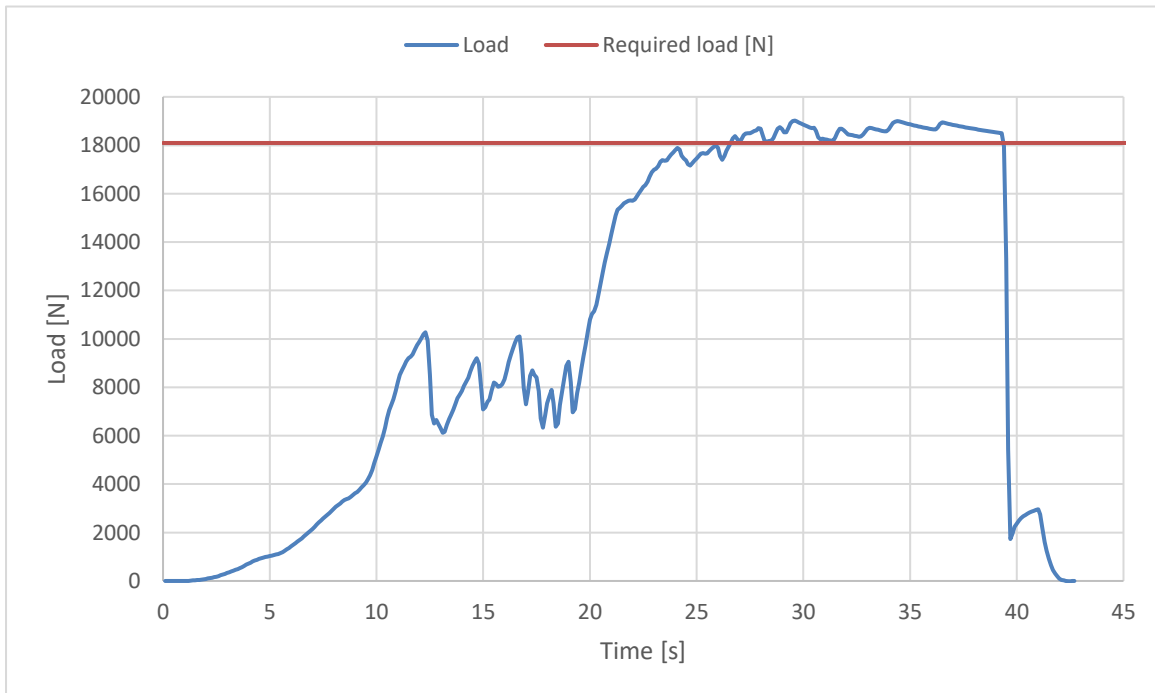
**Test ID 13**

Standard	<b>EN 1651:1999</b>
Reference in standard	<b>5.3.2.7</b>
Test setup	<b>Flying position before landing</b>
Attachment points	<b>Both main riser attachment (3,4)</b>
Anchor points	<b>Dummy (7,8)</b>
Required load [g]	<b>15</b>
Required load [N]	<b>18000</b>
Minimum test duration [s]	<b>5</b>
<b>Result</b>	
Test duration [s]	<b>12.8</b>
Any signs of structural failure	<b>No</b>
Test results	<b>POSITIVE</b>

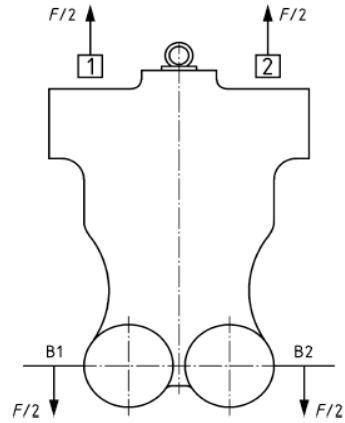
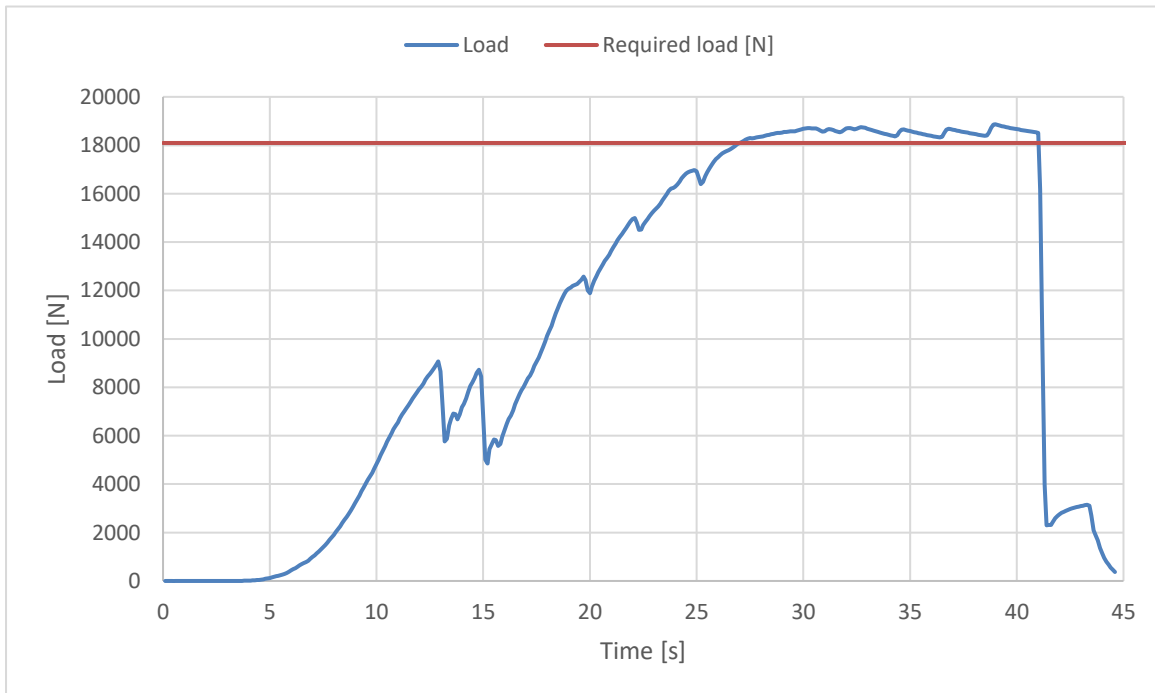
**Test ID 09**

Standard **EN 1651:1999**  
 Reference in standard **5.3.2.4**  
 Test setup **Rescue attachments**  
 Attachment points **Rescue riser attachment (1,2)**  
 Anchor points **Dummy (B1,B2)**

Test duration [s] **14**  
 Any signs of structural failure **No**  
 Test results **POSITIVE**

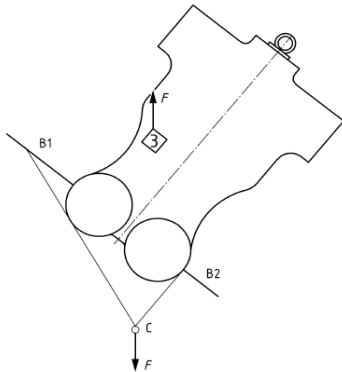
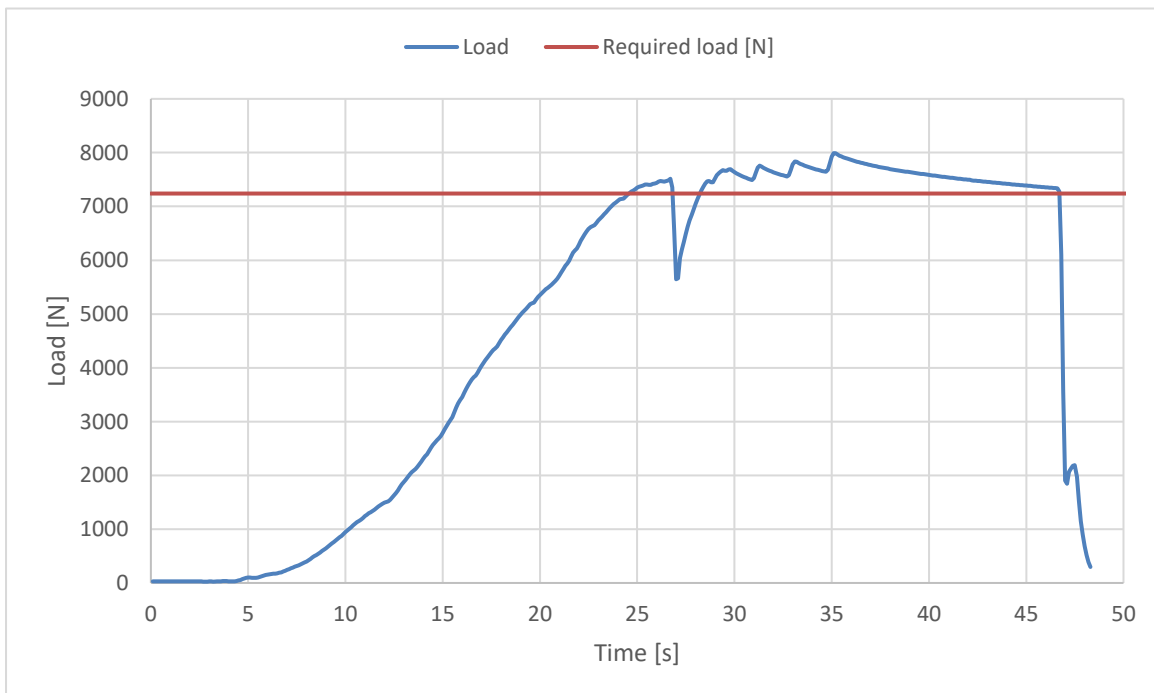
**Test ID 04**

Reference in standard	<b>5.3.2.3</b>	
Test setup	<b>Asymmetric, one riser</b>	
Attachment points	<b>One main riser attachment (3)</b>	
Anchor points	<b>Dummy (B1,B2)</b>	
Required load [g]	<b>6</b>	
Required load [N]	<b>7200</b>	
Minimum test duration [s]	<b>10</b>	
<b>Result</b>		
Test duration [s]	<b>18.5</b>	
Any signs of structural failure	<b>No</b>	
Test results	<b>POSITIVE</b>

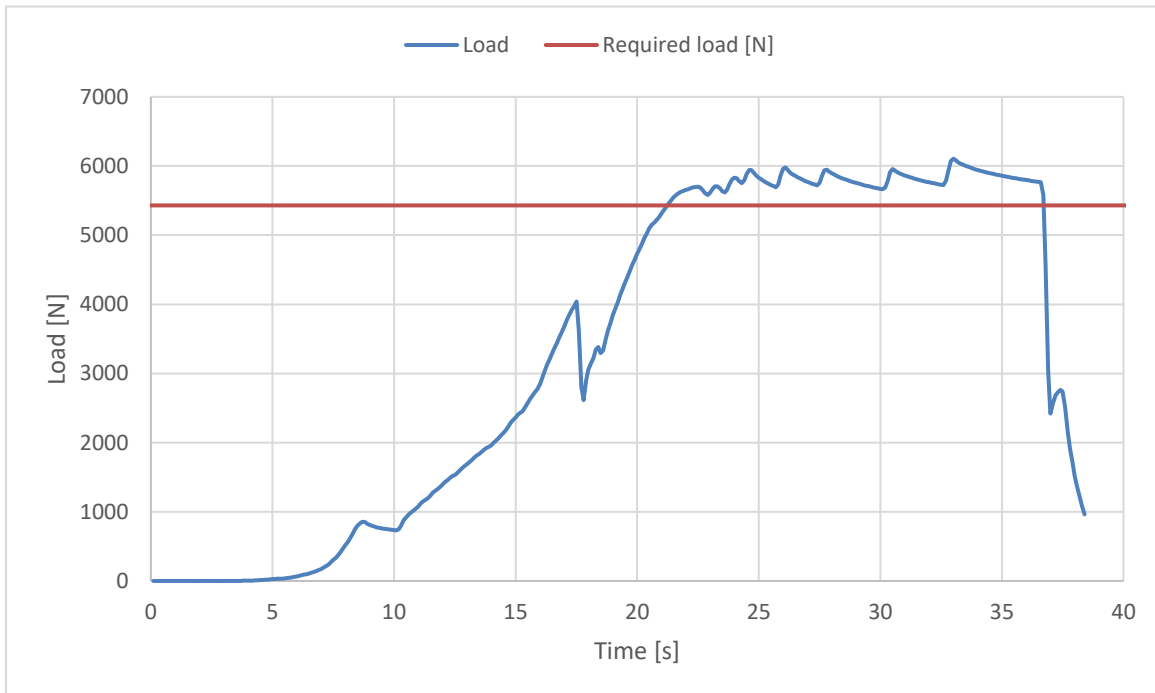
**Test ID 07**

Reference in standard	<b>5.3.2.6</b>	
Test setup	<b>Asymmetric, negative</b>	
Attachment points	<b>One main riser attachment (3 or 4) downwards</b>	
Anchor points	<b>Dummy (9)</b>	
Required load [g]	<b>4.5</b>	
Required load [N]	<b>5400</b>	
Minimum test duration [s]	<b>10</b>	
<b>Result</b>		
Test duration [s]	<b>15.5</b>	
Any signs of structural failure	<b>No</b>	
Test results	<b>POSITIVE</b>

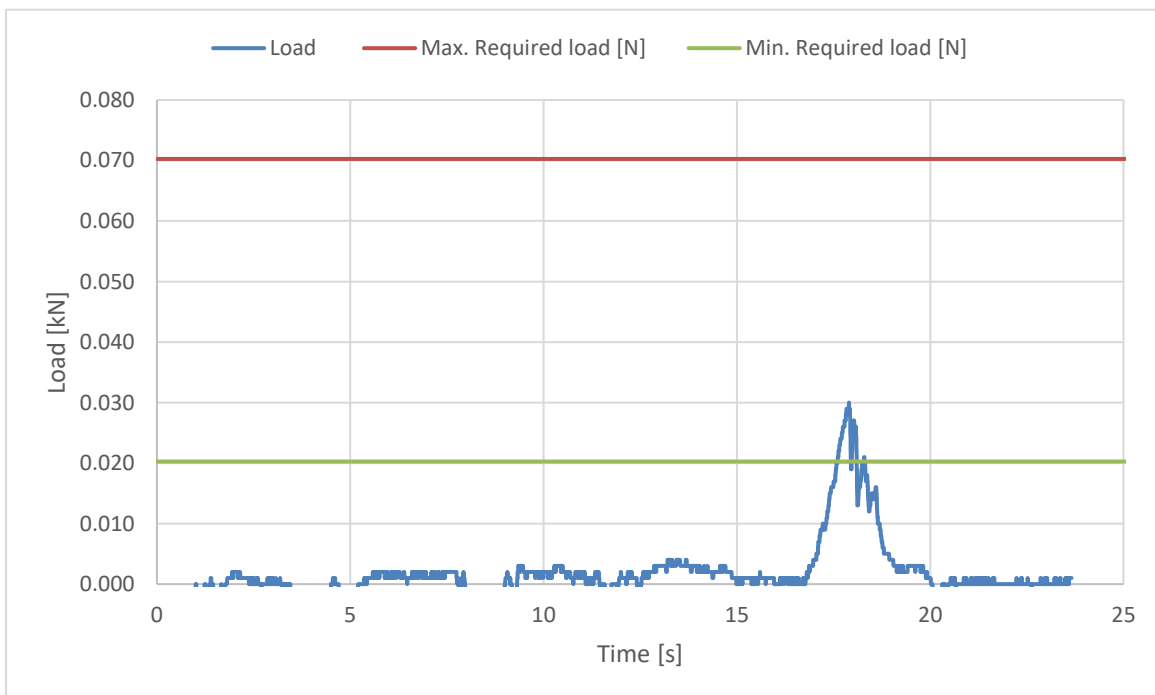
**Test ID RRDT**

Standard	<b>LTF NfL II 91/09</b>
Reference in standard	<b>6.1.5</b>
Test setup	<b>Default flying position</b>
Attachment points	<b>Sensor connect to handle, and pull in opening direction</b>
	The test is to simulate the load required to open the emergency parachute(1st action).
Min. Required load [N]	<b>20</b>
Max. Required load [N]	<b>70</b>
<b>Result</b>	
Load for first action [N]	<b>29.74</b>
Test results	<b>POSITIVE</b>

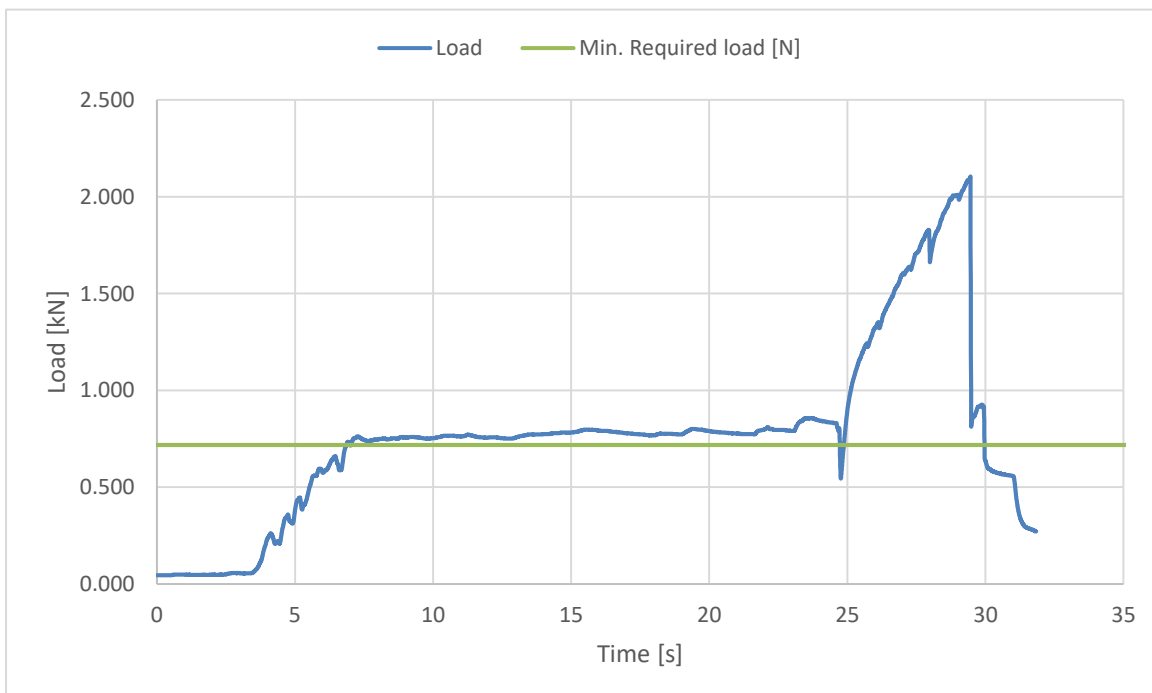
**Test ID RRST**

Standard	<b>EN12491:2015</b>
Reference in standard	<b>5.3.2</b>
Test setup	<b>Two end points of handle</b>
Attachment points	<b>Sensor connect to end of handle, pull on the other side</b> The handle must support min 700 N for 10 s, after measure breaking strength
Min. Required load [N]	<b>700</b>
Minimum test duration [s]	<b>10</b>
<b>Result</b>	
Test duration [s]:	<b>17.5</b>
Breaking strength [N]	<b>2085.76</b>
Test results	<b>POSITIVE</b>
