Harness Structural test Report - NfL

Inspection certificate number: **PH_387.2023**

Name: **Genie race 5**
 Type: **ABS**
 Size: **M**
 Serial number: **0922-VGA50001M**
 Impact pad type: ⁽¹⁾ **Koroyd**
 Clip-in weight [kg]: **120**
 Integrated container: **Yes**
 Date of test: **13.04.2023**

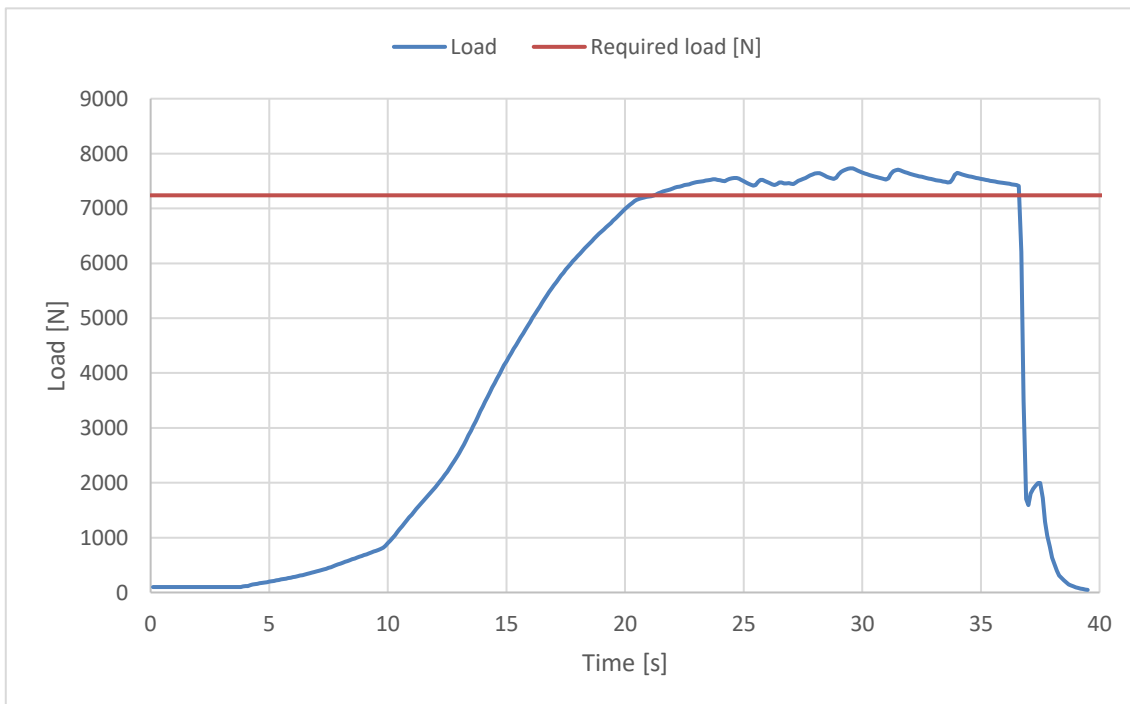
Test ID 02

Standard	EN 1651:1999
Reference	5.3.2.1
Test setup	Default flying position
Attachment points	Both main riser attachment (3,4)
Anchor points	Dummy (B1, B2)
Required load [g]	6
Required load [N]	7200
Minimum test duration [s]	10
Result	
Test duration [s]	15.4
Any signs of structural failure	No
Test results	POSITIVE

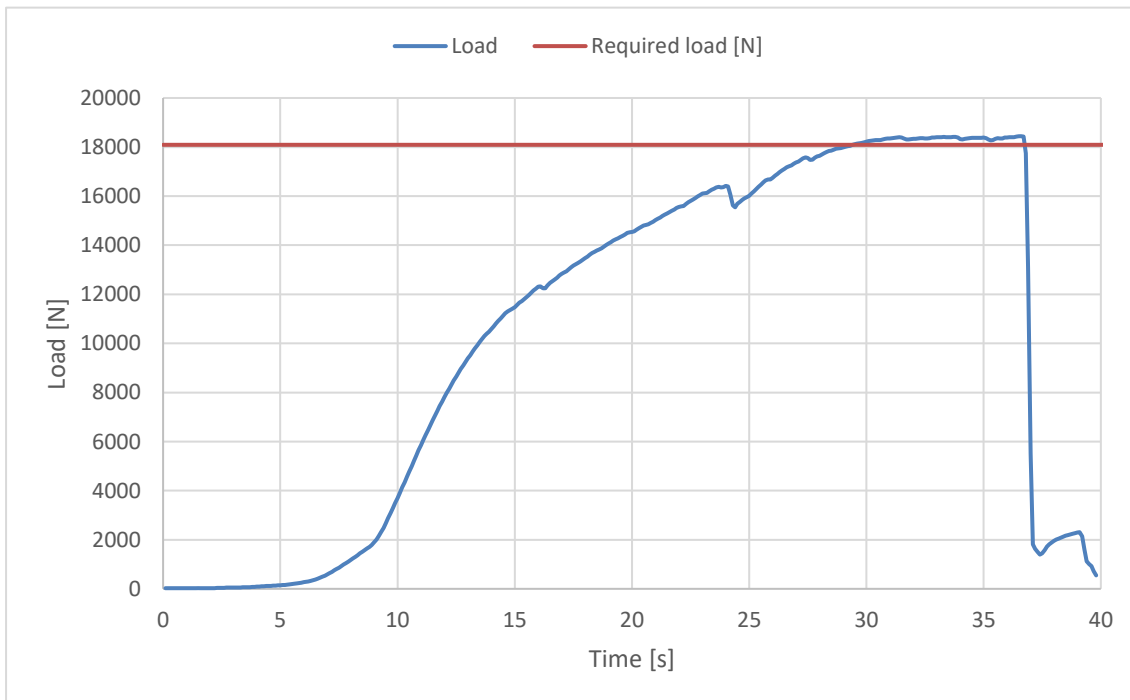
Test ID 03

Test duration [s] **7.3**
 Any signs of structural failure **No**
 Test results **POSITIVE**

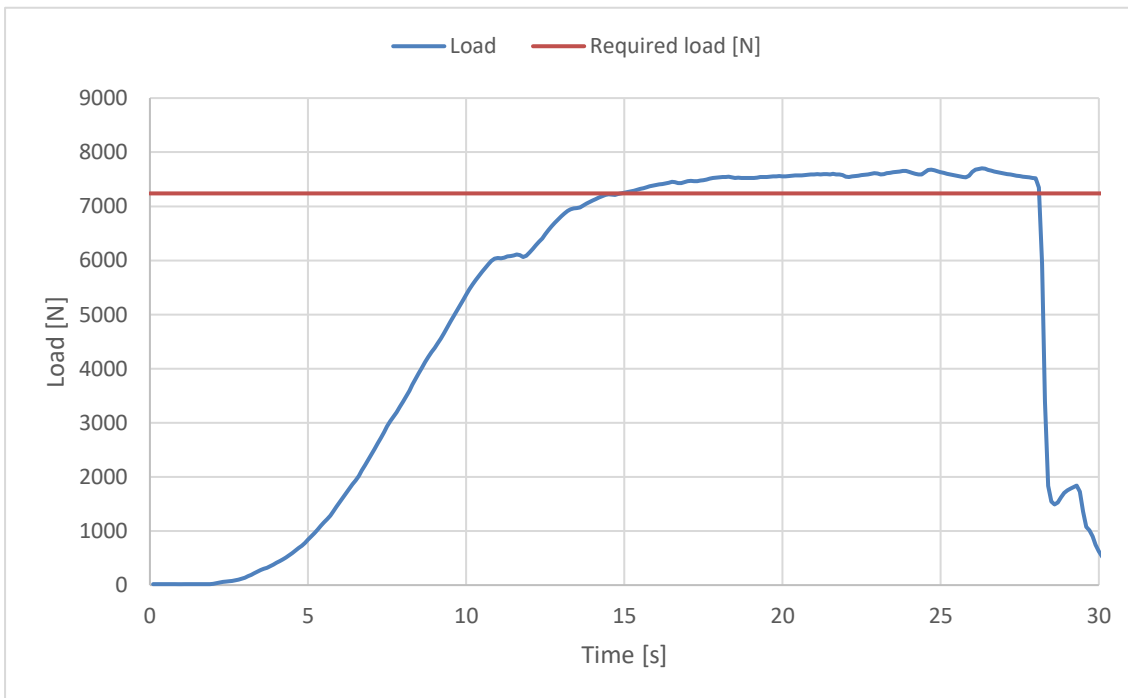
Test ID 04

Test duration [s] **13.3**
 Any signs of structural failure **No**
 Test results **POSITIVE**

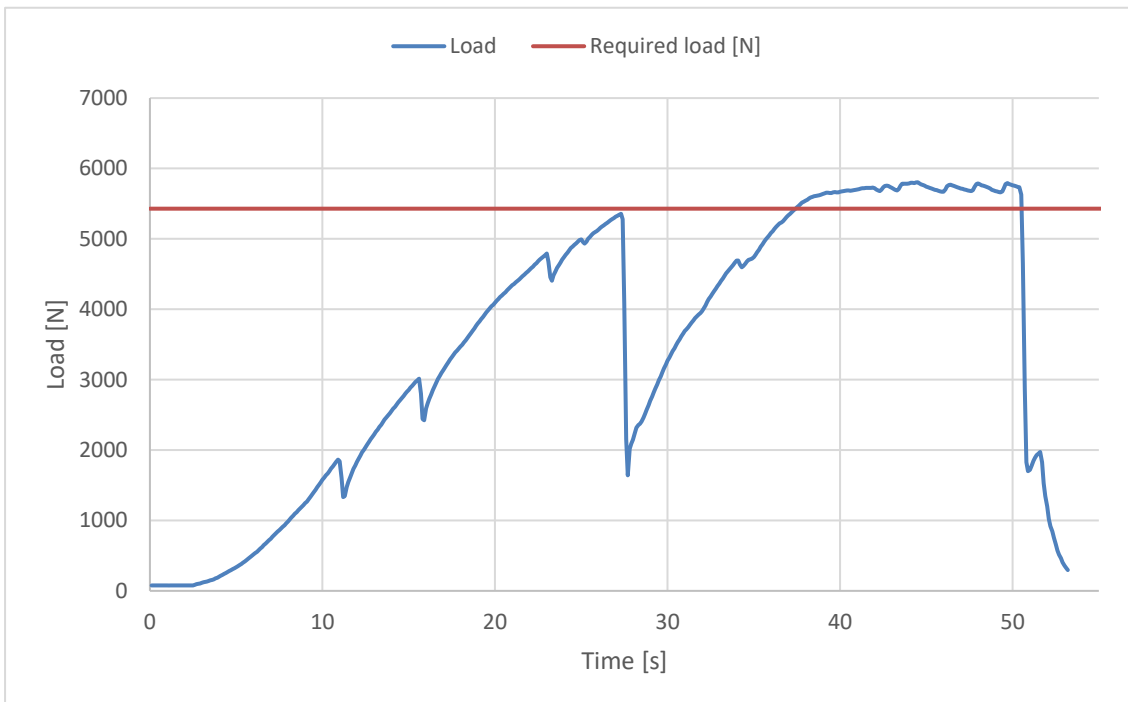
Test ID 07

Standard	EN 1651:1999
Reference	5.3.2.6
Test setup	Asymmetric, negative
Attachment points	One main riser attachment (3 or 4) downwards
Anchor points	Dummy (9)
Required load [g]	4.5
Required load [N]	5400
Minimum test duration [s]	10
Result	
Test duration [s]	13.1
Any signs of structural failure	No
Test results	POSITIVE

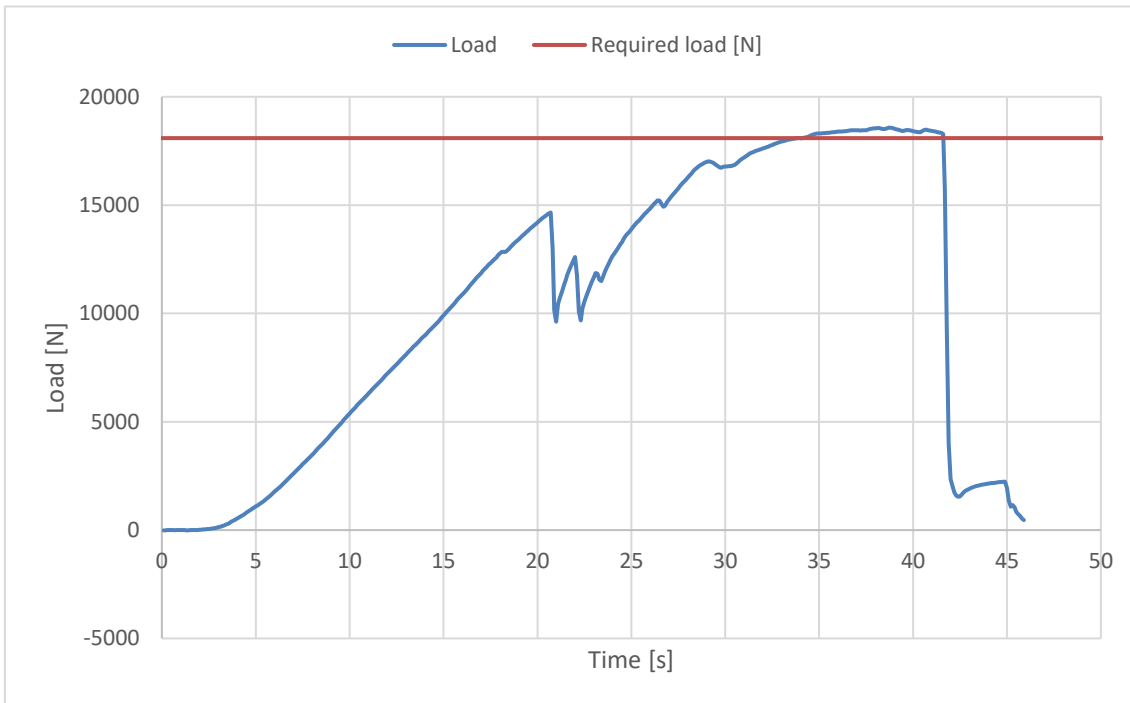
Test ID 09

Test duration [s] **7.5**
 Any signs of structural failure **No**
 Test results **POSITIVE**

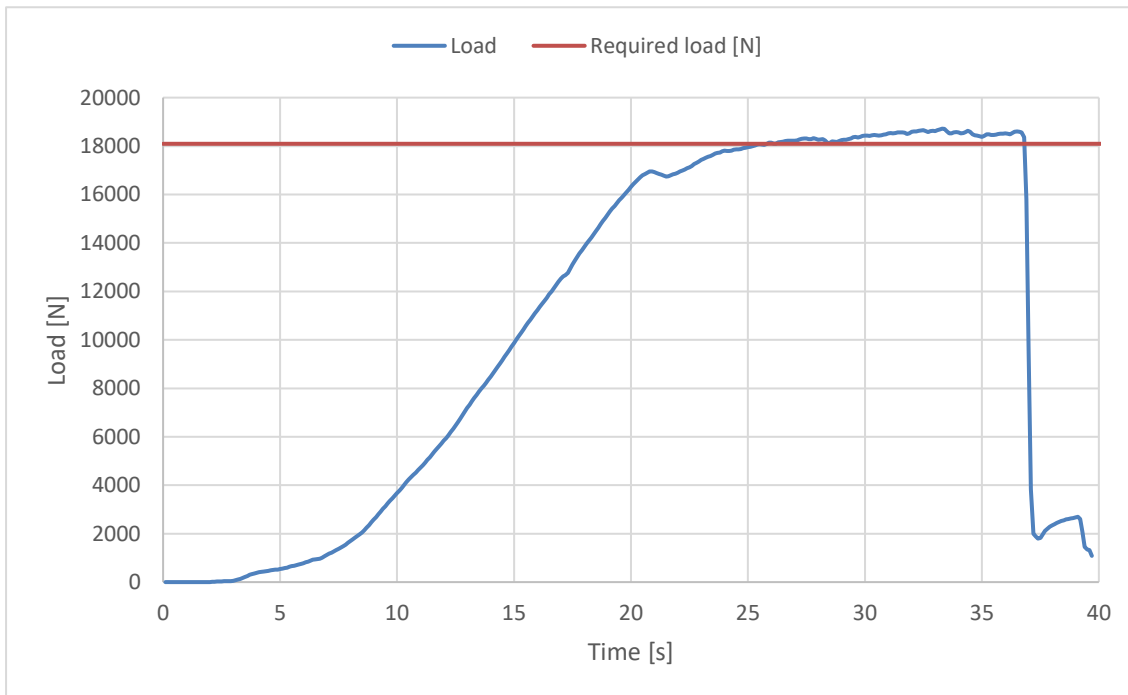
Test ID 13

Test duration [s] **11**
 Any signs of structural failure **No**
 Test results **POSITIVE**

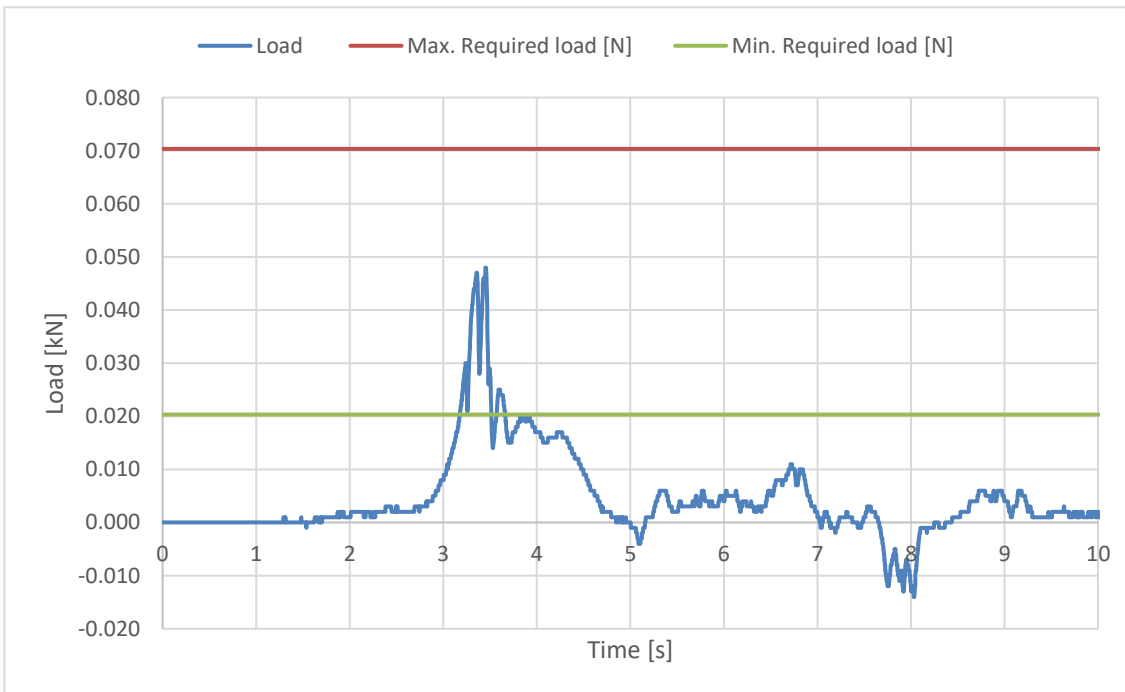
Test ID RRDT

Load for first action [N] **47.68**
 Test results **POSITIVE**

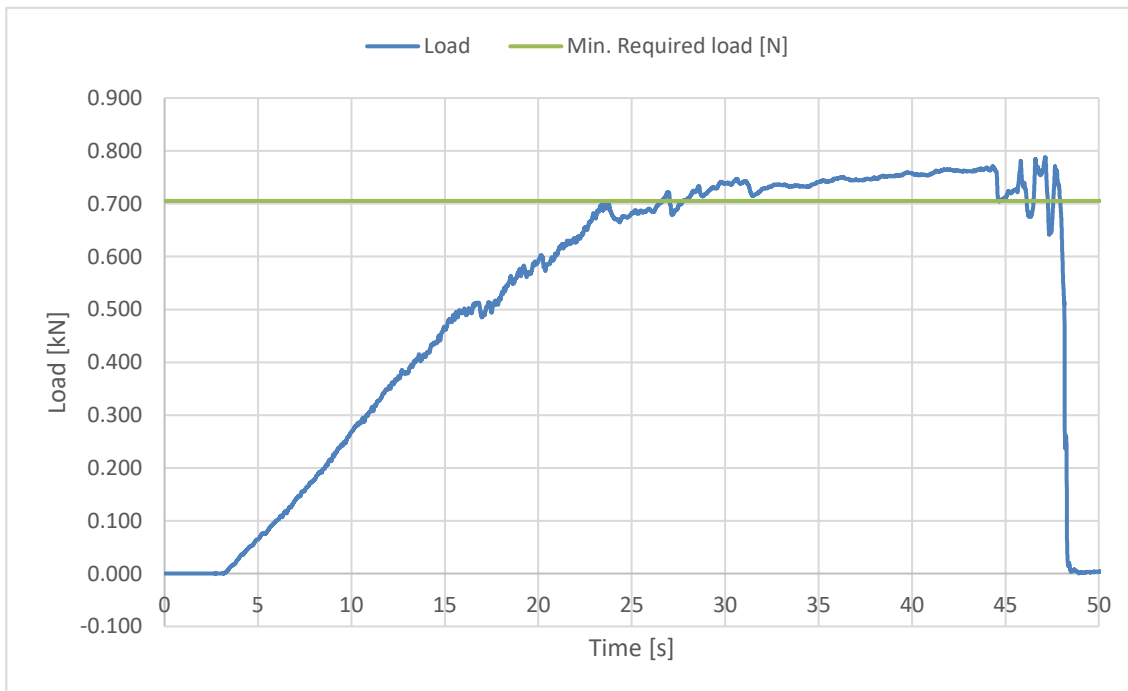
Test ID RRST

Standard	EN 12491
Reference in standard	5.3.2
Test setup	Two end points of handle
Attachment points	Sensor connect to end of handle, pull on the other side
	The handle must support min 700 N for 10 s, after measure breaking strength
Min. Required load [N]	700
Minimum test duration [s]	10
Result	
Test duration [s]:	16.9
Breaking strength [N]	782.77
Test results	POSITIVE
