Harness Structural test Report - EN

Inspection certificate number: **PH_416.2023**

Name: **Puma**
 Type: **ABS**
 Size: **L**
 Serial number: **02.L.07.2023-BL**
 Impact pad type: ⁽¹⁾ **Inflatable**
 Clip-in weight [kg]: **120**
 Date of test: **17.08.2023**

Harness Structural test

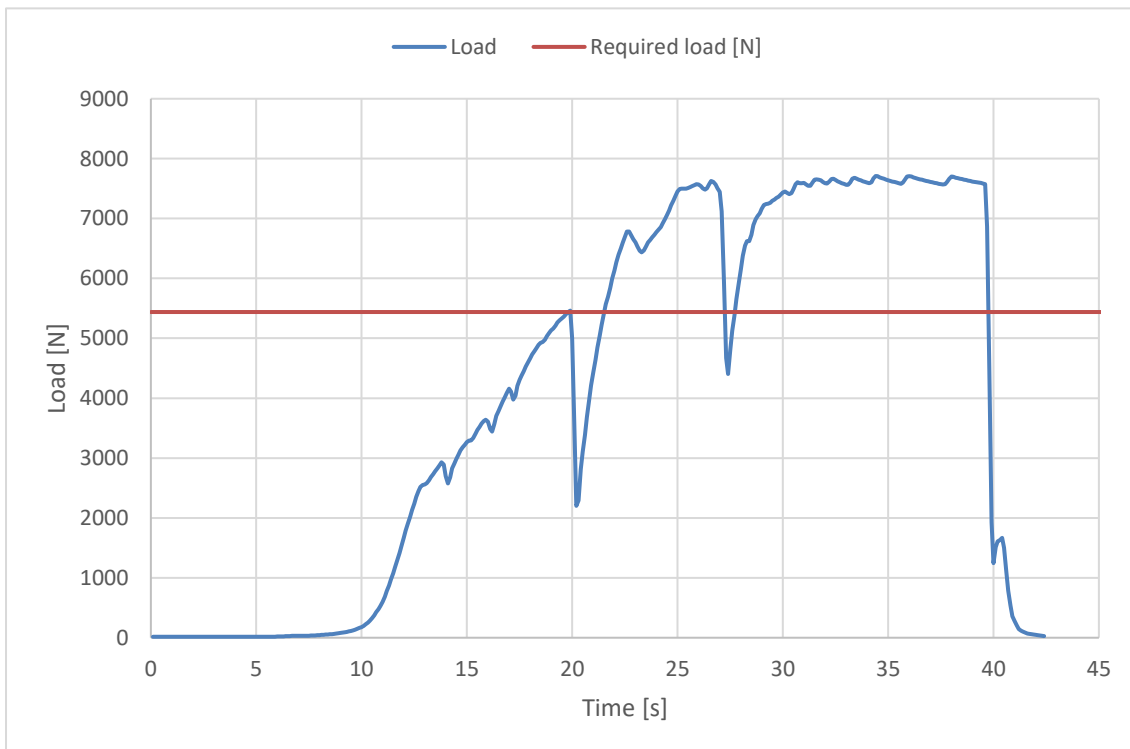
Test ID 01

Test duration [s] **12**
 Any signs of structural failure **No**
 Slippery test OK **Yes**
 Test results **POSITIVE**

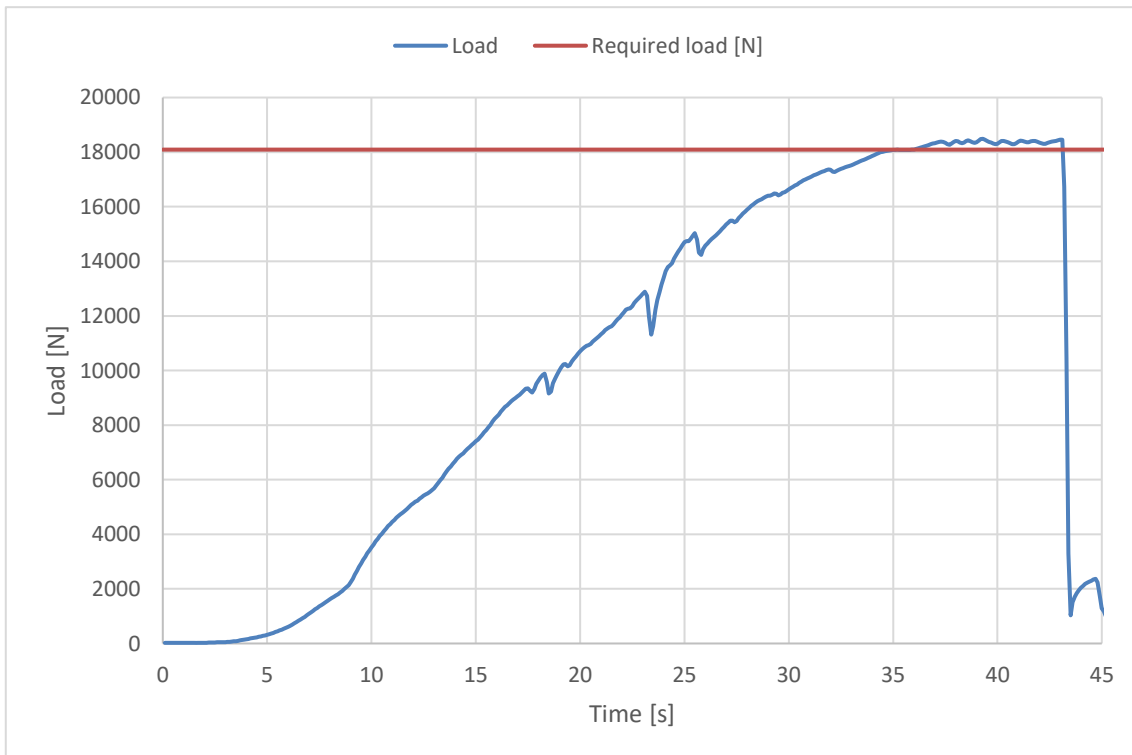
Test ID 03

Test duration [s] **7.2**
 Any signs of structural failure **No**
 Slippery test OK **Yes**
 Test results **POSITIVE**

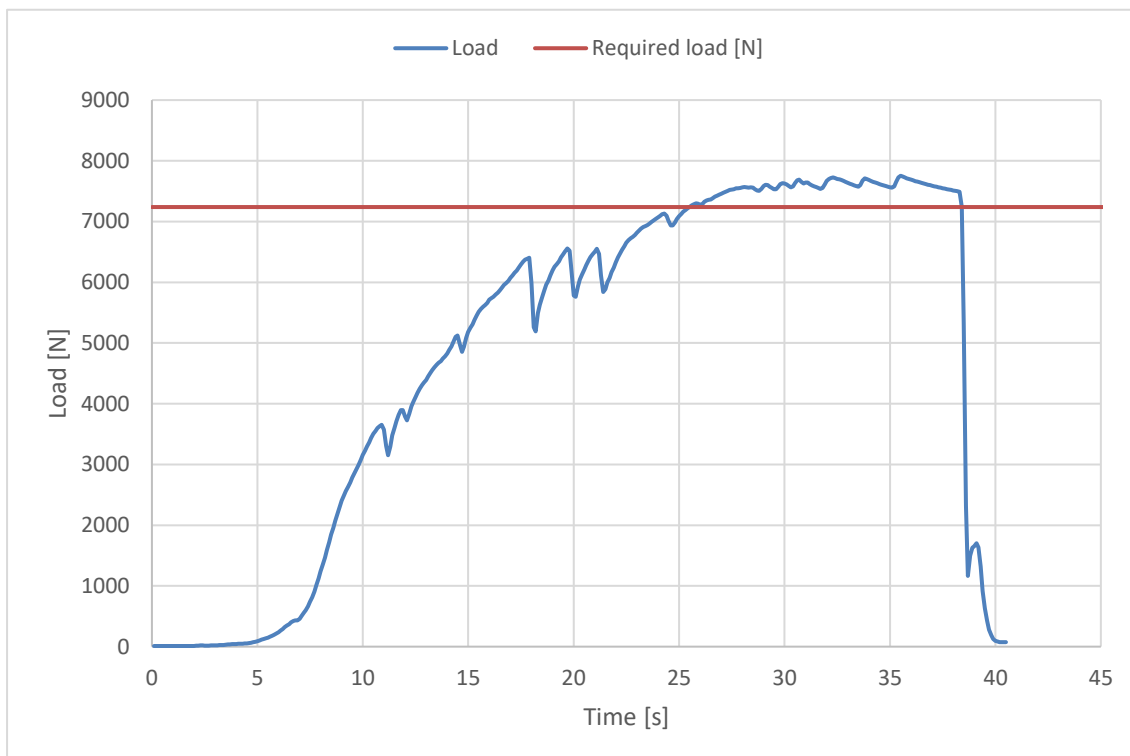
Test ID 05

Standard	EN 1651
Reference in standard	5.5.1.2
Test setup	Positive asymmetric load
Attachment points	One riser attachment (3 or 4)
Anchor points	Dummy (C)
Required load [g]	6
Required load [N]	7200
Minimum test duration [s]	5
Result	
Test duration [s]	13
Any signs of structural failure	No
Test results	POSITIVE

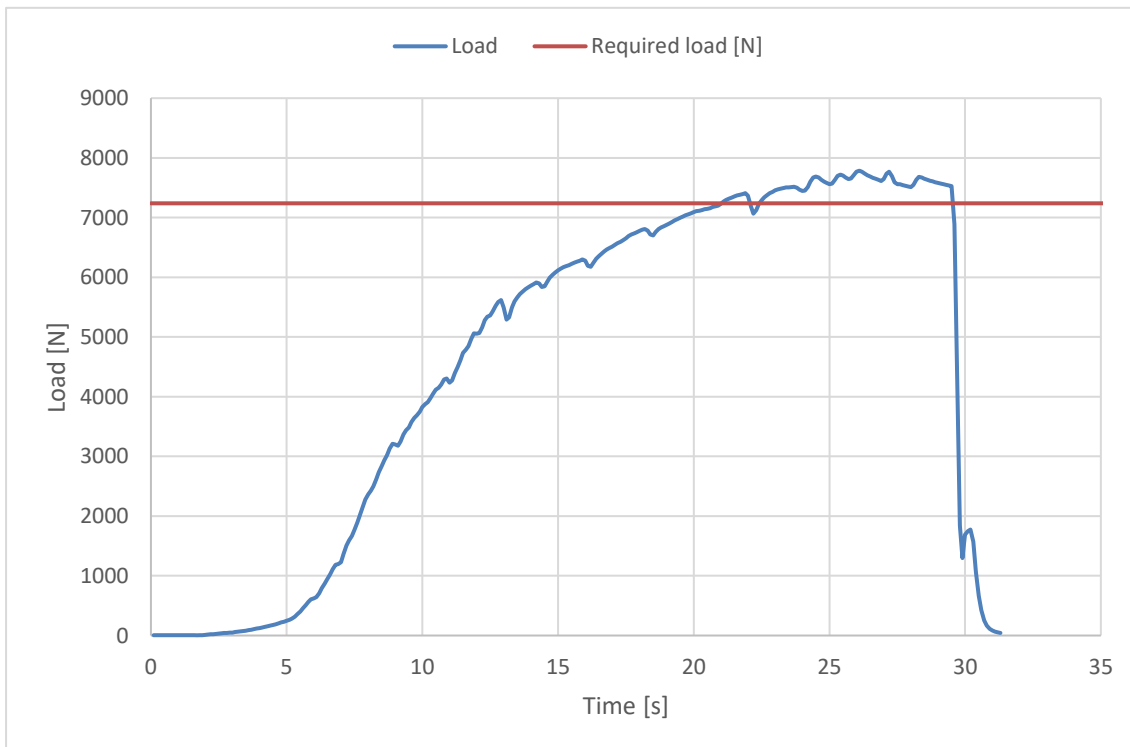
Test ID 06

Standard	EN 1651
Reference in standard	5.5.1.6
Test setup	Negative symmetric load
Attachment points	Both main riser attachment (3,4)
Anchor points	Dummy (A)
Required load [g]	6
Required load [N]	7200
Minimum test duration [s]	5
Result	
Test duration [s]	7.1
Any signs of structural failure	No
Test results	POSITIVE

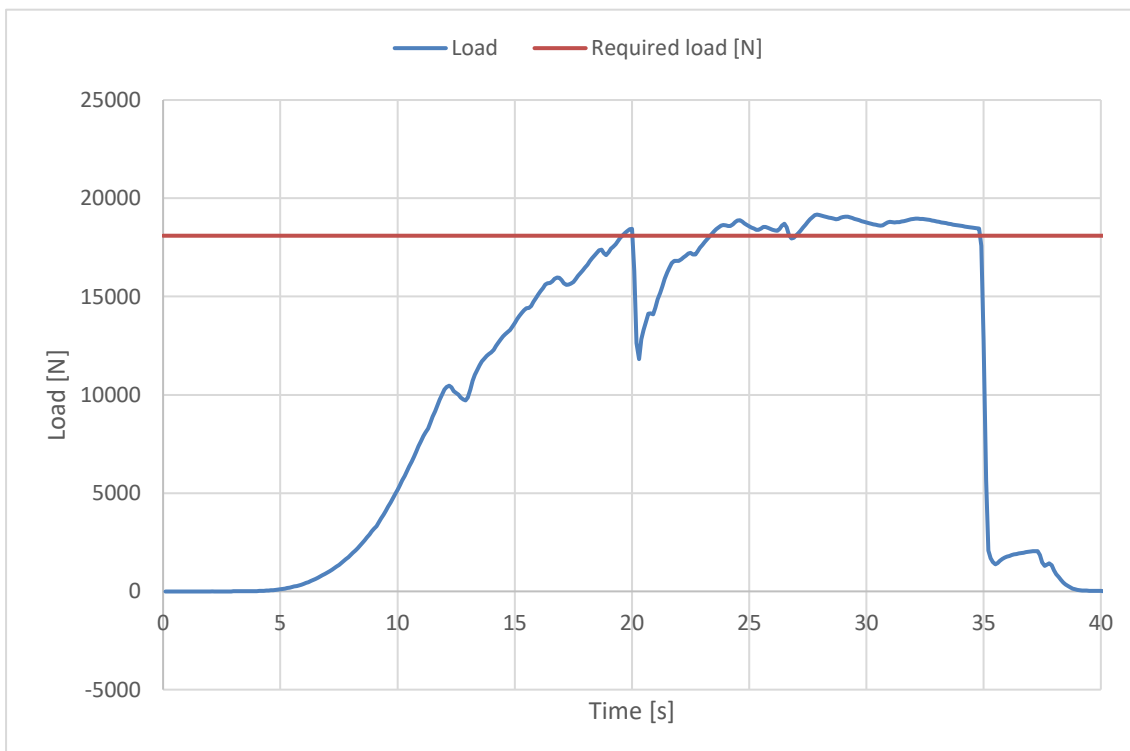
Test ID 09

Standard	EN 1651
Reference in standard	5.5.1.3
Test setup	Positive symmetric load rescue points
Attachment points	Both main riser attachment (1,2)
Anchor points	Dummy (B1,B2)
Required load [g]	15
Required load [N]	18000
Minimum test duration [s]	5
Result	
Test duration [s]	7.8
Any signs of structural failure	No
Slippery test OK	Yes
Test results	POSITIVE

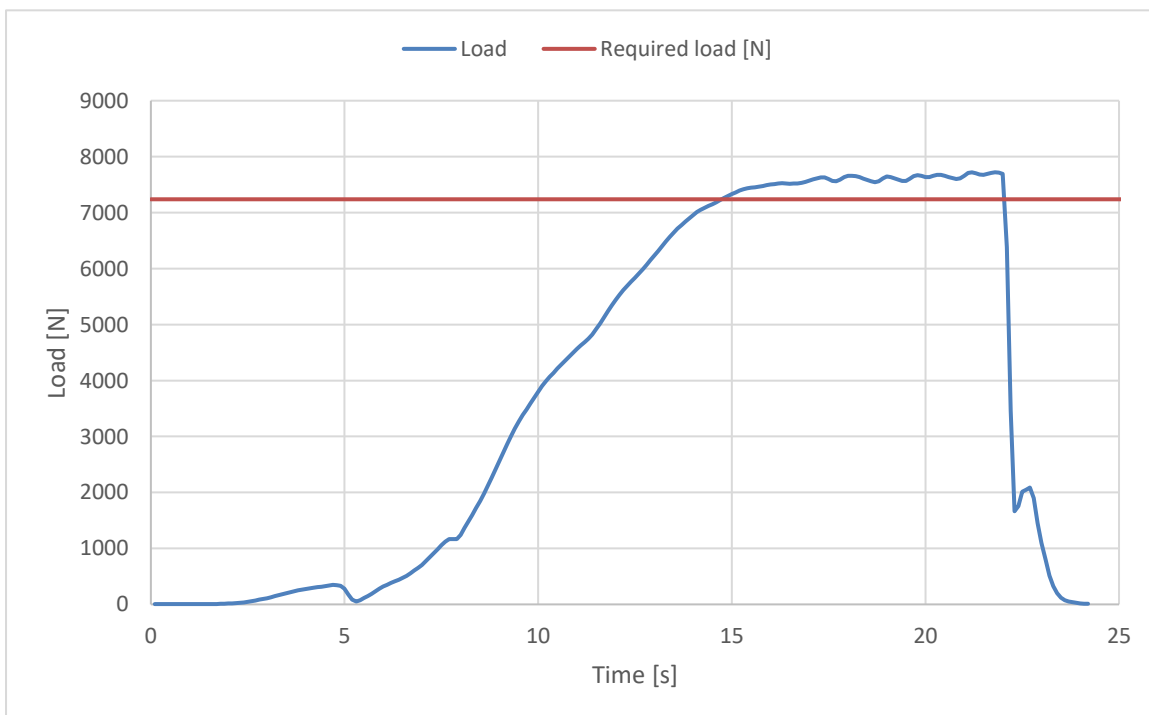
Test ID 12

Standard	EN 1651
Reference in standard	5.5.1.7
Test setup	Upright (landing) position load
Attachment points	Both main riser attachment (3, 4)
Anchor points	Both legstrap of harness (no dummy)
Required load [g]	6
Required load [N]	7200
Minimum test duration [s]	5
Harness type	type b
Result	
Test duration [s]	7.3
Any signs of structural failure	No
Slippery test OK	Yes
Test results	POSITIVE

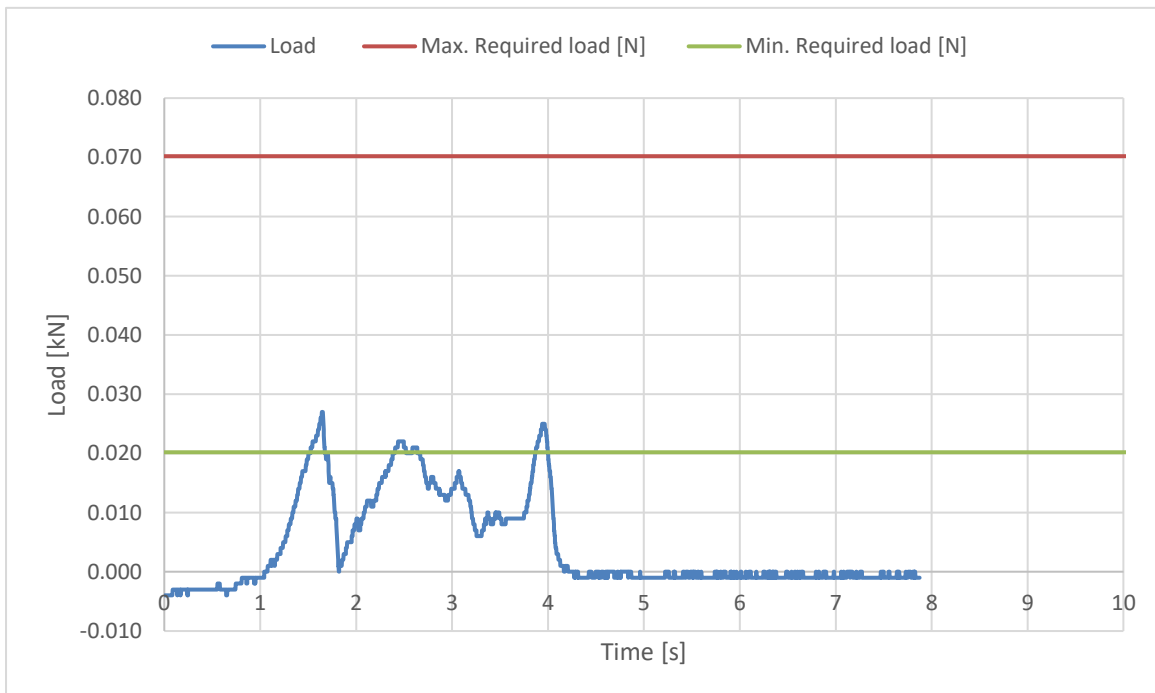
Test ID RRDT

Standard	EN 1651
Reference in standard	5.5.1.11
Test setup	Default flying position
Attachment points	Sensor connect to handle, and pull in opening direction
	The test is to simulate the load required to open the emergency parachute(1st action).
Min. Required load [N]	20
Max. Required load [N]	70
Result	
Load for first action [N]	27.18
Test results	POSITIVE

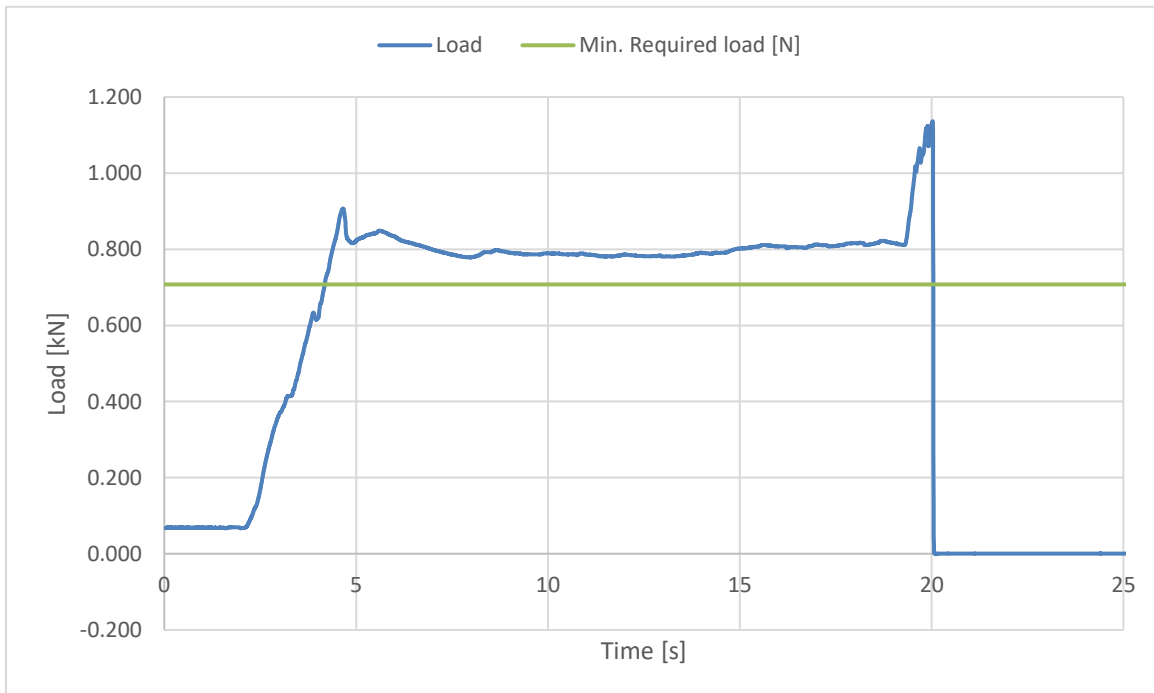
Test ID RRST

Standard	EN 12491
Reference in standard	5.3.2
Test setup	Two end points of handle
Attachment points	Sensor connect to end of handle, pull on the other side
	The handle must support min 700 N for 10 s, after measure breaking strength
Min. Required load [N]	700
Minimum test duration [s]	10
Result	
Test duration [s]:	15.9
Breaking strength [N]	1129.45
Test results	POSITIVE
