# Harness Structural test Report - EN

Inspection certificate number: **PH\_346.2021**

Name: **Lycia Acro Base**  
 Type: **ABS**  
 Size: **M**  
 Serial number: **M-TM-ACROBASE-1**  
 Impact pad type: <sup>(1)</sup> **Foam**  
 Clip-in weight [kg]: **120**

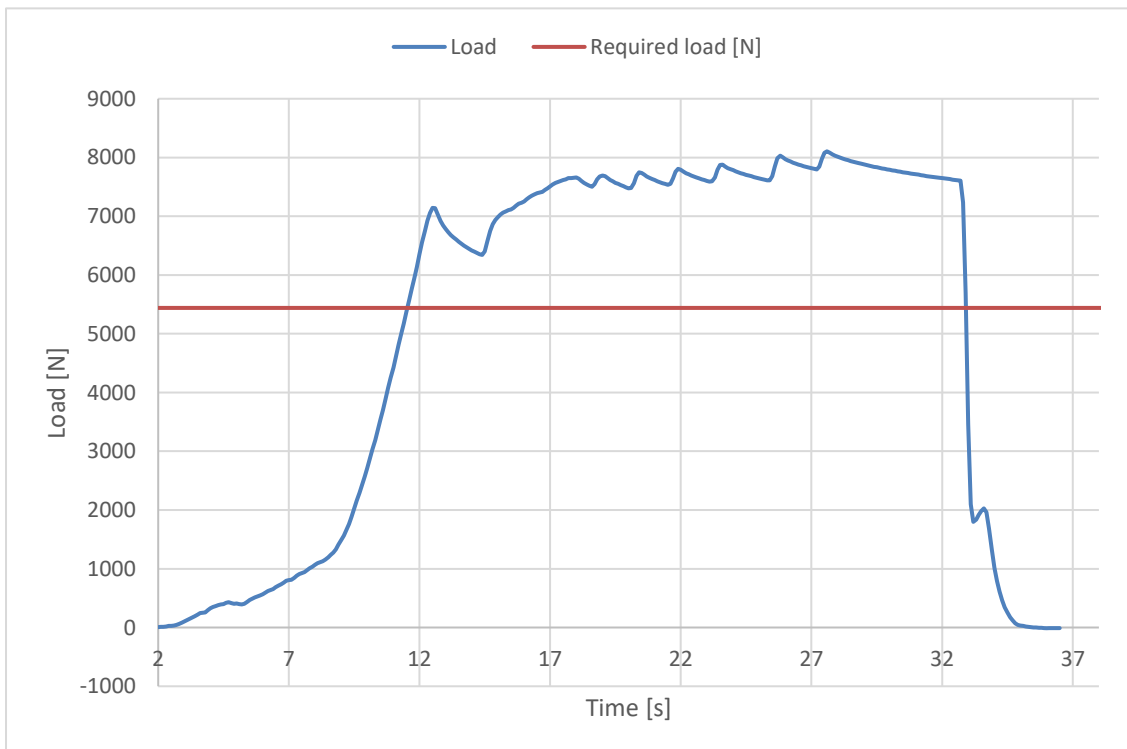
**Test ID 01**

Test duration [s] **21.4**  
 Any signs of structural failure **No**  
 Slippery test OK **Yes**  
 Test results **POSITIVE**

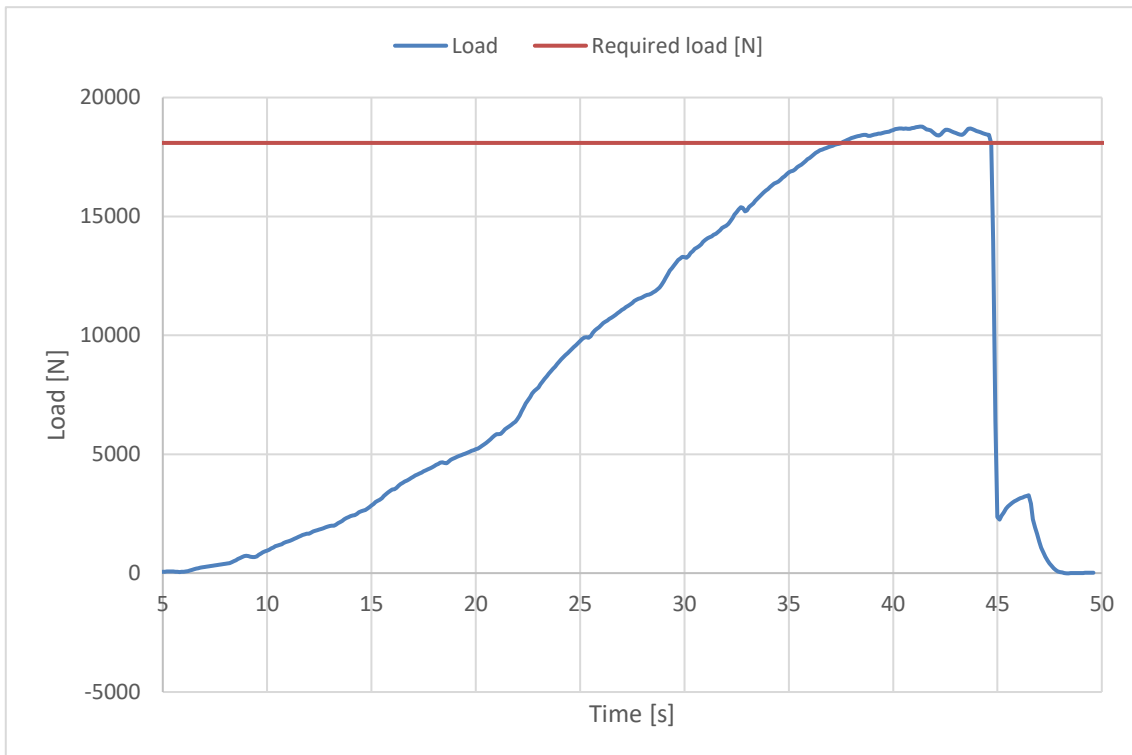
**Test ID 03**

Test duration [s] **7.1**  
 Any signs of structural failure **No**  
 Slippery test OK **Yes**  
 Test results **POSITIVE**

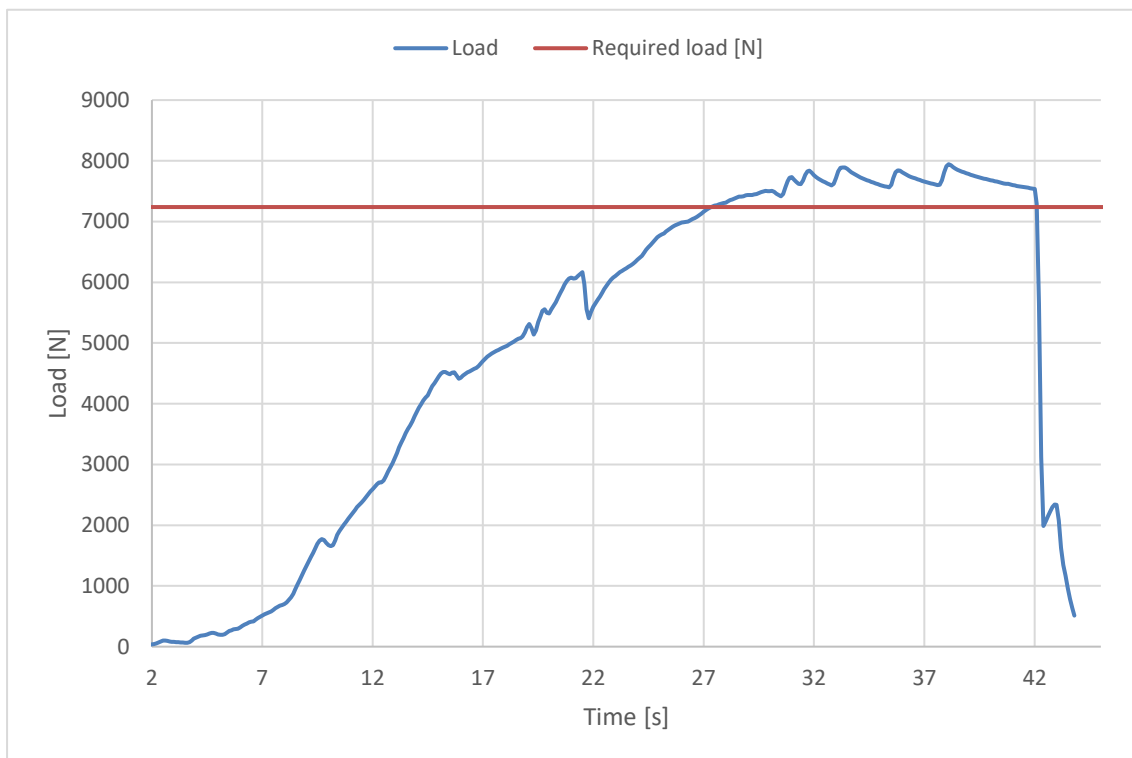
**Test ID 05**

Standard	<b>EN 1651</b>
Reference in standard	<b>5.5.1.2</b>
Test setup	<b>Positive asymmetric load</b>
Attachment points	<b>One riser attachment (3 or 4)</b>
Anchor points	<b>Dummy (C)</b>
Required load [g]	<b>6</b>
Required load [N]	<b>7200</b>
Minimum test duration [s]	<b>5</b>
<b>Result</b>	
Test duration [s]	<b>14.8</b>
Any signs of structural failure	<b>No</b>
Test results	<b>POSITIVE</b>

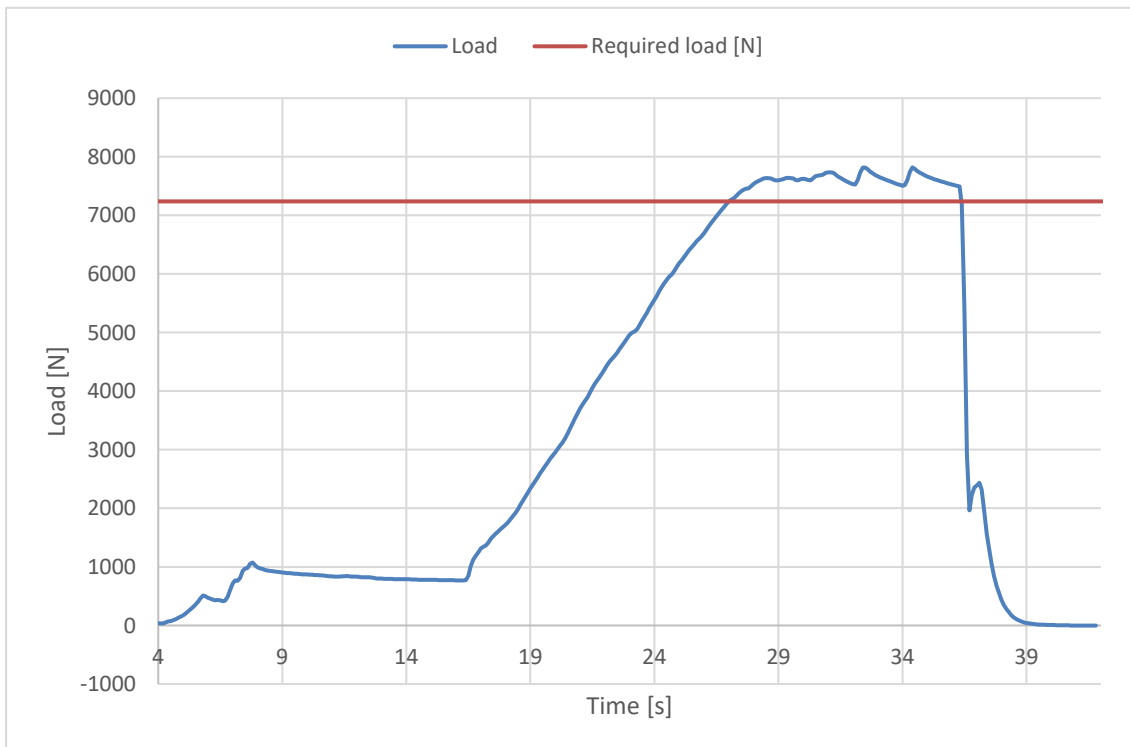
**Test ID 06**

Standard	<b>EN 1651</b>
Reference in standard	<b>5.5.1.6</b>
Test setup	<b>Negative symmetric load</b>
Attachment points	<b>Both main riser attachment (3,4)</b>
Anchor points	<b>Dummy (A)</b>
Required load [g]	<b>6</b>
Required load [N]	<b>7200</b>
Minimum test duration [s]	<b>5</b>
<b>Result</b>	
Test duration [s]	<b>9.3</b>
Any signs of structural failure	<b>No</b>
Test results	<b>POSITIVE</b>

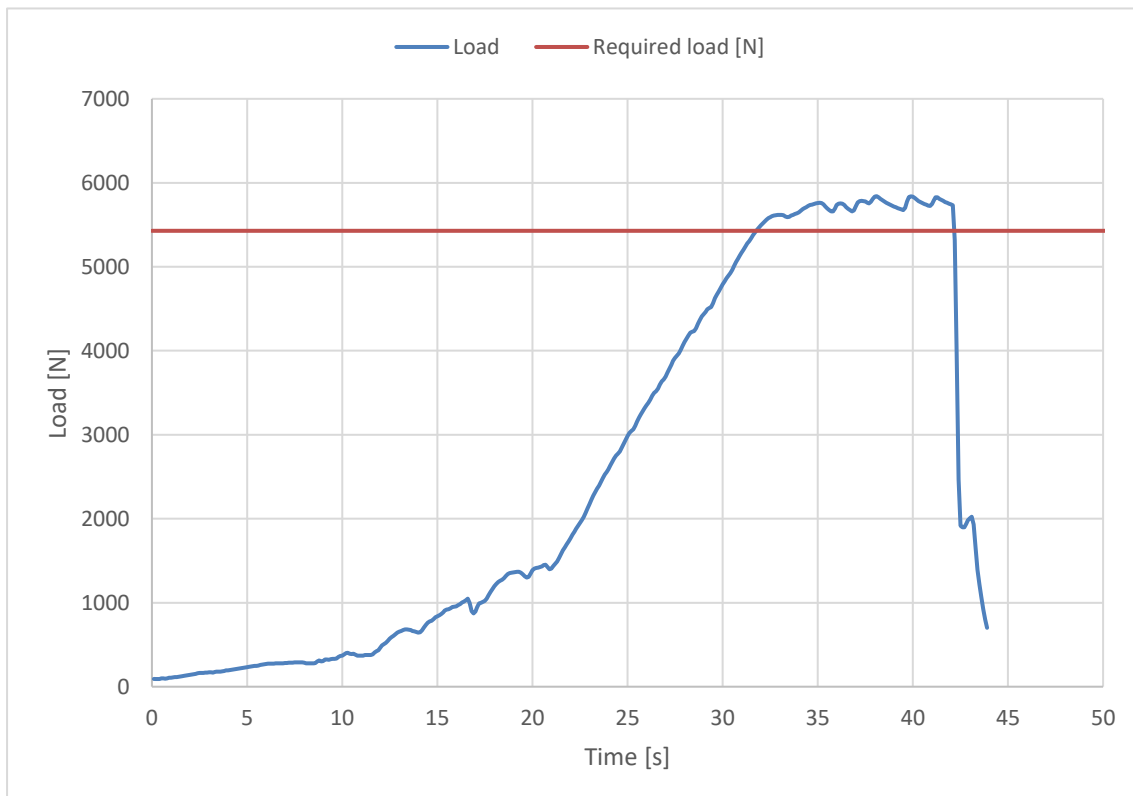
**Test ID 08**

Standard	<b>EN 1651</b>
Reference in standard	<b>5.5.1.9</b>
Test setup	<b>Anti falling-out system</b>
Attachment points	<b>Around anti falling-out system</b>
Anchor points	<b>Both main riser attachment (no dummy)</b>
Required load [g]	<b>4.5</b>
Required load [N]	<b>5400</b>
Minimum test duration [s]	<b>5</b>
<b>Result</b>	
Test duration [s]	<b>10.4</b>
Any signs of structural failure	<b>No</b>
Test results	<b>POSITIVE</b>

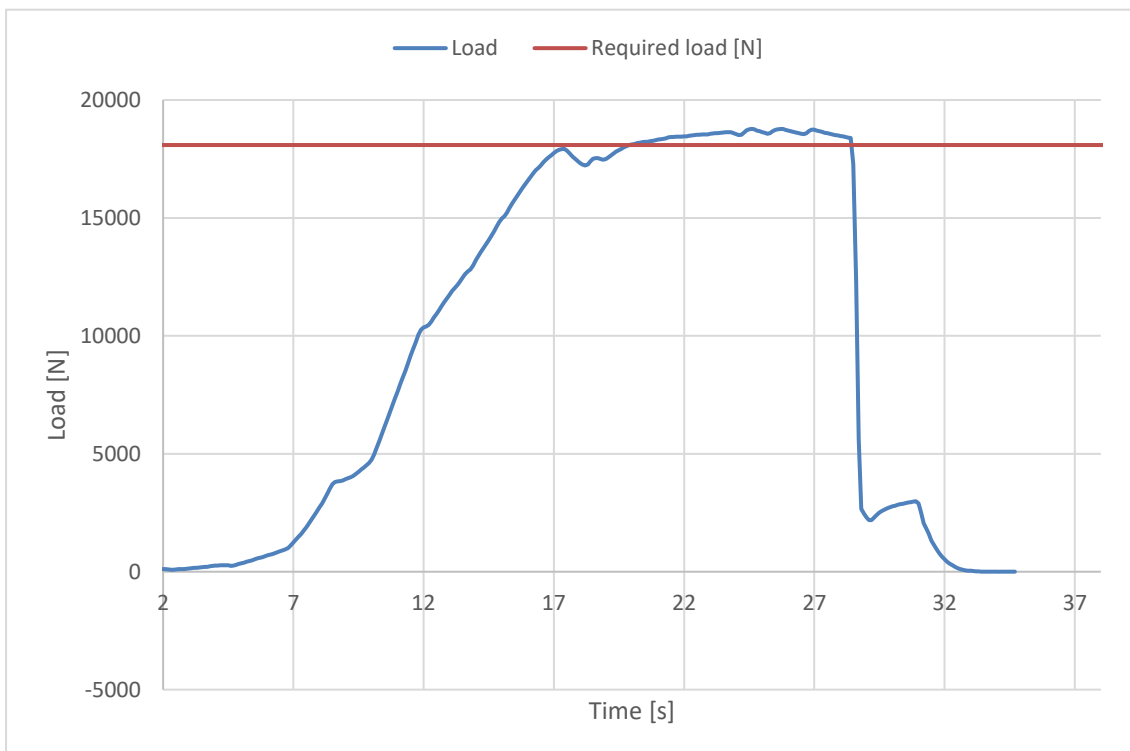
**Test ID 09**

Reference in standard	<b>5.5.1.3</b>	
Test setup	<b>Positive symmetric load rescue points</b>	
Attachment points	<b>Both main riser attachment (1,2)</b>	
Anchor points	<b>Dummy (B1,B2)</b>	
Required load [g]	<b>15</b>	
Required load [N]	<b>18000</b>	
Minimum test duration [s]	<b>5</b>	
<b>Result</b>		
Test duration [s]	<b>8.5</b>	
Any signs of structural failure	<b>No</b>	
Slippery test OK	<b>Yes</b>	
Test results	<b>POSITIVE</b>

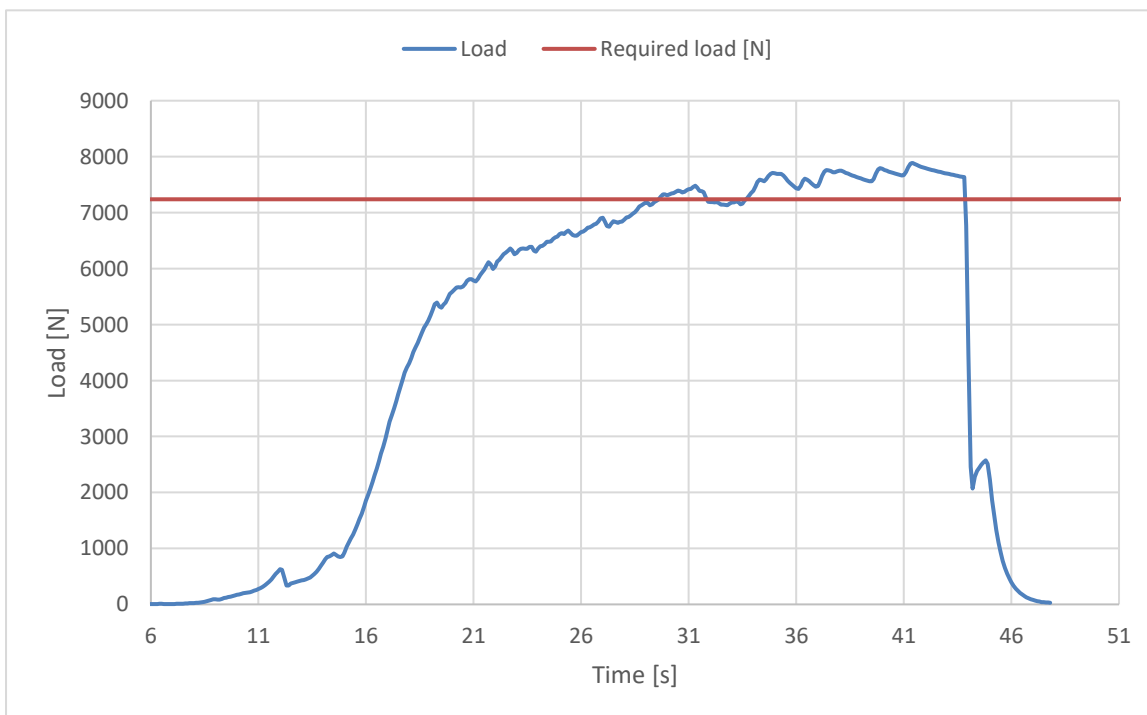
**Test ID 12**

Standard	<b>EN 1651</b>
Reference in standard	<b>5.5.1.7</b>
Test setup	<b>Upright (landing) position load</b>
Attachment points	<b>Both main riser attachment (3, 4)</b>
Anchor points	<b>Both legstrap of harness (no dummy)</b>
Required load [g]	<b>6</b>
Required load [N]	<b>7200</b>
Minimum test duration [s]	<b>5</b>
Harness type	<b>type a</b>
<b>Result</b>	
Test duration [s]	<b>10.2</b>
Any signs of structural failure	<b>No</b>
Slippery test OK	<b>Yes</b>
Test results	<b>POSITIVE</b>

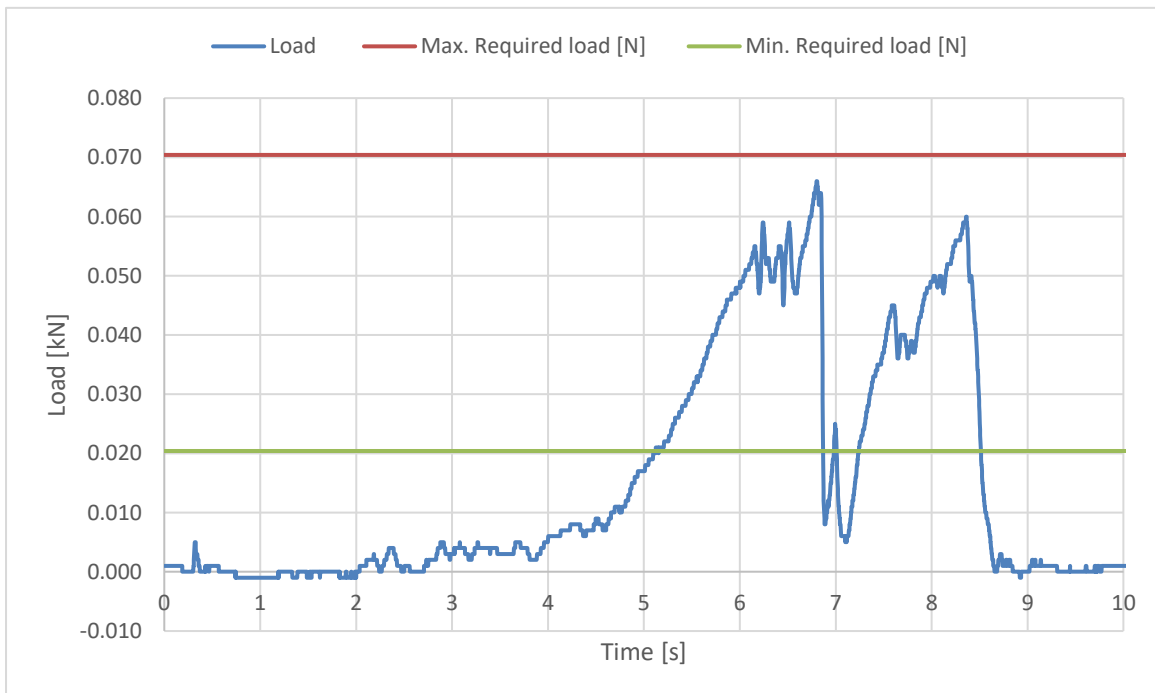
**Test ID RRDT**

Standard	<b>LTF NfL II 91/09</b>
Reference in standard	<b>6.1.5</b>
Test setup	<b>Default flying position</b>
Attachment points	<b>Sensor connect to handle, and pull in opening direction</b>
	The test is to simulate the load required to open the emergency parachute(1st action).
Min. Required load [N]	<b>20</b>
Max. Required load [N]	<b>70</b>
<b>Result</b>	
Load for first action [N]	<b>65.60</b>
Test results	<b>POSITIVE</b>

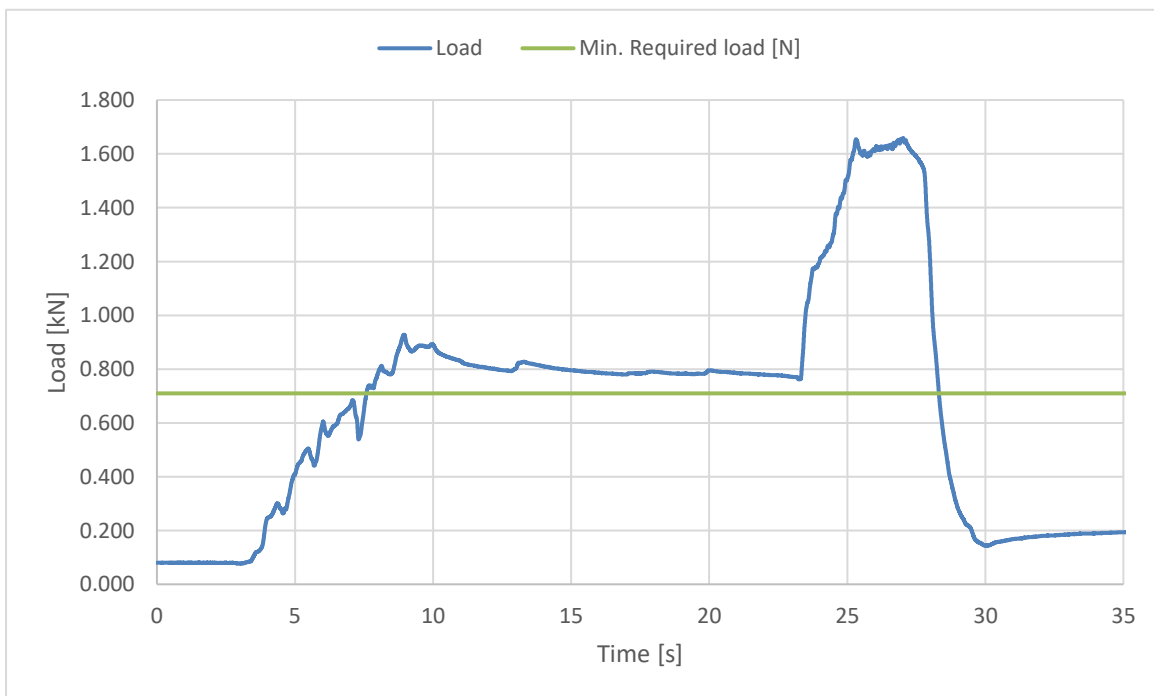
**Test ID RRST**

Standard	<b>EN12491:2015</b>
Reference in standard	<b>5.3.2</b>
Test setup	<b>Two end points of handle</b>
Attachment points	<b>Sensor connect to end of handle, pull on the other side</b>
	The handle must support min 700 N for 10 s, after measure breaking strength
Min. Required load [N]	<b>700</b>
Minimum test duration [s]	<b>10</b>
<b>Result</b>	
Test duration [s]:	<b>20.7</b>
Breaking strength [N]	<b>1649.03</b>
Test results	<b>POSITIVE</b>
