Harness Structural test Report - NfL

Inspection certificate number: **PH_413.2023**

Name: **TANDEM PASSENGER MUSEBAG**
 Type: **ABS**
 Size: **L**
 Serial number: **20**
 Impact pad type: ⁽¹⁾ **Foam**
 Clip-in weight [kg]: **100**
 Integrated container: **No**
 Date of test: **06.07.2023**

Summary of Structural test

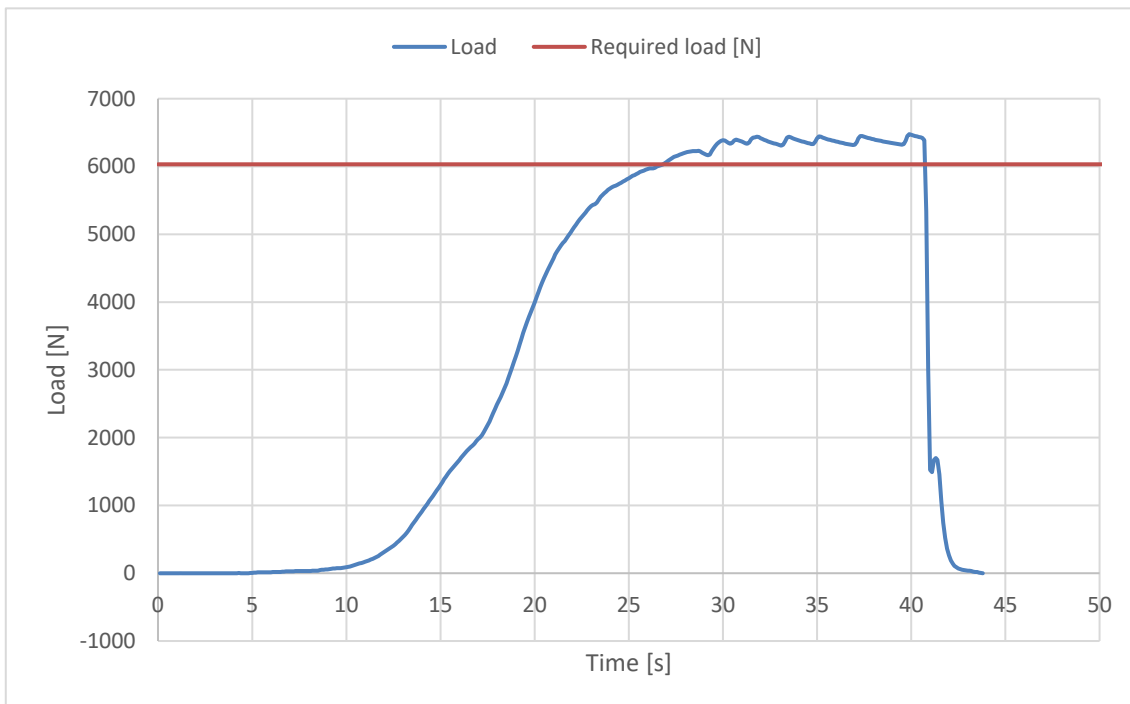
Test ID 02

Test duration [s] **13.9**
 Any signs of structural failure **No**
 Test results **POSITIVE**

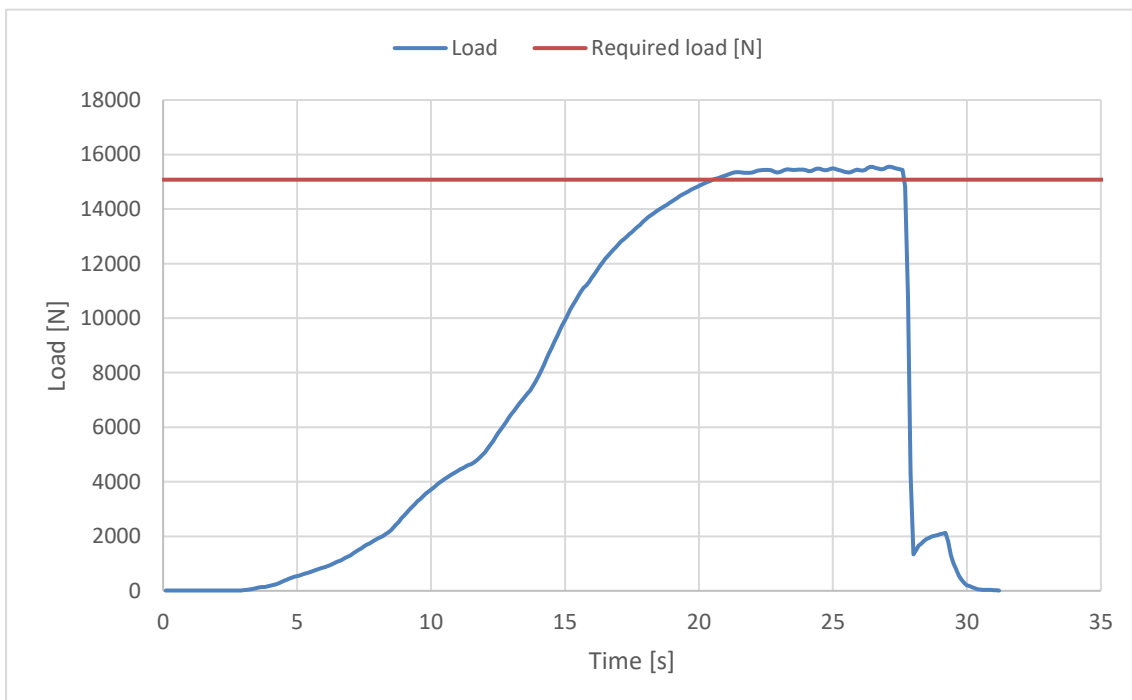
Test ID 03

Standard	EN 1651:1999
Reference	5.3.2.2
Test setup	Default flying position
Attachment points	Both main riser attachment (3,4)
Anchor points	Dummy (B1, B2)
Required load [g]	15
Required load [N]	15000
Minimum test duration [s]	5
Result	
Test duration [s]	7.1
Any signs of structural failure	No
Test results	POSITIVE

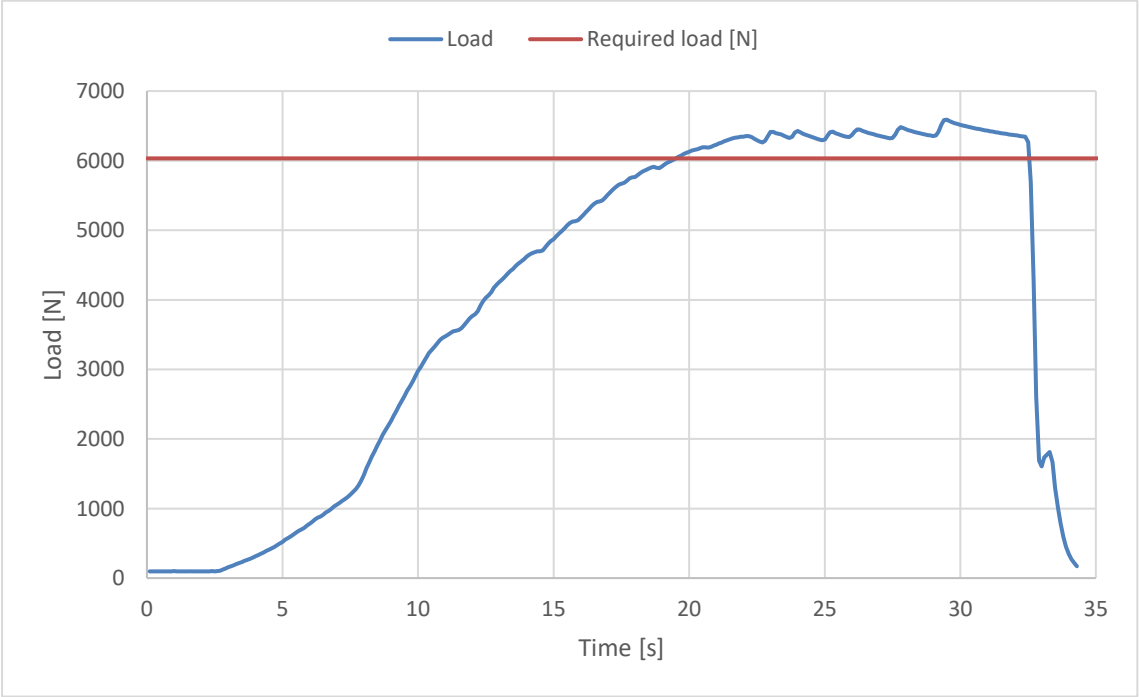
Test ID 04

Reference	5.3.2.3	
Test setup	Asymmetric, one riser	
Attachment points	One main riser attachment (3)	
Anchor points	Dummy (B1,B2)	
Required load [g]	6	
Required load [N]	6000	
Minimum test duration [s]	10	
Result		
Test duration [s]	13	
Any signs of structural failure	No	
Test results	POSITIVE

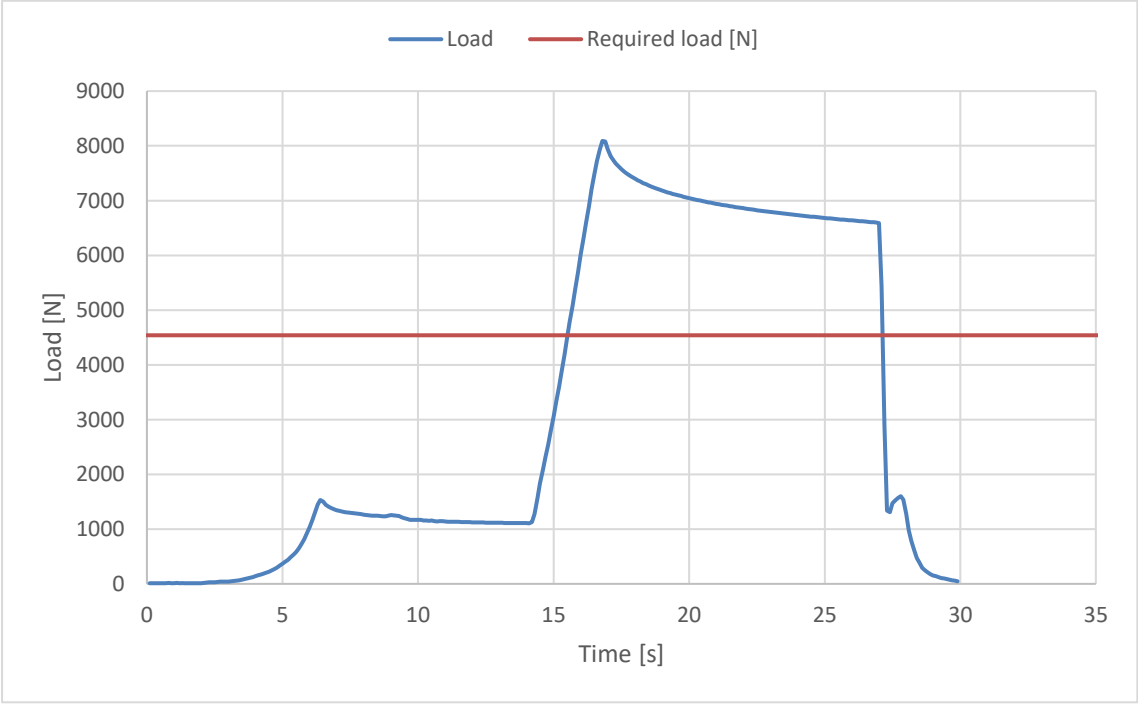
Test ID 07

Reference	5.3.2.6	
Test setup	Asymmetric, negative	
Attachment points	One main riser attachment (3 or 4) downwards	
Anchor points	Dummy (9)	
Required load [g]	4.5	
Required load [N]	4500	
Minimum test duration [s]	10	
Result		
Test duration [s]	11.6	
Any signs of structural failure	No	
Test results	POSITIVE

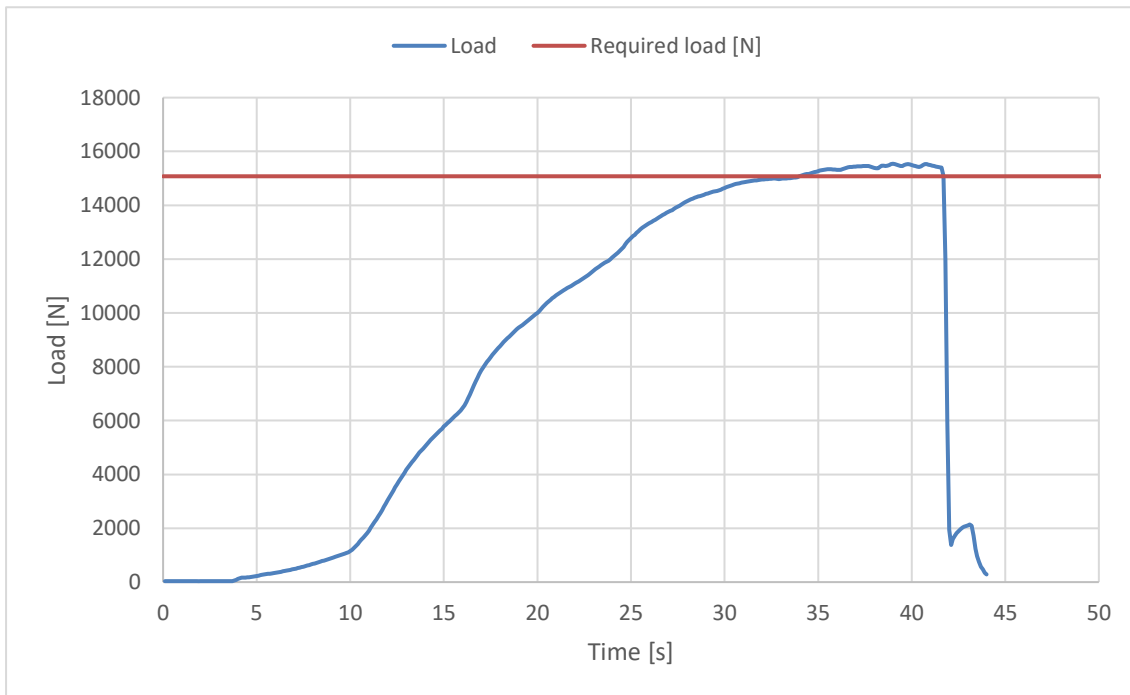
Test ID 13

Standard	EN 1651:1999
Reference	5.3.2.7
Test setup	Flying position before landing
Attachment points	Both main riser attachment (3,4)
Anchor points	Dummy (7,8)
Required load [g]	15
Required load [N]	15000
Minimum test duration [s]	5
Result	
Test duration [s]	7.7
Any signs of structural failure	No
Test results	POSITIVE
