## Harness Structural test Report - EN / NfL

Inspection certificate number: **PH\_467.2025**

Name: **Passenger**  
 Type: **ABS**  
 Size: **L**  
 Serial number: **TP0000**  
 Impact pad type: <sup>(1)</sup> **Foam**  
 Clip-in weight [kg]: **120**

**EN1651:2018+A1:2020 and EN12491:2015+A1:2021 and NFL 2024-2-785**

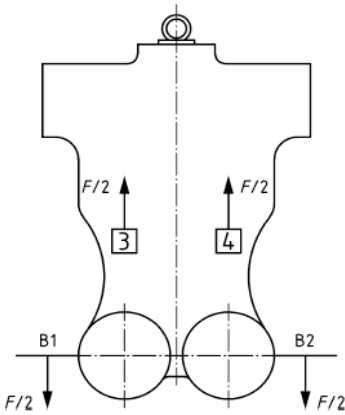
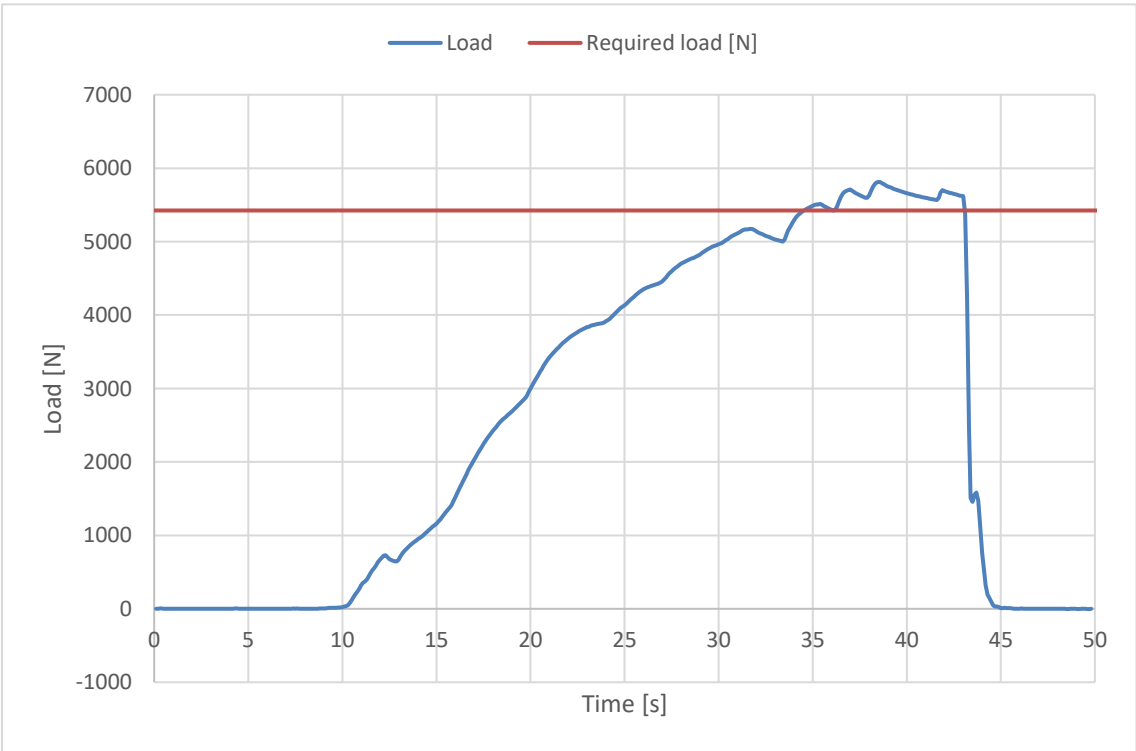
**Test ID 01**

Test duration [s] **6.9**  
Any signs of structural failure **No**  
Slippery test OK **Yes**  
Test results **POSITIVE**

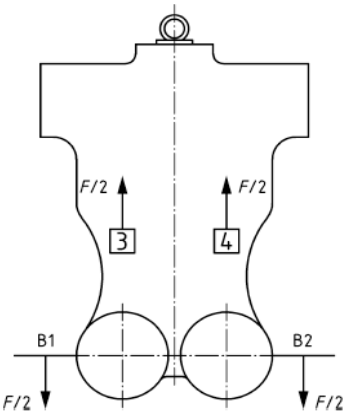
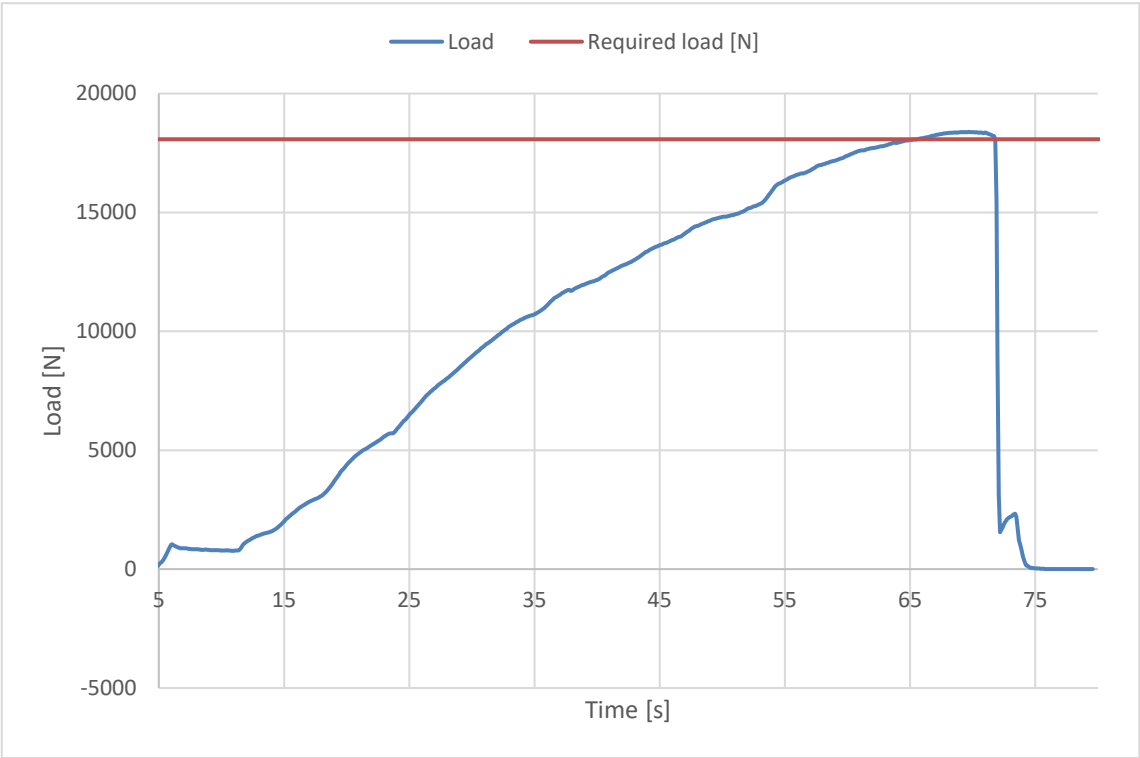
Test ID 03

Any signs of structural failureNo

Test resultsPOSITIVE

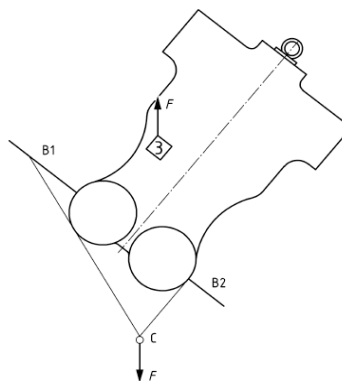
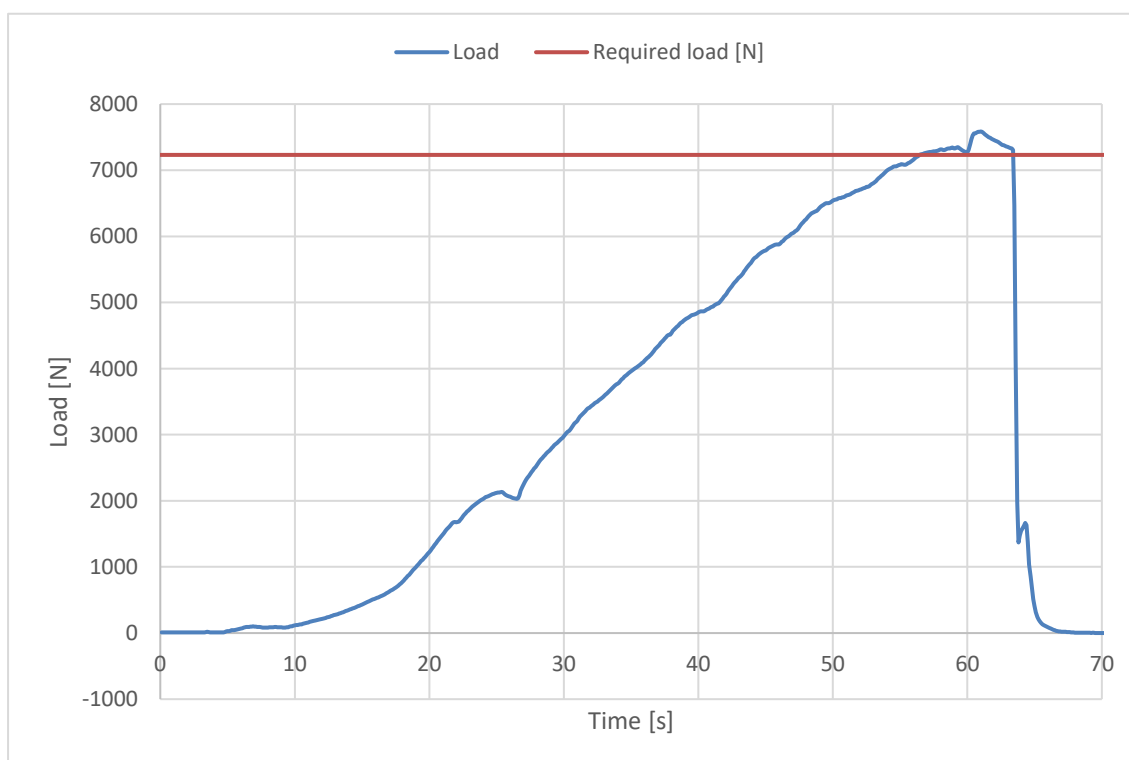
**Test ID 05**

| Any signs of structural failure | No |
| Test results | <b>POSITIVE</b> |

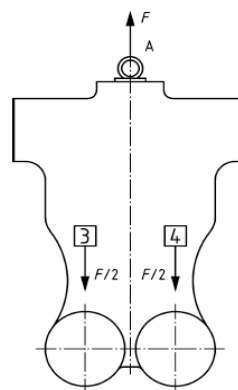
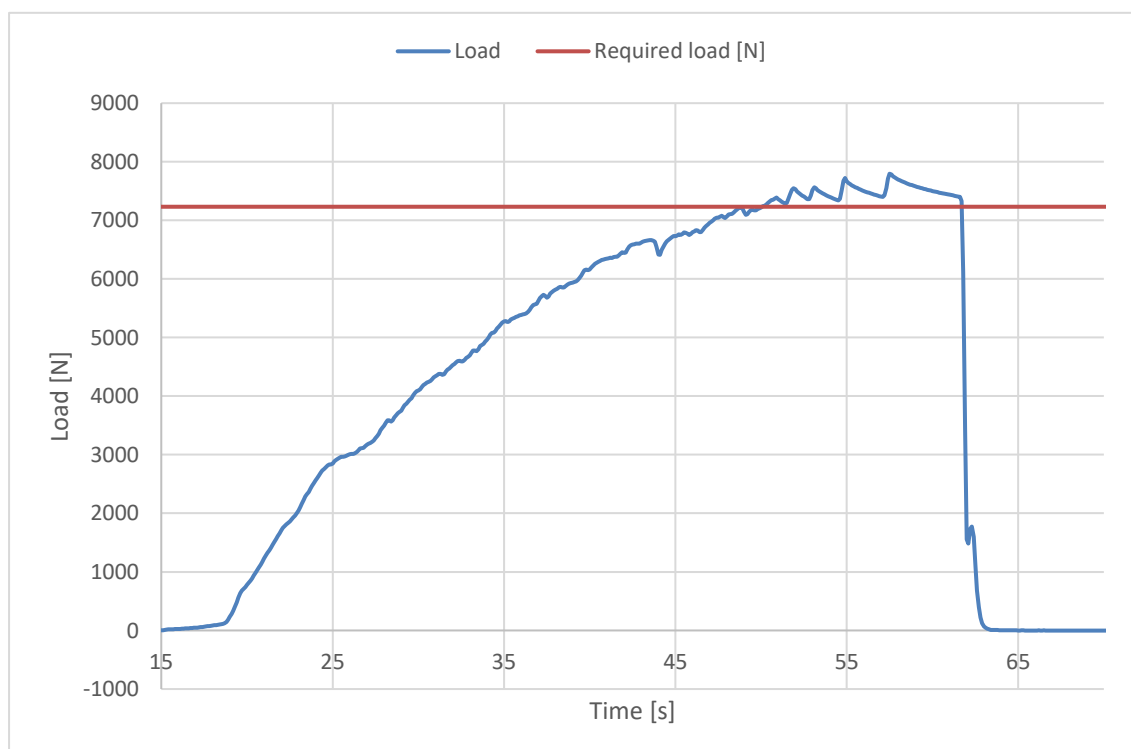
Test ID 06

| Any signs of structural failure | <b>No</b> |
| Test results | <b>POSITIVE</b> |

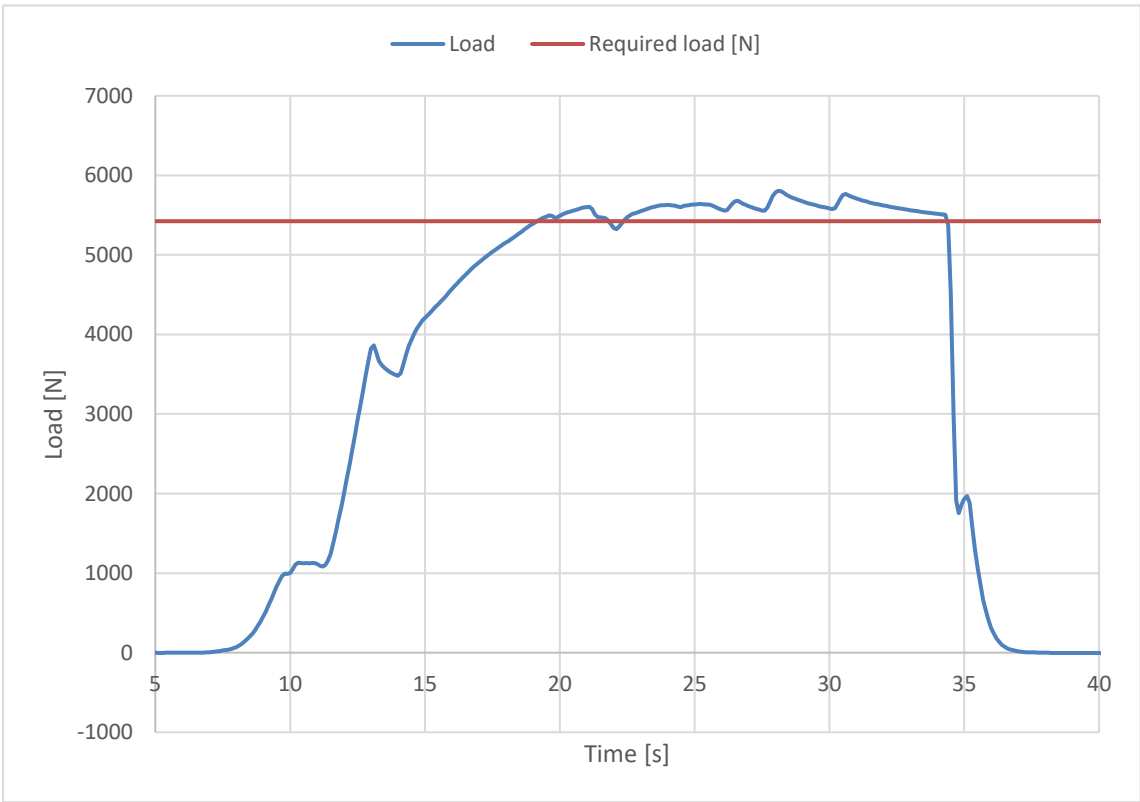
**Harness Structural test** **Test ID 08**

| Any signs of structural failure | No |
| Test results | POSITIVE |

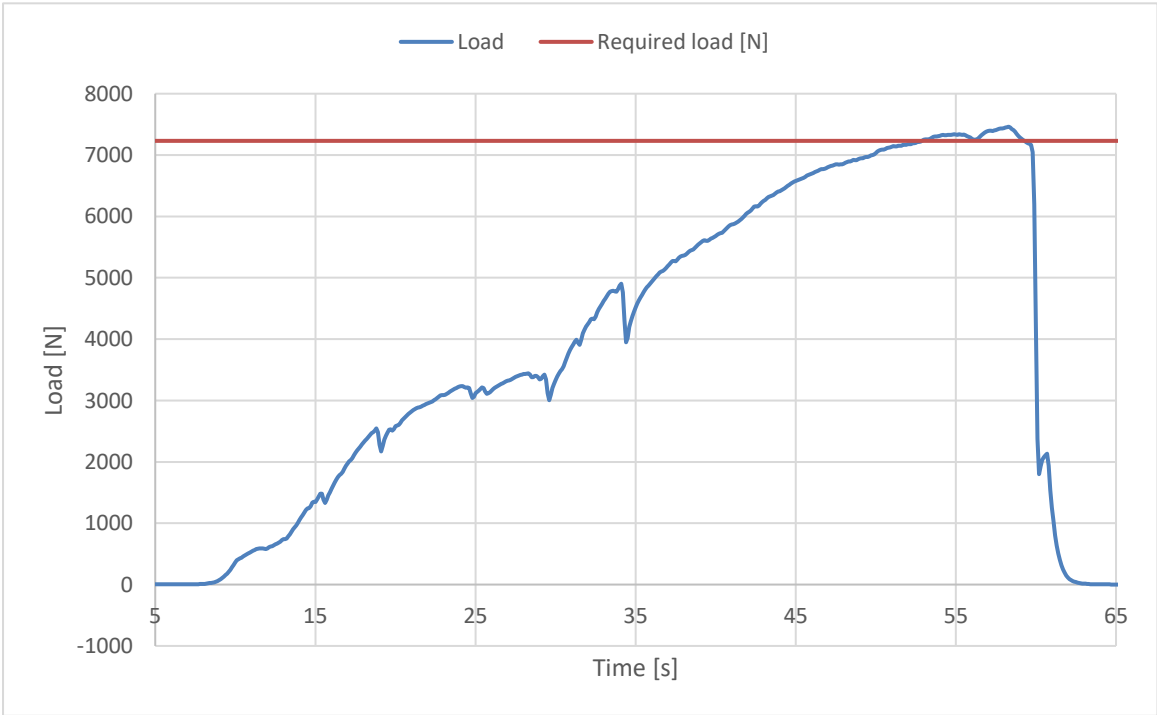
**Harness Structural test** Test ID 12

| Any signs of structural failure | No |
| Test results | POSITIVE |
