Harness Structural test Report - LTF

Inspection certificate number: **PH_317.2020**

Name: **Arrow**
 Type: **ABS**
 Size: **L**
 Serial number: **Arrow L-V8**
 Impact pad type: ⁽¹⁾ **Foam**
 Clip-in weight [kg]: **120**

Date of test: **22.10.2020**

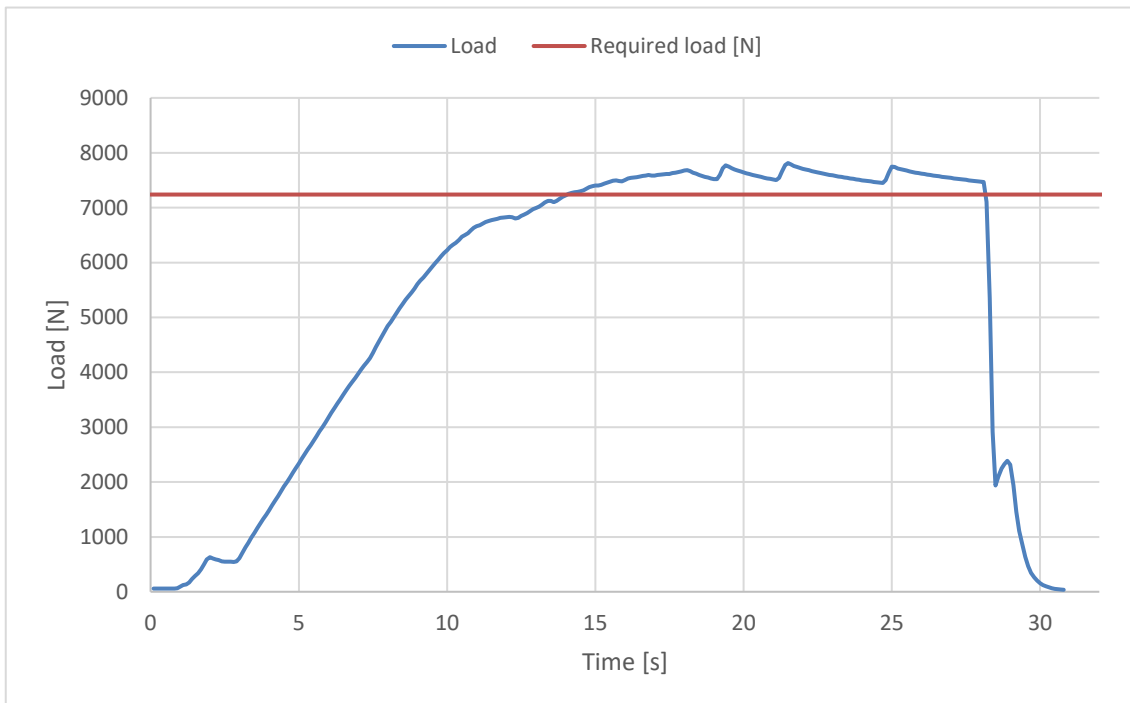
Test ID 02

Test duration [s] **14.1**
 Any signs of structural failure **No**
 Test results **POSITIVE**

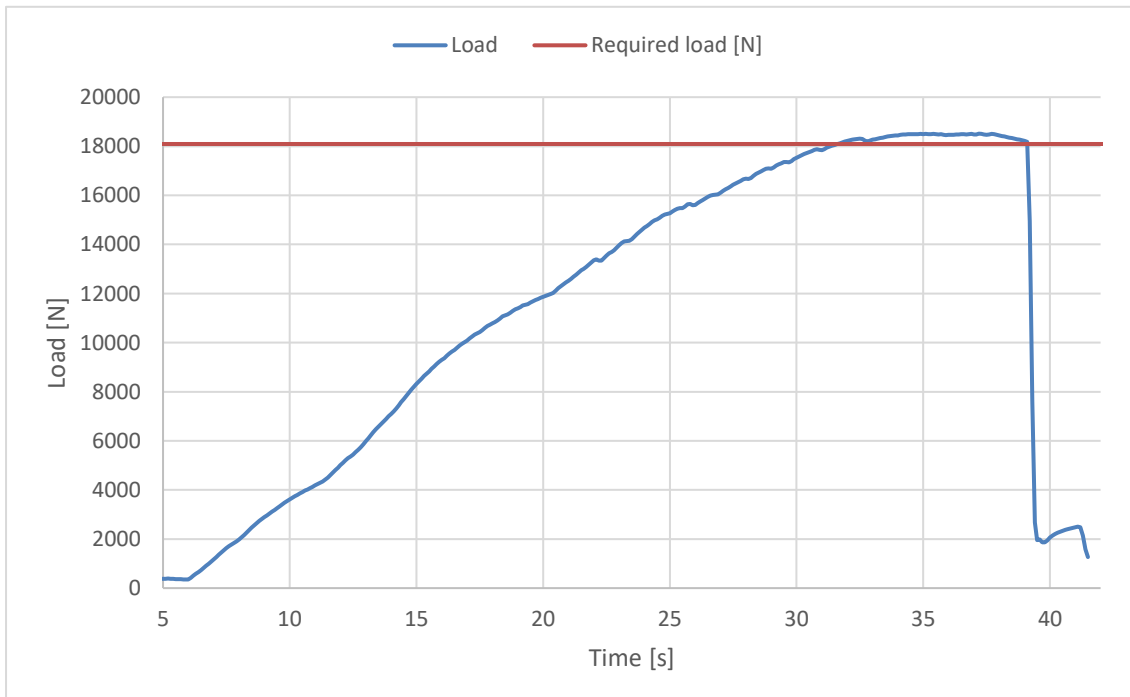
Test ID 03

Test duration [s] **7.5**
 Any signs of structural failure **No**
 Test results **POSITIVE**

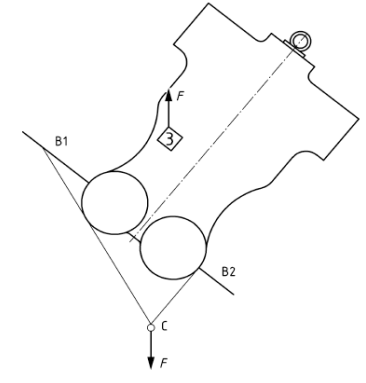
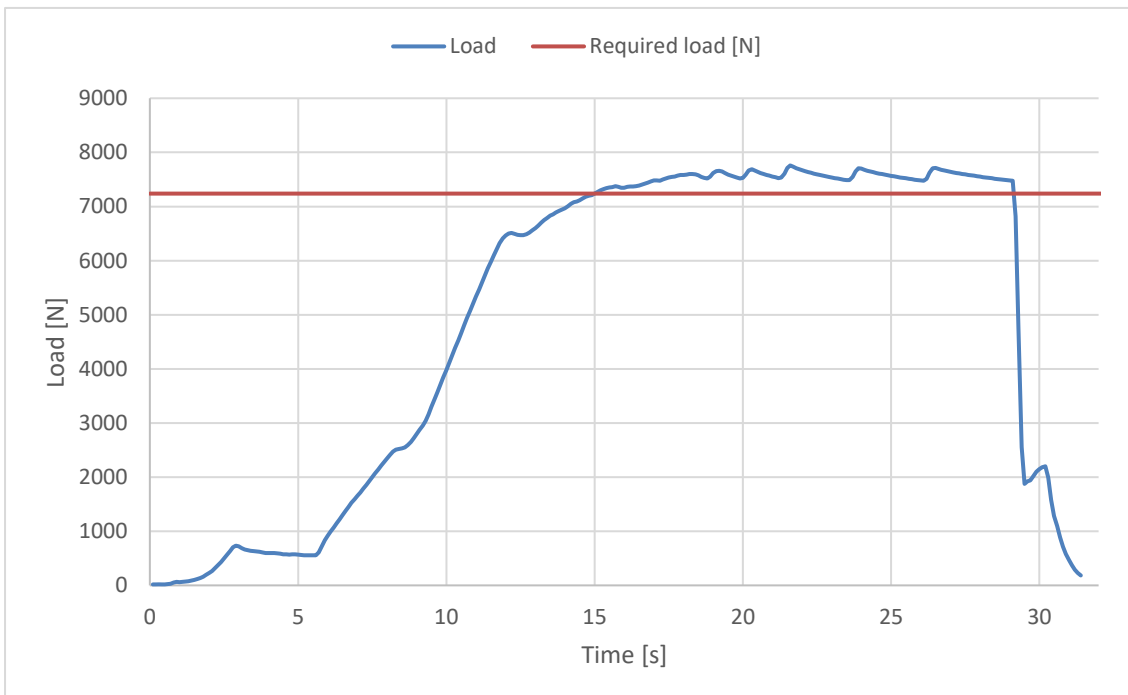
Test ID 04

Standard	LTF NfL II 91/09
Reference	5.3.2.3
Test setup	Asymmetric, one riser
Attachment points	One main riser attachment (3)
Anchor points	Dummy (B1,B2)
Required load [g]	6
Required load [N]	7200
Minimum test duration [s]	10
Result	
Test duration [s]	14.1
Any signs of structural failure	No
Test results	POSITIVE

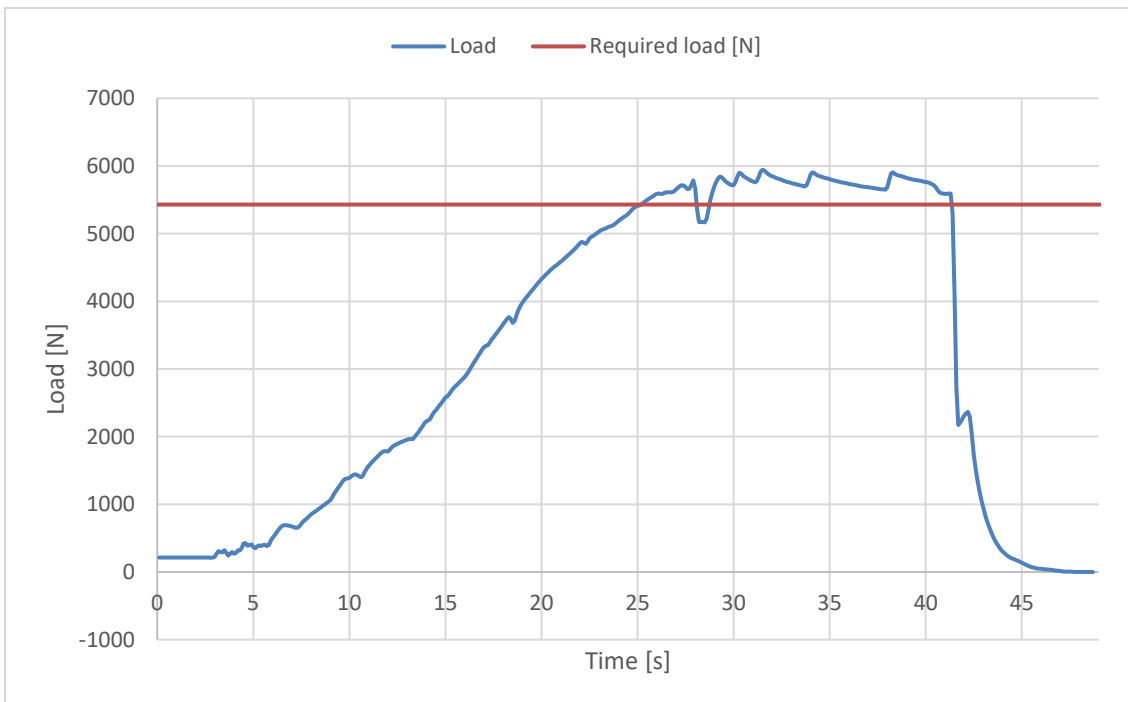
Test ID 07

Standard	LTF NfL II 91/09
Reference	5.3.2.6
Test setup	Asymmetric, negative
Attachment points	One main riser attachment (3 or 4) downwards
Anchor points	Dummy (9)
Required load [g]	4.5
Required load [N]	5400
Minimum test duration [s]	10
Result	
Test duration [s]	12.6
Any signs of structural failure	No
Test results	POSITIVE

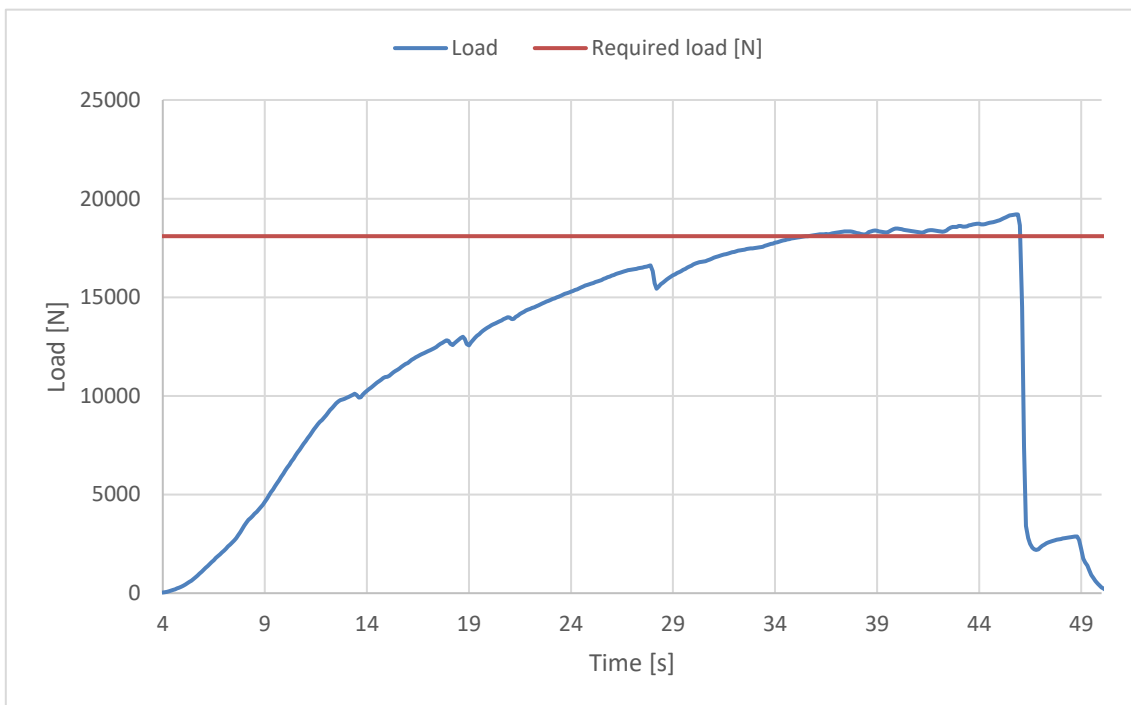
Test ID 09

Standard	LTF NfL II 91/09
Reference	5.3.2.4
Test setup	Rescue attachments
Attachment points	Rescue riser attachment (1,2)
Anchor points	Dummy (B1,B2)
Required load [g]	15
Required load [N]	18000
Minimum test duration [s]	5
Result	
Test duration [s]	10.4
Any signs of structural failure	No
Test results	POSITIVE

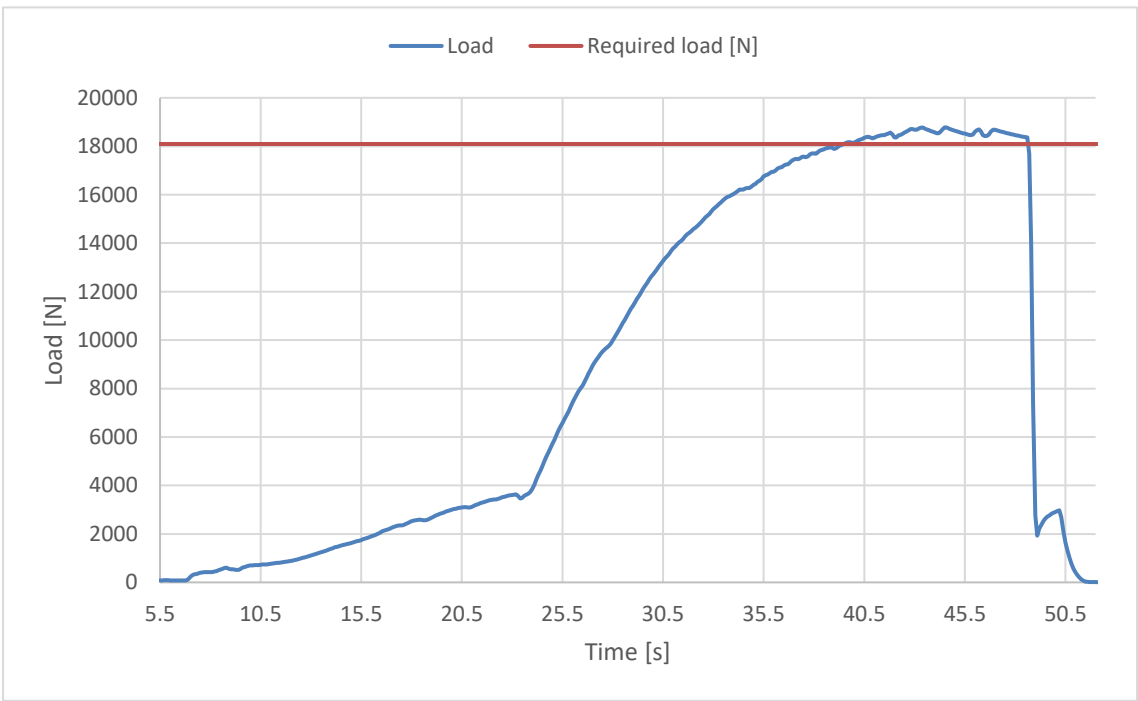
Test ID 13

Standard	LTF NfL II 91/09
Reference	5.3.2.7
Test setup	Flying position before landing
Attachment points	Both main riser attachment (3,4)
Anchor points	Dummy (7,8)
Required load [g]	15
Required load [N]	18000
Minimum test duration [s]	5
Result	
Test duration [s]	9.2
Any signs of structural failure	No
Test results	POSITIVE

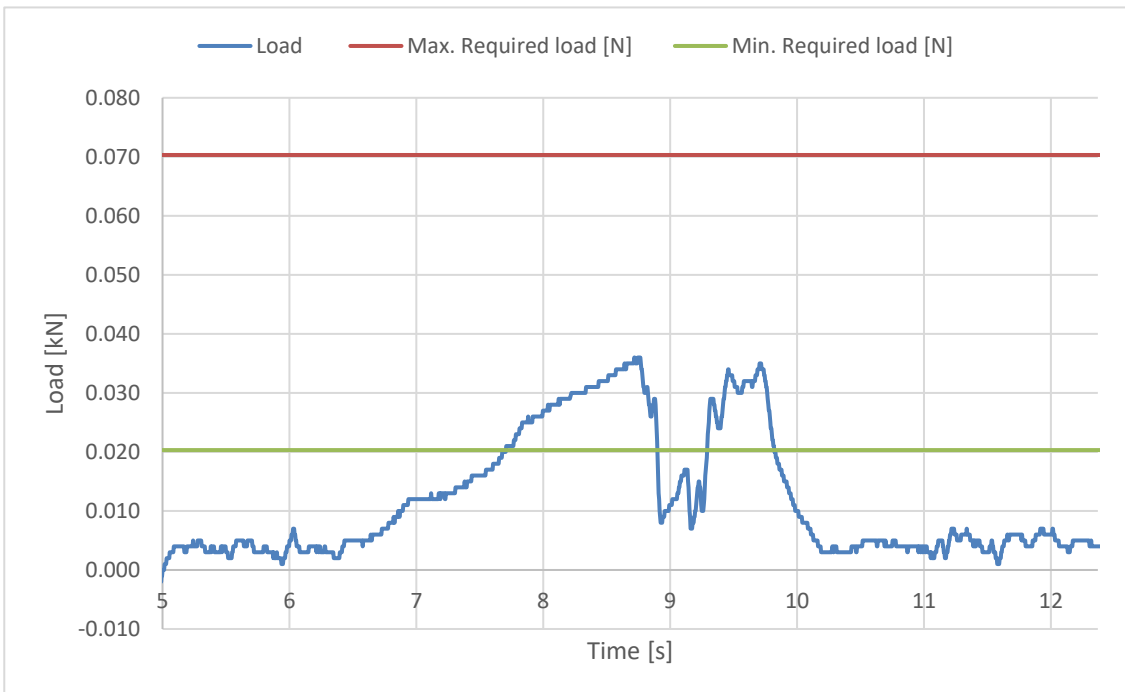
Test ID RRDT

Standard	LTF NfL II 91/09
Reference	6.1.5
Test setup	Default flying position
Attachment points	Sensor connect to handle, and pull in opening direction The test is to simulate the load required to open the emergency parachute(1st action).
Min. Required load [N]	20
Max. Required load [N]	70
Result	
Load for first action [N]	35.69
Test results	POSITIVE

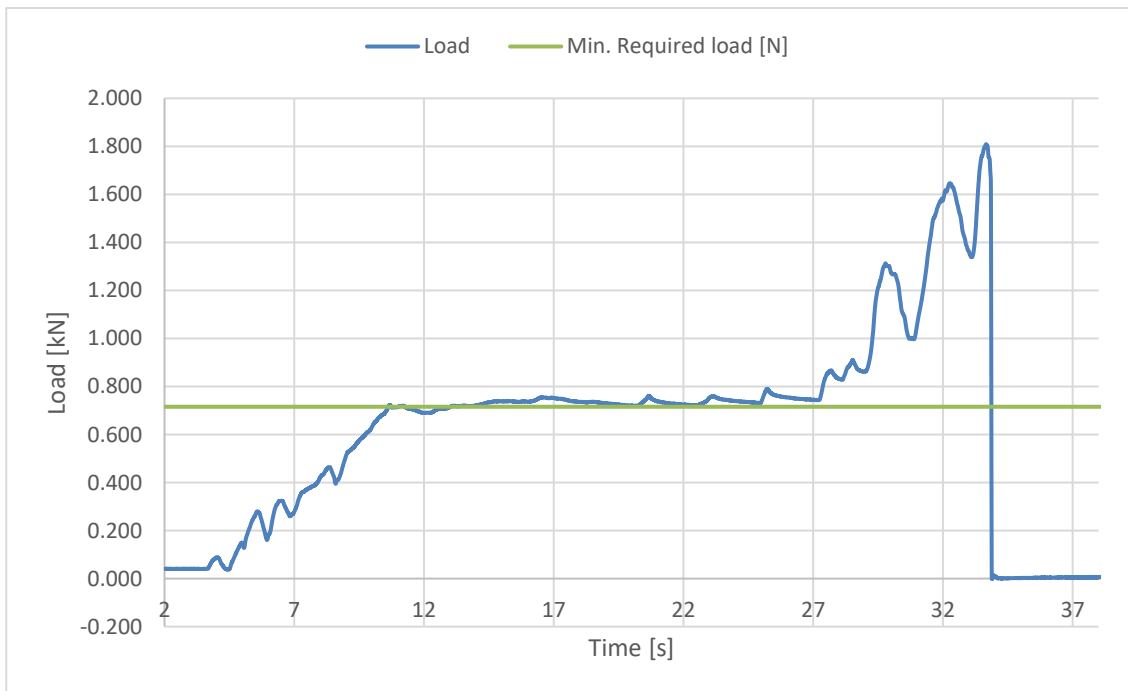
Test ID RRST

Standard	EN12491:2015
Reference in standard	5.3.2
Test setup	Two end points of handle
Attachment points	Sensor connect to end of handle, pull on the other side
	The handle must support min 700 N for 10 s, after measure breaking strength
Min. Required load [N]	700
Minimum test duration [s]	10
Result	
Test duration [s]:	20.8
Breaking strength [N]	1793.31
Test results	POSITIVE
