# Harness Structural test Report - EN

Inspection certificate number: **PH\_407.2023**

Name: **Arrow P**  
 Type: **ABS**  
 Size: **M**  
 Serial number: **PMV6\_V2**  
 Impact pad type: <sup>(1)</sup> **Foam**  
 Clip-in weight [kg]: **120**

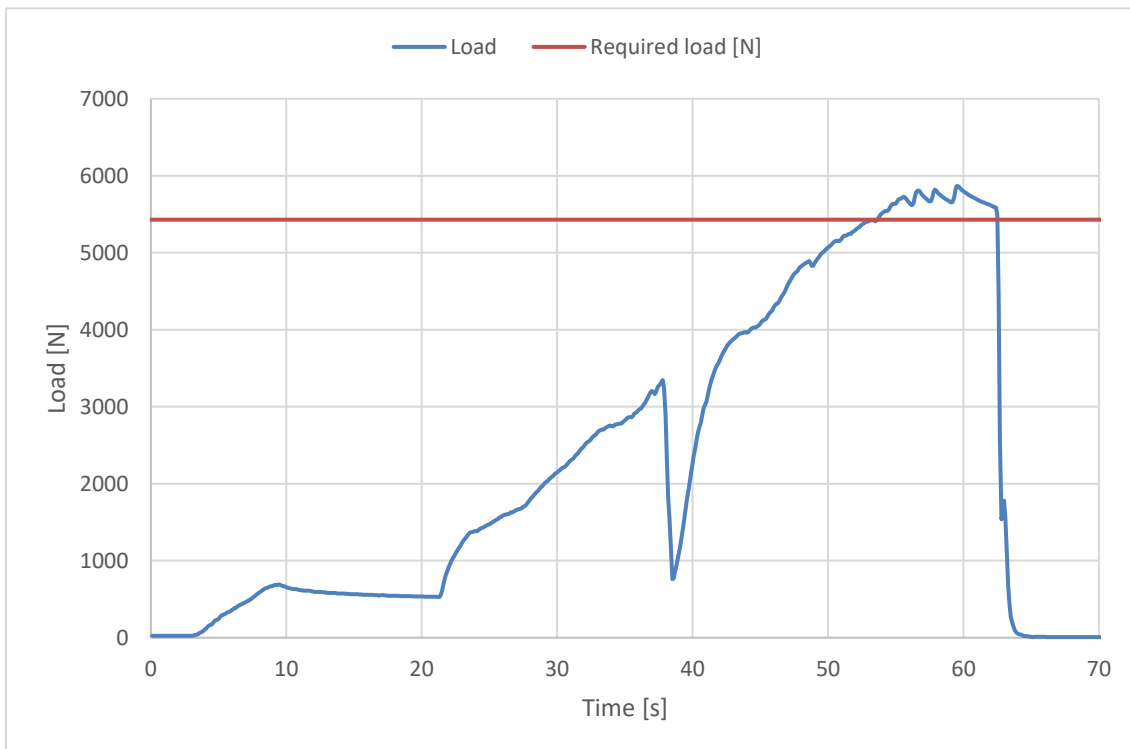
**Test ID 01**

Standard **EN 1651**  
 Reference in standard **5.5.1.1**  
 Test setup **Positive symmetric load (Slippage)**  
 Attachment points **Both main riser attachment (3,4)**  
 Anchor points **Dummy (B1, B2)**

Test duration [s] **8.9**  
 Any signs of structural failure **No**  
 Slippery test OK **Yes**  
 Test results **POSITIVE**

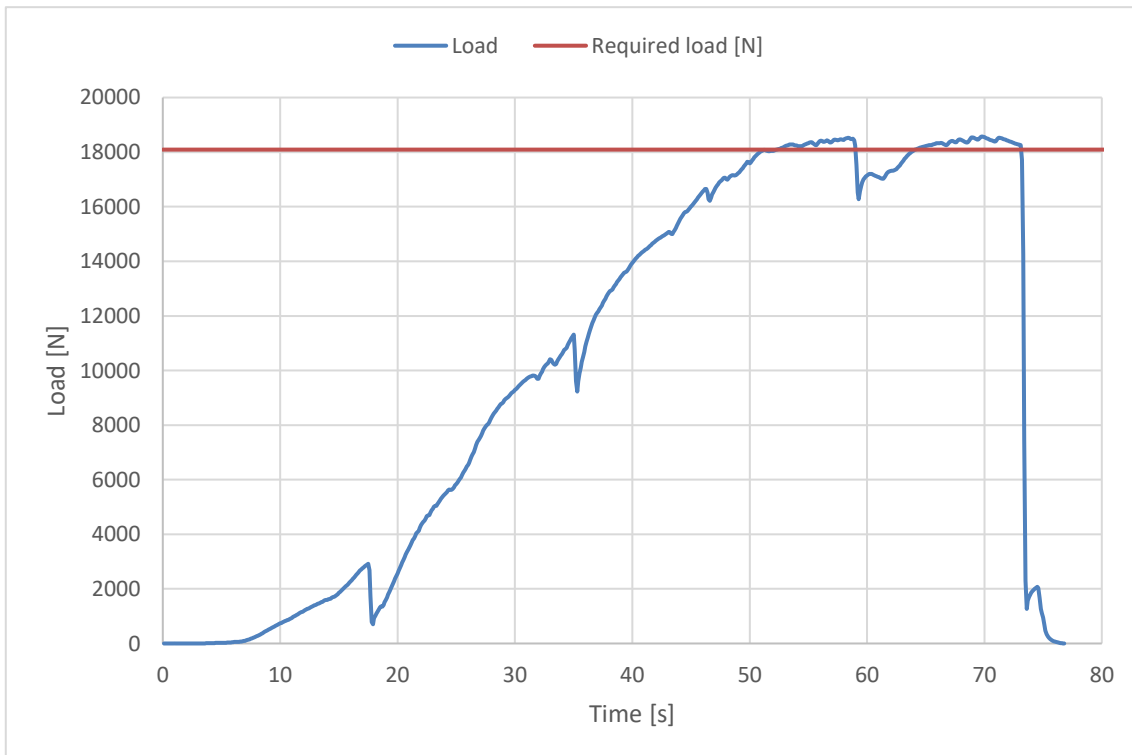
**Test ID 03**

Standard **EN 1651**  
 Reference in standard **5.5.1.1b**  
 Test setup **Positive symmetric load**  
 Attachment points **Both main riser attachment (3,4)**  
 Anchor points **Dummy (B1, B2)**

Test duration [s] **9**  
 Any signs of structural failure **No**  
 Slippery test OK **Yes**  
 Test results **POSITIVE**

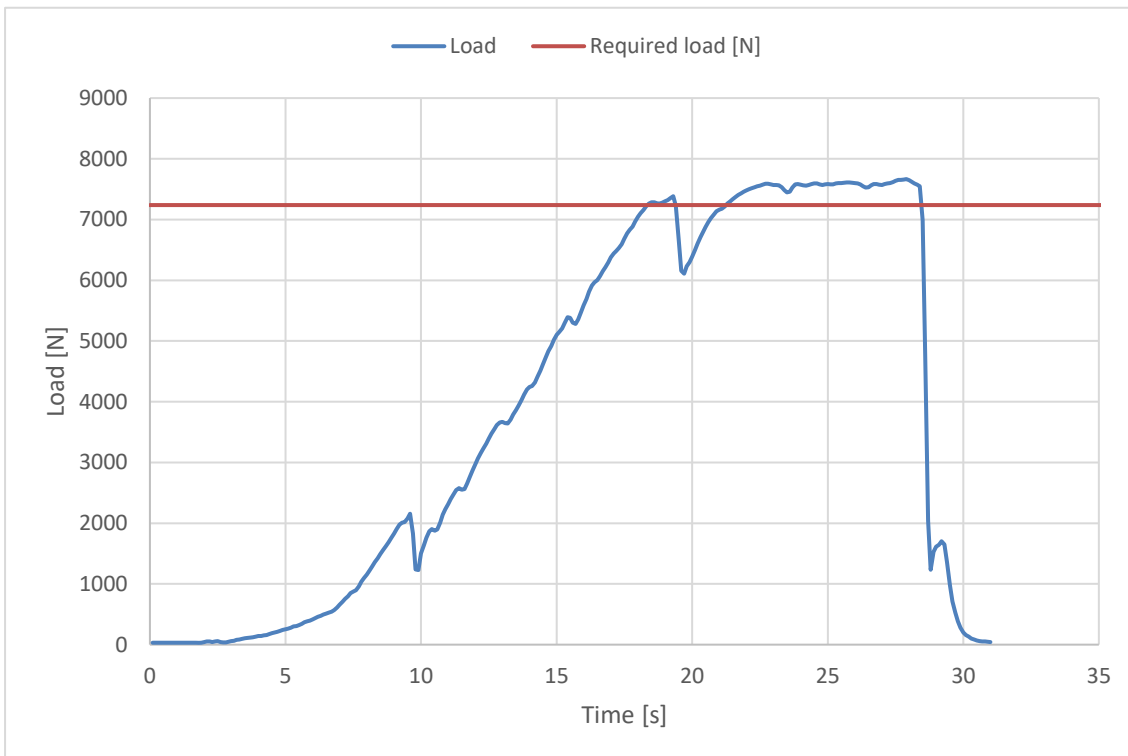
**Test ID 05**

Standard	<b>EN 1651</b>
Reference in standard	<b>5.5.1.2</b>
Test setup	<b>Positive asymmetric load</b>
Attachment points	<b>One riser attachment (3 or 4)</b>
Anchor points	<b>Dummy (C)</b>
Required load [g]	<b>6</b>
Required load [N]	<b>7200</b>
Minimum test duration [s]	<b>5</b>
<b>Result</b>	
Test duration [s]	<b>7.2</b>
Any signs of structural failure	<b>No</b>
Test results	<b>POSITIVE</b>

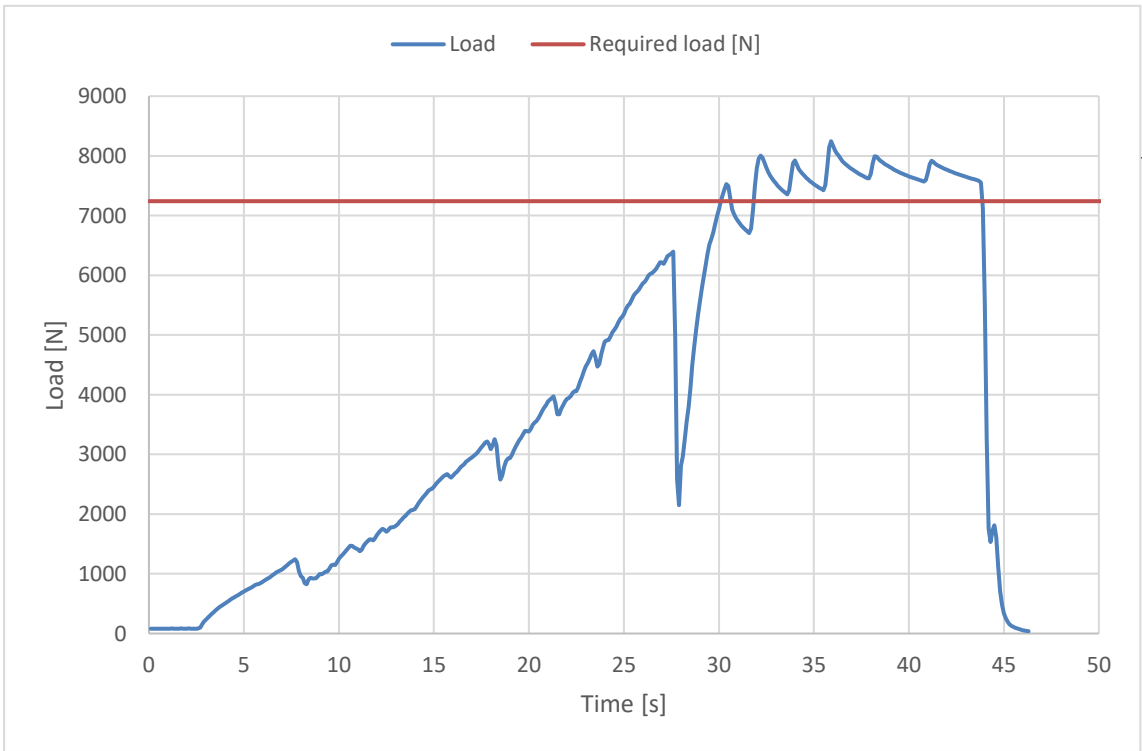
**Test ID 06**

Standard	<b>EN 1651</b>
Reference in standard	<b>5.5.1.6</b>
Test setup	<b>Negative symmetric load</b>
Attachment points	<b>Both main riser attachment (3,4)</b>
Anchor points	<b>Dummy (A)</b>
Required load [g]	<b>6</b>
Required load [N]	<b>7200</b>
Minimum test duration [s]	<b>5</b>
<b>Result</b>	
Test duration [s]	<b>12</b>
Any signs of structural failure	<b>No</b>
Test results	<b>POSITIVE</b>

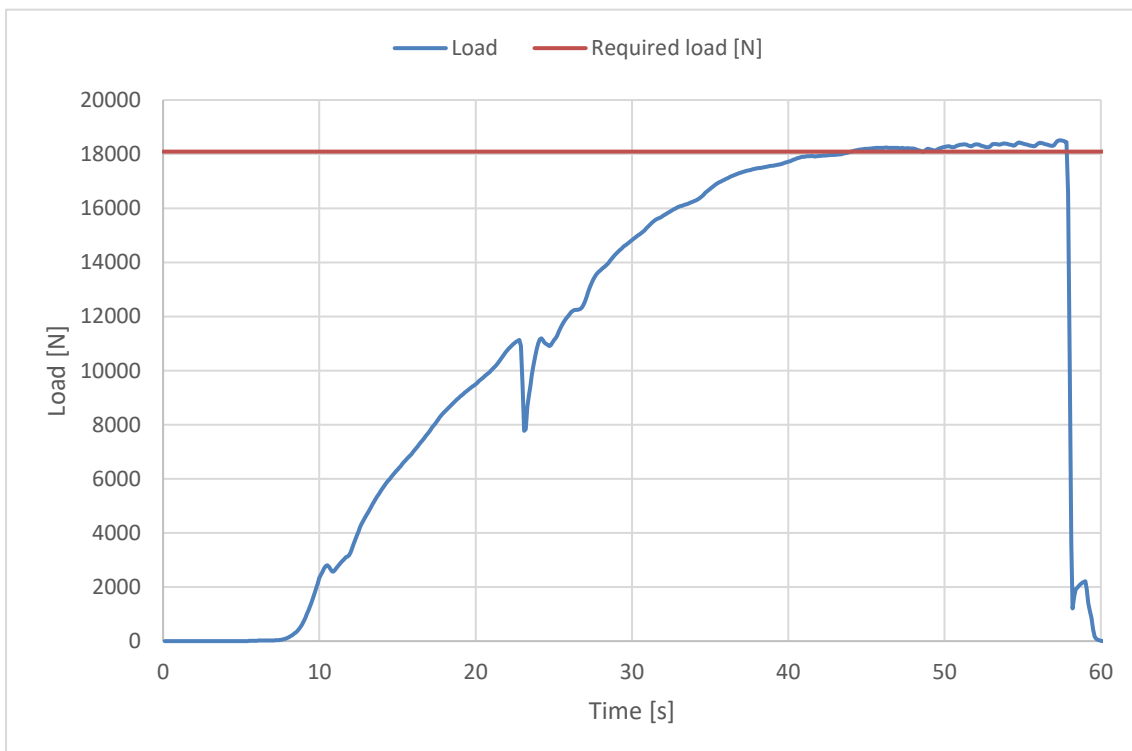
**Test ID 09**

Standard	<b>EN 1651</b>
Reference in standard	<b>5.5.1.3</b>
Test setup	<b>Positive symmetric load rescue points</b>
Attachment points	<b>Both main riser attachment (1,2)</b>
Anchor points	<b>Dummy (B1,B2)</b>
Required load [g]	<b>15</b>
Required load [N]	<b>18000</b>
Minimum test duration [s]	<b>5</b>
<b>Result</b>	
Test duration [s]	<b>13.8</b>
Any signs of structural failure	<b>No</b>
Slippery test OK	<b>Yes</b>
Test results	<b>POSITIVE</b>

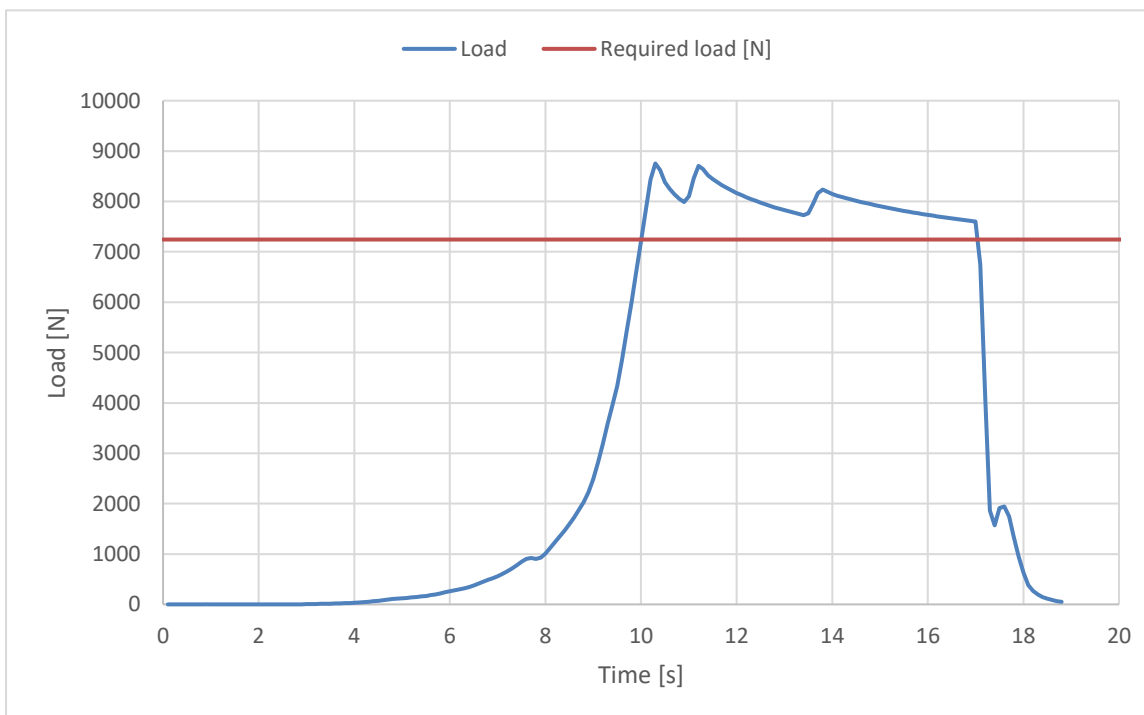
**Test ID 12**

Standard	<b>EN 1651</b>
Reference in standard	<b>5.5.1.7</b>
Test setup	<b>Upright (landing) position load</b>
Attachment points	<b>Both main riser attachment (3, 4)</b>
Anchor points	<b>Both legstrap of harness (no dummy)</b>
Required load [g]	<b>6</b>
Required load [N]	<b>7200</b>
Minimum test duration [s]	<b>5</b>
Harness type	<b>type b</b>
<b>Result</b>	
Test duration [s]	<b>7</b>
Any signs of structural failure	<b>No</b>
Slippery test OK	<b>Yes</b>
Test results	<b>POSITIVE</b>

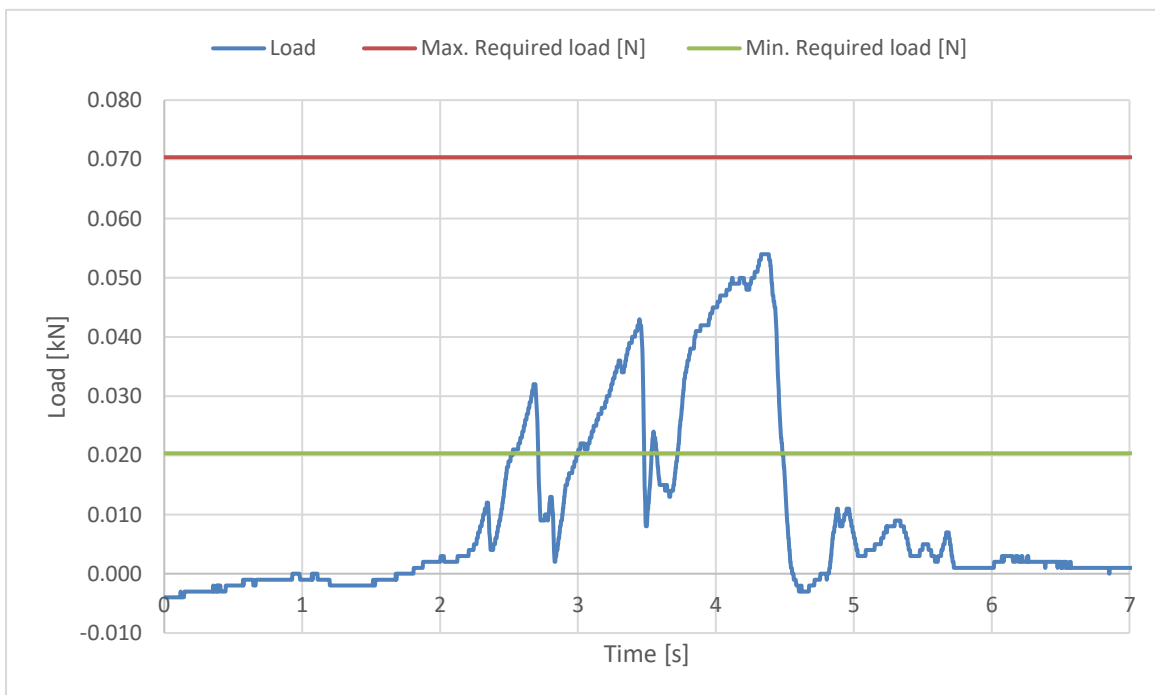
**Test ID RRDT**

Standard	<b>EN 1651</b>
Reference in standard	<b>5.5.1.11</b>
Test setup	<b>Default flying position</b>
Attachment points	<b>Sensor connect to handle, and pull in opening direction</b>
	The test is to simulate the load required to open the emergency parachute(1st action).
Min. Required load [N]	<b>20</b>
Max. Required load [N]	<b>70</b>
<b>Result</b>	
Load for first action [N]	<b>54.36</b>
Test results	<b>POSITIVE</b>

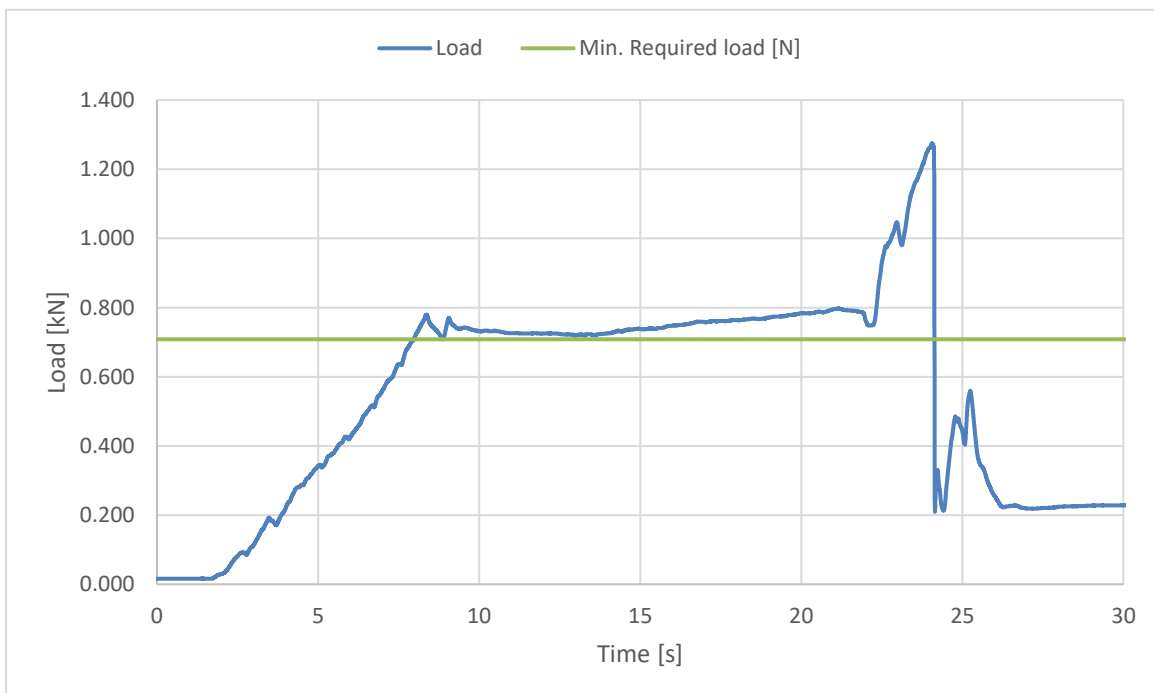
**Test ID RRST**

Standard	<b>EN 12491</b>
Reference in standard	<b>5.3.2</b>
Test setup	<b>Two end points of handle</b>
Attachment points	<b>Sensor connect to end of handle, pull on the other side</b>
	The handle must support min 700 N for 10 s, after measure breaking strength
Min. Required load [N]	<b>700</b>
Minimum test duration [s]	<b>10</b>
<b>Result</b>	
Test duration [s]:	<b>15.2</b>
Breaking strength [N]	<b>1267.52</b>
Test results	<b>POSITIVE</b>
